Site Investigation Report

Site: 16 Provost Road, NW3 4ST

Report Date: July 2014

Project Reference: J11866

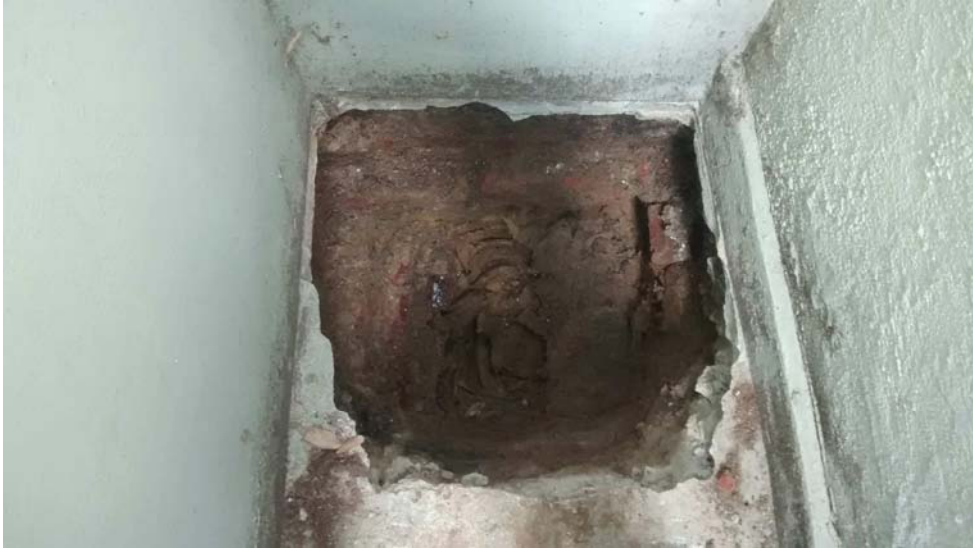
Photo showing TP1.

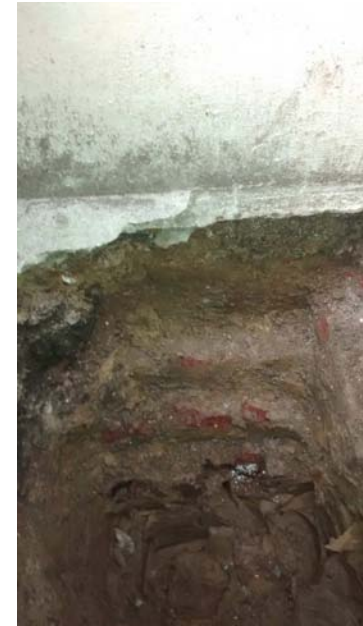
Brick Corbels on left hand section of TP1.

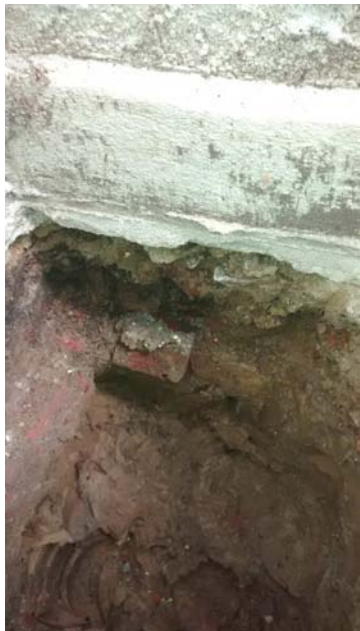
Brick foundation on right hand side of TP1.

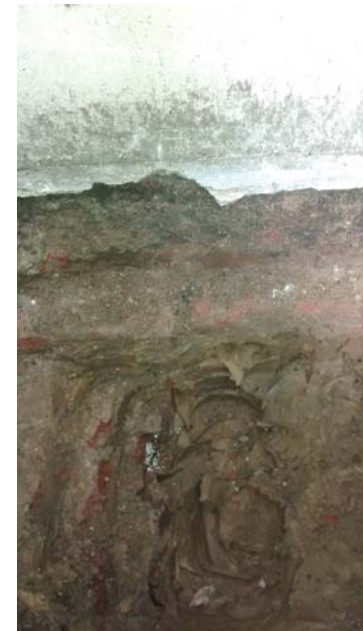
Brick foundation in central section of TP1.

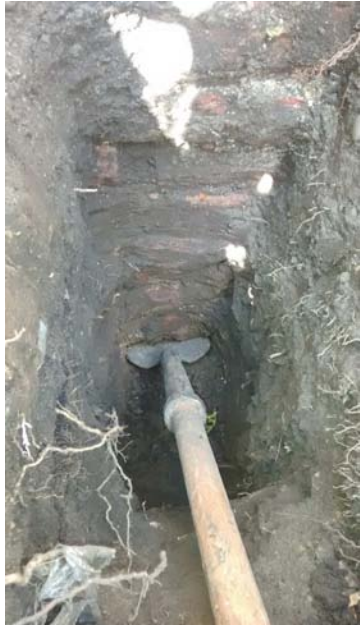
Photo showing TP2

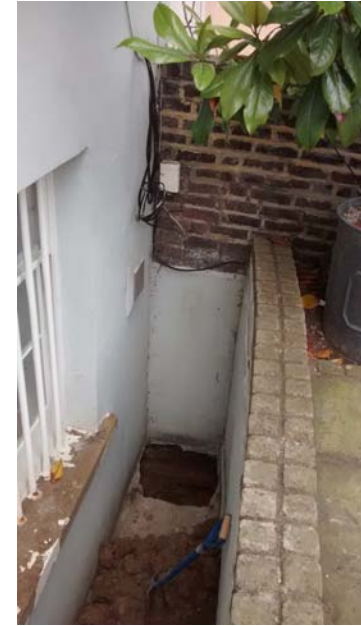
Photo to show height difference between TP1 and TP2

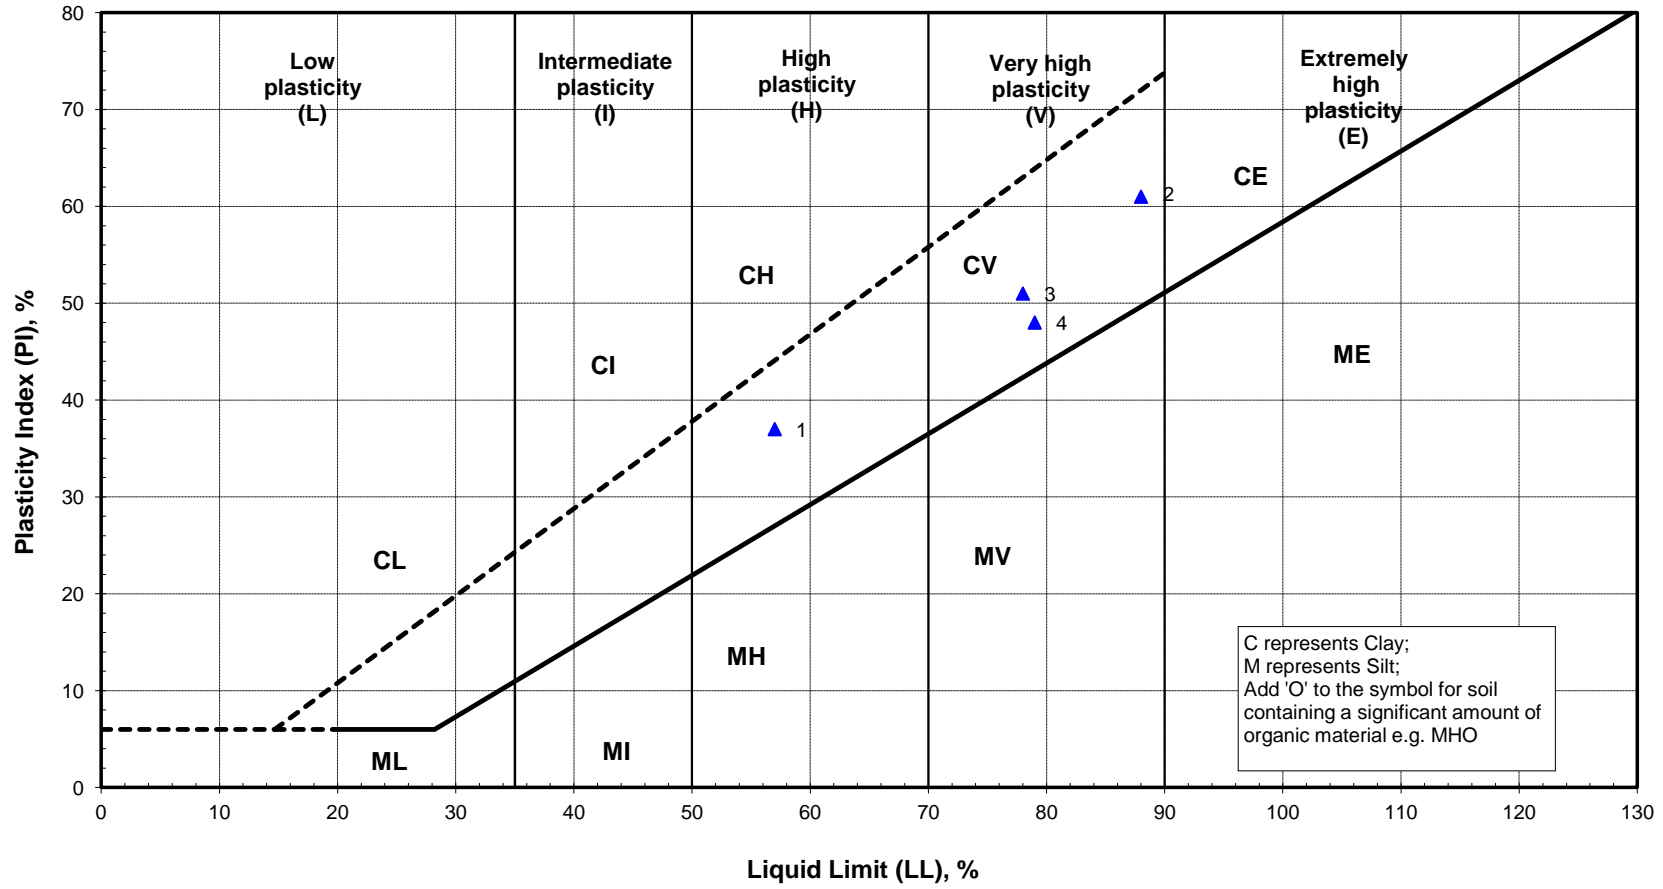
No.	TH No.	Depth
1	BH1A	1.00
2	BH1A	2.00
3	BH1A	3.00
4	BH1A	4.00

C represents Clay;
M represents Silt;
Add 'O' to the symbol for soil containing a significant amount of organic material e.g. MHO

Liquid Limit		Plastic Limit		Plasticity Index	
Maximum Value	88	Maximum Value	31	Maximum Value	61
Minimum Value	57	Minimum Value	20	Minimum Value	37
Average Value	76	Average Value	26	Average Value	49

The results of the Atterberg Limit Tests on selected samples of the Weathered London Clay soils indicate that NHBC High Volume Change Potential precautions are applicable.
