FOR PLANNING

Christ Church Hampstead South Elevation **Existing Condition** 537A SU03 1:100 (1:200@A3)

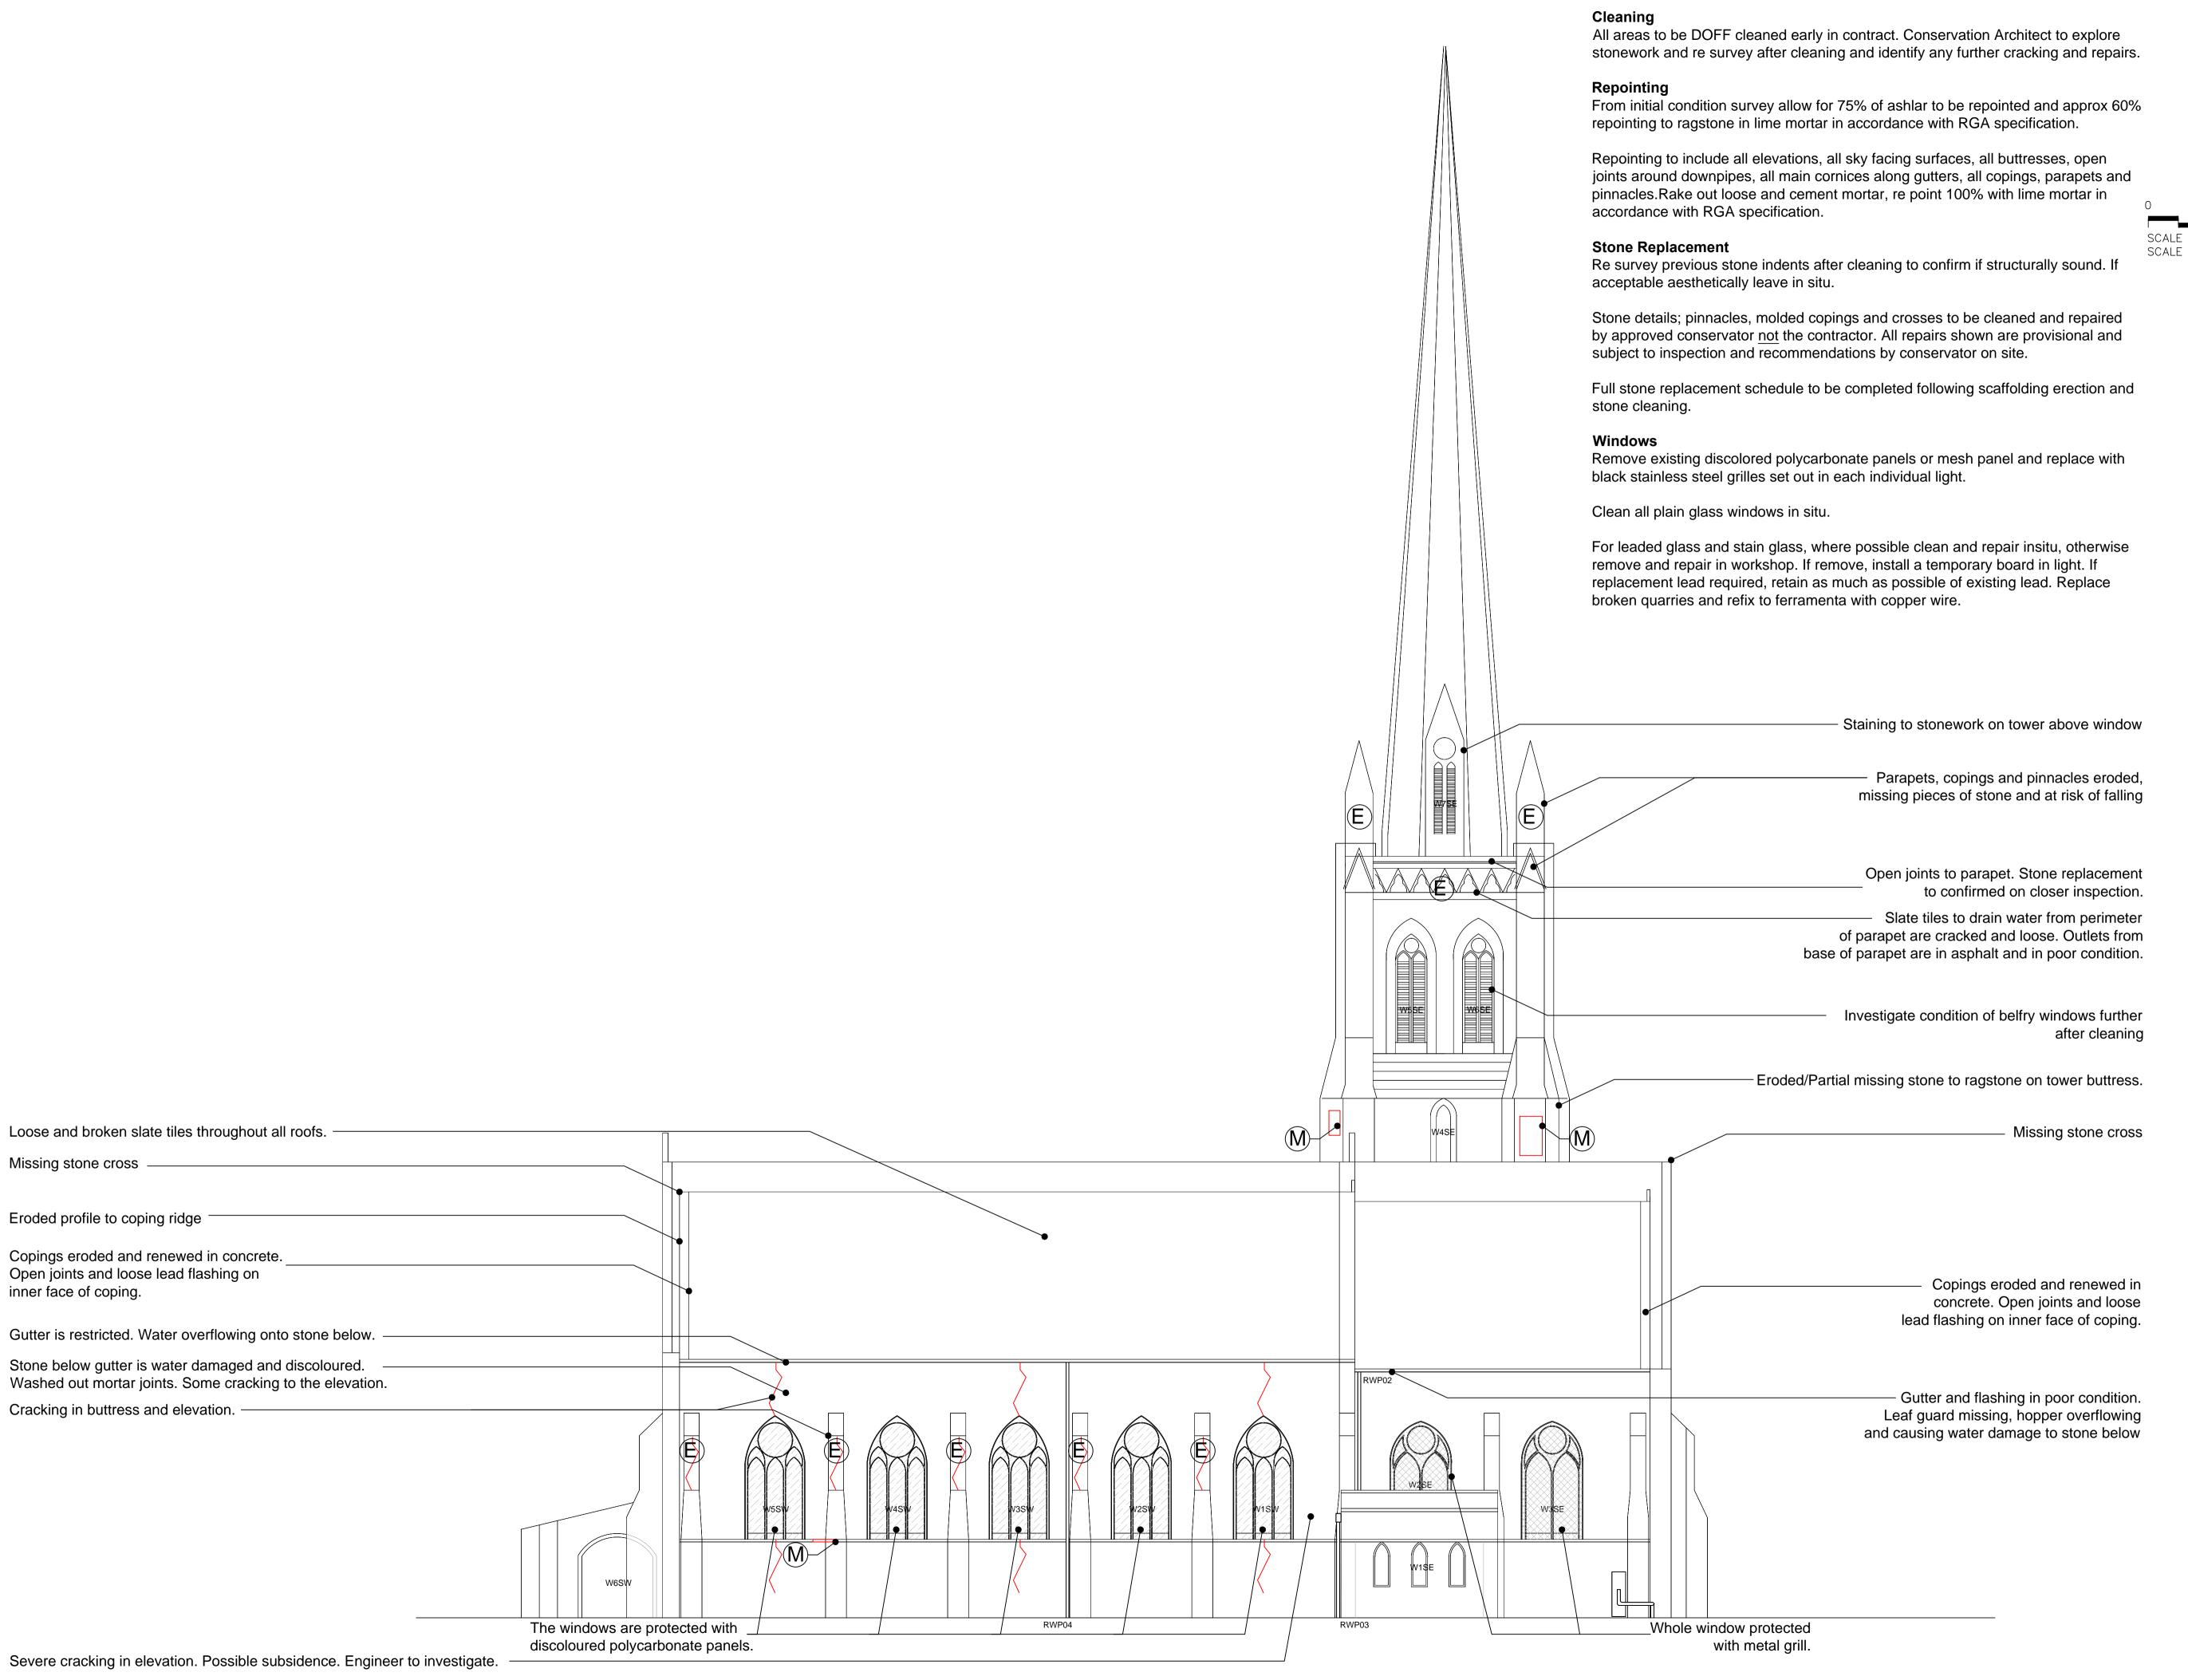
Existing polycarbonate panel

Vegetation - Algae/Moss build up

(M) Missing Stone - Partial or whole stone missing

Eroded Stone - Due to weathering/water damage

Due to limited roof access, inspection undertaken from ground level and tower parapet. Carry out a closer roof inspection, by scaffolding, to ascertain any repairs required to slates, battens, underlay, gutters and flashing's. Replace slates and lead flashing to all areas of roof as RGA condition survey and specification and LSA recommendations.
