## SITE INVESTIGATION & BASEMENT IMPACT ASSESSMENT REPORT

55 Lancaster Grove  
London  
NW3 4HD

J14387

February 2015

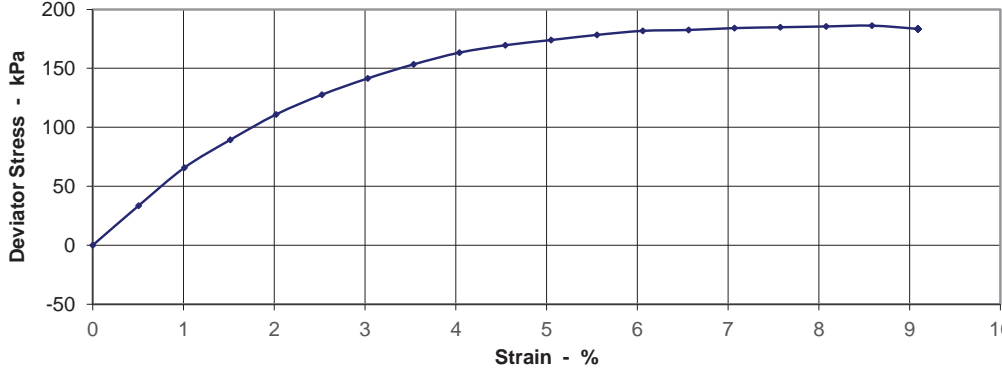
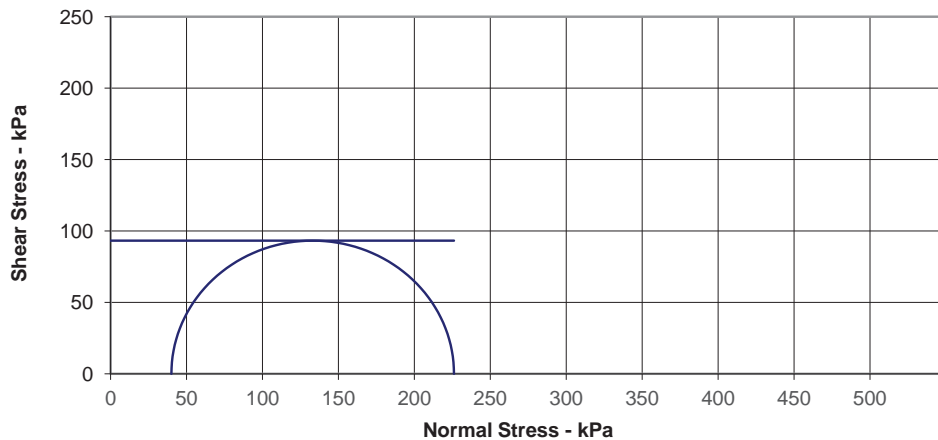
Sample Condition	Undisturbed																																									
Height	mm198.0																																									
Diameter	mm102.0																																									
Moisture Content	%27																																									
Bulk Density	Mg/m³1.99																																									
Dry Density	Mg/m³1.56																																									
Membrane Thickness	mm	0.2																																								
Membrane Correction	kPa	0.39																																								
Rate of Axial Displacement	%/min	2.02																																								
Cell Pressure	kPa	40																																								
Strain at Failure	%	8.6																																								
Maximum Deviator Stress	kPa	186																																								
Shear Strength	kPa	93																																								
Mode of Failure	Compound																																									
C	93 kPa

Phi	0.0 °																																									
<div>Specimen 1</div> <div><div><div>Deviator Stress - kPa</div><div>

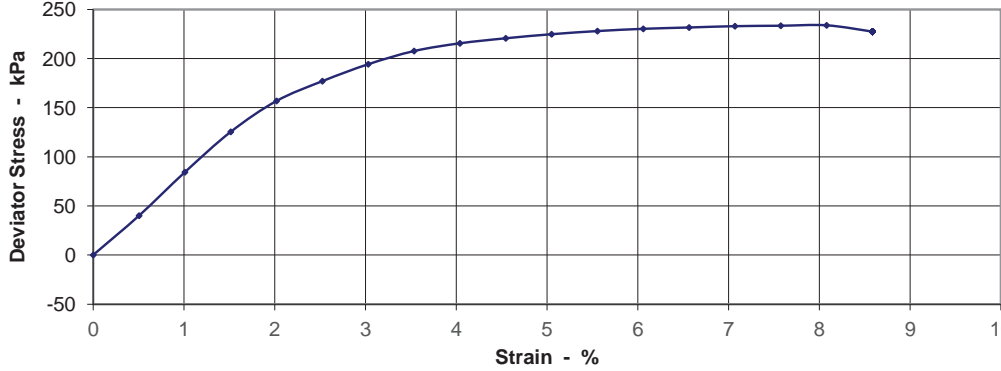
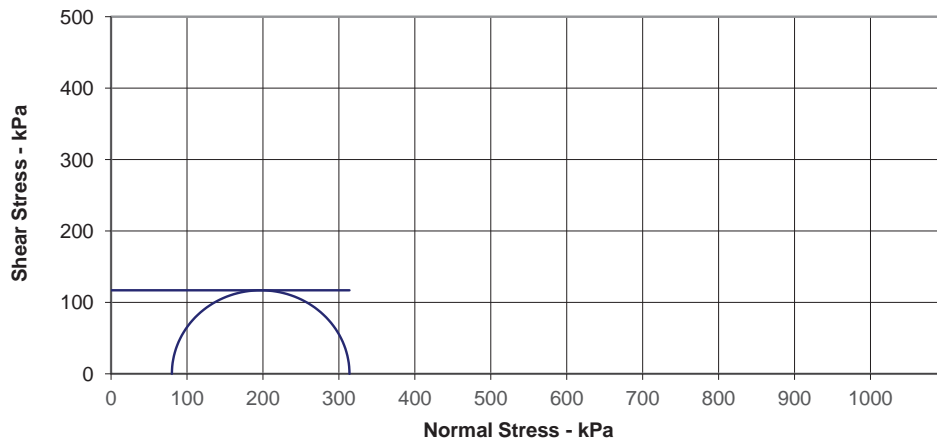
Sample Condition	Undisturbed																																									
Height	mm198.0																																									
Diameter	mm102.0																																									
Moisture Content	%26																																									
Bulk Density	Mg/m³2.01																																									
Dry Density	Mg/m³1.59																																									
Membrane Thickness	mm	0.2																																								
Membrane Correction	kPa	0.38																																								
Rate of Axial Displacement	%/min	2.02																																								
Cell Pressure	kPa	80																																								
Strain at Failure	%	8.1																																								
Maximum Deviator Stress	kPa	234																																								
Shear Strength	kPa	117																																								
Mode of Failure	Brittle																																									
C	117 kPa

Phi	0.0 °																																									
<div>Specimen 1</div> <div><div><div>Deviator Stress - kPa</div><div>

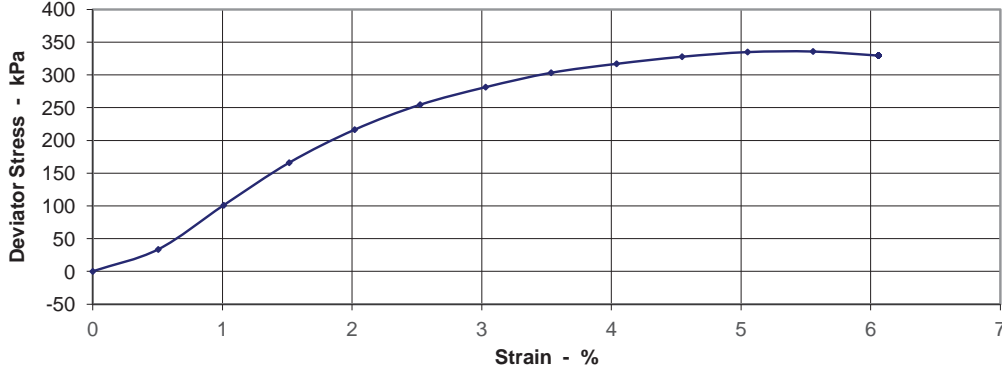
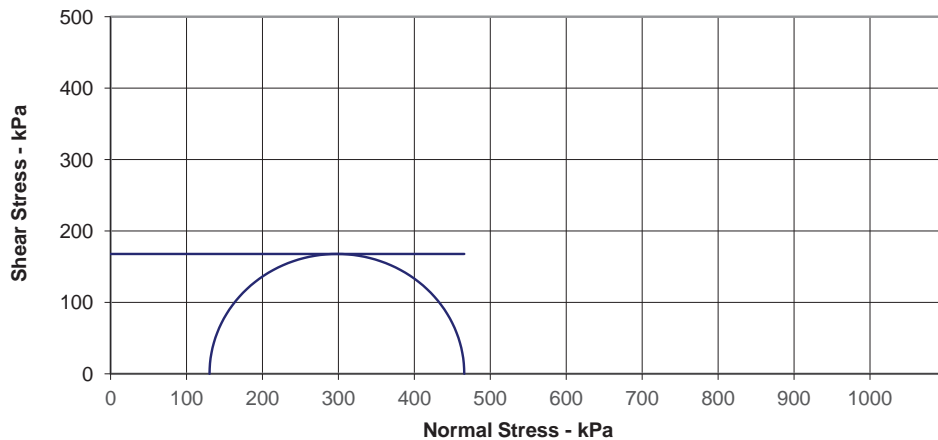
Specimen 1																																				
Sample Condition	Undisturbed																																			
Height	mm 198.0																																			
Diameter	mm 102.0																																			
Moisture Content	% 26																																			
Bulk Density	Mg/m³ 2.03																																			
Dry Density	Mg/m³ 1.61																																			
Membrane Thickness	mm 0.2																																			
Membrane Correction	kPa 0.28																																			
Rate of Axial Displacement	%/min 2.02																																			
Cell Pressure	kPa 130																																			
Strain at Failure	% 5.6																																			
Maximum Deviator Stress	kPa 336																																			
Shear Strength	kPa 168																																			
Mode of Failure	Brittle																																			
C	168 kPa

Phi	0.0 °																																			
Specimen 1																																				
<div><div><div>Deviator Stress - kPa</div>

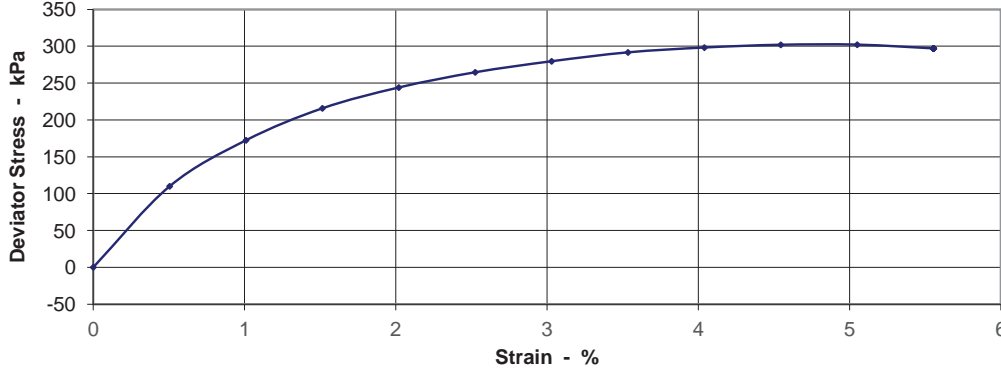
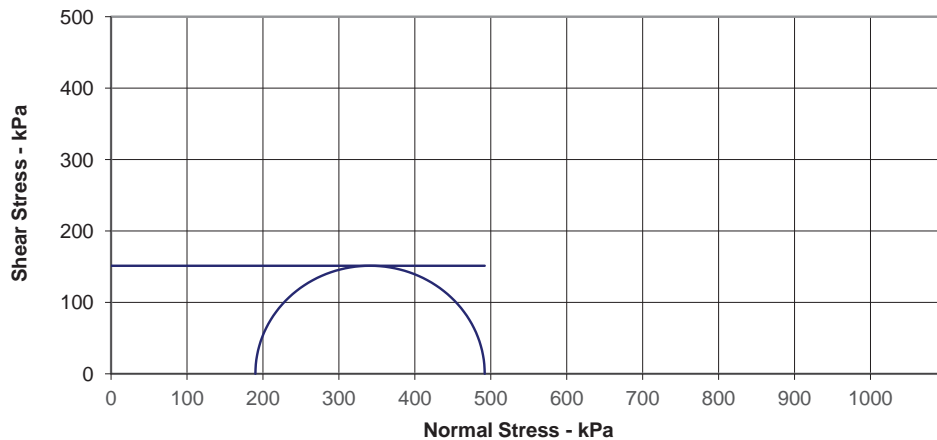
Specimen 1																																				
Sample Condition	Undisturbed																																			
Height	mm 198.0																																			
Diameter	mm 102.0																																			
Moisture Content	% 28																																			
Bulk Density	Mg/m³ 2.04																																			
Dry Density	Mg/m³ 1.59																																			
Membrane Thickness	mm 0.2																																			
Membrane Correction	kPa 0.26																																			
Rate of Axial Displacement	%/min 2.02																																			
Cell Pressure	kPa 190																																			
Strain at Failure	% 5.1																																			
Maximum Deviator Stress	kPa 302																																			
Shear Strength	kPa 151																																			
Mode of Failure	Brittle																																			
C	151 kPa

Phi	0.0 °																																			
Specimen 1																																				
<div><div><div>Deviator Stress - kPa</div>

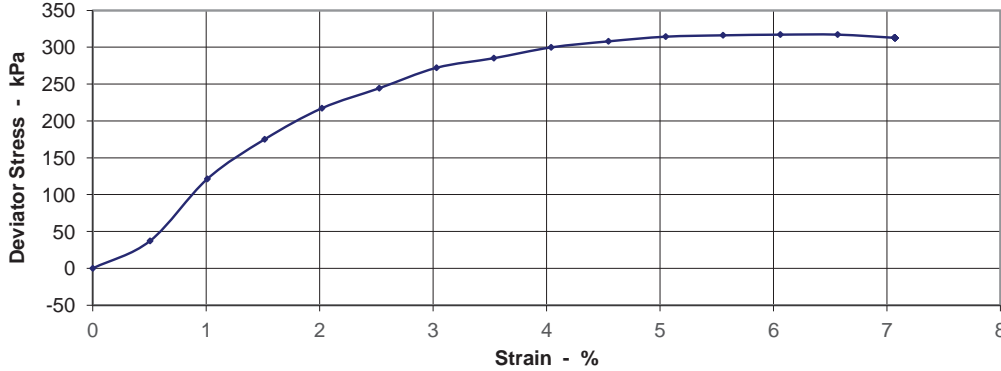
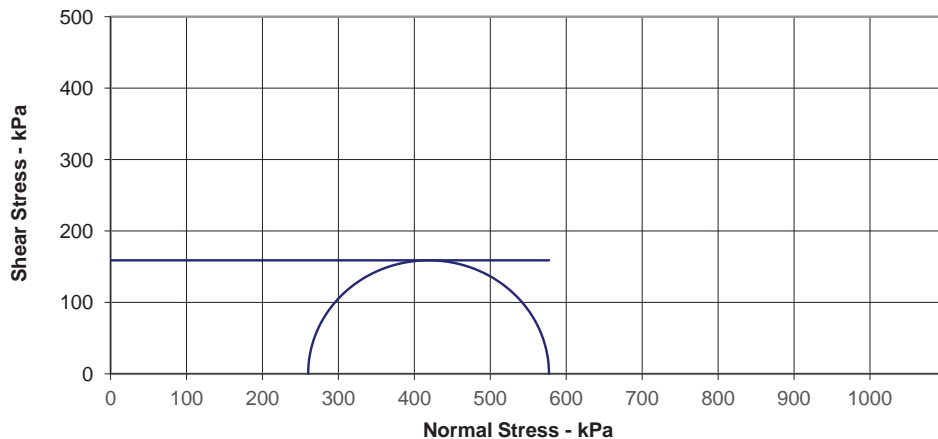
<b>Report of Undrained Triaxial Compression Test</b>		
	<b>BS 1377 : Part 7 : 1990 Clause 8.0</b>		
<b>Project name:</b> 55 Lancaster Grove, London, NW3 4HD		<b>Samples Received:</b> 16/01/2015	
		<b>Project Started:</b> 20/01/2015	
<b>Client:</b> GEA		<b>Testing Started:</b> 06/02/2015	
<b>Project no:</b> J14387	<b>Our job /report no:</b> 18199	<b>Date Reported:</b> 10/02/2015	
<b>BH / TP no:</b> BH1	<b>Sample no:</b> U5	<b>Depth (m):</b> 12.50	
<b>Soil Description:</b> Very high strength fissured dark grey silty CLAY			
<b>Sample Details</b>			
<b>Specimen 1</b>		<div>Position and orientation within the original sample</div> <div></div>	
Sample Condition			Undisturbed
Height			mm 198.0
Diameter			mm 102.0
Moisture Content			% 28
Bulk Density			Mg/m³ 2.01
Dry Density			Mg/m³ 1.57
<b>Test Details</b>		<div>Shear Strength Parameters</div> <div>C 159 kPa</div> <div>Phi 0.0 °</div>	
Membrane Thickness			mm 0.2

Membrane Correction			kPa 0.32
Rate of Axial Displacement			%/min 2.02
Cell Pressure			kPa 260
Strain at Failure			% 6.6
Maximum Deviator Stress			kPa 317
Shear Strength		kPa 159	
Mode of Failure		Brittle	
<b>Specimen 1</b>
