Project No.	P4808-14
Project Title	SITESAFE UXO DESK STUDY
Project Location	Crogsland Road, London Borough of Camden
Client	EC Harris
Report Ref.	P4808-14-R1-A
Report Date	18 th July 2014

SITESAFE UXO DESK STUDY

Crogsland Road, London Borough of Camden

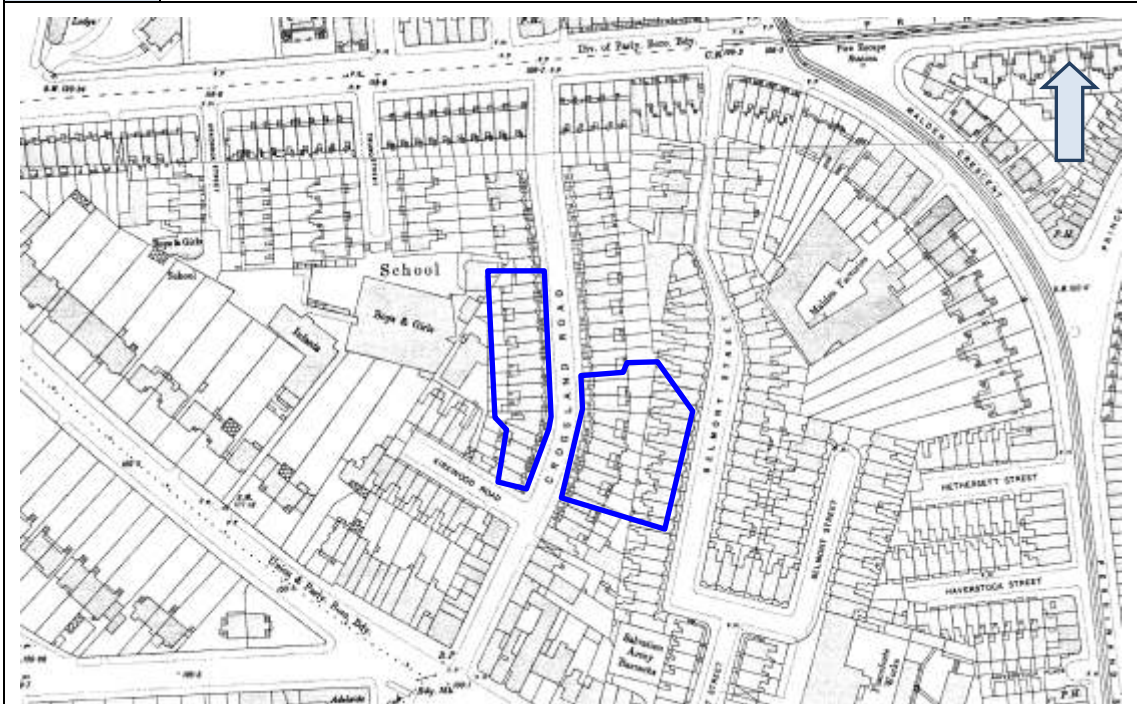
Figure 2 Historical map, 1897

At the end of the 19th century, the Site was occupied by, and surrounded by, residential properties. This is shown on the historical map of 1895 (Figure 2).

A school was located adjacent in a western direction to the Site. The Malden Factories, which manufactured watercolour and oil paintings, were located approximately 0.1km northeast of the Site.

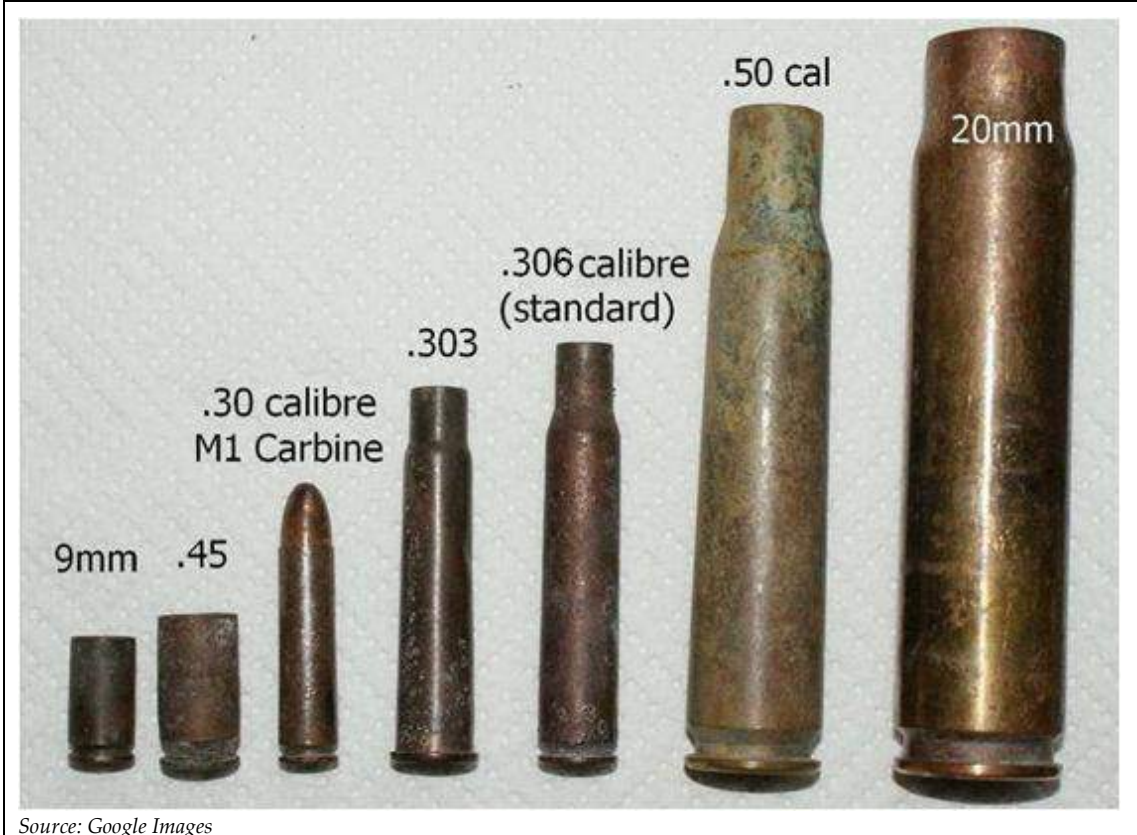
Plate 7	Photograph of typical WWII small arms ammunition
----------------	--

11.1.1 Small Arms Ammunition	
Small Arms Ammunition (SAA) is one of the more recognisable categories of ordnance which is primarily designed for anti-personnel use. SAA include items such as bullets, generally up to a calibre (diameter) of 20mm.	
Larger calibre small arms munitions can contain fuze mechanisms and high explosives or pyrotechnic fillings and may have been used for anti-aircraft or anti-vehicle purposes.	
Generally small arms ordnance has a relatively low risk as UXO, although the larger calibre categories may have the same detonation risk as larger high explosive ordnance. SAA is often associated with discarded ammunition boxes around firing practice ranges. Plate 7 illustrates some common SAA.

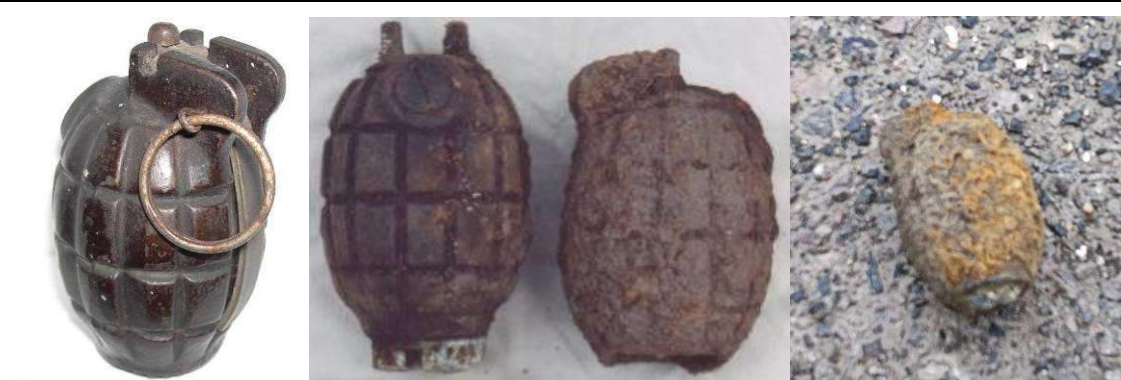
Plate 8 Photographs of a typical and an excavated WWII Mills Type 36 hand grenade

Hand grenades can be filled with explosives or chemicals and have 3No. main parts, a body, a fuze with a pull ring and a safety-clip assembly. Fragmentation grenades are the most common and have a metal or plastic body filled with an explosive. Most use a burning delay fuze that functions for 3 to 5 seconds after the safety lever is released.

Some, such as smoke grenades, are activated instantly when the lever is released. Plate 8 illustrates the typical character and condition of Mills Type 36 hand grenades that have been excavated from a site.

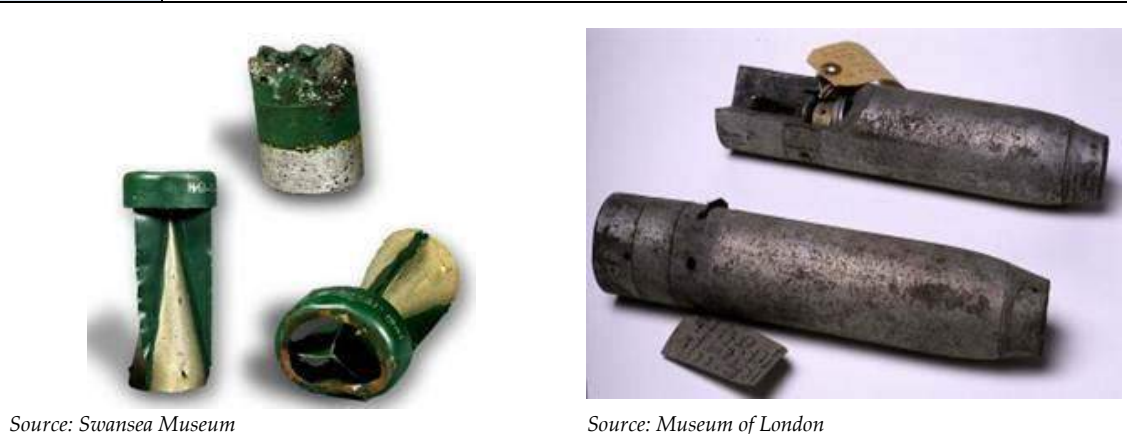
Plate 9 Photographs of typical fragmentary remains of IBs and a UXIB

Plate 9 shows a typical variety of fragmentary remains of IBs and 2No. IBs recovered by the Civil Defence during WWII.

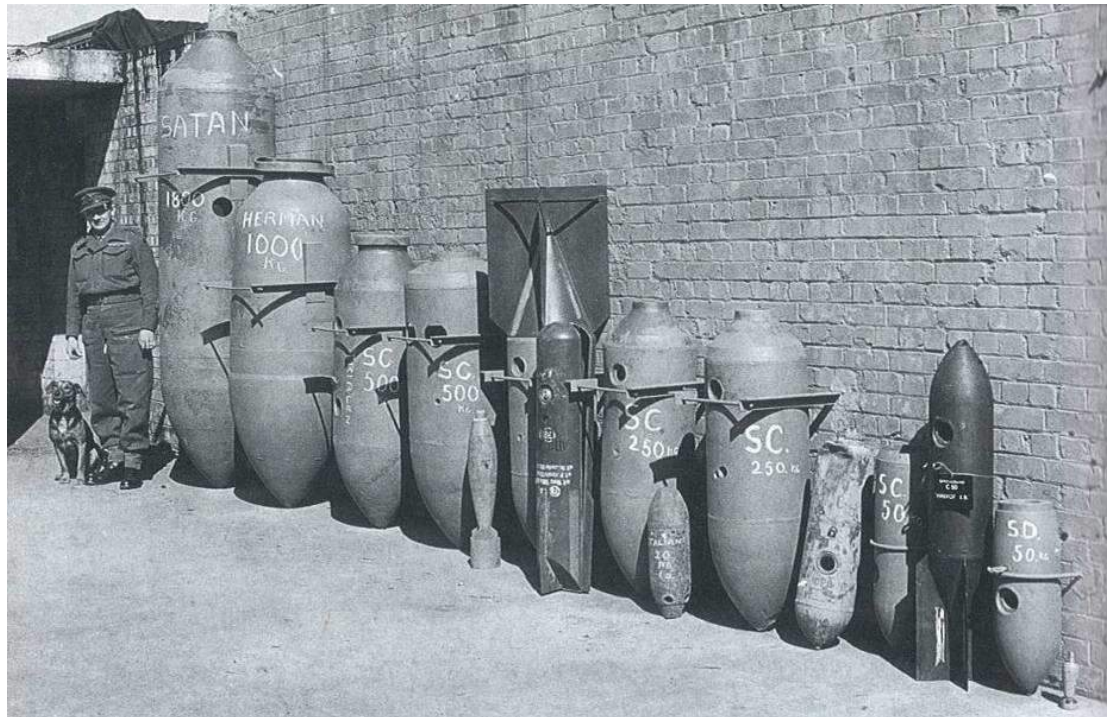
Plate 11 shows the variety of UXBs recovered by the Civil Defence during WWII.

Plate 11 Photograph of a variety of UXBs recovered by the Civil Defence during WWII

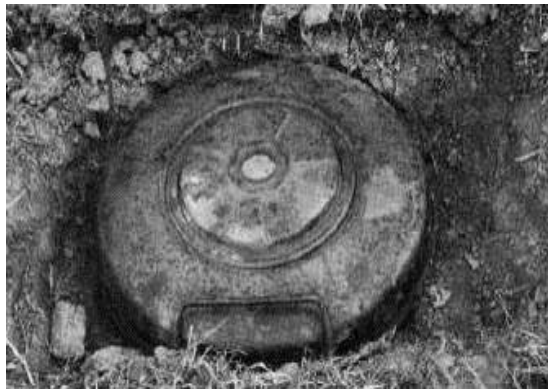
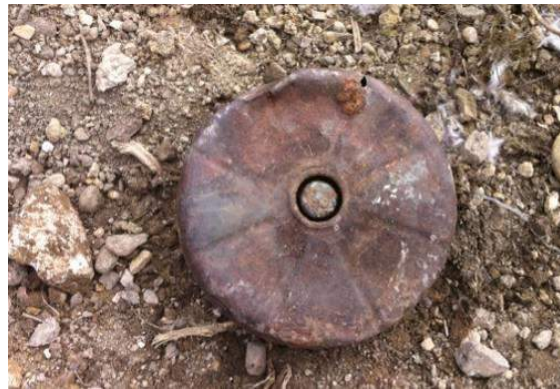
Plate 12 is a photograph of a typical WWII land mine used on the land area, beaches and cliffs around Britain. This example was found at Gatwick Airport formerly RAF Gatwick.

Photographs of original and recently excavated WWII land mines

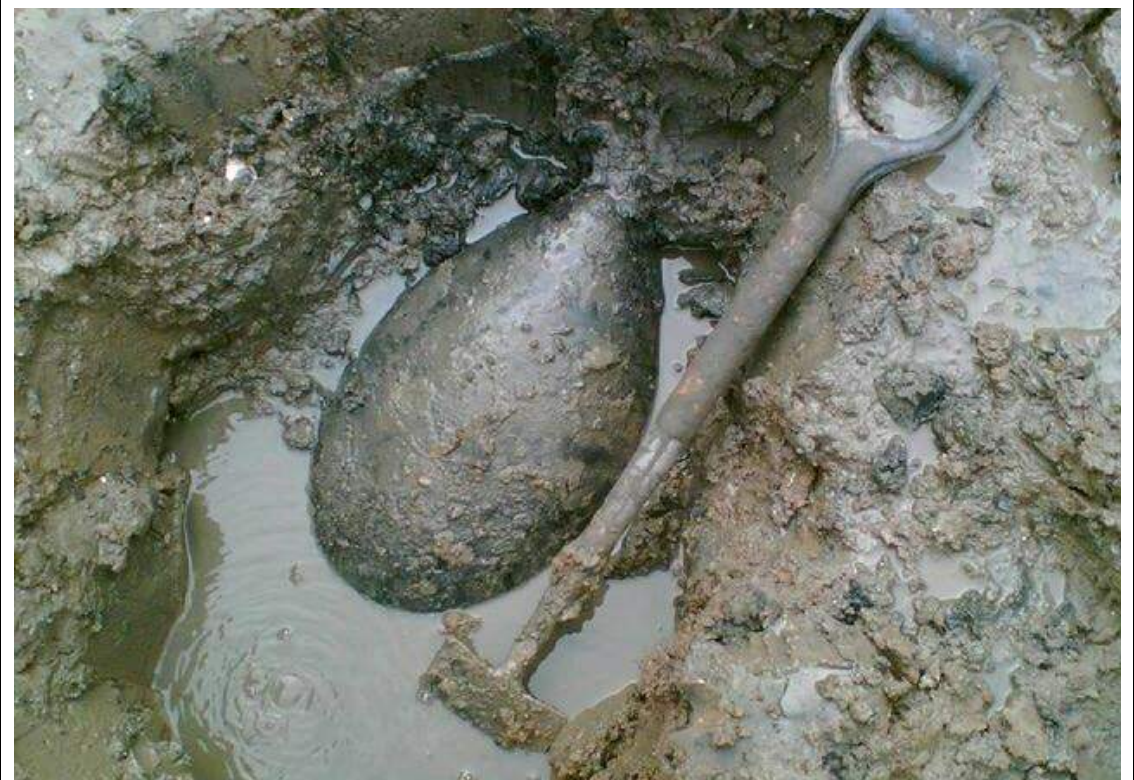
Plate 13 | Photograph of the 500kg WWII UXB at Bowers Marsh, 8th March 2010

This led to a detailed geophysical survey being carried out by Zetica to detect targets which could be UXB and thus mitigate the risk to future ground works. Plate 13 is a photograph of the bomb as it was discovered in the ground. The bomb was demolished in situ by members of the Army Royal Logistics Corps (RLC).

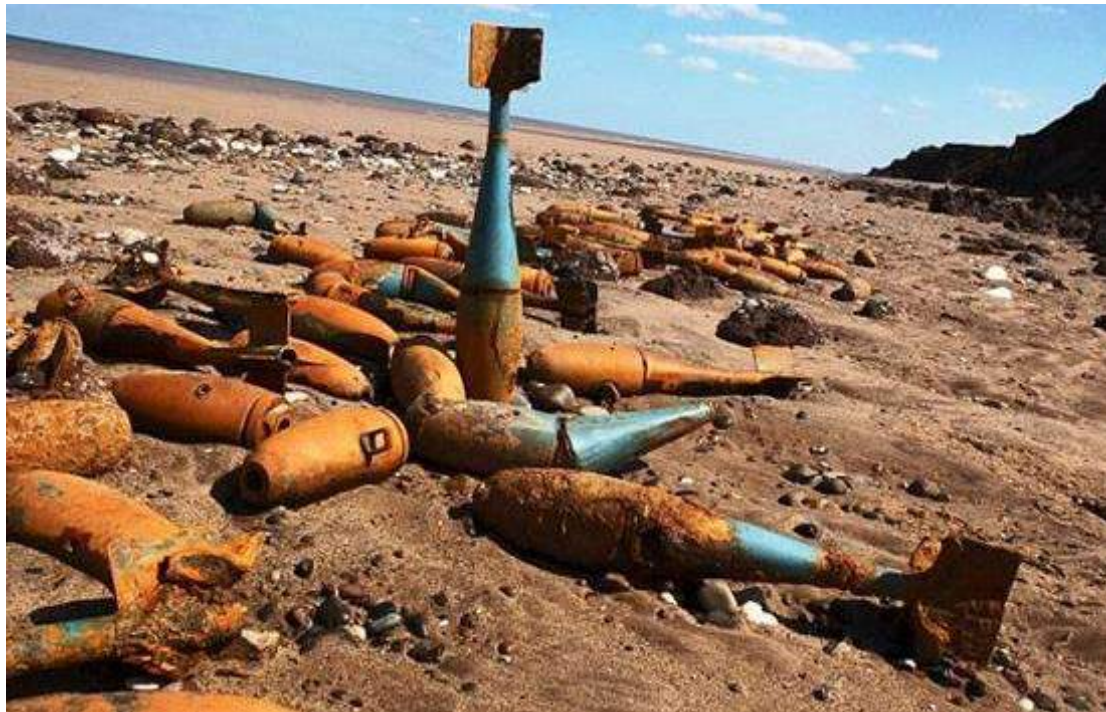
Plate 14 is a photograph of some of the UXO exposed by the landslip at Mappleton.

Plate 14	Photograph of exposed UXO at Mappleton, 22 nd July 2012
-----------------	--

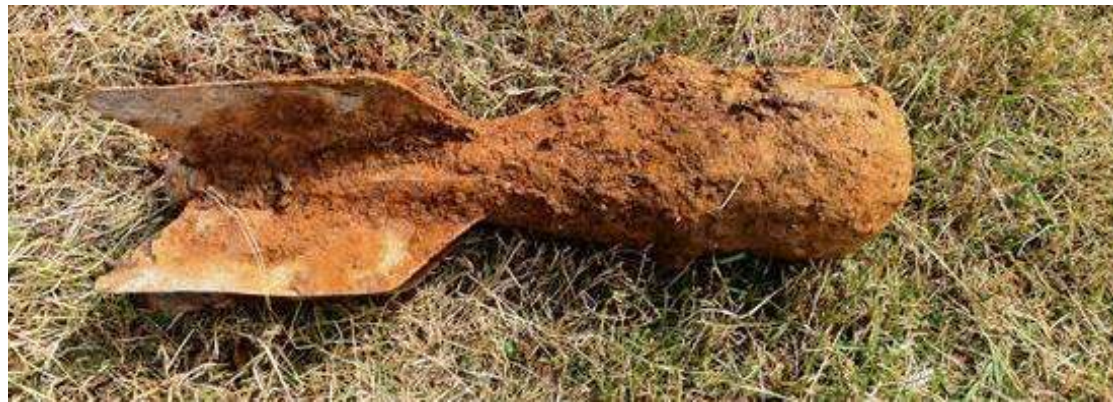
Plate 15

1No. WWI bomb (Plate 15) was found on the Isle of Sheppey on the 2nd August 2012 during a geophysical survey following desk study research by Zetica Ltd. which had established that a previously unknown WWI bombing range existed on the site.

Photograph of WWI bomb, Isle of Sheppey, 2nd August 2012

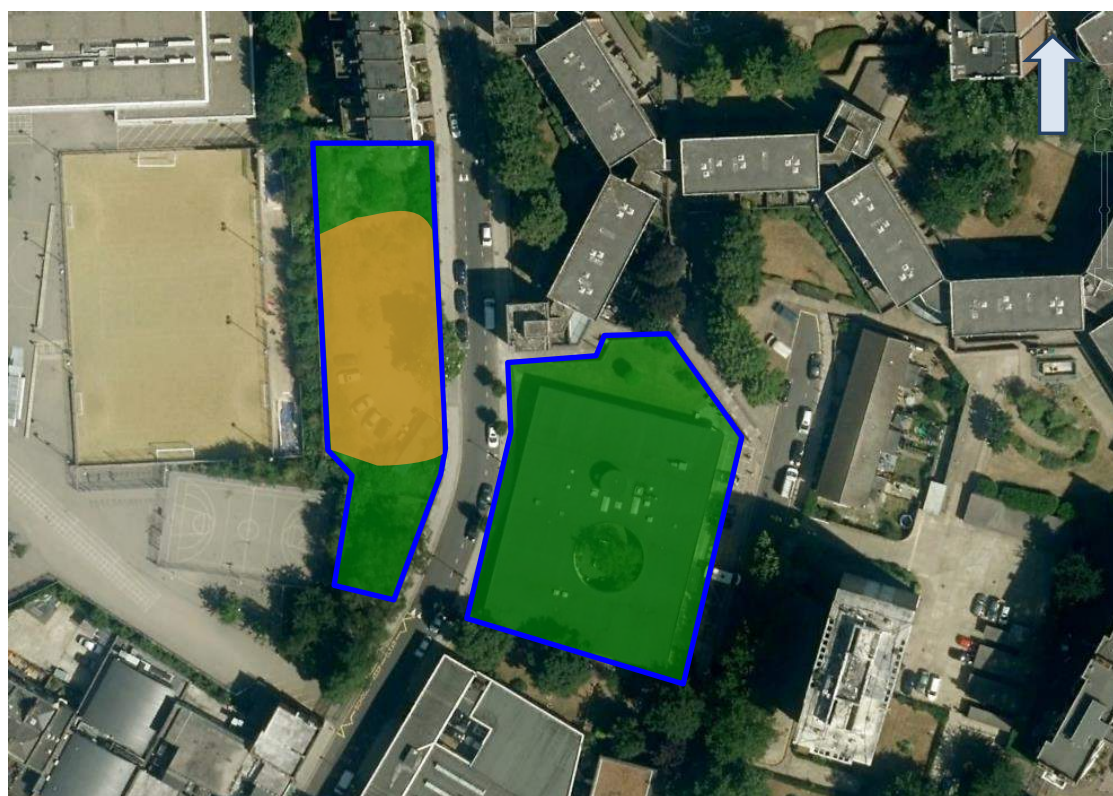
Figure 7 UXO hazard zone plan of the Site

It is considered that the UXO hazard level on the Site can be zoned from low to moderate as shown in Figure 7.

There is evidence that 1No. High Explosive (HE) bomb fell on part of the western section of the Site during World War Two (WWII), causing significant damage that may have masked the impact of an Unexploded Bomb (UXB). This area is considered to have a moderate UXO hazard level.

There is no evidence of bombing or other significant sources of UXO on the remainder of the Site, which is assigned a low UXO hazard level.

It is considered that the UXO hazard level on the Site can be zoned from low to moderate as shown in the accompanying figure, reproduced as Figure 7 in the main report.

In the area with a moderate UXO hazard level, clearance certification for borehole or pile locations is considered essential. For excavations, non-intrusive geophysical investigation methods, if practical, and Explosive Ordnance Clearance (EOC) Operative supervision is considered prudent.

In areas with a low UXO hazard level, clearance certification for borehole or pile locations is considered prudent only if a zero tolerance to risk is adopted. Zero tolerance is commonly adopted for sites that have safety critical infrastructure such as nuclear establishments and oil refineries.
