Russell Hotel
 Bloomsbury
 LIFT ENCLOSURE TYPICAL DETAILS
 DETAILS 1 - 6

PLANNING 1: 5 @ A1 03.02.15
 Project No Type Btg Number Zone/Lvl Rev
10089 - T - 01 - 6602 - ZXX 01

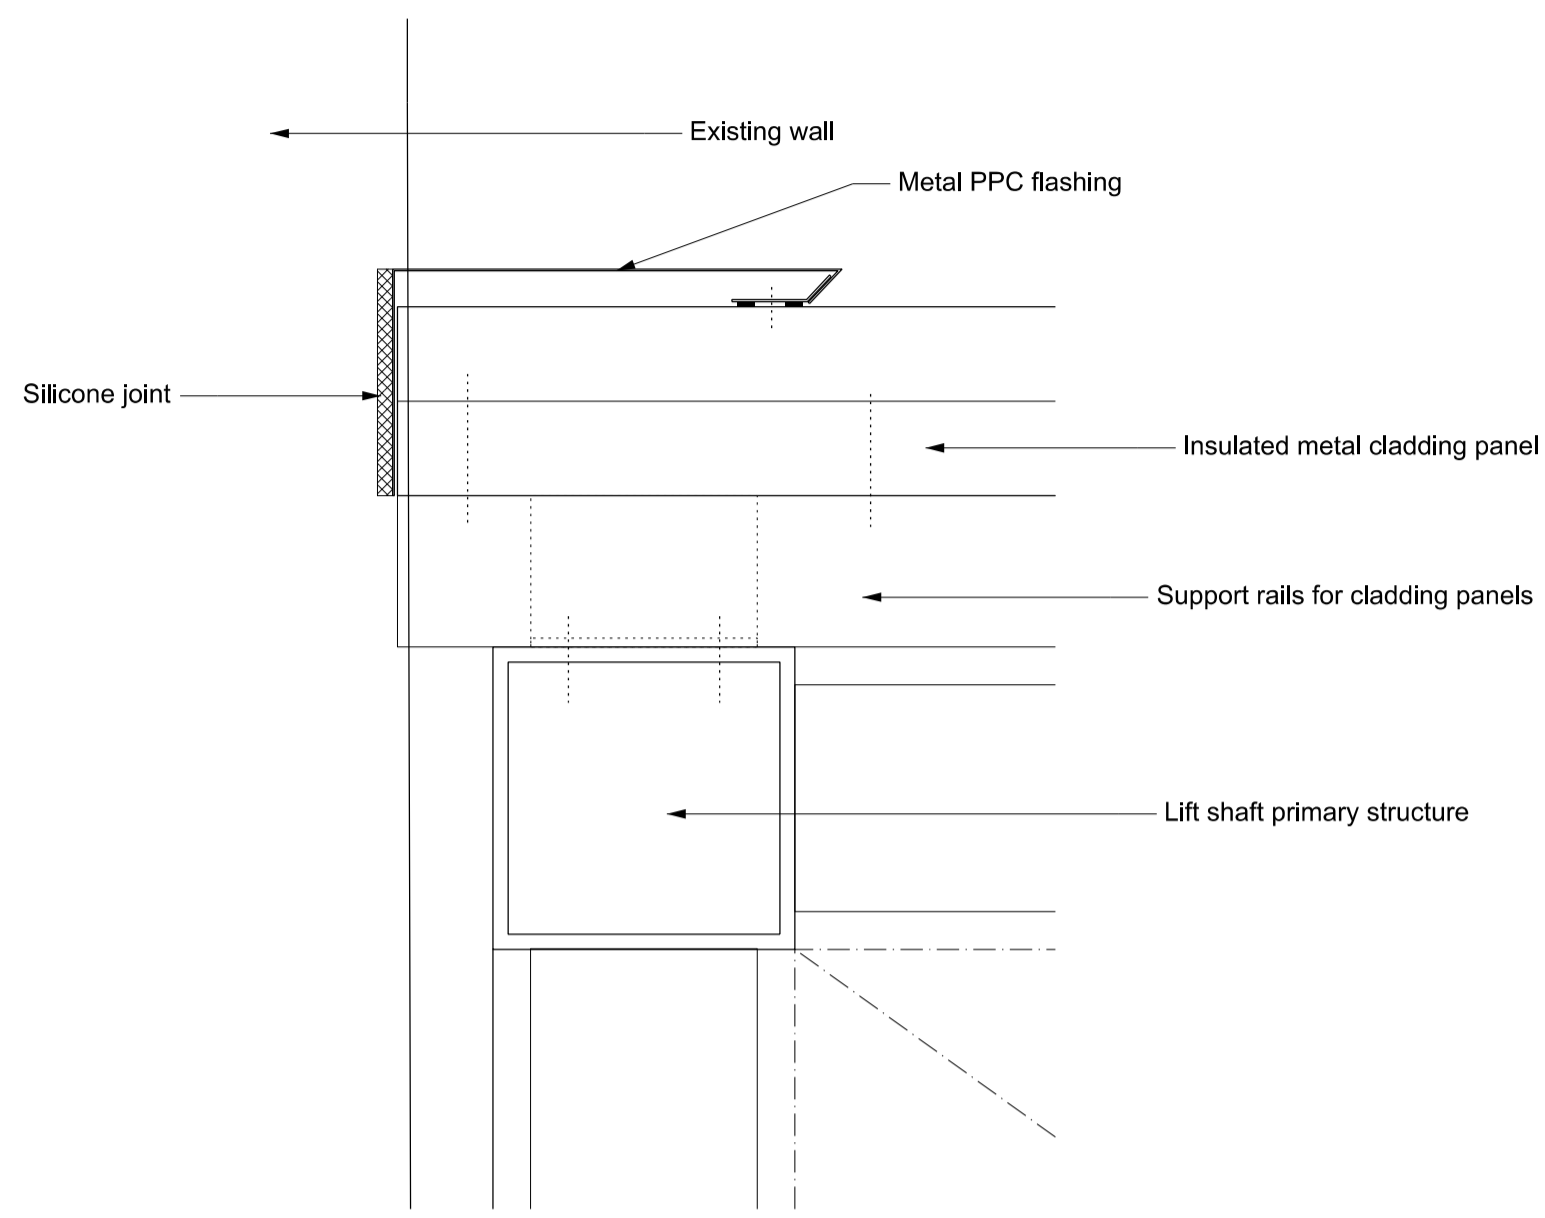
Detail 1 - Typical existing wall abutment

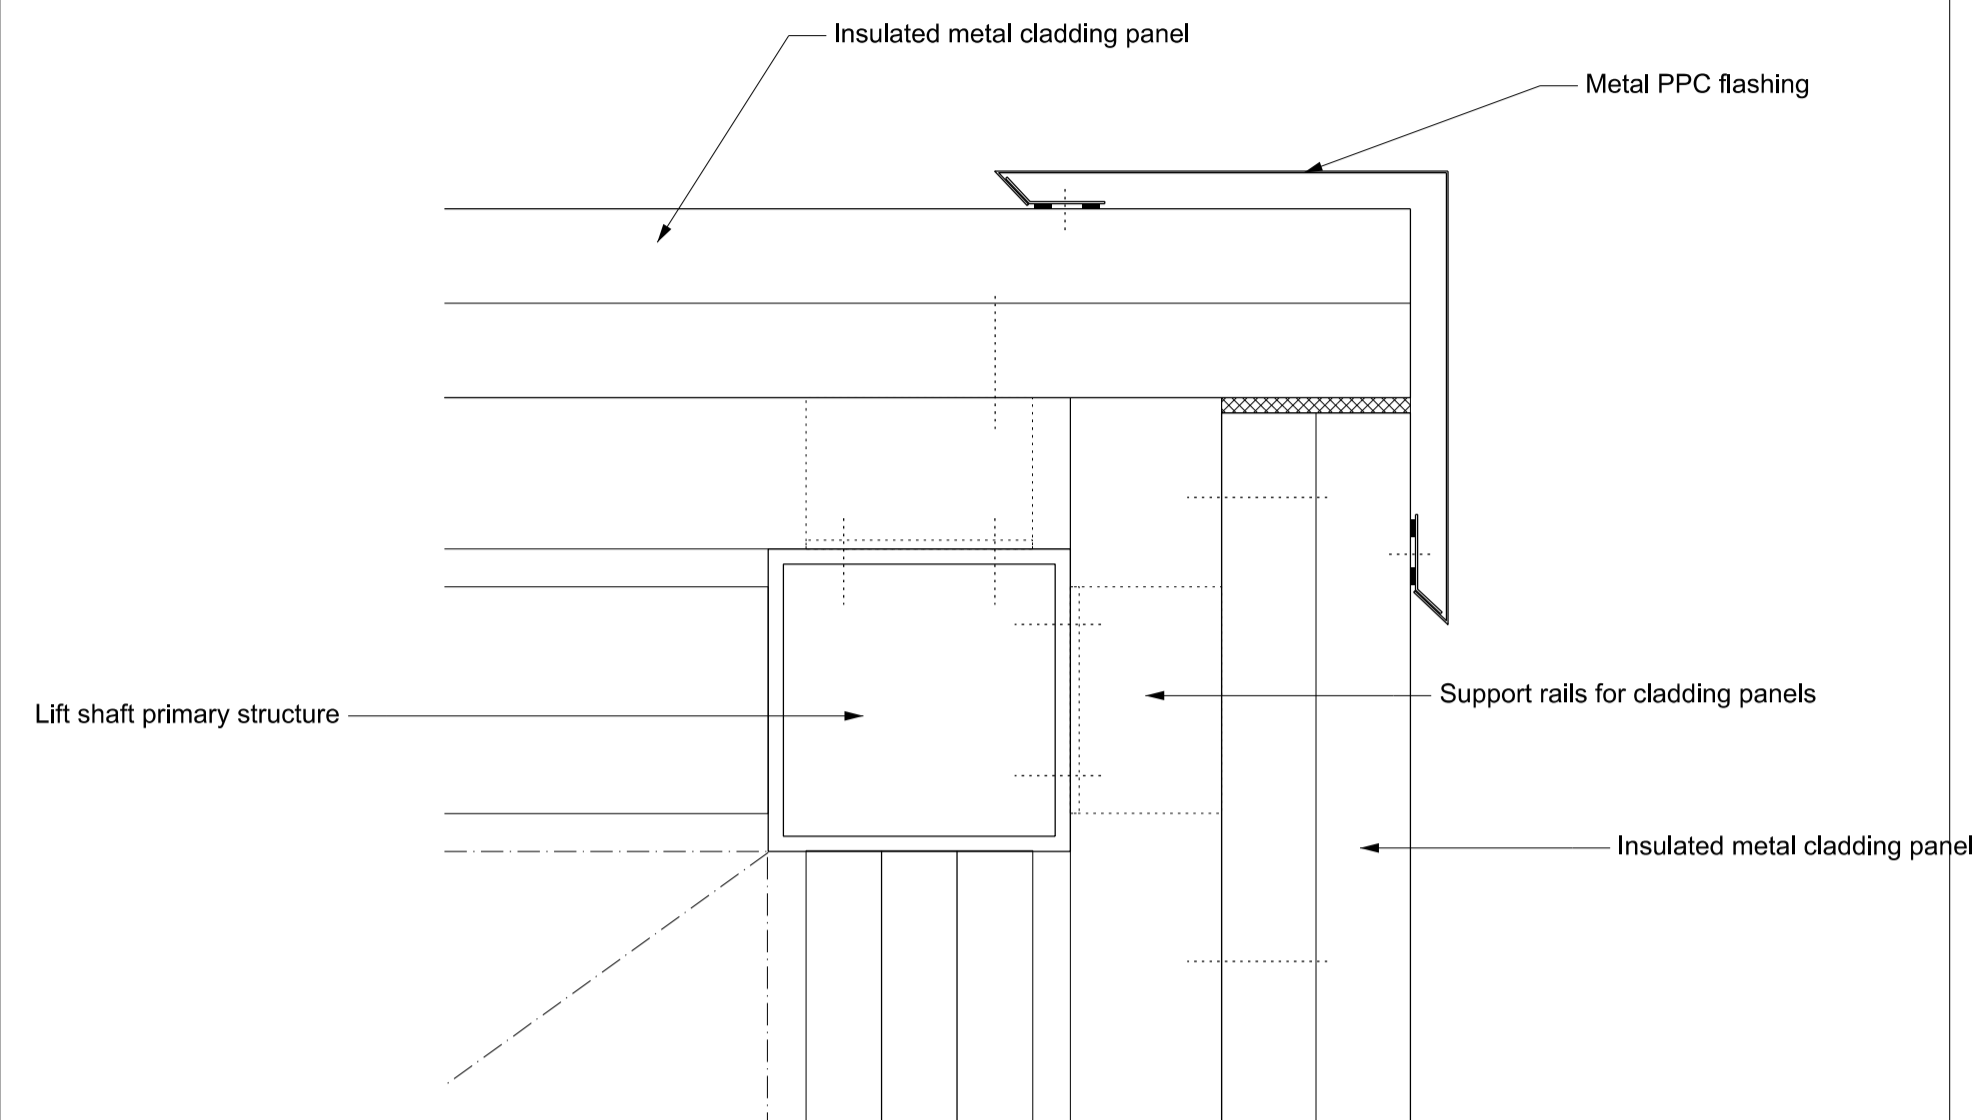
Detail 2 - Typical corner junction

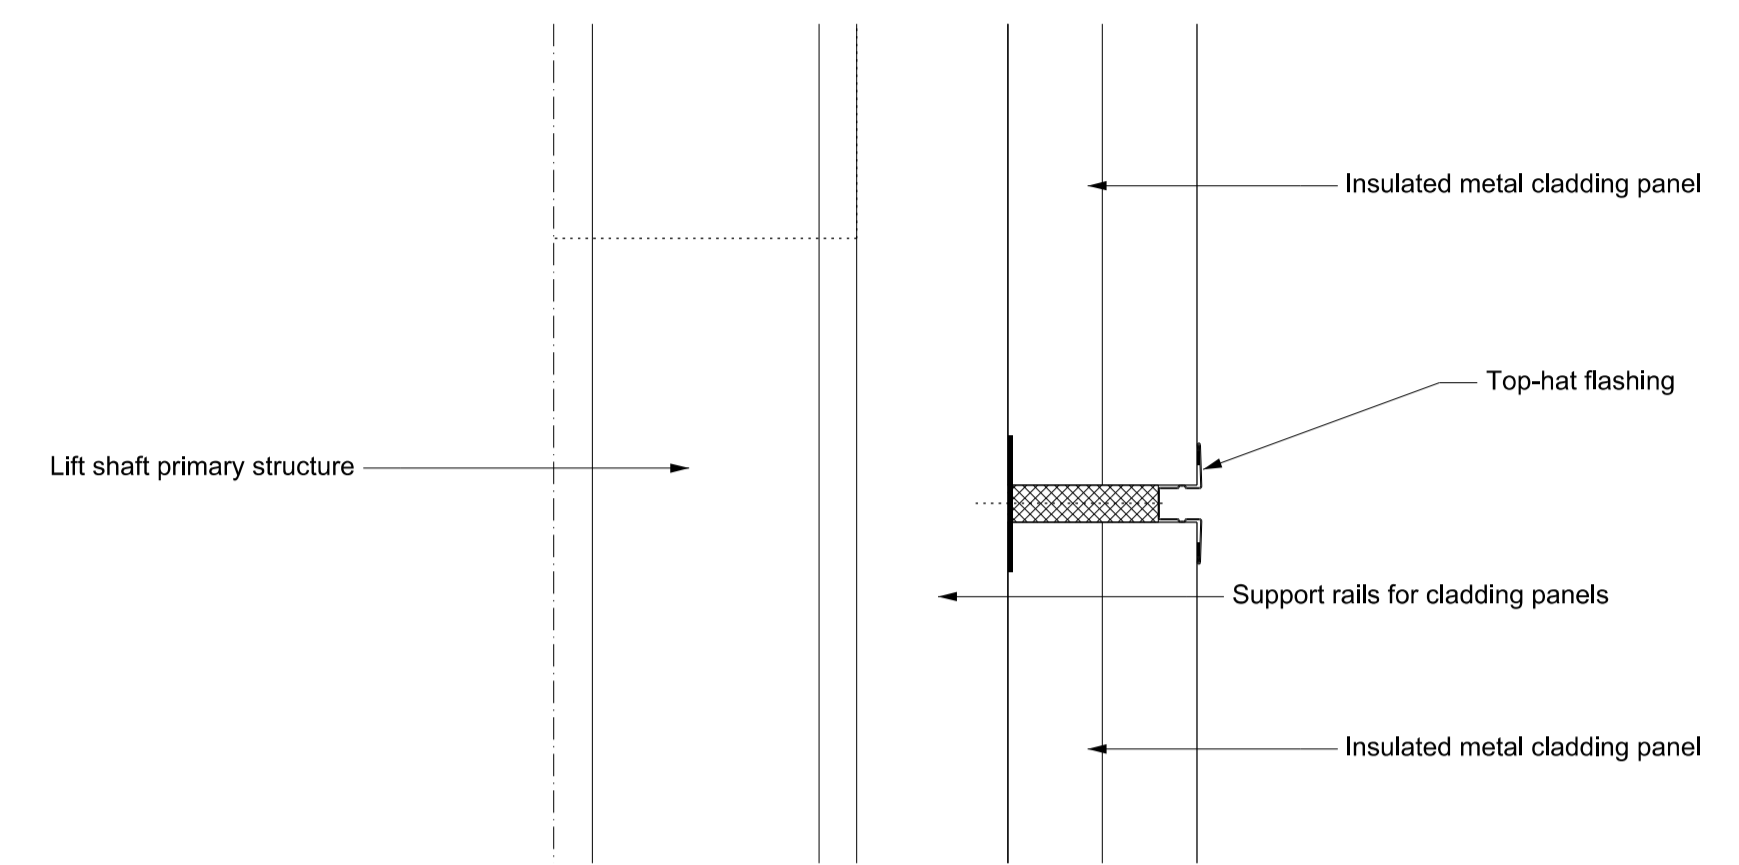
Detail 3 - Typical vertical joint

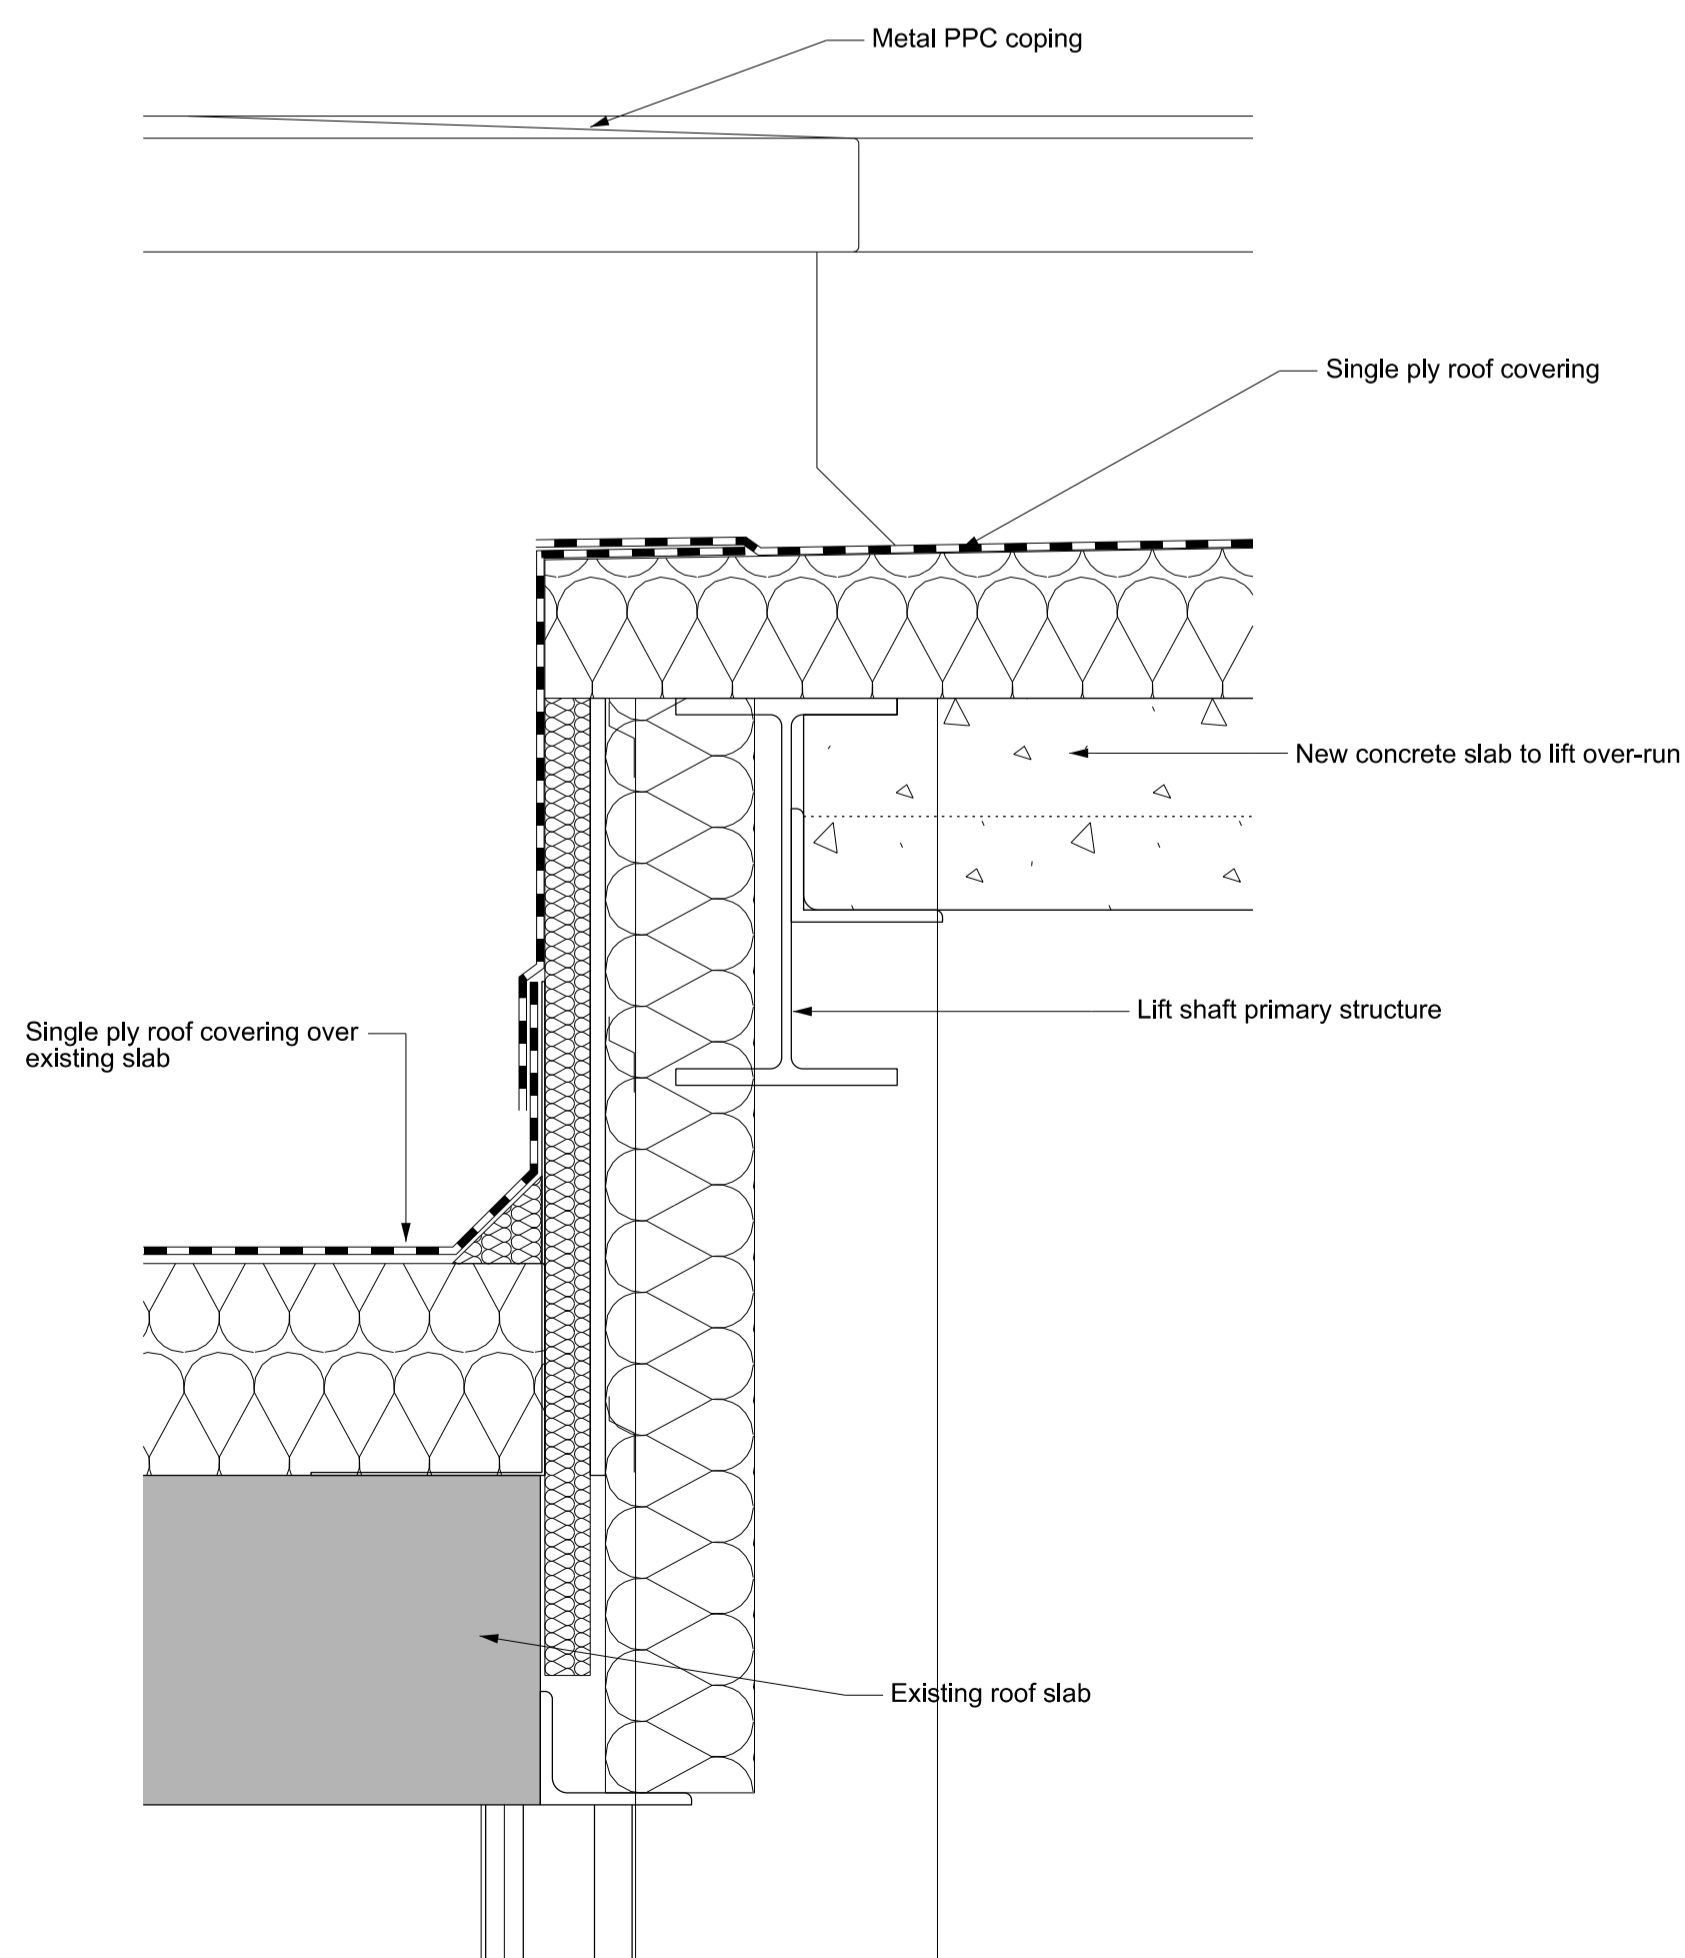
Detail 4 - Existing and new roof interface

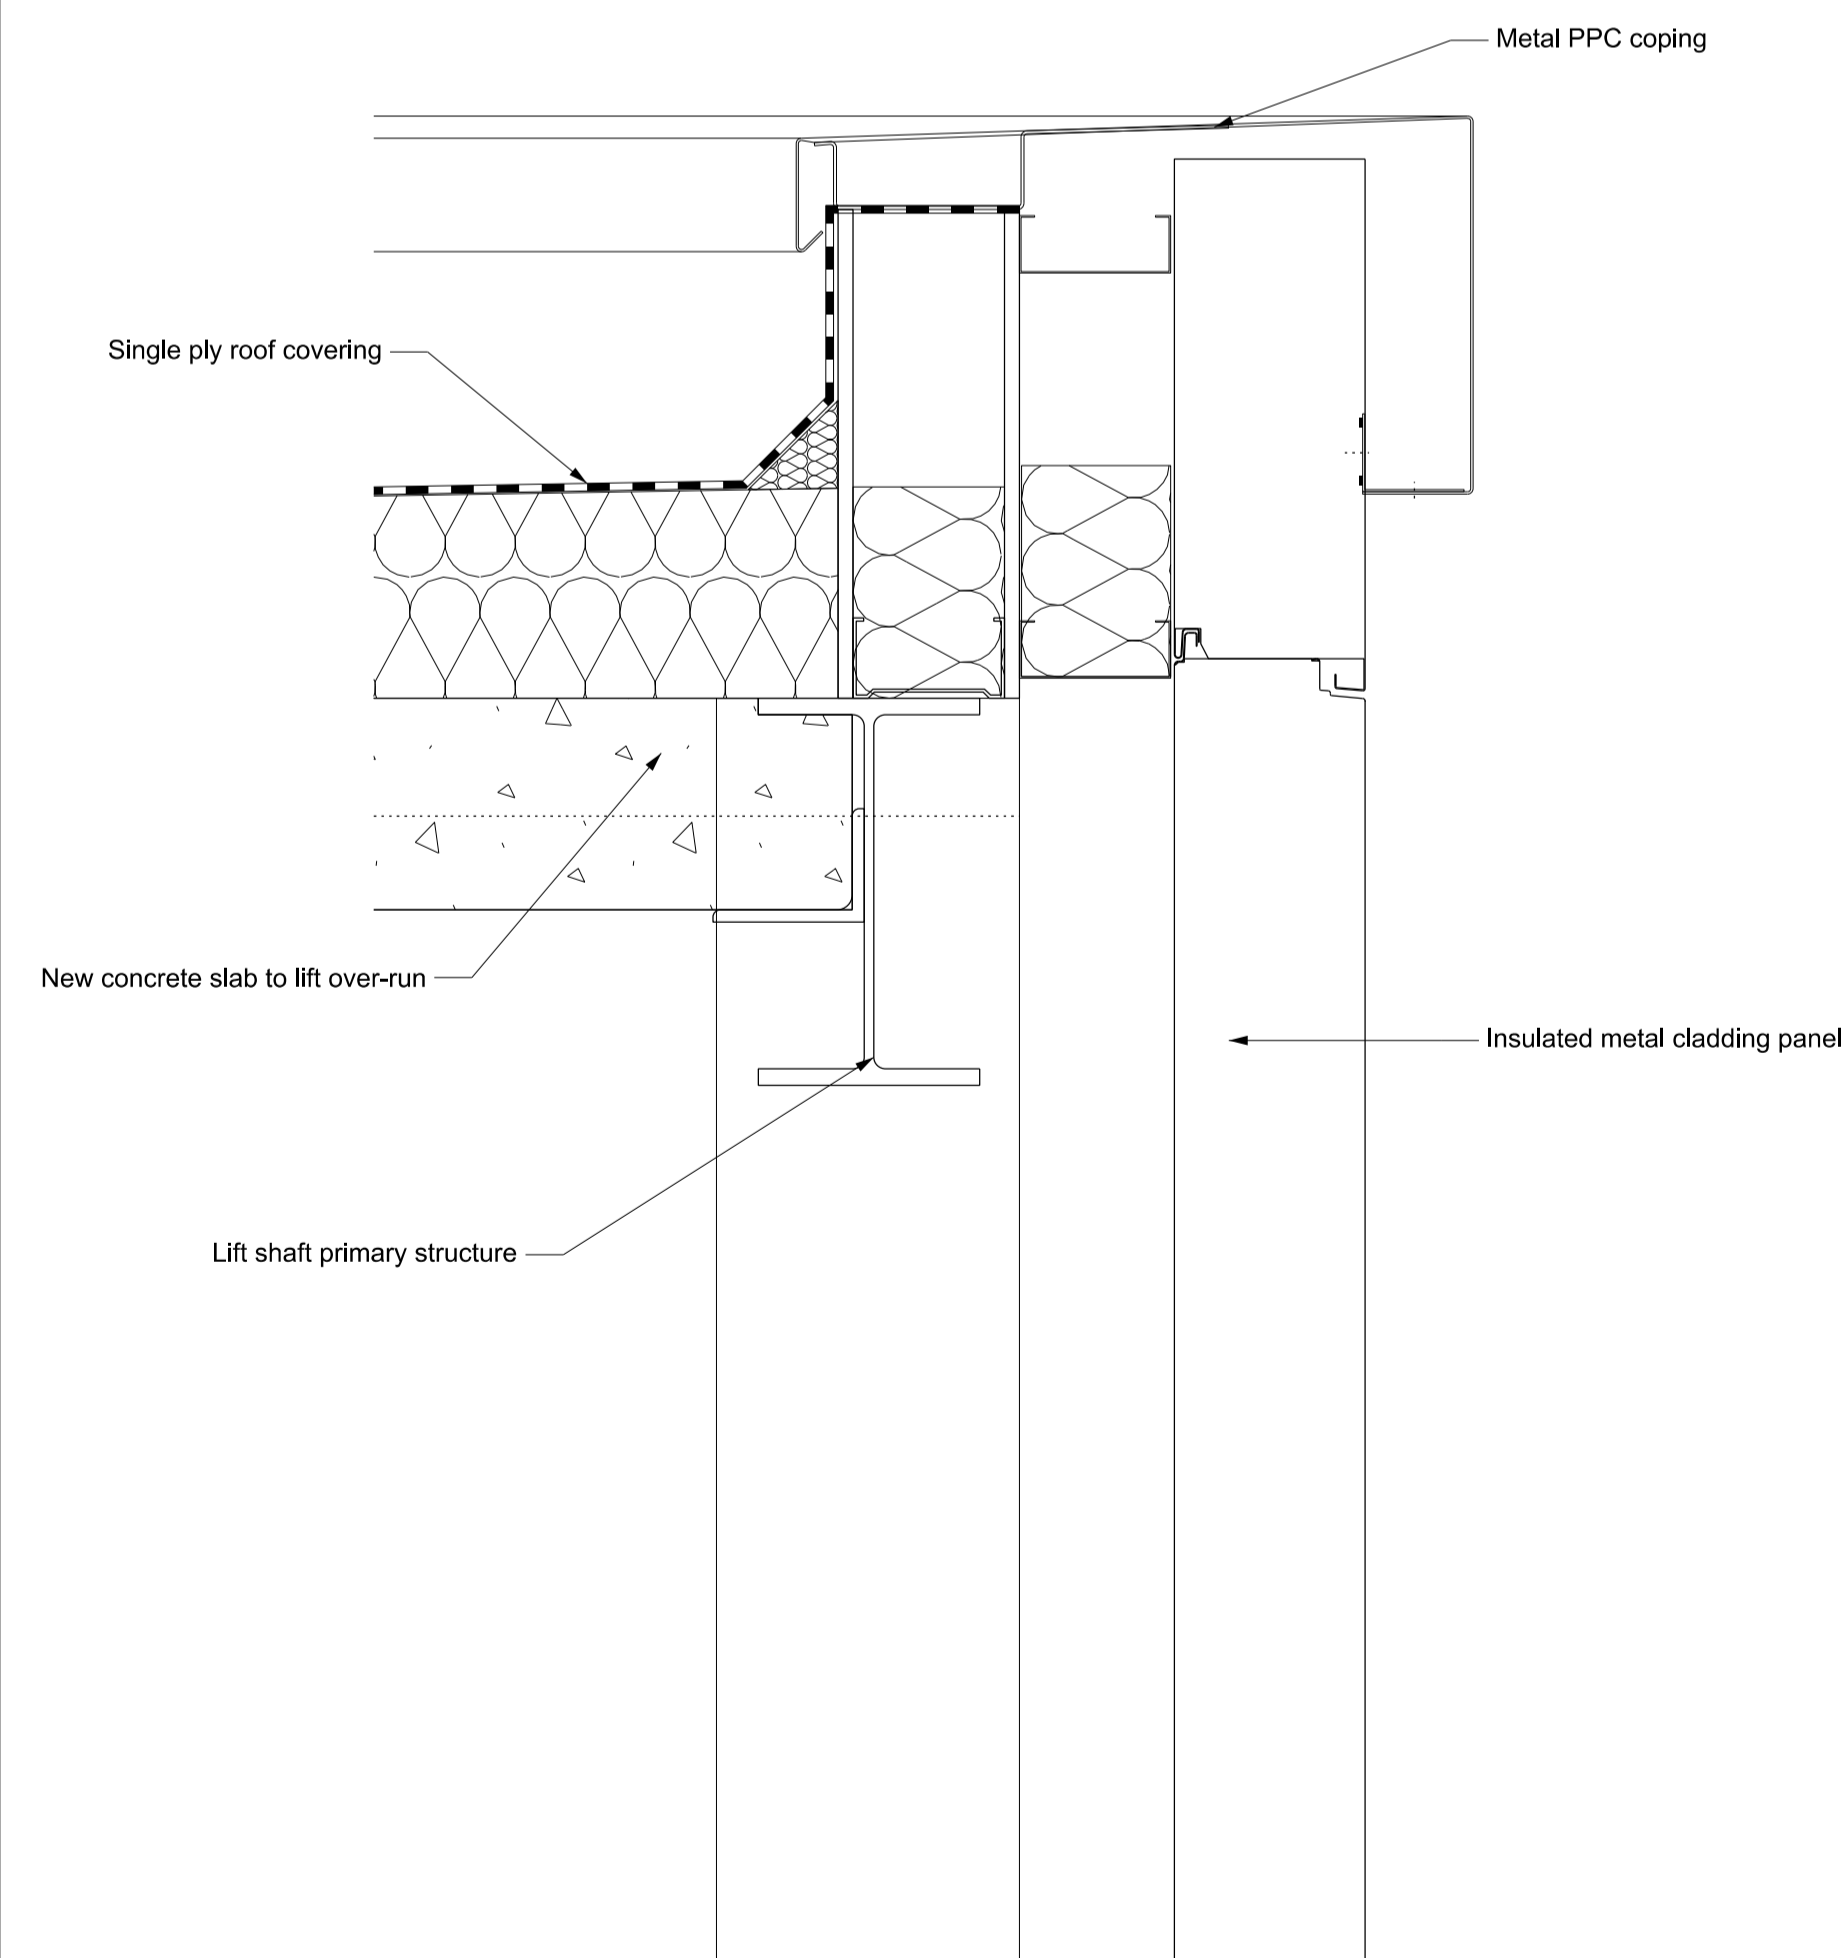
Detail 5 - Parpet

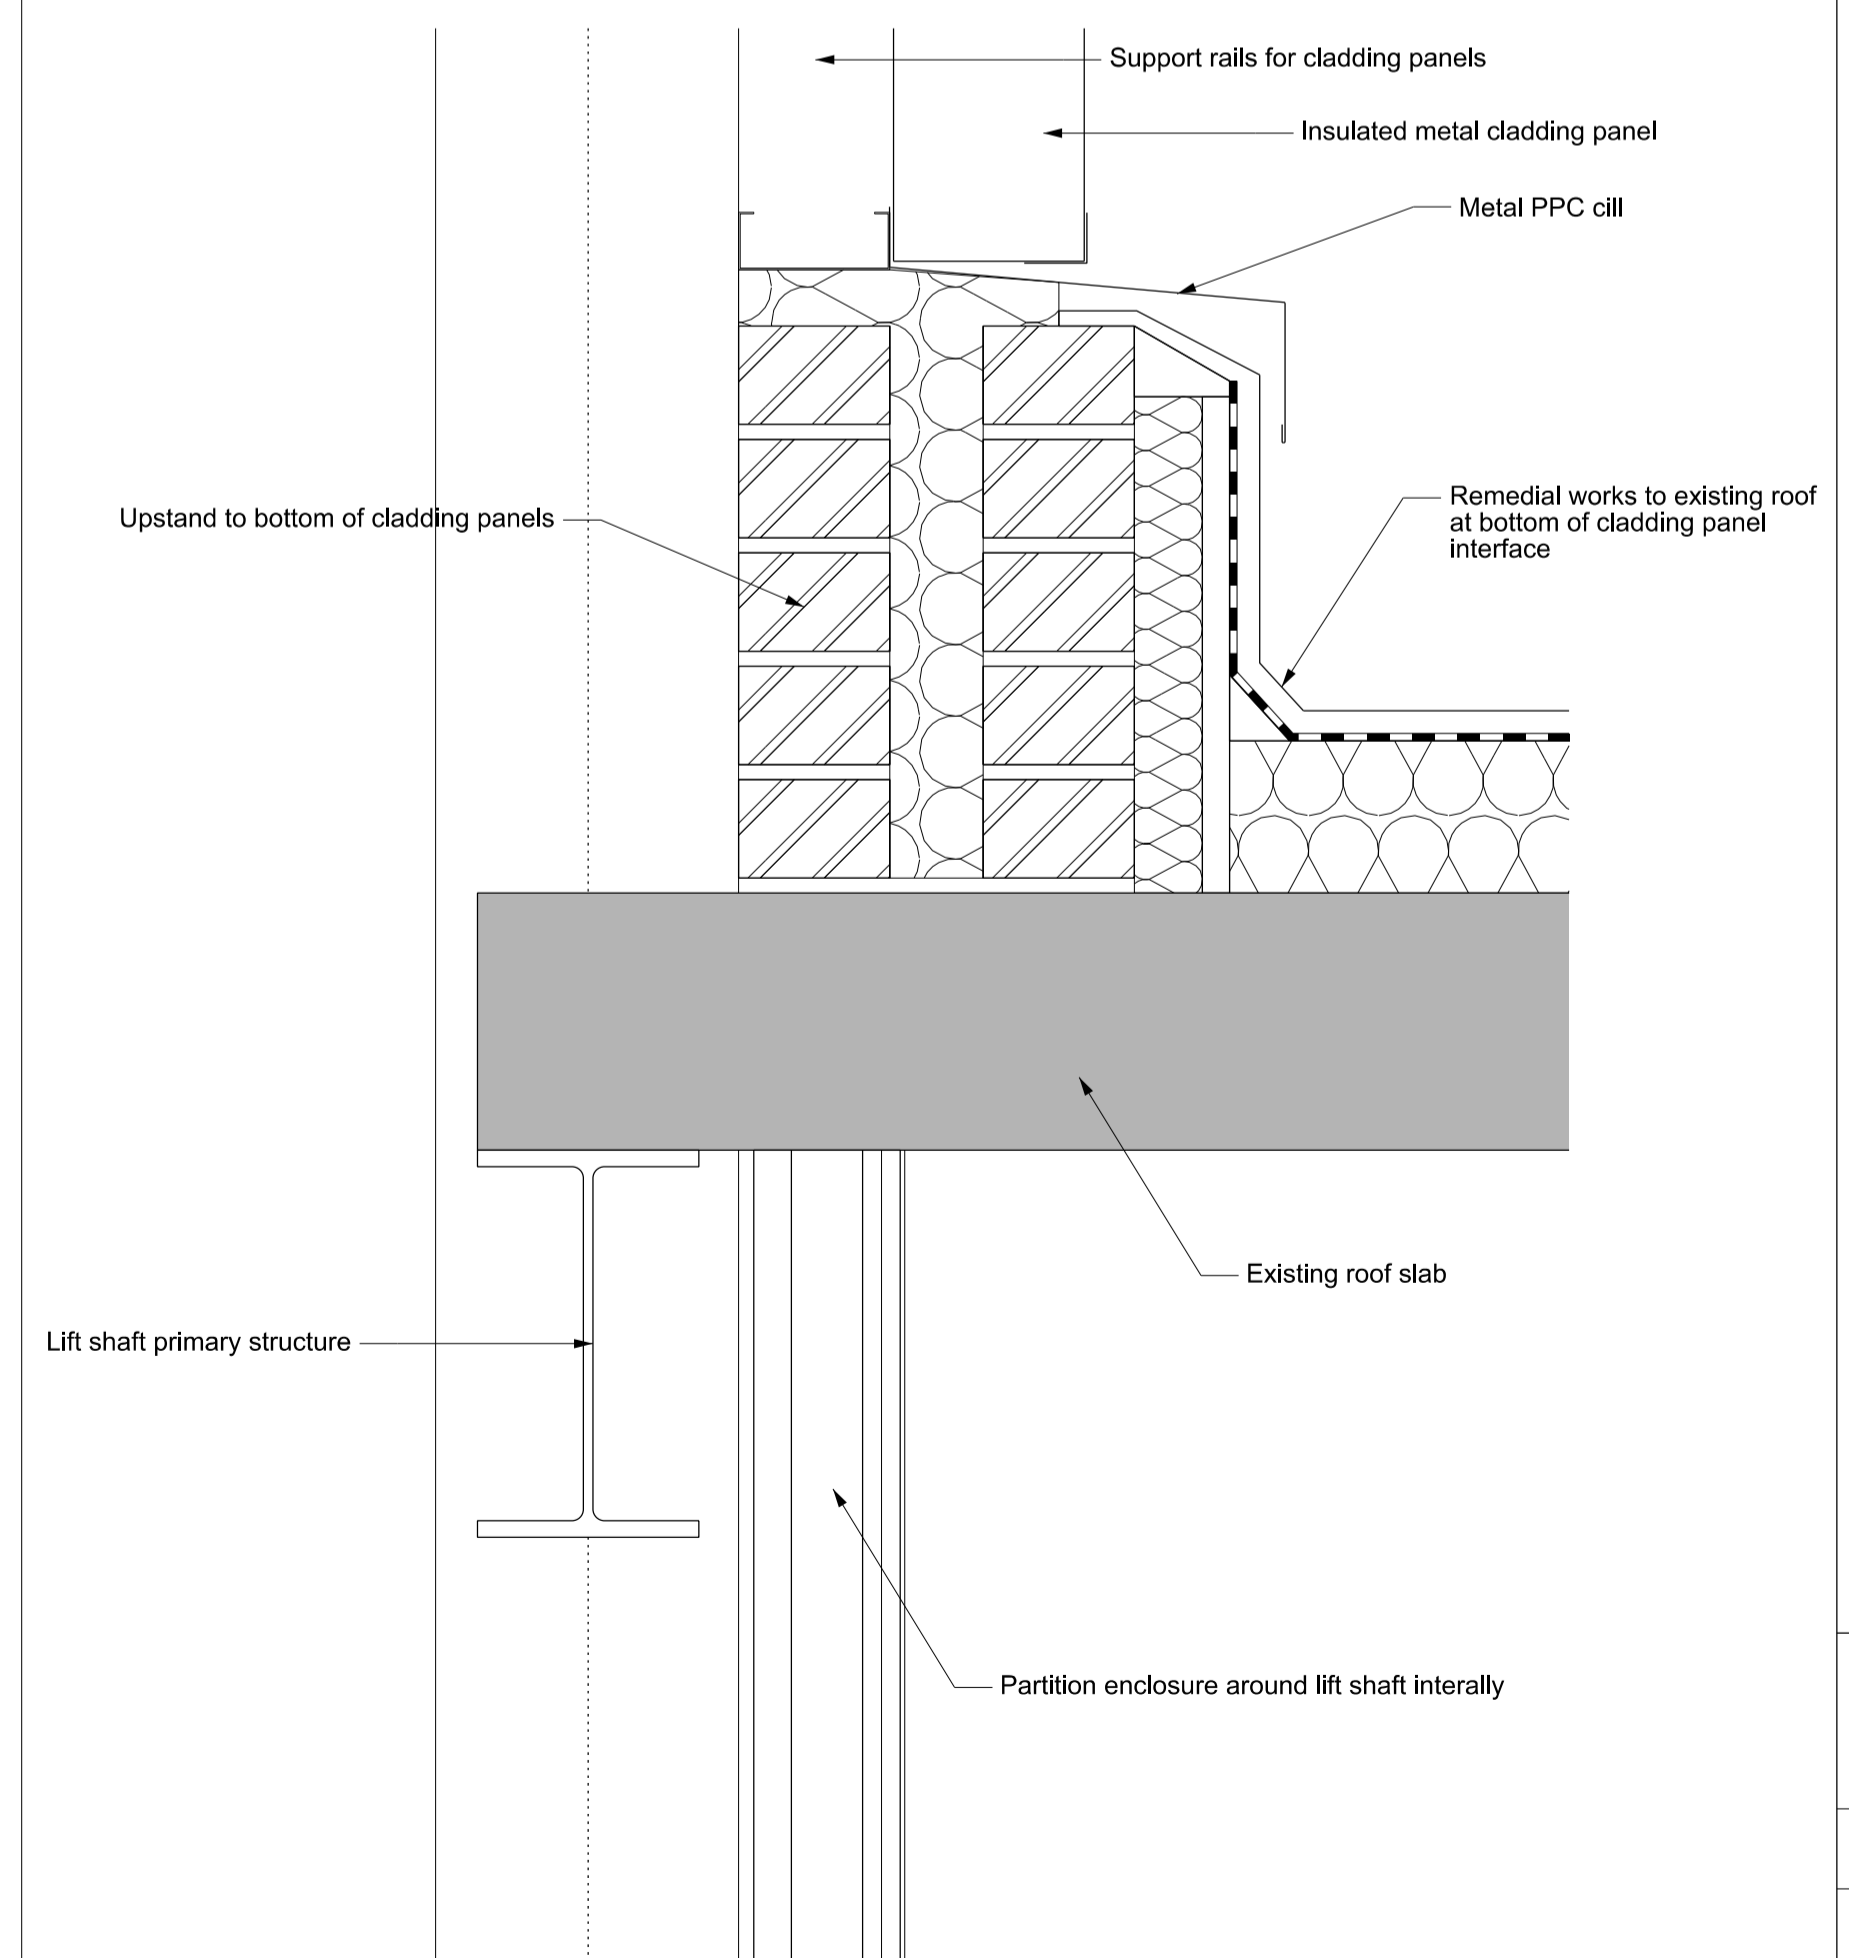
Detail 6 - Base of cladding panels
