**THE BRITISH MUSEUM**

**WINDOW TO ROOM 2 / GRENVILLE LIBRARY**

**HERITAGE  
AND  
DESIGN AND ACCESS STATEMENT  
TO SUPPORT  
LISTED BUILDING APPLICATION**

17<sup>th</sup> February 2015

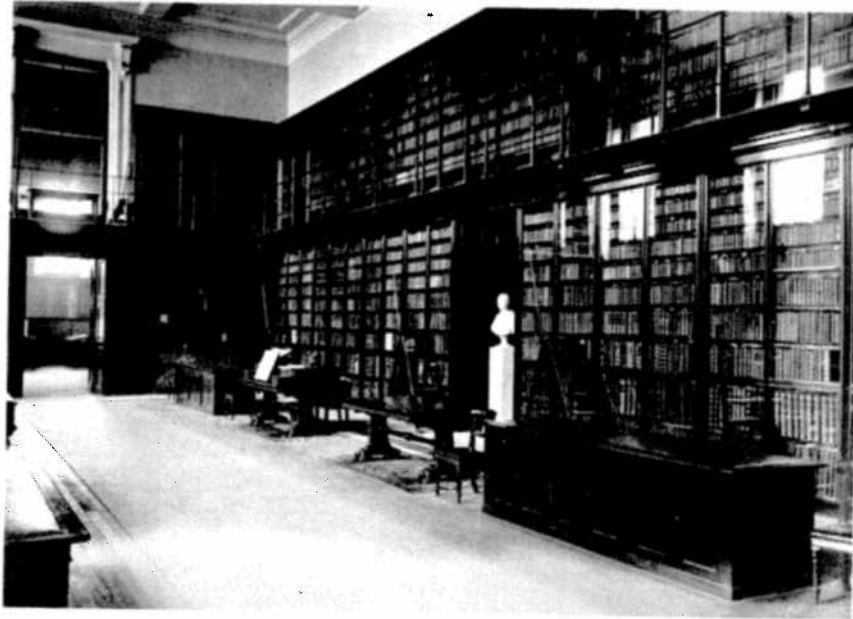
Original arrangement (from Grenville Library side)

The West Manuscripts Saloon (The Grenville Library) as designed by Sir Robert Smirke and completed in 1847 survives in its entirety including all the fittings and finishes (*with the exception of the altered window at balcony level 3*) The Room as existing is highly significant historically and of great heritage merit. Architecturally it is significant as one of the last rooms designed by Robert Smirke.

The reinstatement of a 2/2 sash window at this level will greatly improve the shared natural light between the two rooms as was the original intention. The proposals remove the utilitarian plain partition from the Room 2 side and the uncomfortably detailed door/screen from the Grenville Library side.

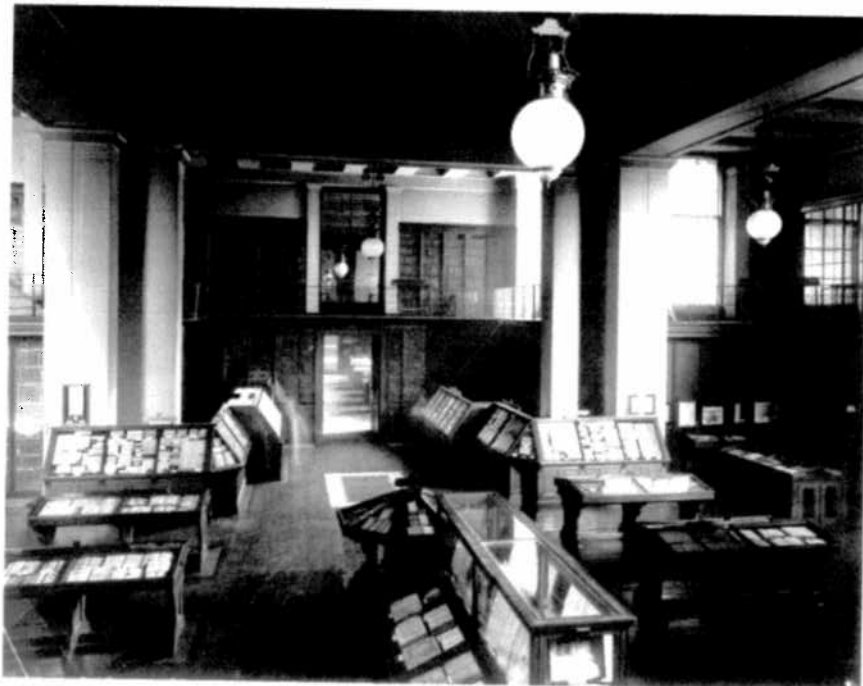
Original arrangement (from Room 2 side)

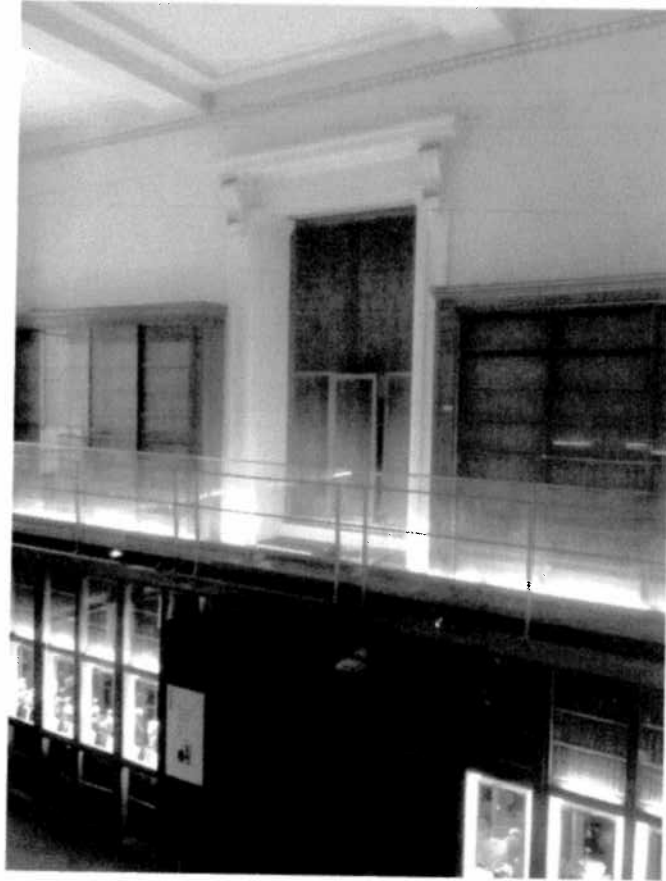
Current arrangement (from Grenville Library side)

The proposals are to replace the stud partition and glazed door/screen at balcony level between the Grenville Library and Room 2 with a new glazed window similar in form to the original window.

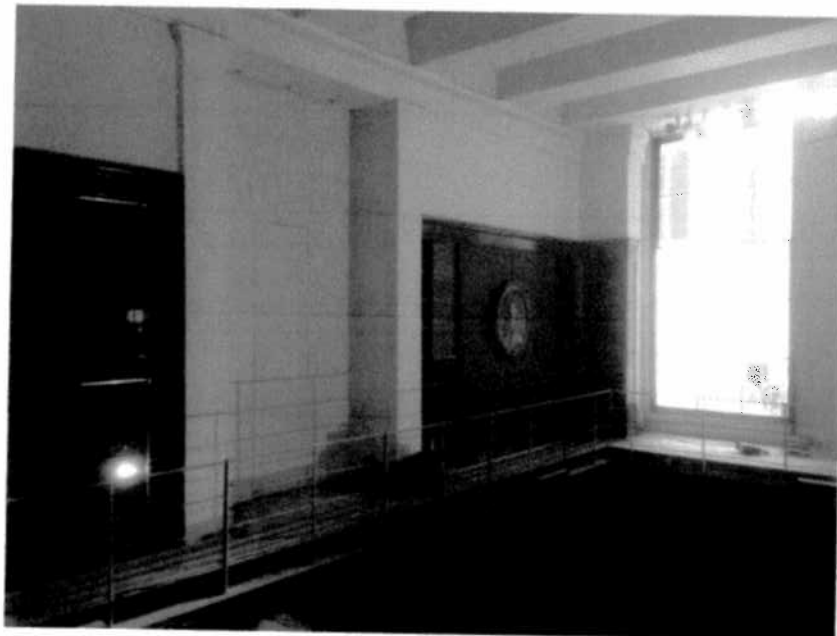
Current arrangement (from Room 2 side)
