THE BRITISH MUSEUM

WINDOW TO ROOM 2 / GRENVILLE LIBRARY

HERITAGE AND DESIGN AND ACCESS STATEMENT TO SUPPORT LISTED BUILDING APPLICATION

17th February 2015

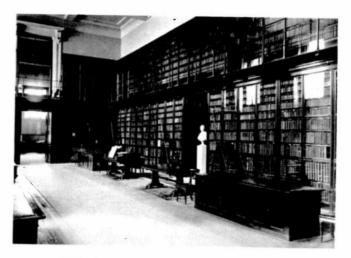
Original arrangement (from Grenville Library side)

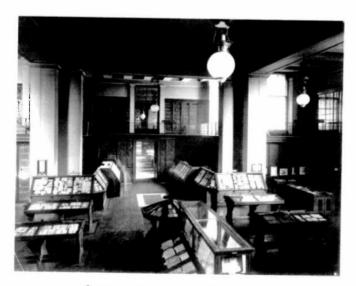
Original arrangement (from Room 2 side)

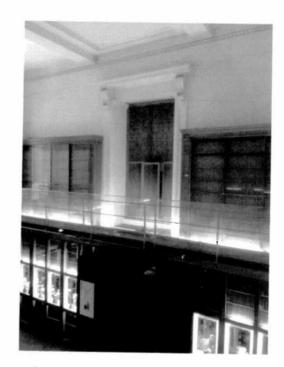
Current arrangement (from Grenville Library side)

The proposals are to replace the stud partition and glazed door/screen at balcony level between the Grenville Library and Room 2 with a new glazed window similar in form to the original window.

The reinstatement of a 2/2 sash window at this level will greatly improve the shared natural light between the two rooms as was the original intention. The proposals remove the utilitarian plain partition from the Room 2 side and the uncomfortably detailed door/screen from the Grenville Library side.
