2 Redington Road, Hampstead, Borough of Camden,
Design and Access Statement and
Statement of Significance

April 2015

No. 2, Redington Road, Hampstead, Borough of Camden. Statement of Significance

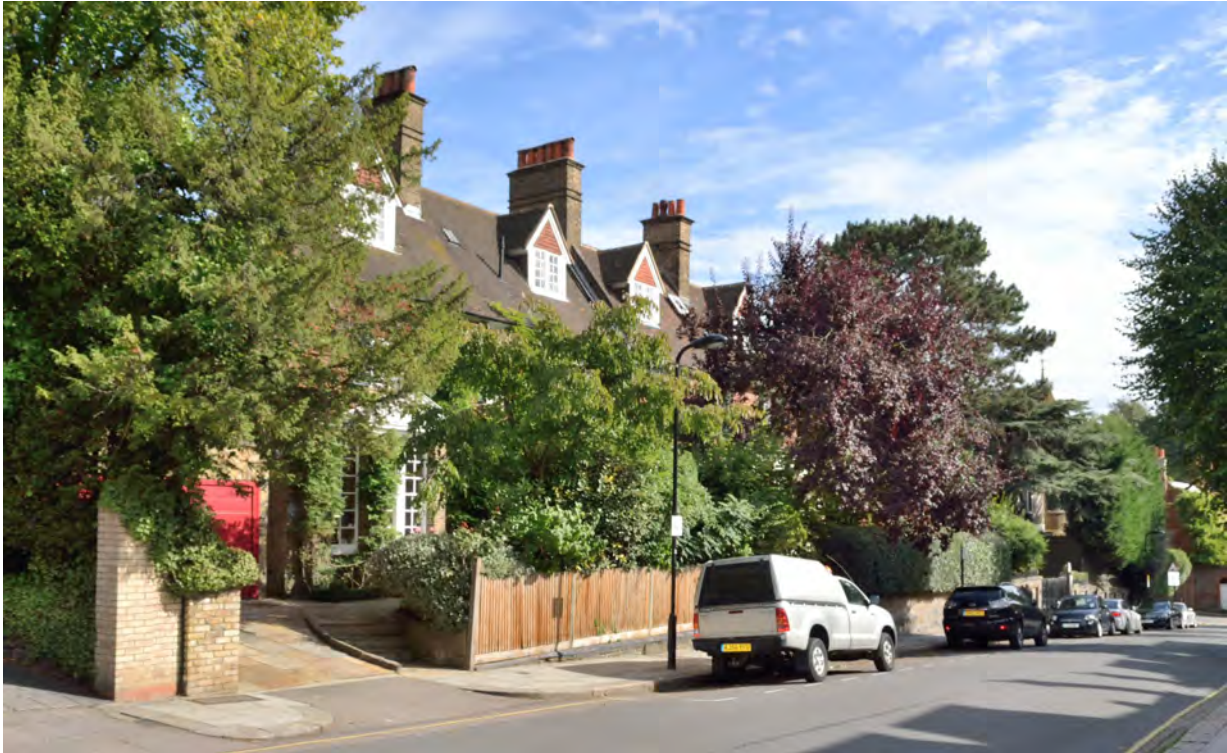
Fig 1, Nos 2 and 4 Redington Road visible behind mature garden foliage. No 4 in the foreground, retains the timber fence over the blue brick retaining wall. When built both properties had a picket fence.

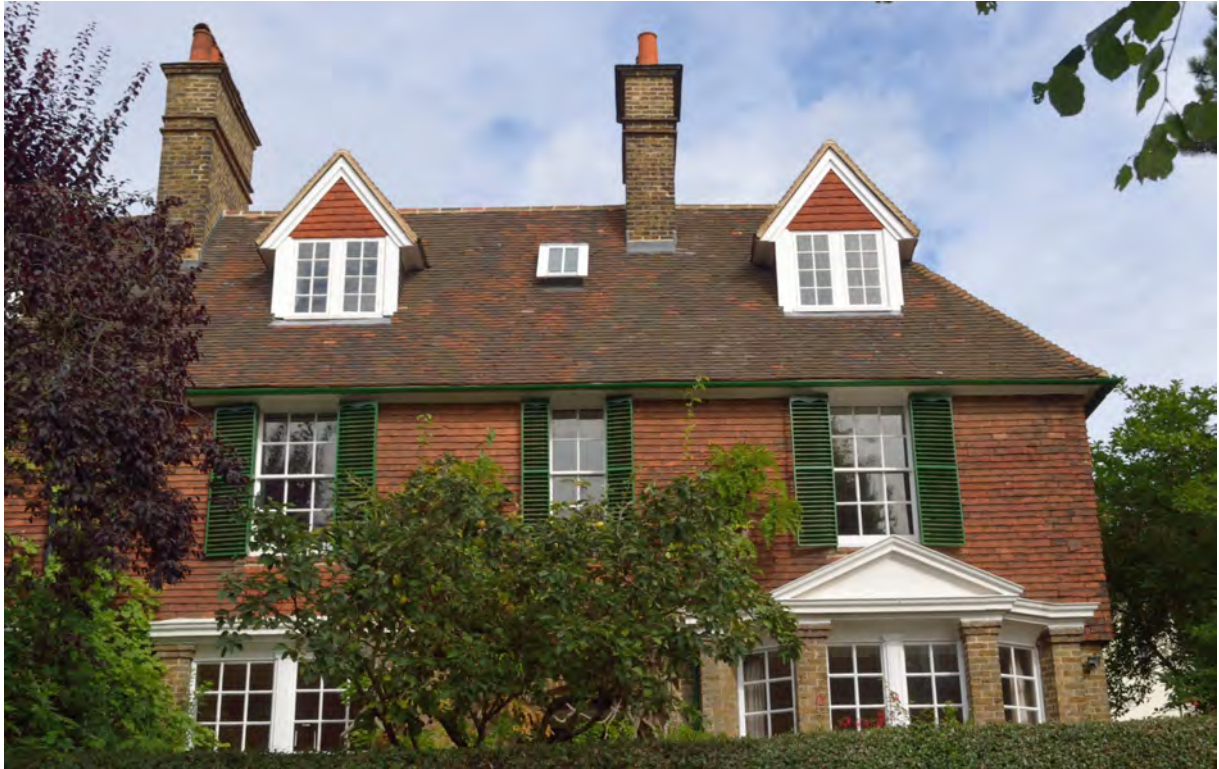
Fig 2, Detail of No 2 showing the (original) slightly projecting pair of nine pane sashes to the left (dining room) window and the later pedimented canted bay window with six pane sashes to the right (drawing room) .

No 2 has a 4-light canted bay window incorporating a pair of six pane sash windows separated by a timber pilaster between brick pilasters, with a single six pane sash to either side. The brick pilasters support a deep projecting curved cornice supporting a triangular pediment to the front face. The bay to No 4 is identical with a similarly curved and dentilled eaves cornice. At first floor level, both buildings have three windows with external louvred shutters and small-paned six-over-six sashes. There are three tall chimney stacks - one to each side and a shared central stack; and two gabled dormers, detailed with tile-hung cheeks and a pair of small-paned casements, and a small centrally-positioned rooflight to each dwelling.

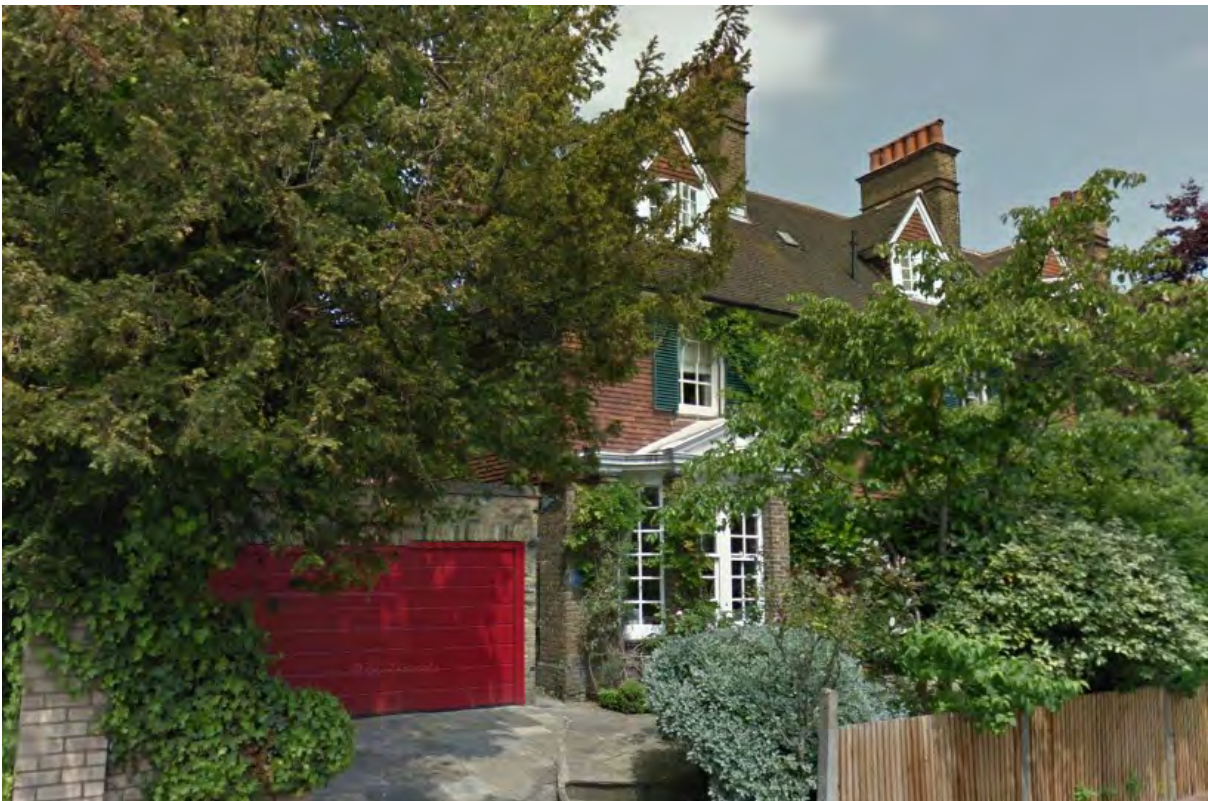
Fig 3, The adjacent No 4, with similar detailing to the front elevation just visible through the mature foliage.

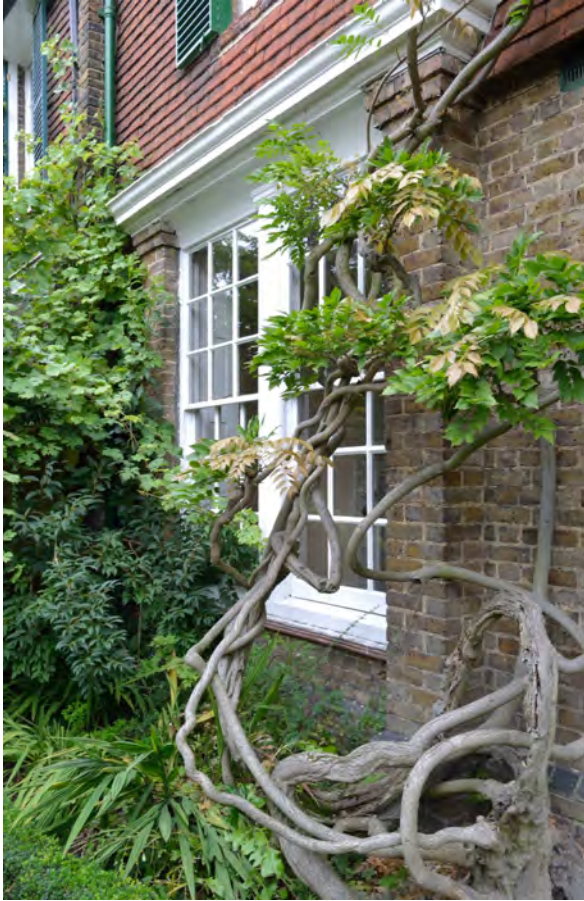
Fig 4, The slightly projecting dining room window has a pair of nine pane sashes beneath a deep cornice supported on brick pilasters.

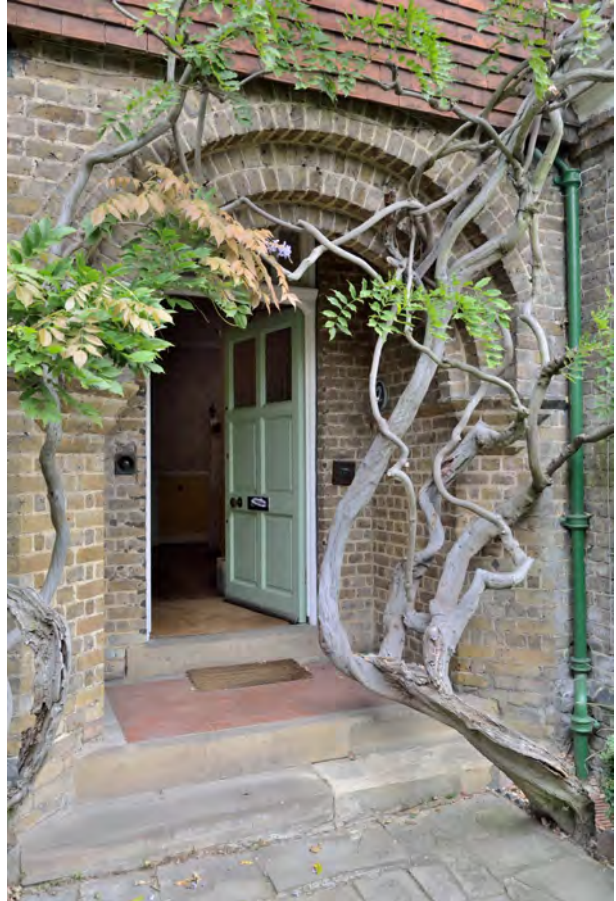
Fig 5, The front door showing the arched brick open porch—a typical Webb detail. The ancient wisteria may well be contemporary with the house.

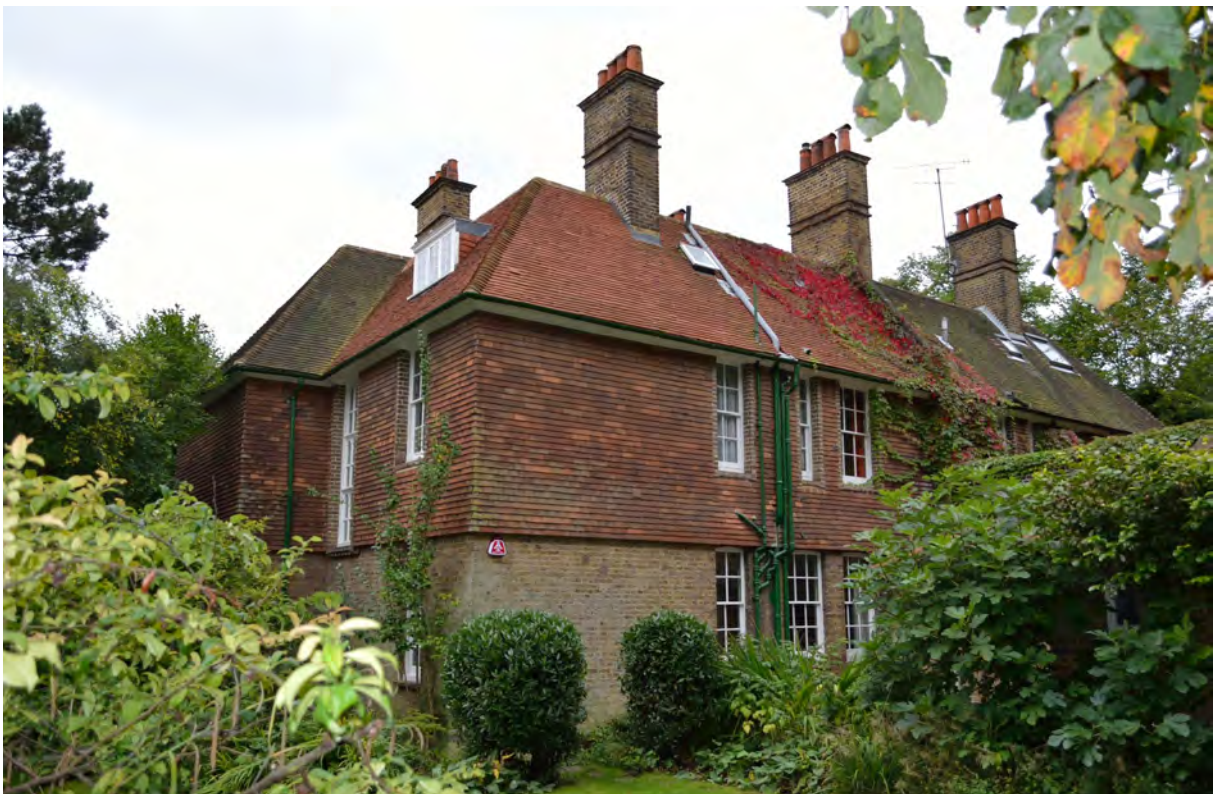
Fig 6. Rear view,. Note the narrower windows of the subservient rooms, the service range is hidden by foliage.

The rear elevation of each property has three narrow six over six sash windows to both floors with roof spaces lit by rooflights (Fig 6). A rear door opens into a narrow single storey mono-pitched service range set against the boundary wall separating the two properties; this in turn is attached to another small lean-to outbuilding, which is set at right angles to run parallel with the rear elevation of the house.

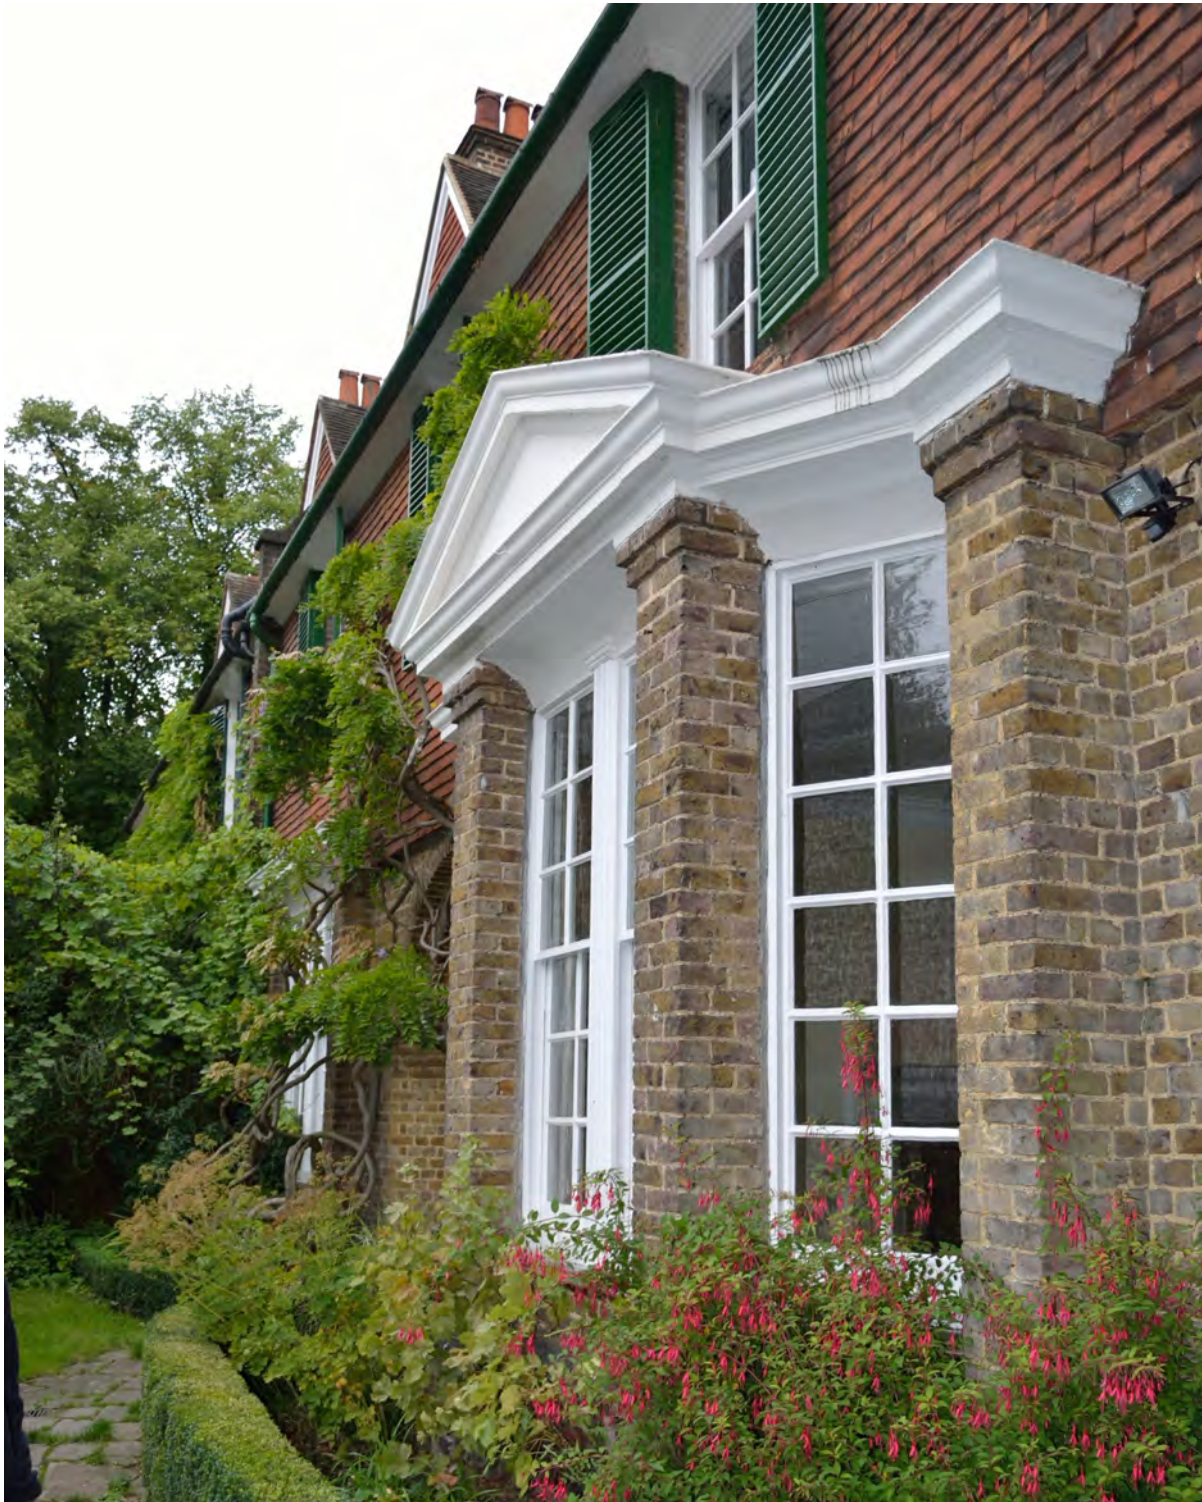
Fig 7. The drawing room bay window with its heavy pediment. Although well detailed, this bay window is an early 20th century addition probably replacing an identical window to that in the dining room.

This shows that the house has survived almost unchanged in terms of its general layout. The pedimented bay window to the drawing room is now known to be an early 20th century alteration, as is the formation of the pantry in the kitchen. In the mid-20th century an attic room was converted into a bathroom and the hatch between the kitchen and dining room probably dates to this period. During the late 20th century the scullery was converted into a kitchen and shower-room. The plan also showed a door from the pantry into the dining room, (where the hatch currently is) but for reasons discussed later this is believed to be unlikely.

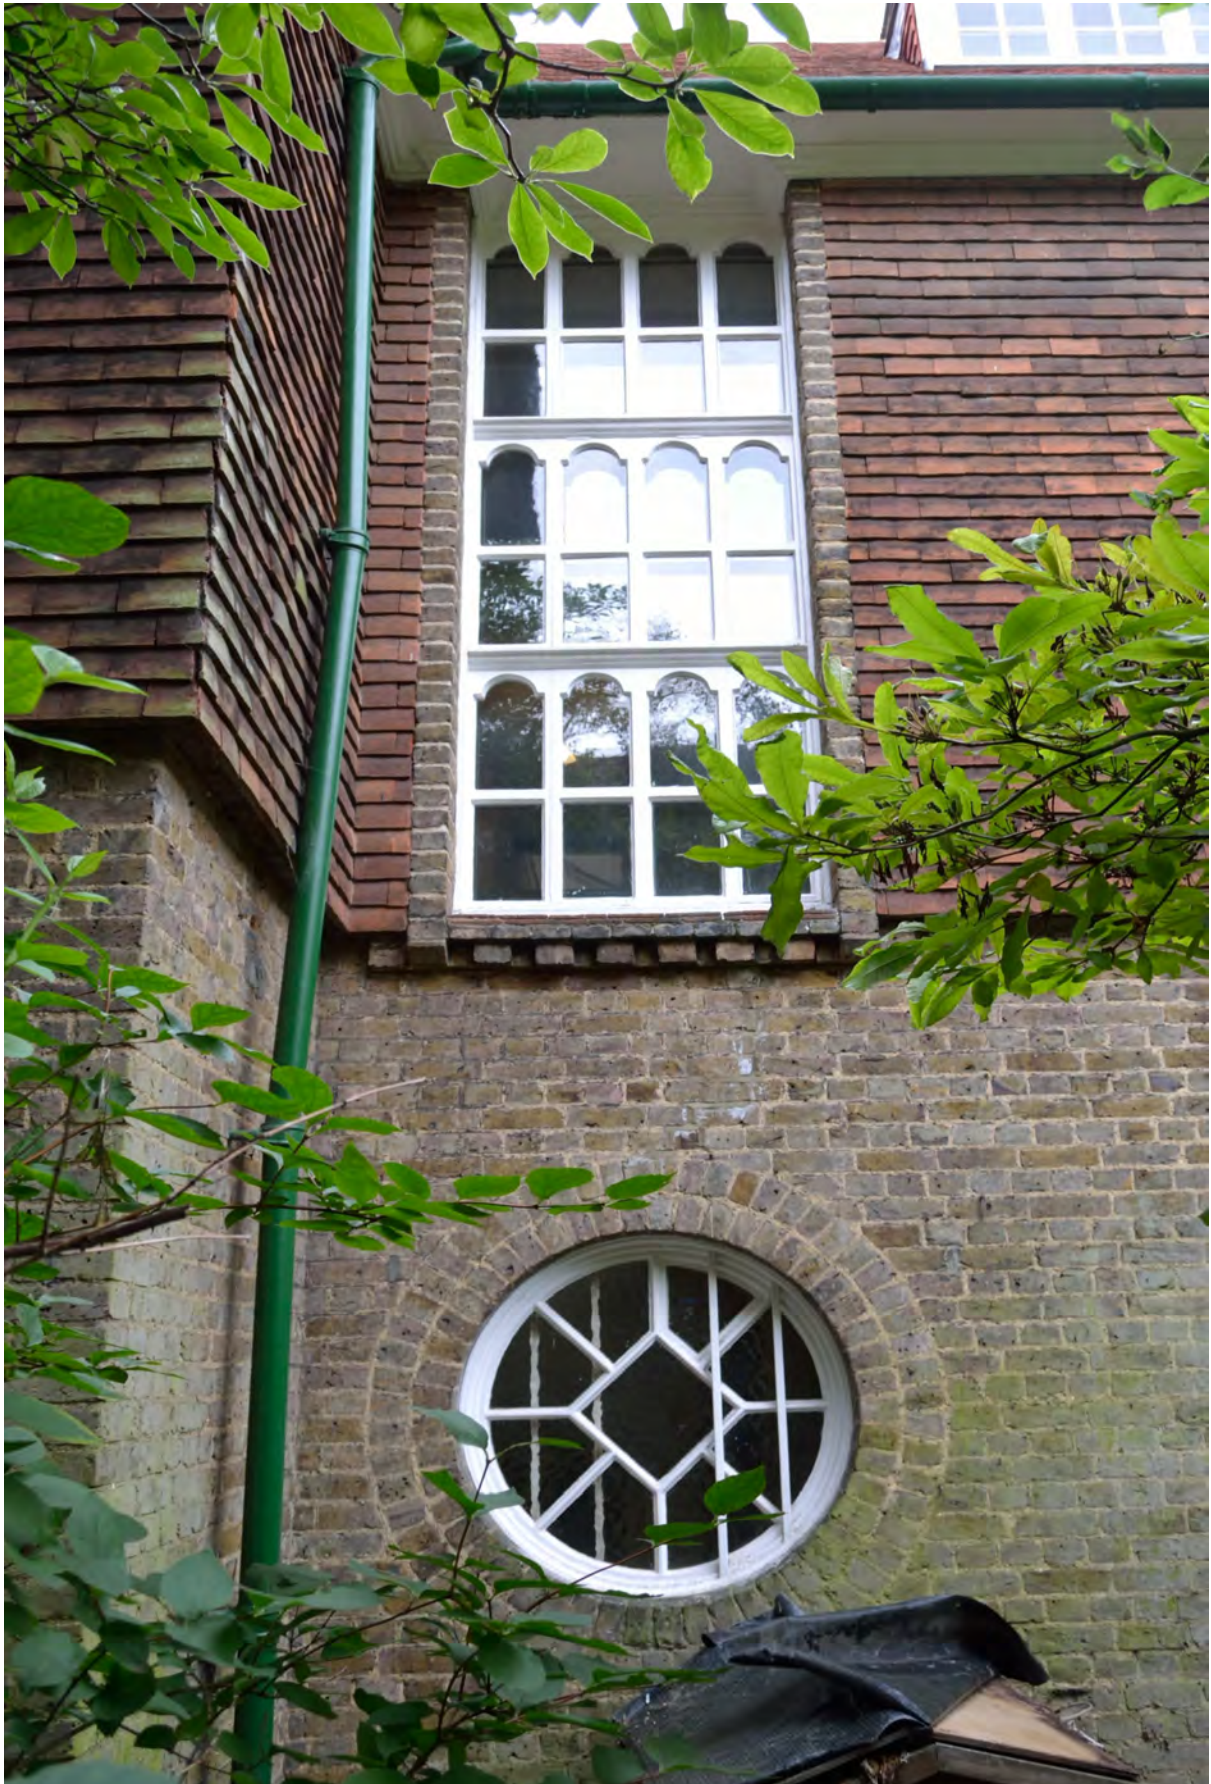
Fig 8. The .side elevation. Showing the narrower rear range containing the tall stair window above a round window lighting the WC, both typical Webb details. The wider front range contains the larger principal rooms

Behind the front range is a slightly shorter rear range, slightly setback behind the front range. It is constructed using the same palate of materials, and has the same projecting eave detail, and arrangement of three chimney stacks. The side elevation has a centrally-positioned 3-light dormer window with curved roof; and a single sash window at ground and first floor level. A full depth first floor window lights the stair well, (which abuts the principal range), with a small circular window below lighting a W.C. beneath the stairs.

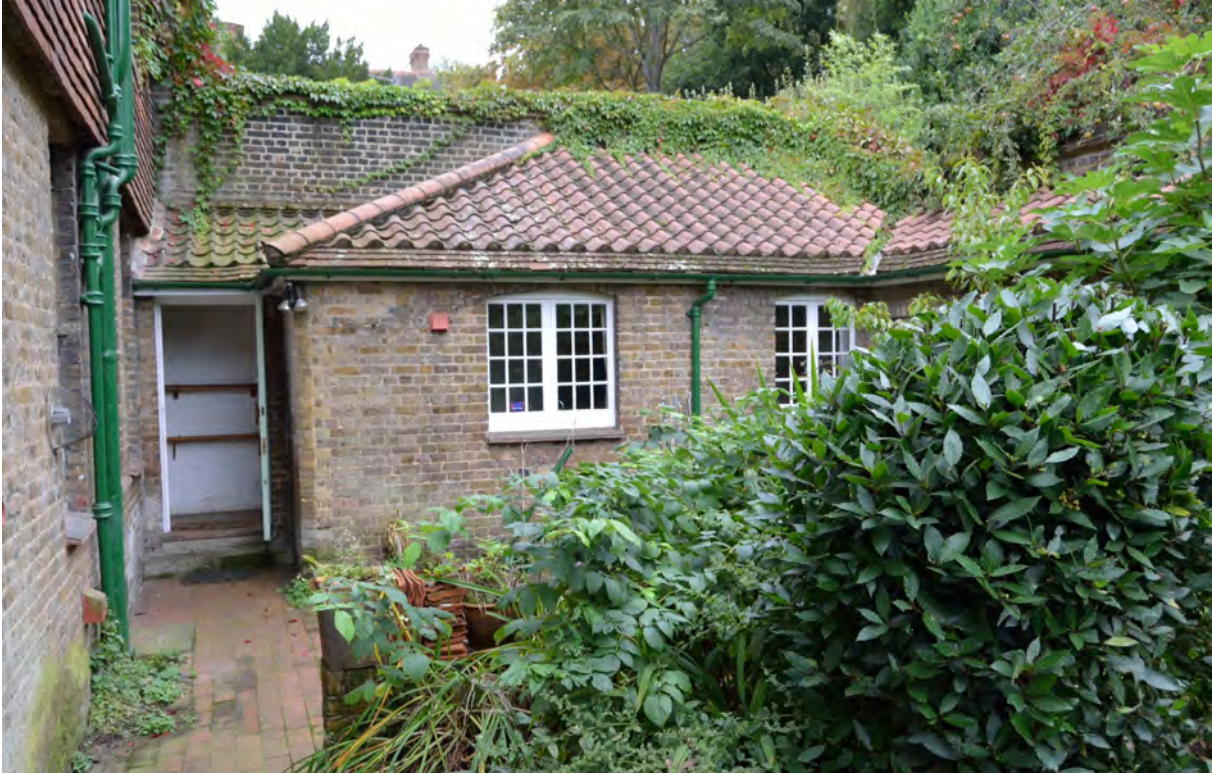
Fig 9. The former scullery and rear door to the kitchen which opens into a small courtyard paved with red brick. The low courtyard wall is just visible in the foreground, largely hidden by vegetation. .

The single storey former scullery was re-roofed when it was converted in the late 20th century into a kitchen and shower-room, the heavy hip tiles were added then and none of its original internal detailing survives. Set at right-angles beyond this is another single storey brick building with a hipped roof, containing a small, externally-accessed store, and an outside WC. These buildings define two sides of a small brick paved courtyard and a remnant of a small wall extends off the corner of the outbuilding, to partially enclose this former yard.

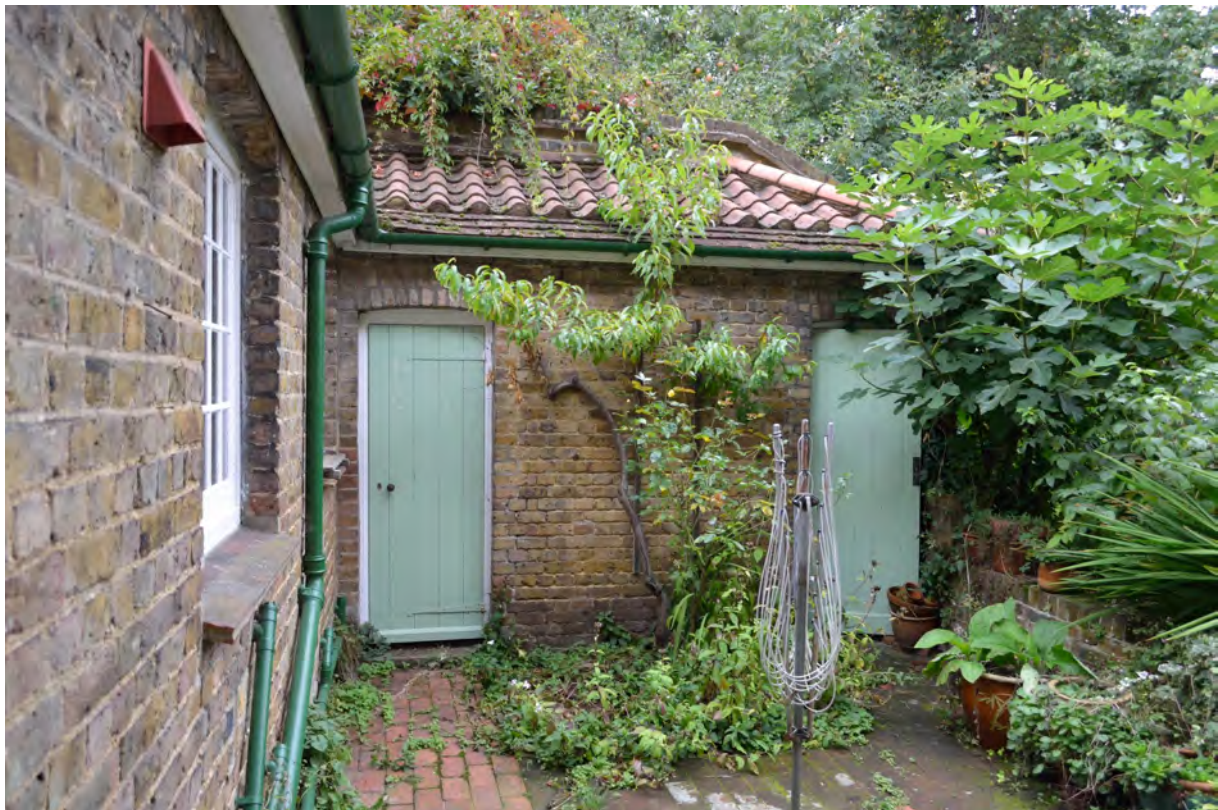
Fig 10. The end of the service range containing fuel stores within the small brick lined yard. The rounded tile hips to the roof are modern. .

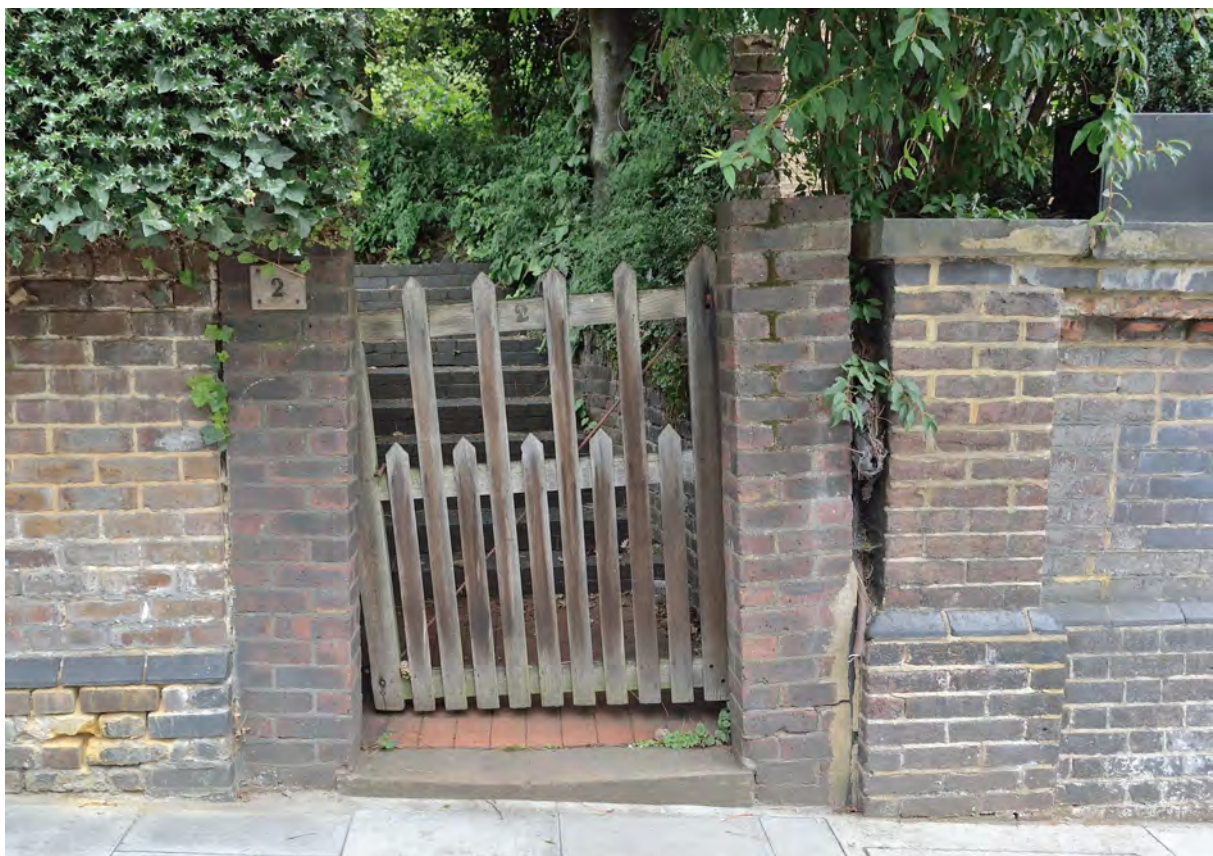
Fig 11. The simple wooden gate with the steps into the garden just visible beyond. The gate has been rehung but may reflect the detailing of the original wooden picket fence along the frontage, which was replaced by a brick wall in the early 20th century.

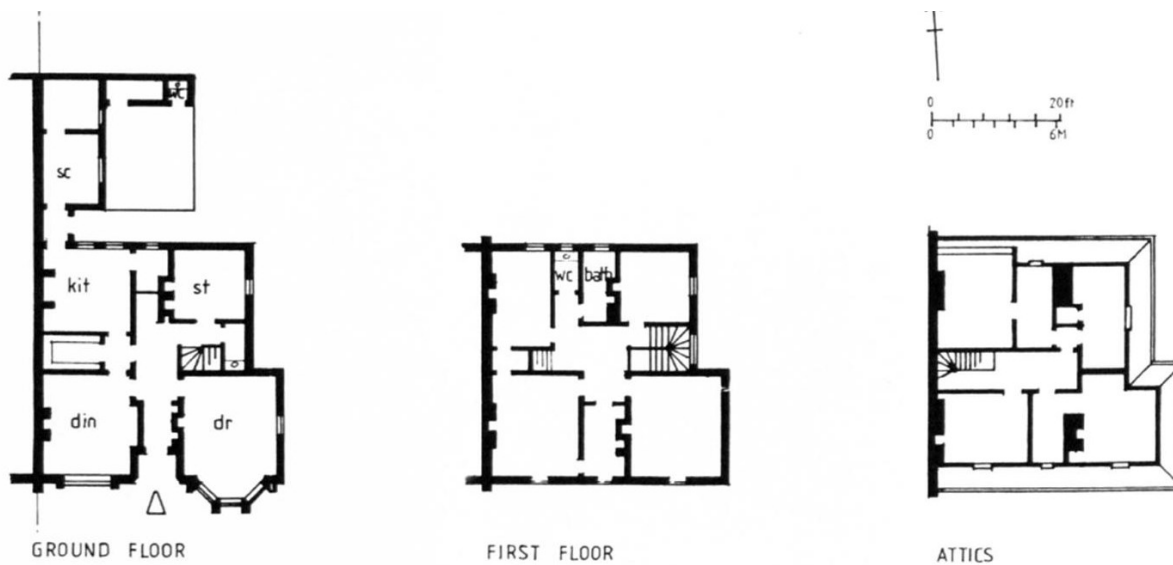
Fig 12 The original form of the building as proposed by the architect and architectural historian John Brandon-Jones, reproduced from a PhD Thesis by Sheila Kirk. For reasons which will be discussed later we do not think there was a door between the pantry and dining room. This is now a serving hatch in a blocked niche that seems in fact to have been for a cupboard not a door. The bay window to the drawing room, appears to be an early 20th century addition, as it first appears after 1919 on the 1:500 OS maps unlike the one to No 4. .

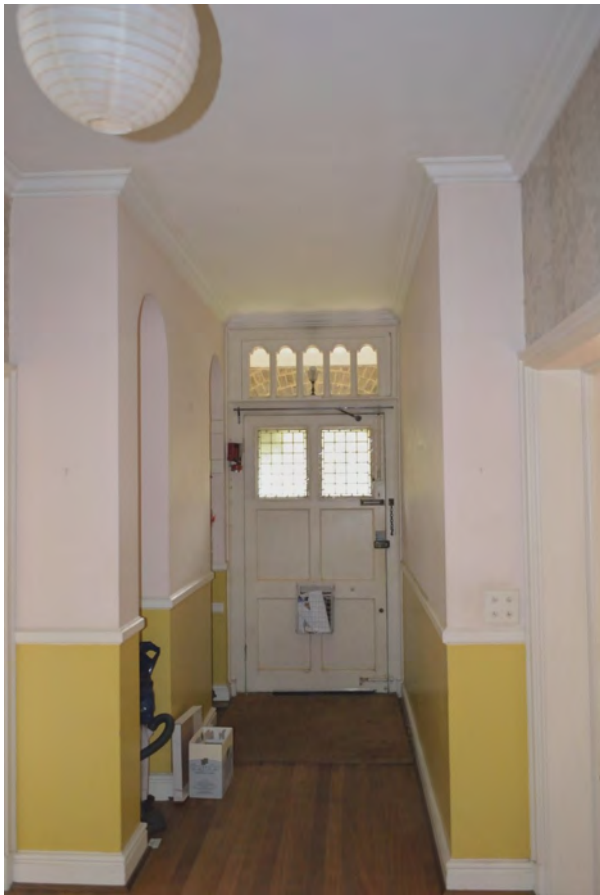
Fig 13, The entrance hall looking toward the front door. The floor is a modern over-boarded floor. Note the modern floorboards in the hall area.

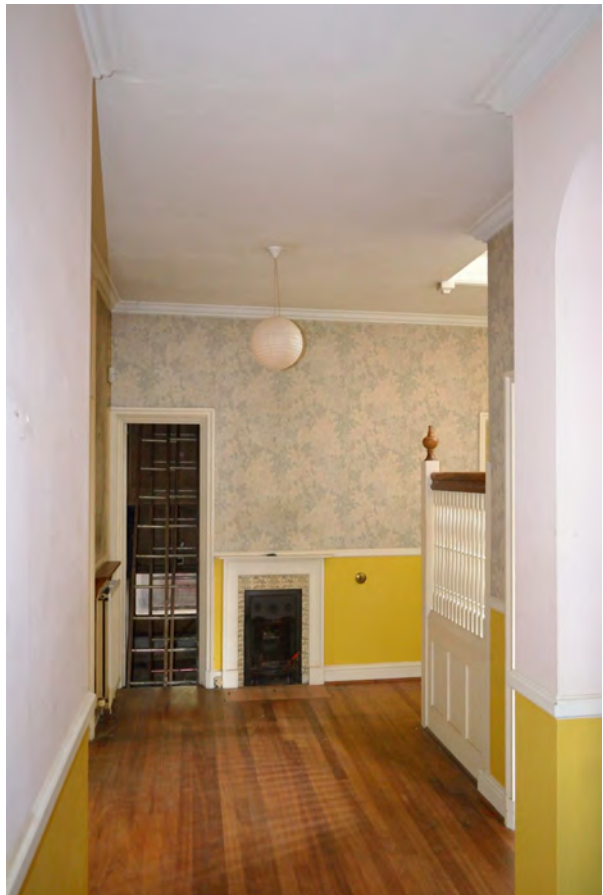
Fig 14, The entrance hall looking towards the stair hall with the decorative newel and baluster of the stairs just visible on the right.

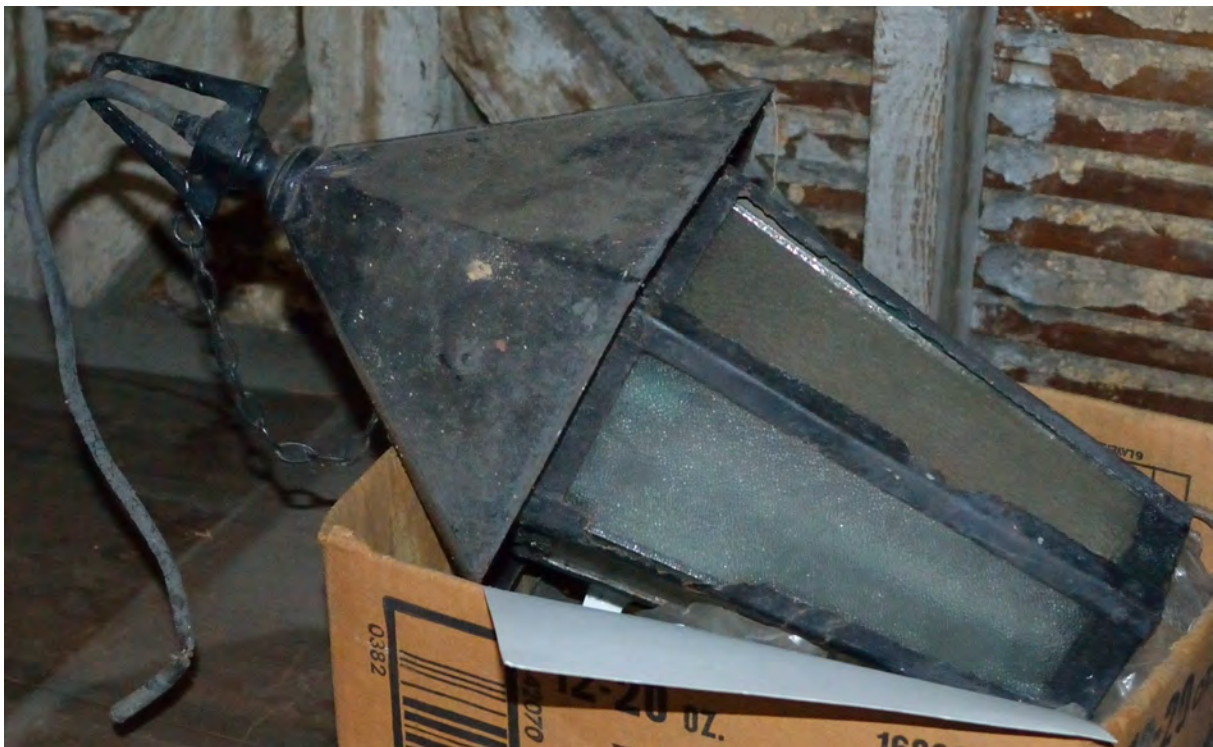
Fig 15, The original lantern from the front entrance porch currently in store in the attic. It is proposed to restore and reinstate this lantern to its original location.

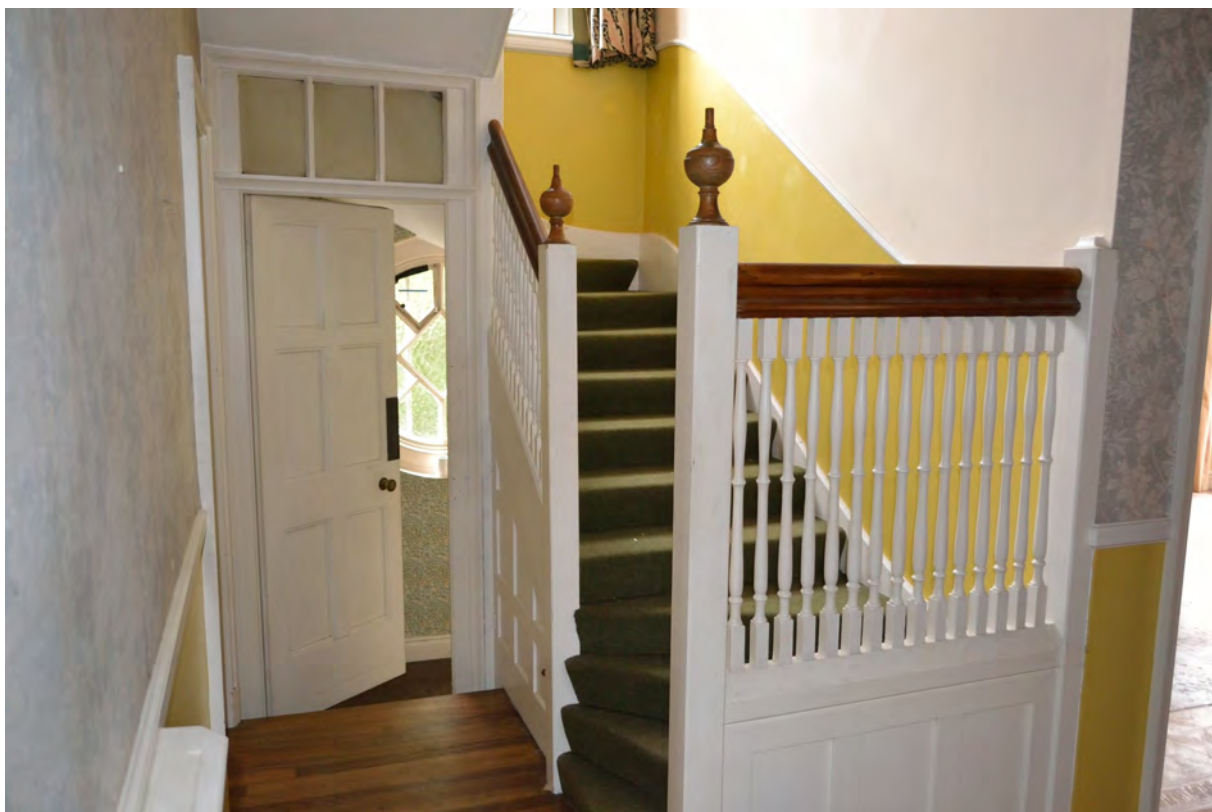
Fig 16 The well detailed stairs. Note the round window just visible in the WC under the half landing..

The main stair is an elegant but restrained wide staircase with slim-section turned and painted balusters, simple square newel posts surmounted by turned pitch pine cup / cover finials (possibly originally painted), and oak handrail. The stairhall is lit by a large mullioned timber window.

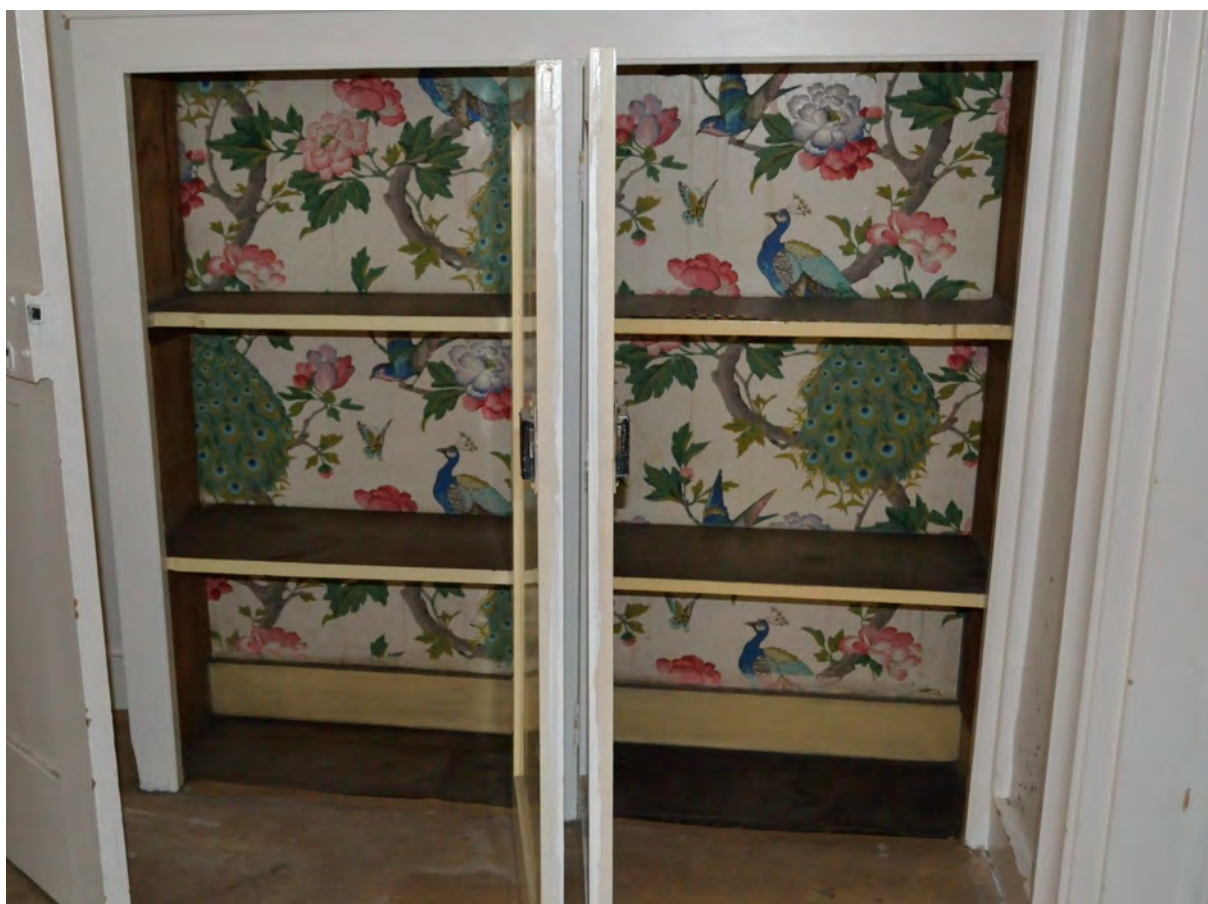
Fig 17 Hand painted wallpaper by Morris and Company surviving within one of the attic cupboards .

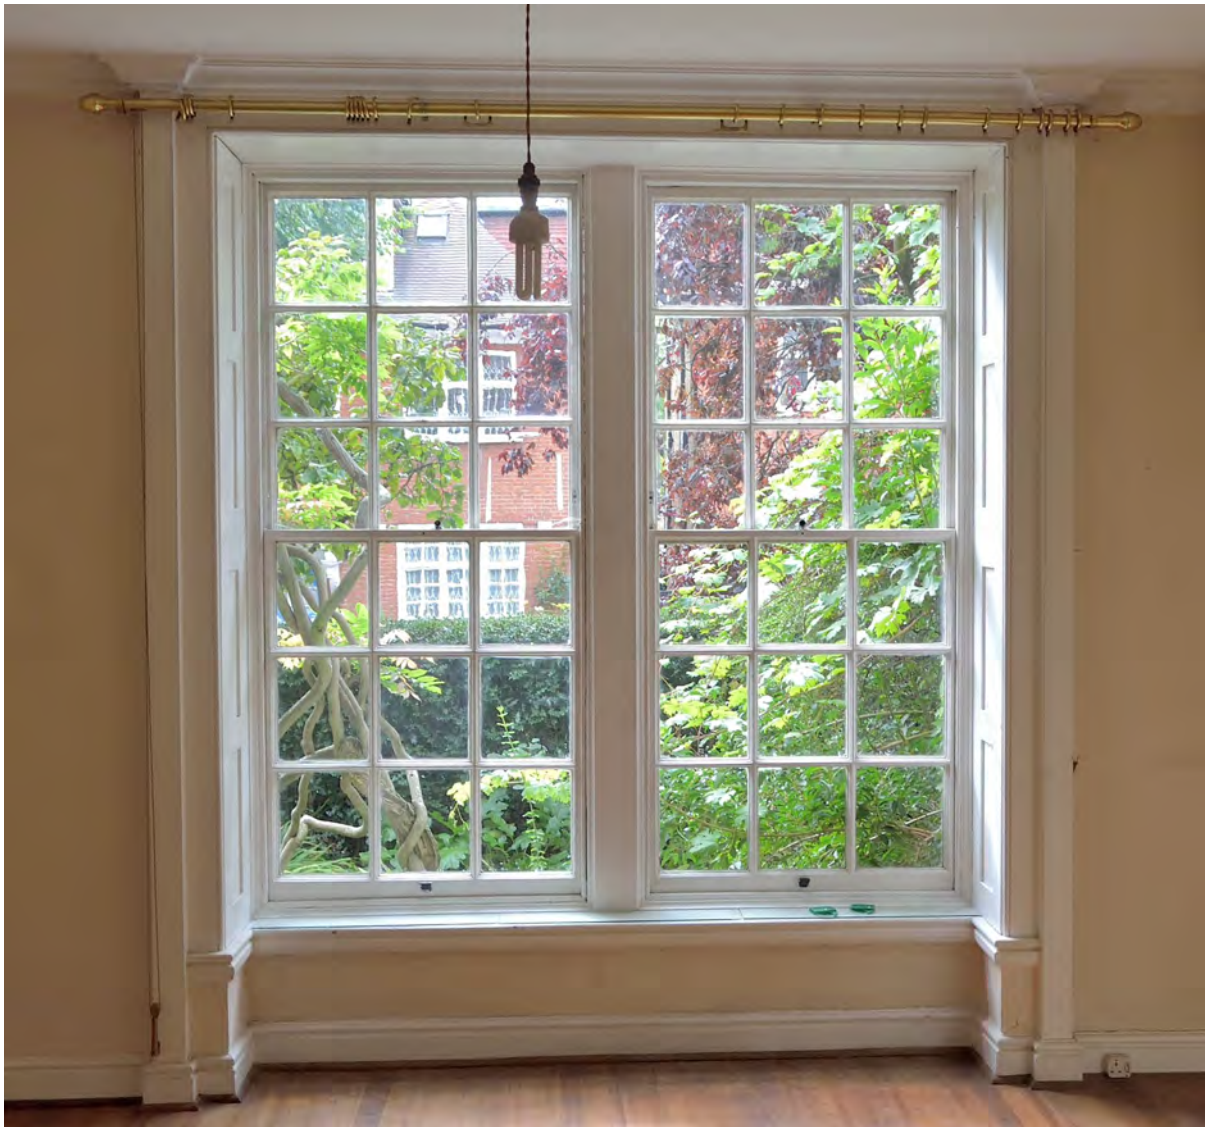
Fig 18, The original deep double sash window surviving in the dining room, with projecting architraves with pronounced moulded capitals and bases.

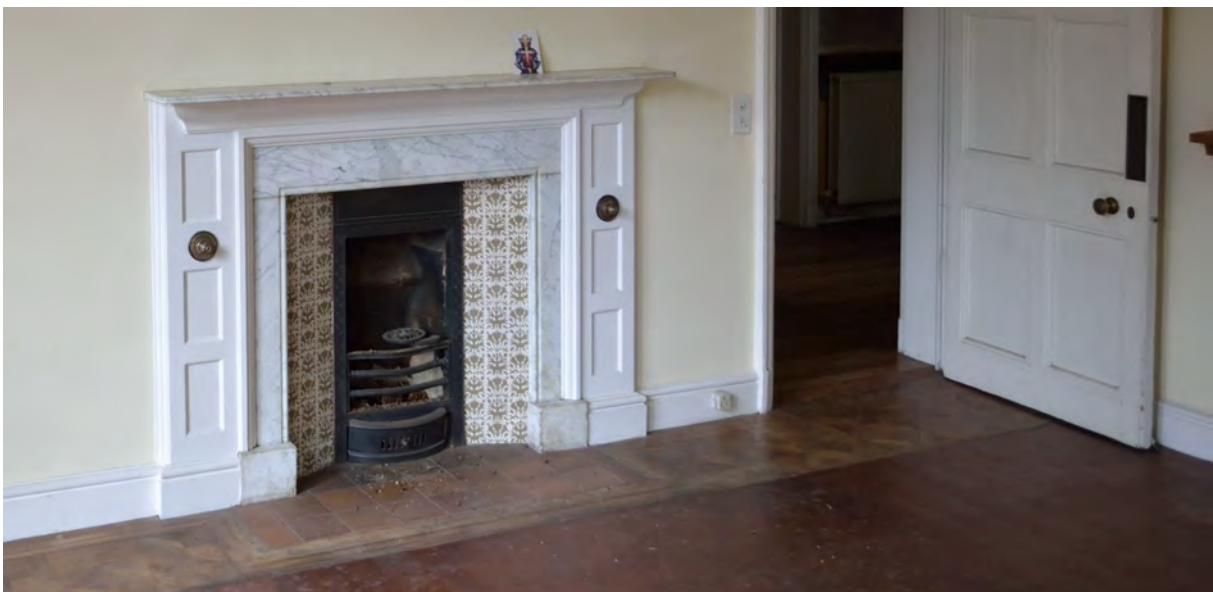
Fig 19 The drawing room fireplace and adjacent 6 panelled door with contemporary door furniture.

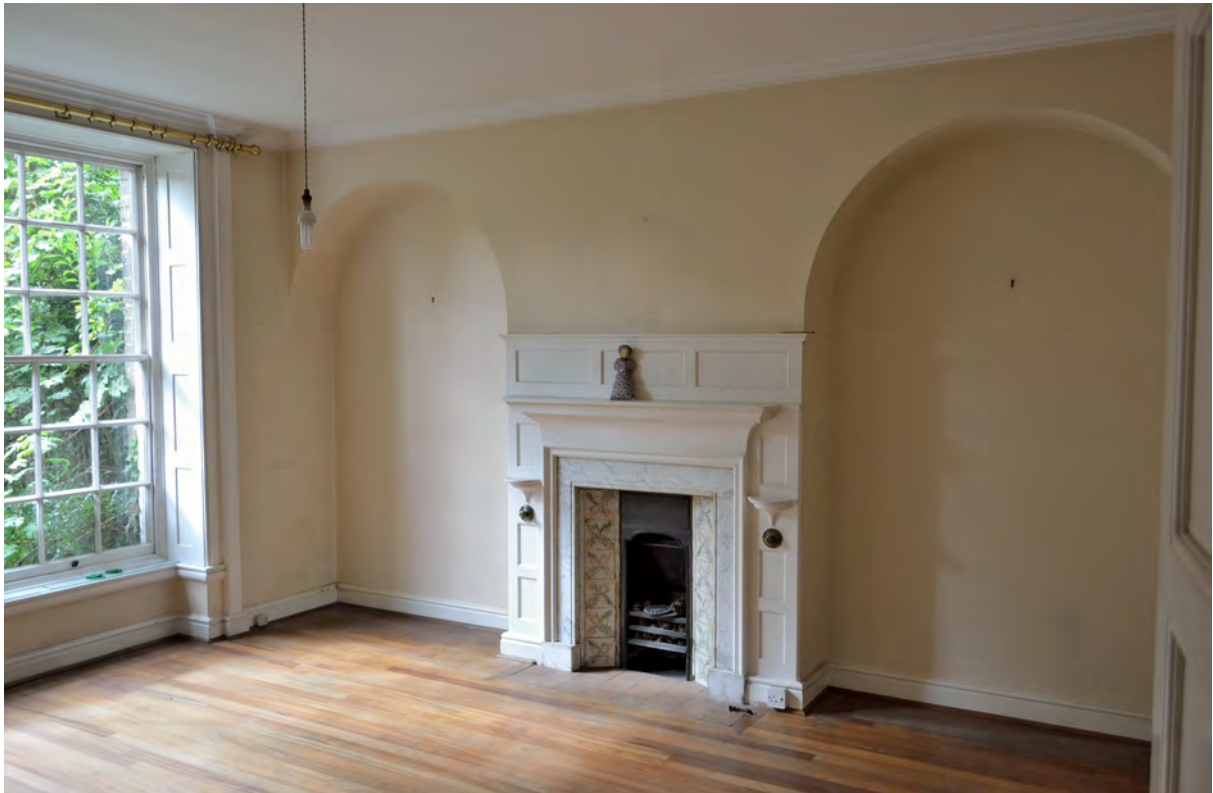
Fig 20. The dining room fireplace with adjacent alcoves which would have held matching furniture. On the opposite wall a larger alcove held a buffet. The floor is over-boarded with modern narrow boards, making the skirtings appear smaller than they really are.

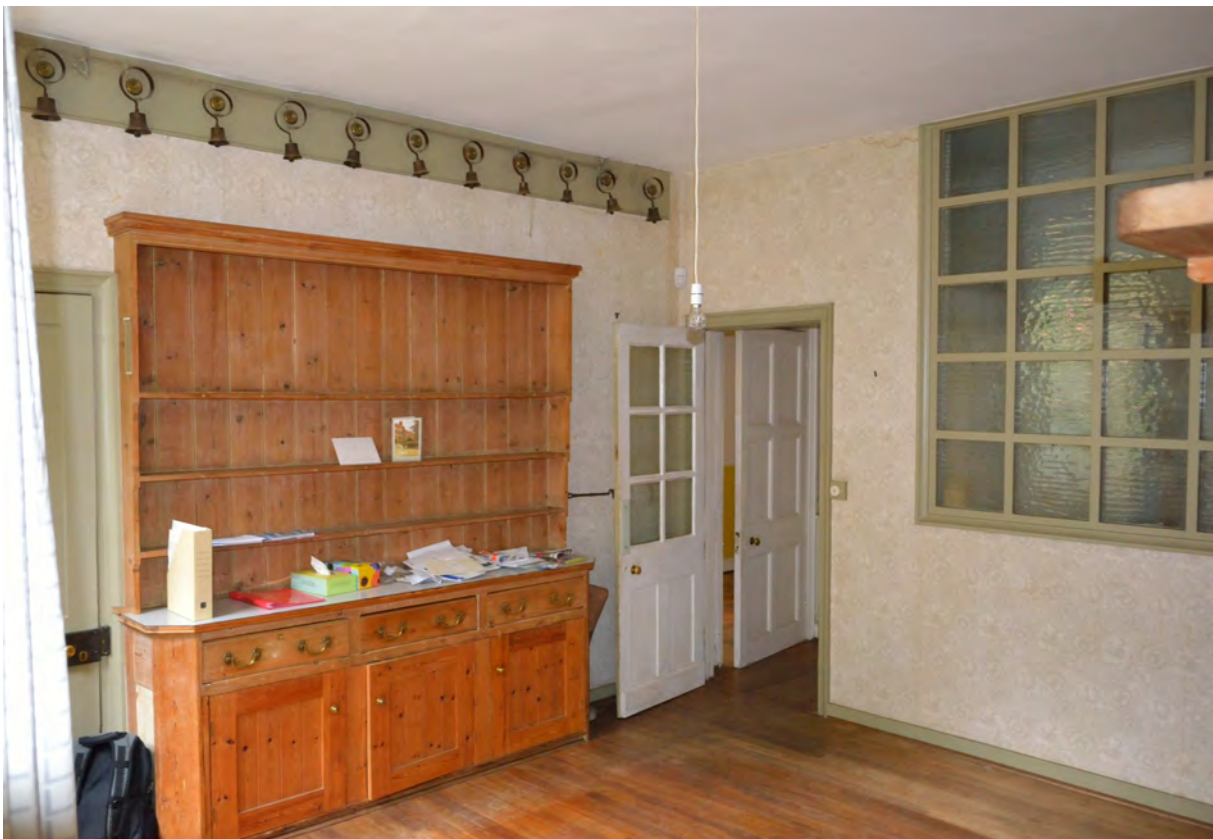
Fig 21. The kitchen dresser, which would originally have been painted, is believed to be original to the house. The modern over-boarded floor makes the skirtings appear mean, and the glazed partition forming the pantry is believed to be an early 20th century alteration.

The dresser in the kitchen is believed to be an original piece of furniture made for the property although the lower half has been altered and doors replaced. The recess in the dining room for a buffet has its archetypal arched head, and the alcoves either side of the fireplace show where other pieces of furniture (possibly supplied by Morris and Co, for whom Webb designed pieces), have been removed. Historic cupboards inserted below the main stairs and throughout the building show the careful thought and detailing that characterise Webb's work.
