2 Redington Road, Hampstead, Borough of Camden,
Design and Access Statement and
Statement of Significance

April 2015

No. 2, Redington Road, Hampstead, Borough of Camden. Statement of Significance

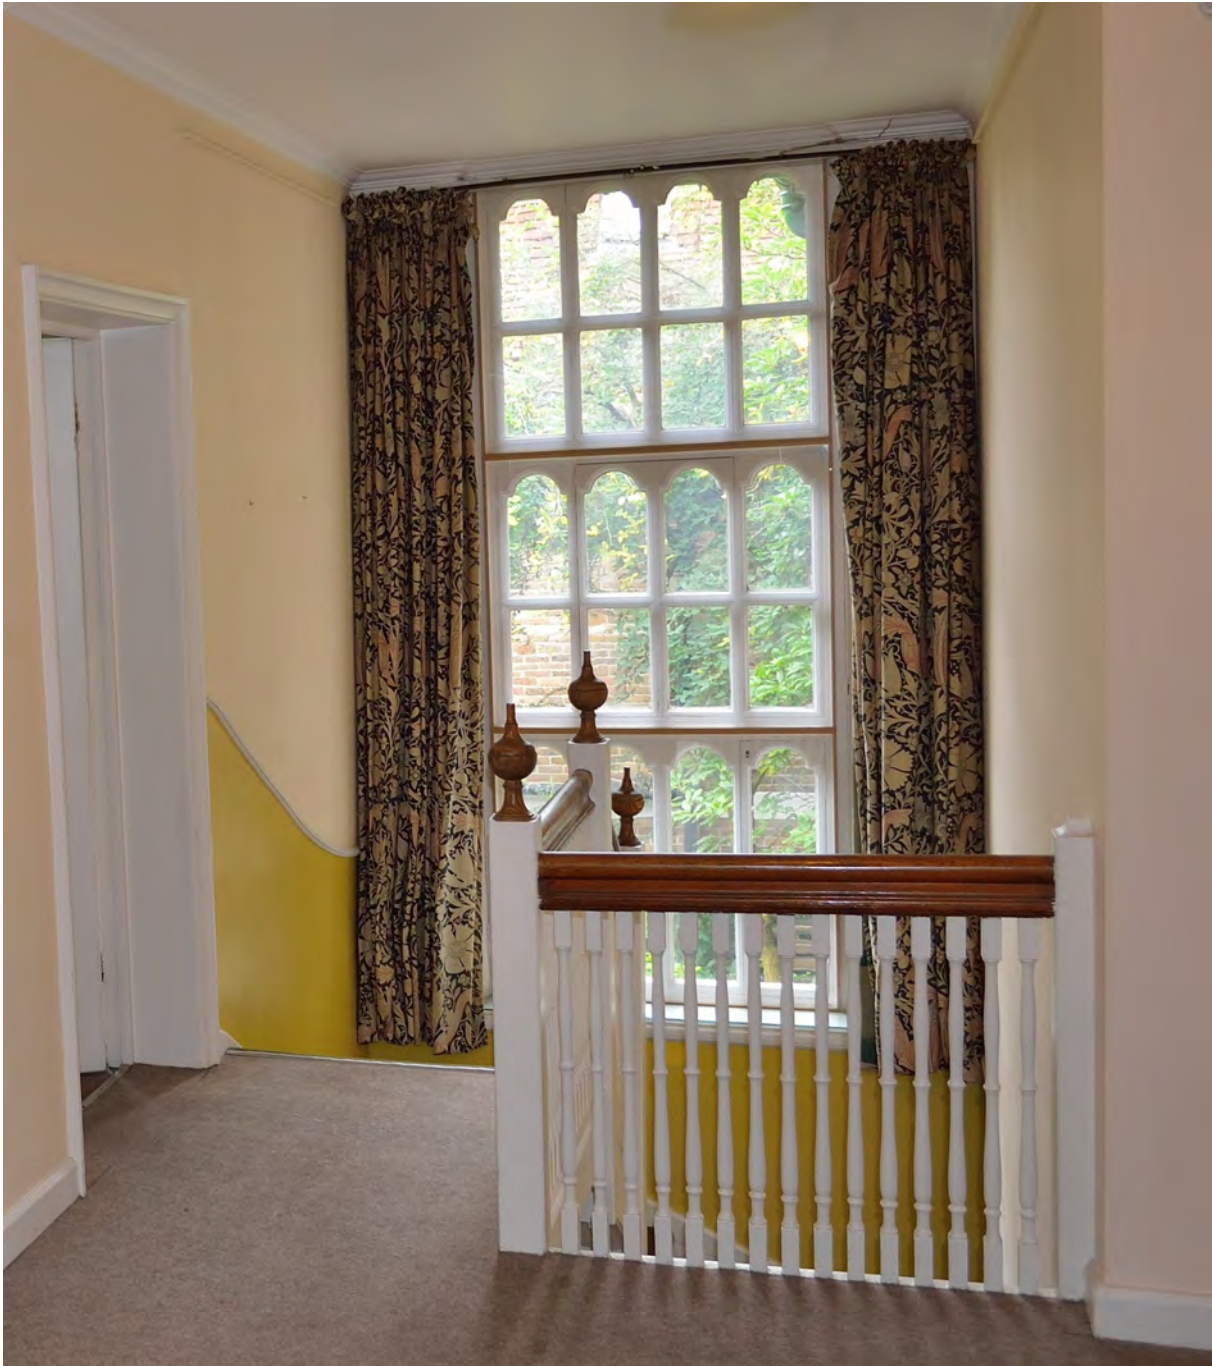
Fig 22. The first floor landing showing the finely detailed stair and simple architraves and cornice.

The main stair is an elegant but restrained wide staircase with slim-section turned and painted balusters, simple square newel posts surmounted by turned pitch pine cup / cover finials (possibly originally painted), and oak handrail. The stairhall is lit by a large mullioned timber window.

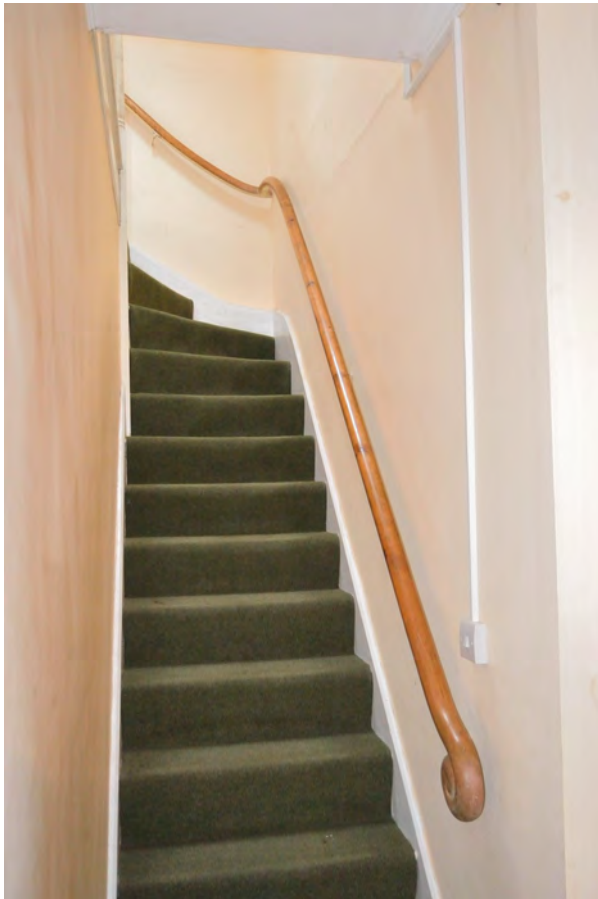
Fig 23, The attic stair, note the finely detailed hand-rail.

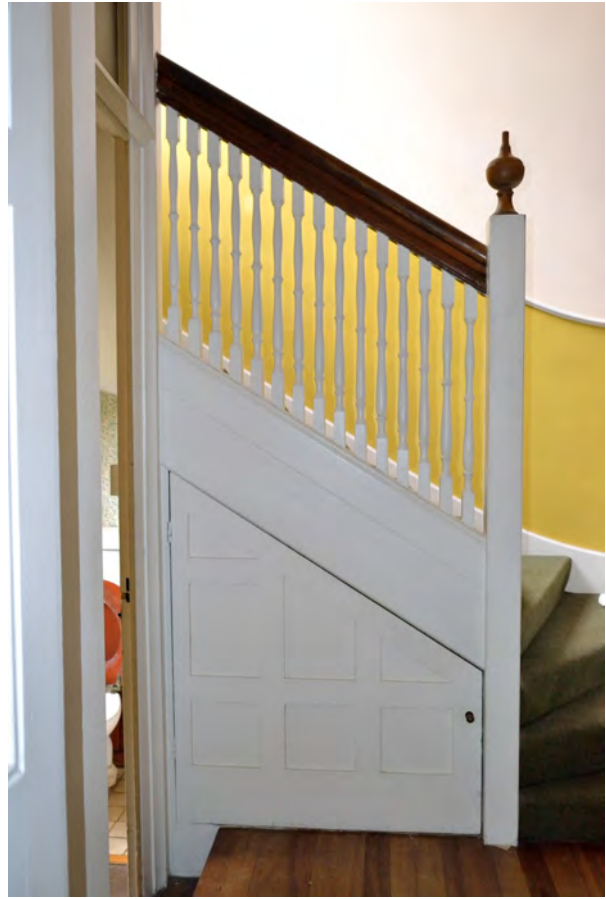
Fig 24, The carefully designed cupboard under the main stair.

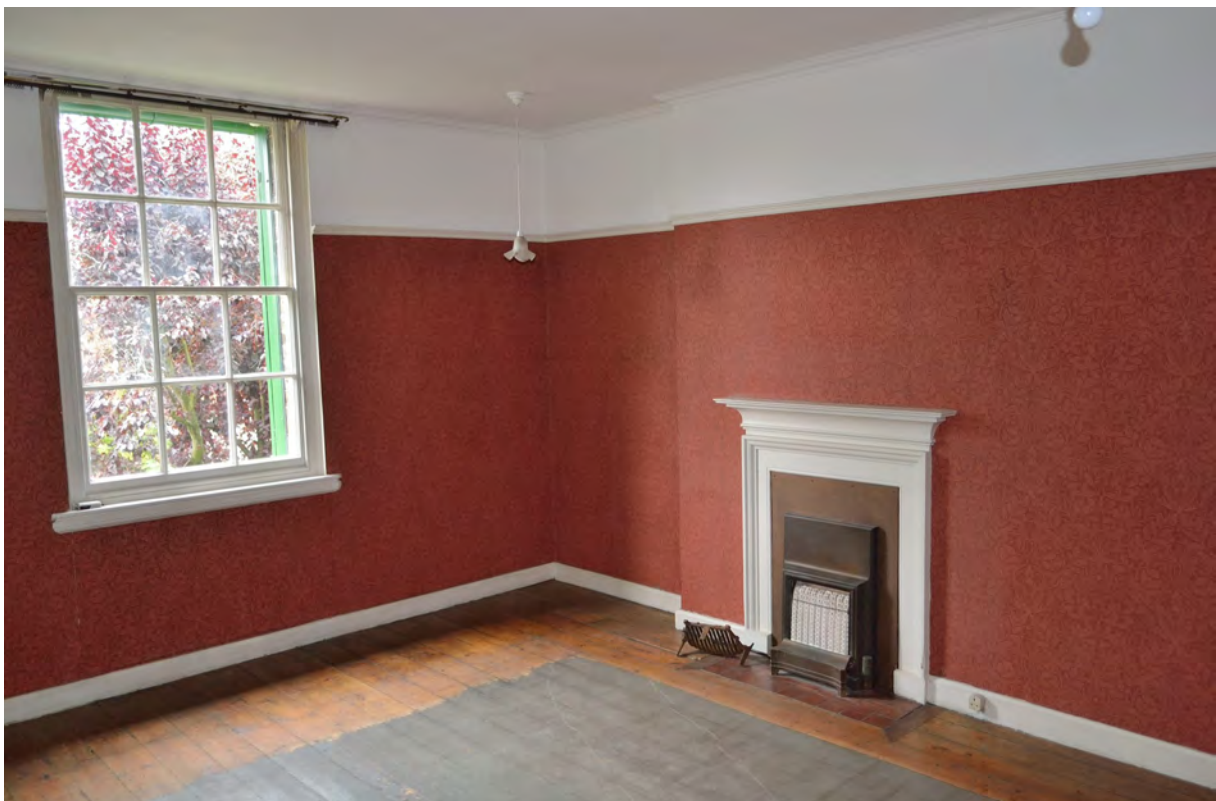
Fig 25, The simpler detailing to the principal bedroom.

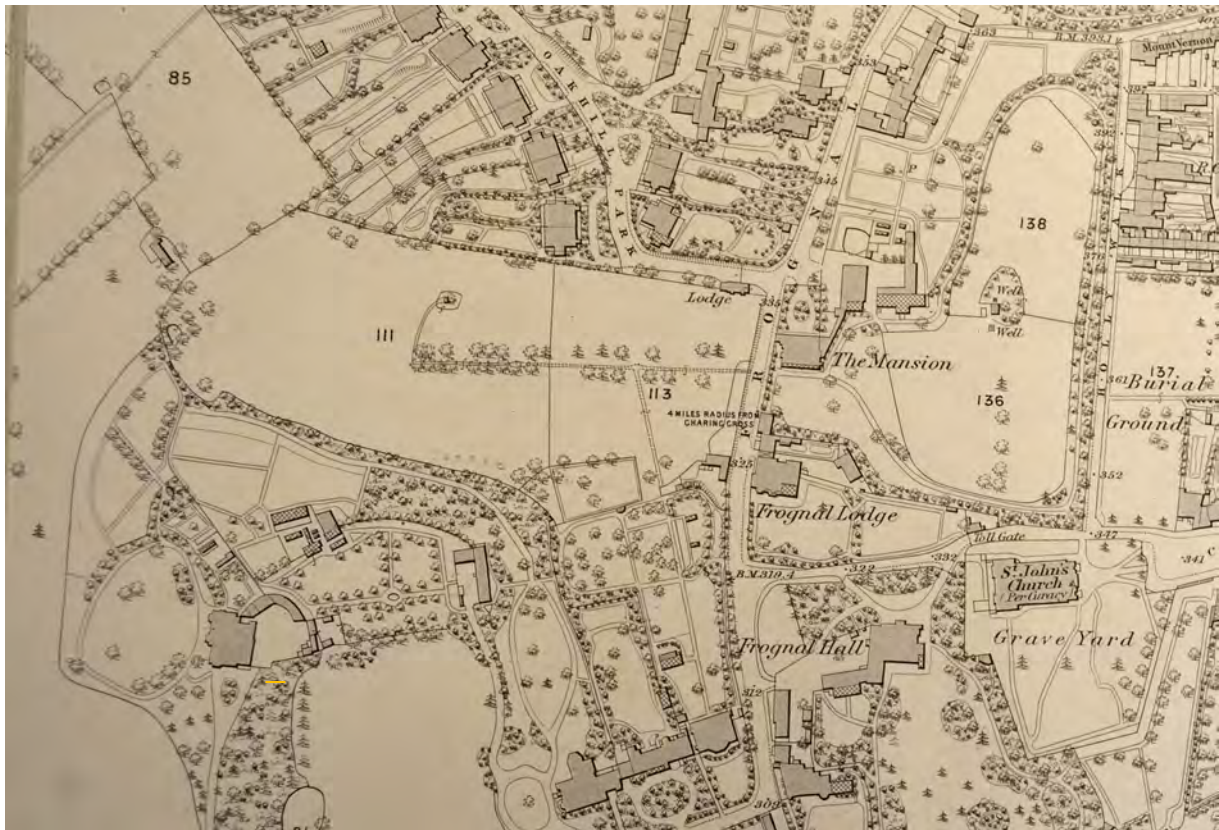
Fig 29, The 1869 1:500 OS map showing the site prior to development.

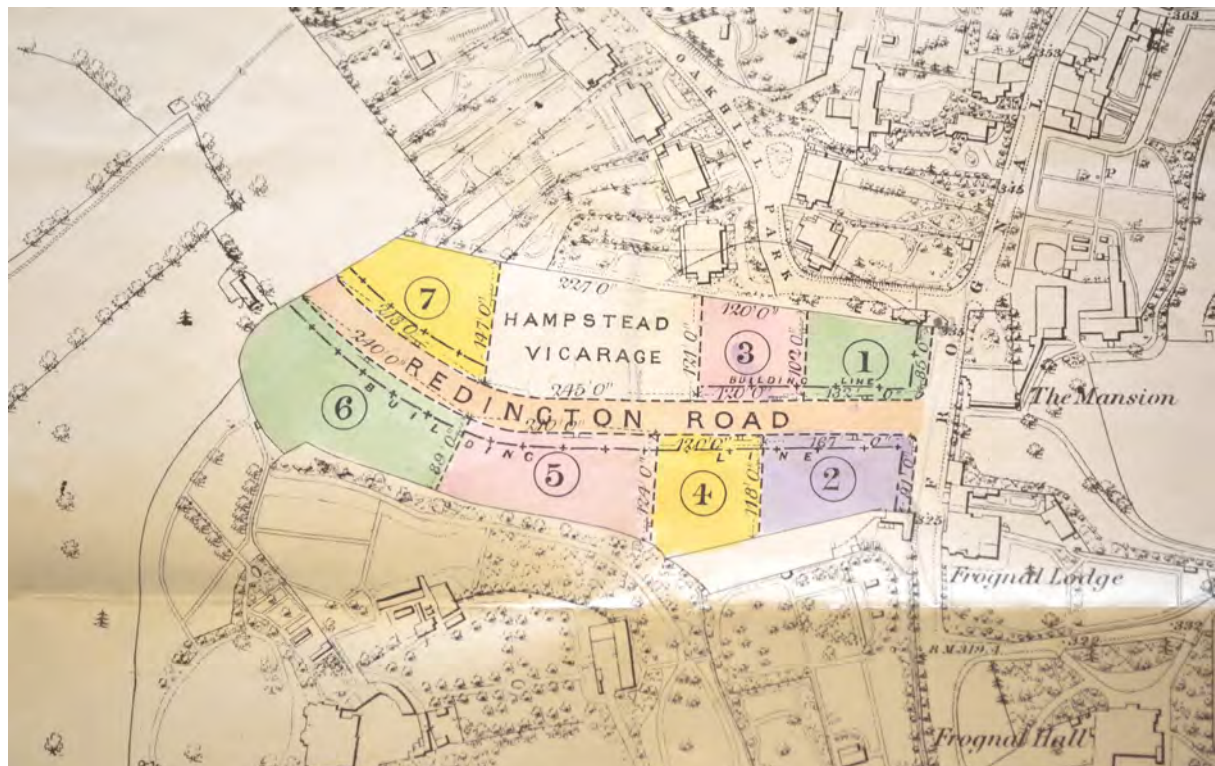
Fig 30, The site divided into plots with the building line marked, in 1875. Nos 2 and 4 Redington Road occupy plot 3.

Lot 3 was acquired by William Chisholm, who commissioned Philip Webb to design a pair of dwellings: one for himself and the other for another member of his family. The development was undertaken in 1876, and the property appears for the first

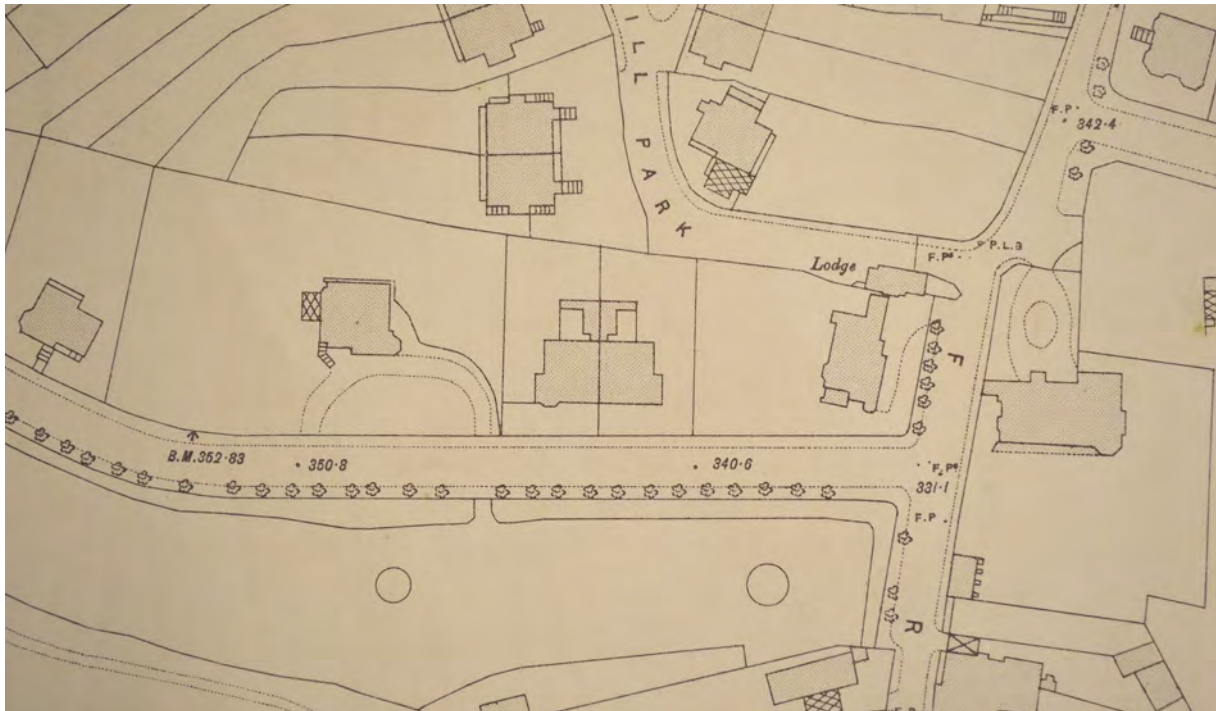
Fig 31, The 2nd edn. OS map of 1894-6. Note the missing bay window to No 2.

The 2nd edition O.S map shows the footprint of the house almost as it survives today with the exception of the bay window omitted from the front elevation of No 2, although one is shown on No 4. These maps are at a scale of 1:500 and the absence of the bay is repeated on the 1919 map suggesting this is not a

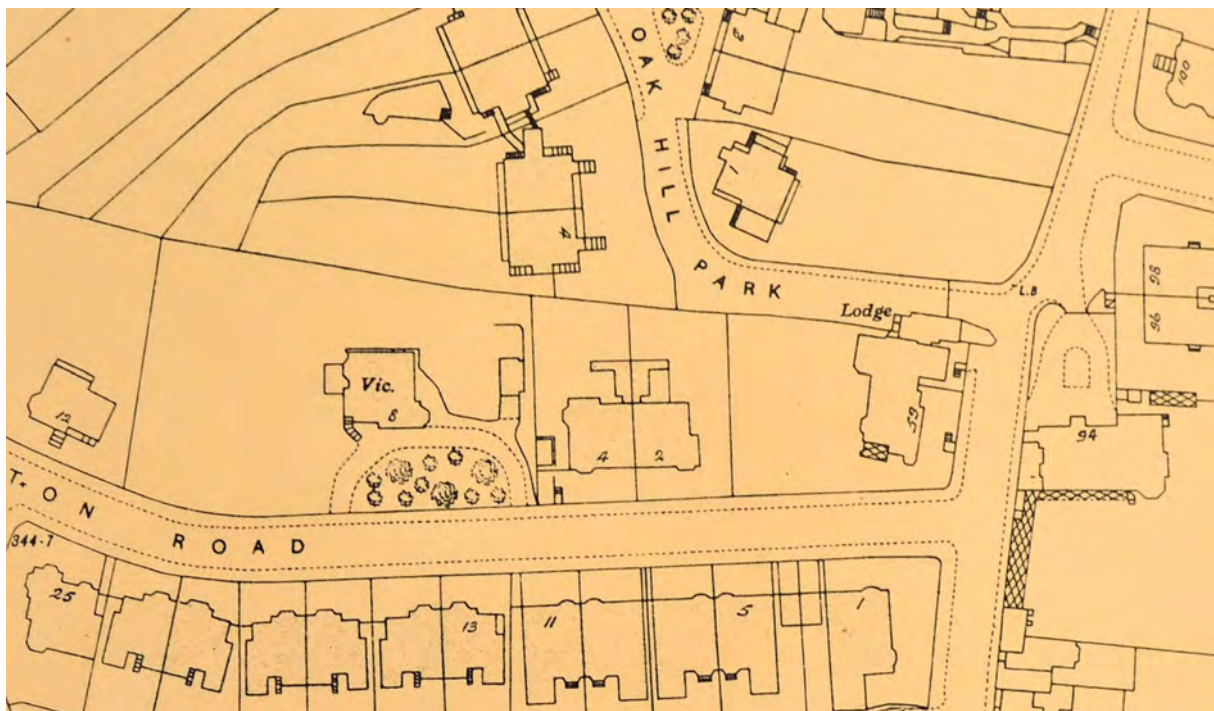
Fig 32, The 4th edn. OS map of 1938, showing both bays for the 1st time. The large garden of No 1 remained open until the late 1990's when an infill property was added.

cartographic error. It is only in 1939 that both bays are shown. This later map also shows further development adjacent to No 4, comprising the erection of a garage, and small additions to the west and north elevations of its rear range.

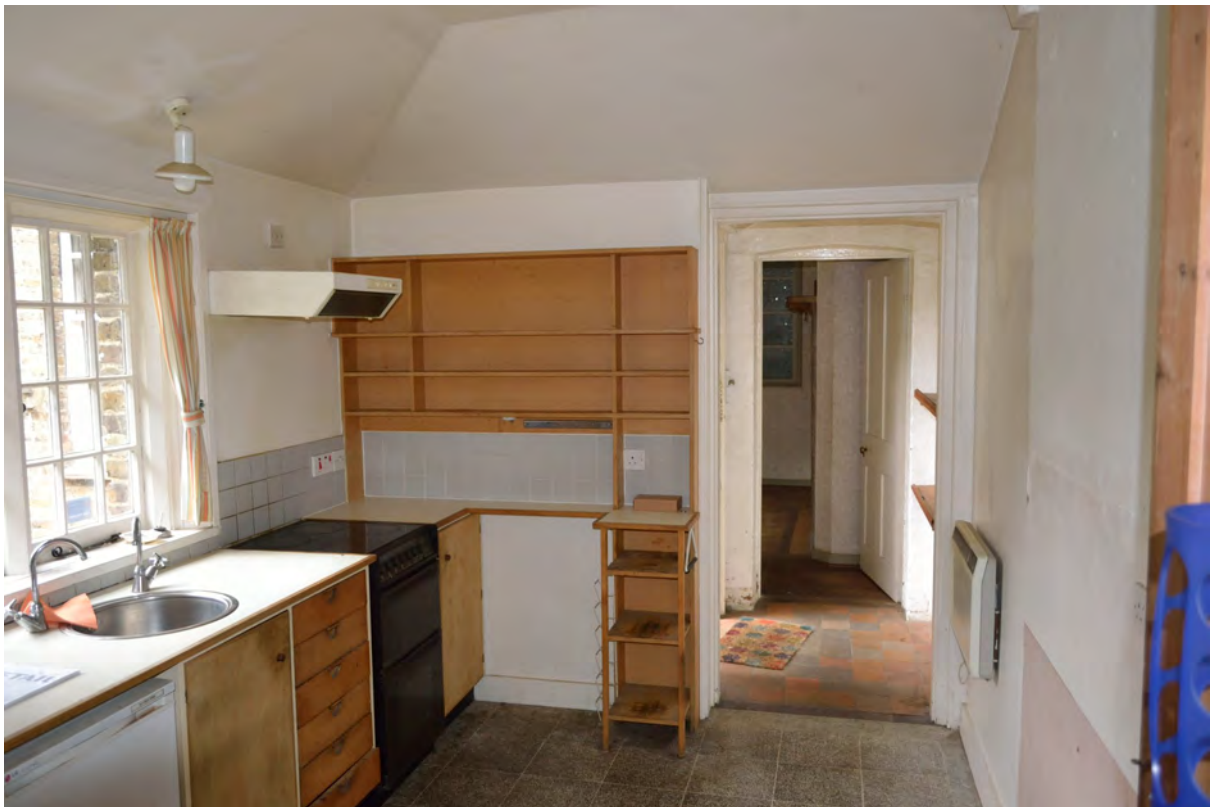
Fig 33, The converted scullery, now a kitchen. The walls have been dry-lined to reduce damp as the rear wall may be cut slightly into the hillside.

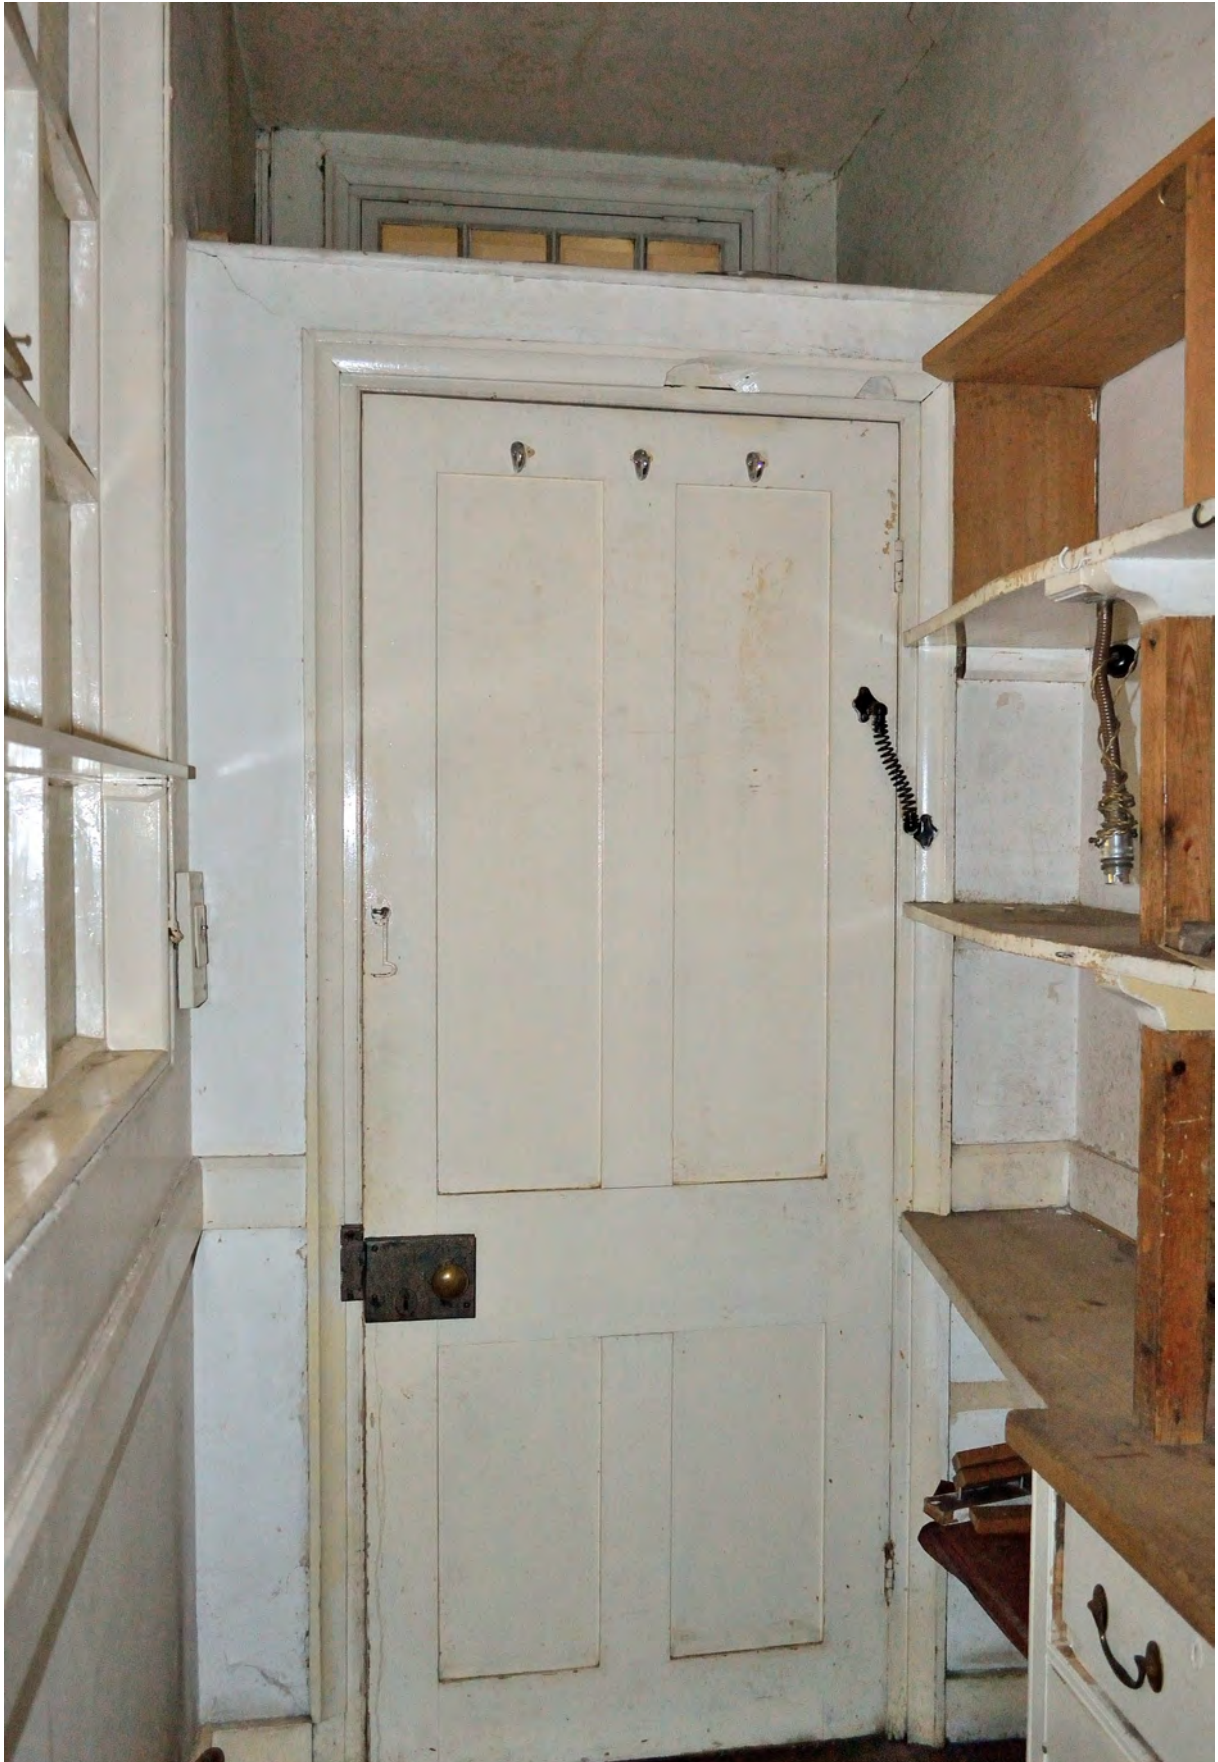
Fig 34, The pantry entrance lobby showing its awkward form. The window to the left appears to be a modern insertion , originally it only had borrowed light from over the kitchen door seen above the lobby.

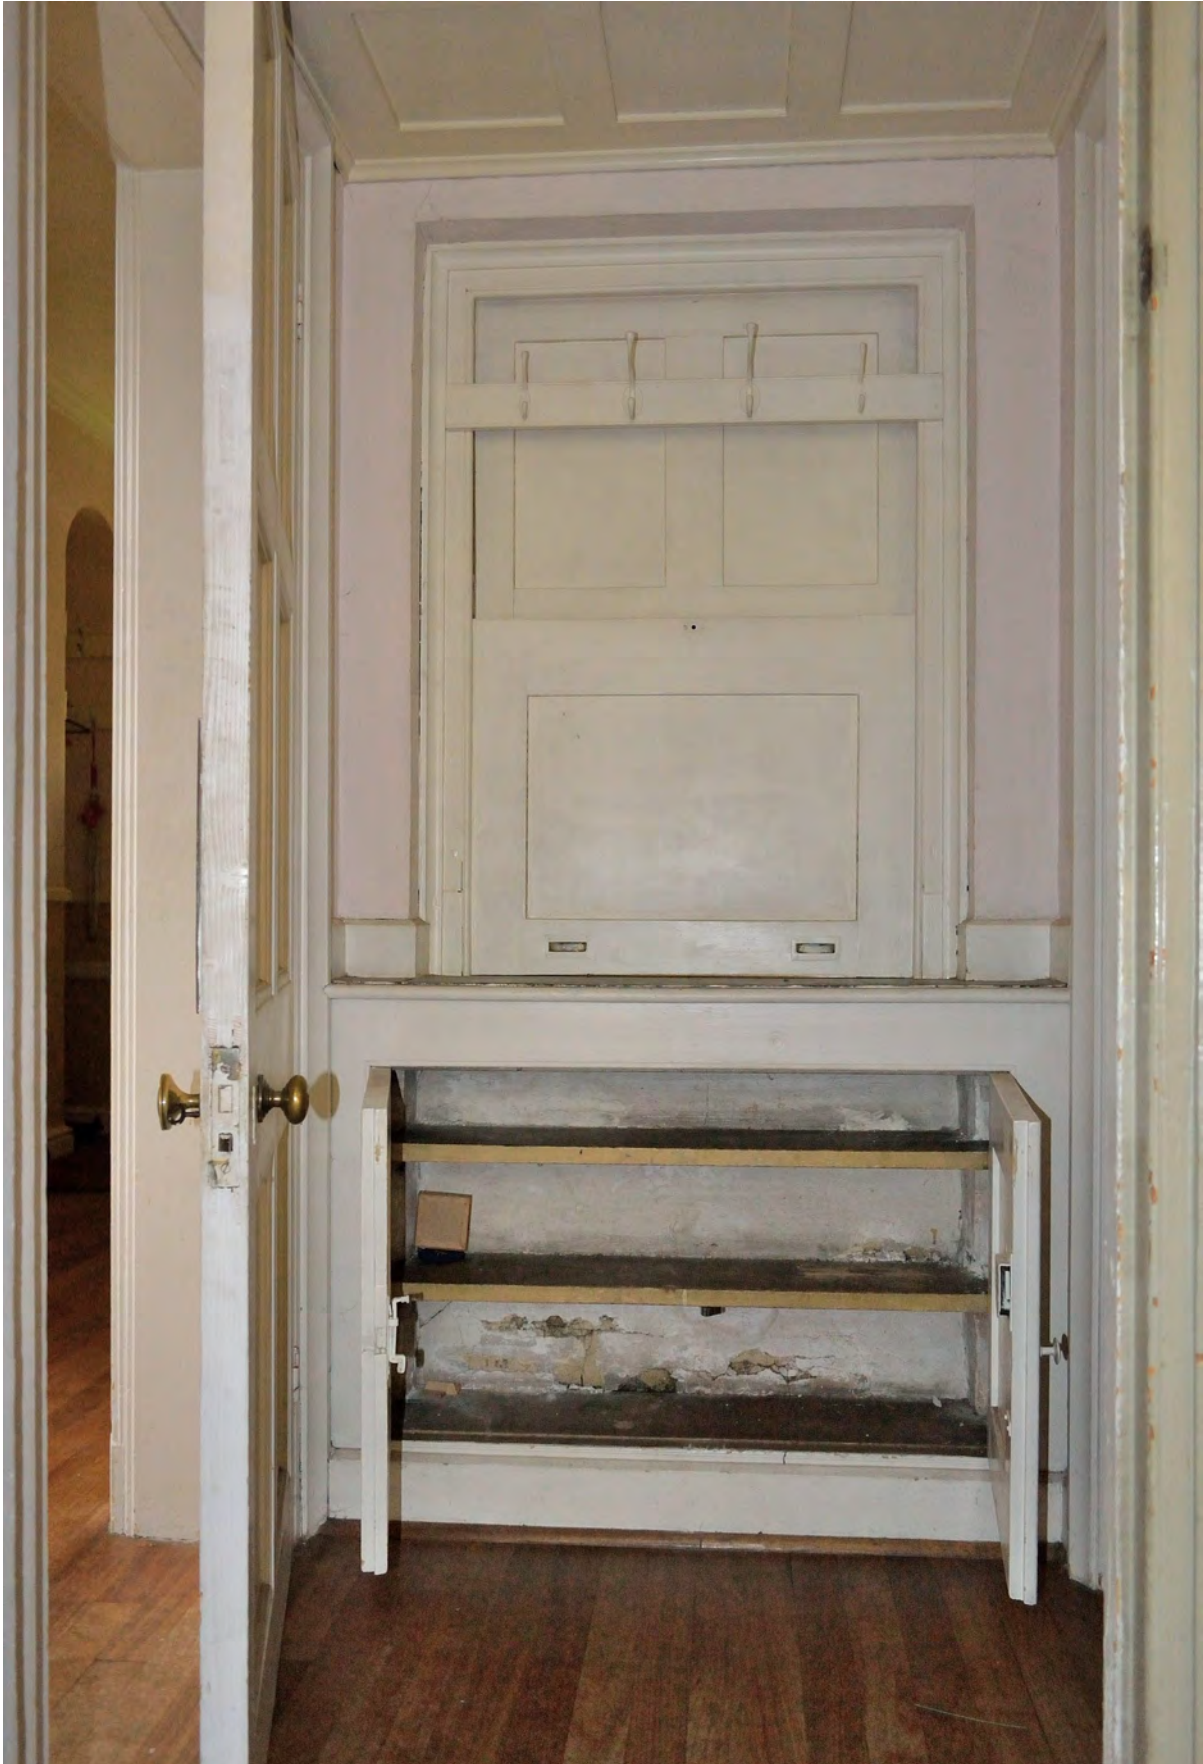
Fig 35, The kitchen / pantry lobby showing the closed serving hatch above a cupboard unit, which appears to be a historic detail. The wall behind also appears not to have been disturbed, and the skirting runs through.

the kitchen adjacent to the dining room wall, and the serving hatch and low-ceilinged panelled lobby may be contemporary with this change. The glazed light with modern frosted glass between the kitchen and the pantry is clearly of mid-20th century date, and although it is impossible to prove without opening up, we wonder whether the original detail was that the cupboards and shelves lining the wall with the dining room were originally exposed within the kitchen and that the historic pantry was the small room off the kitchen behind the hall. This was replaced by the larger pantry perhaps at the same time that the bay window was added during the 1920's—1930's.

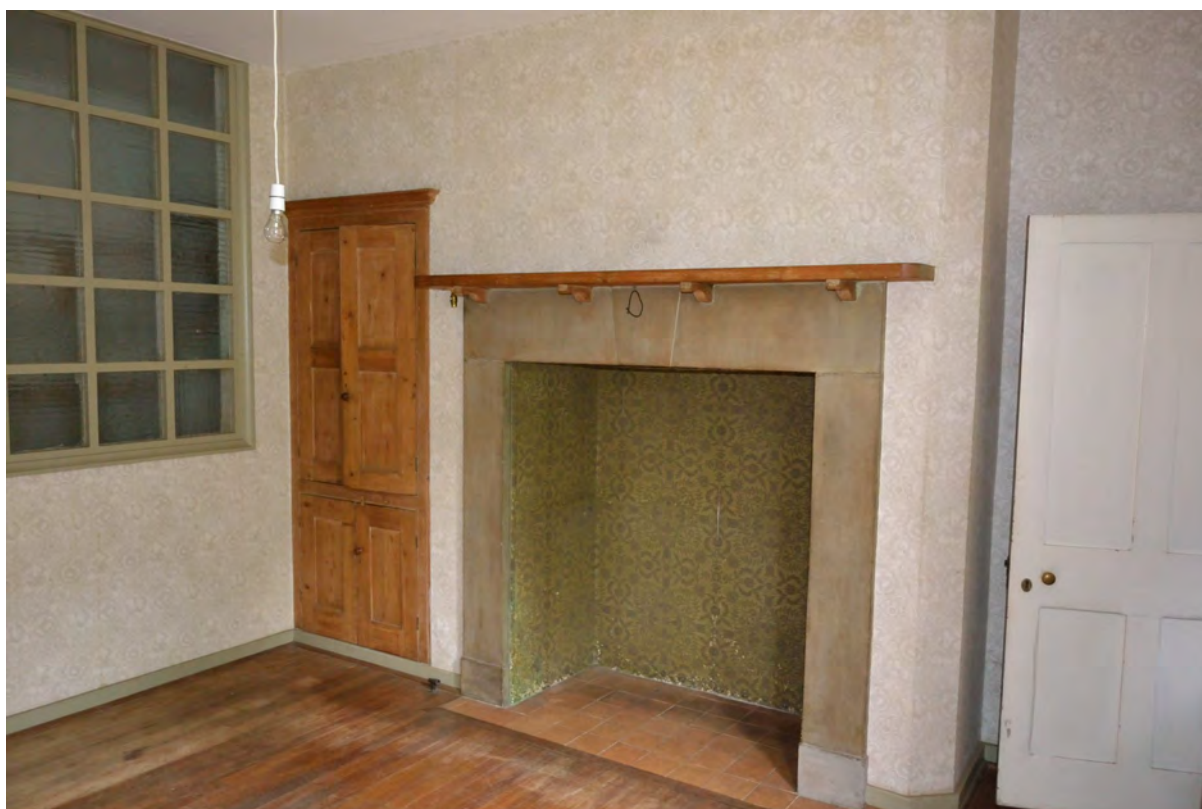
Fig 36, The kitchen fireplace with adjacent cupboard. Note how the screen to the pantry butts tightly up against it, the awkward relationship also suggests the partition may be a later insertion.

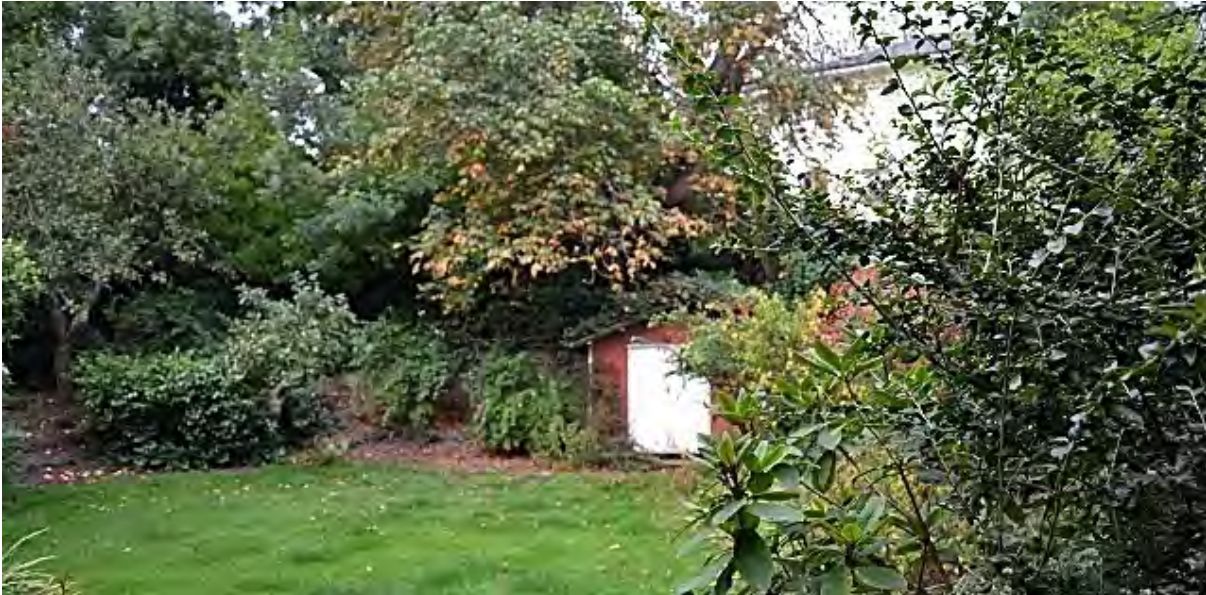
Fig 37, The garden shed to be demolished.

Consent has been granted for the careful repair of the house and upgrading of the existing facilities, including the erection of a carefully-detailed kitchen extension. In association with the construction of the new kitchen extension the rear garden area is to be landscaped, and this application is for new garden buildings as part of these landscaping works. An existing garden shed in the north part of the garden will be replaced with a gazebo, which will occupy the same footprint as the shed.

The proposed replacement building is timber framed with a hipped clay tiled roof with vertical boarding to the rear and right hand elevations, with the other elevations having an open balustrade. This building has been well-designed, and it is considered that it will have a neutral impact on the significance of the setting of the listed building. It will not be publicly visible, and will have no impact on the significance of the Conservation Area.
