BS5837 Tree Constraints Survey Schedule

Site: 41 Frogna, London NW3 6YD

Ref: AKN/41F/AIA

Root Excavation Report

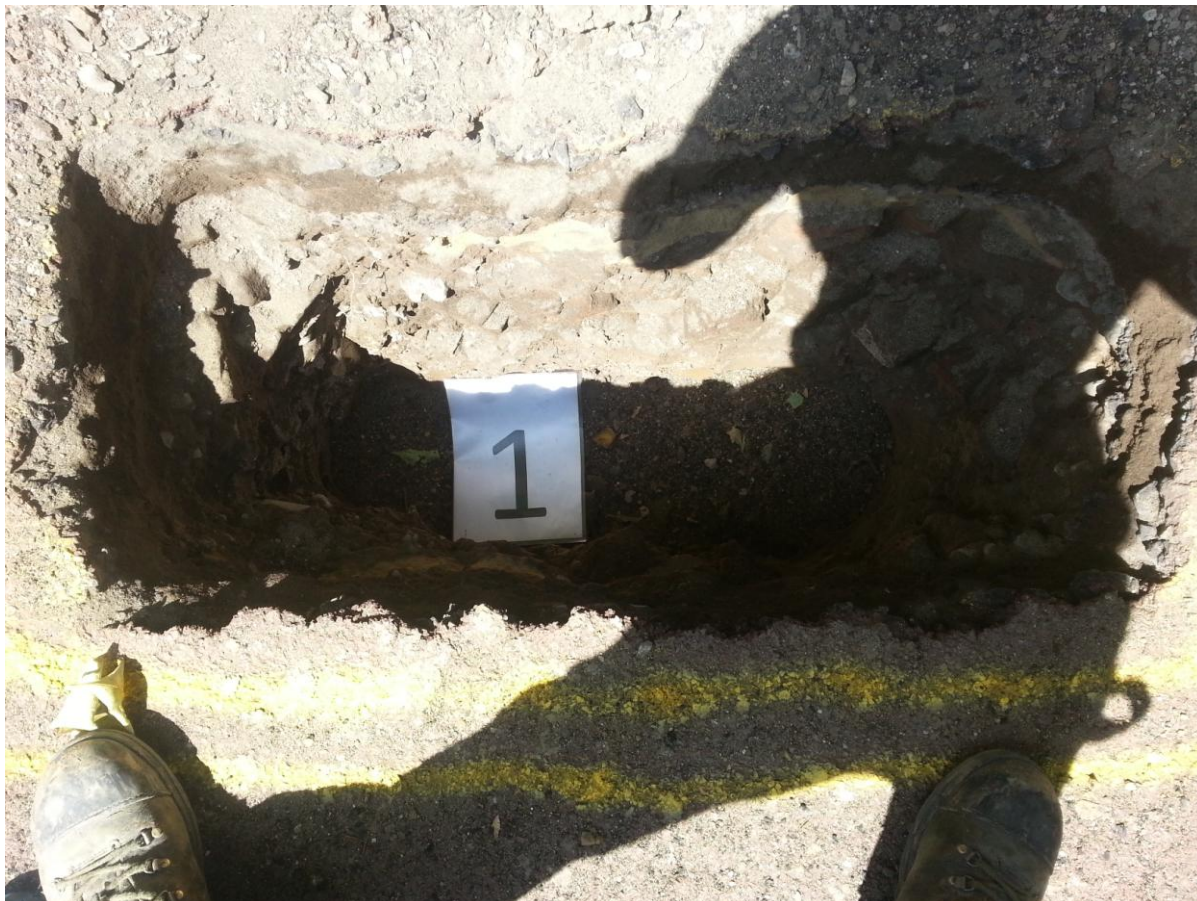
Trial Pit 1	Within driveway in front of T8 100cm long, 40cm wide, 70cm deep No Roots found
Trial Pit 2	To the east of TP1, on the edge of the lawn 100cm long, 40cm wide 1 large 50mm root
Trial Pit 3	Within driveway behind drainage line 100cm long, 40cm wide, 70cm deep No Roots found
Trial Pit 4	In the lawn in front of T13 and T14 100cm Long, 40cm Wide 1 x 25mm root 1 x 20mm root Some <15mm roots
Trial Pit 5	In the lawn between T13 and T2 100cm long, 40cm wide 1 x 25mm root A number of 15-20mm roots
Trial Pit 6	In the lawn between T14 and T15 100cm long, 40cm wide, 70cm deep No Roots found
Trial Pit 7	In the rear of the property 100cm long, 40cm wide, 70cm deep No Roots found
Trial Pit 8	In the lawn, between T2, T10 and the road 100cm long, 40cm wide 1 x 50mm root
Trial Pit 9	In the lawn, 90° to TP5 100cm long, 40cm wide 1 x 25mm root 2 x 20mm roots
