**Pringuer-James Consulting Engineers  
Preliminary Risk Assessment**

**Geotechnical Data – Site Investigation Report  
Soil Consultants Ltd.  
Report Ref: C9117/JRCB/OT**

Site Investigation Report – 10A Belmont Street, London NW1 8HH

## GROUND INVESTIGATION REPORT

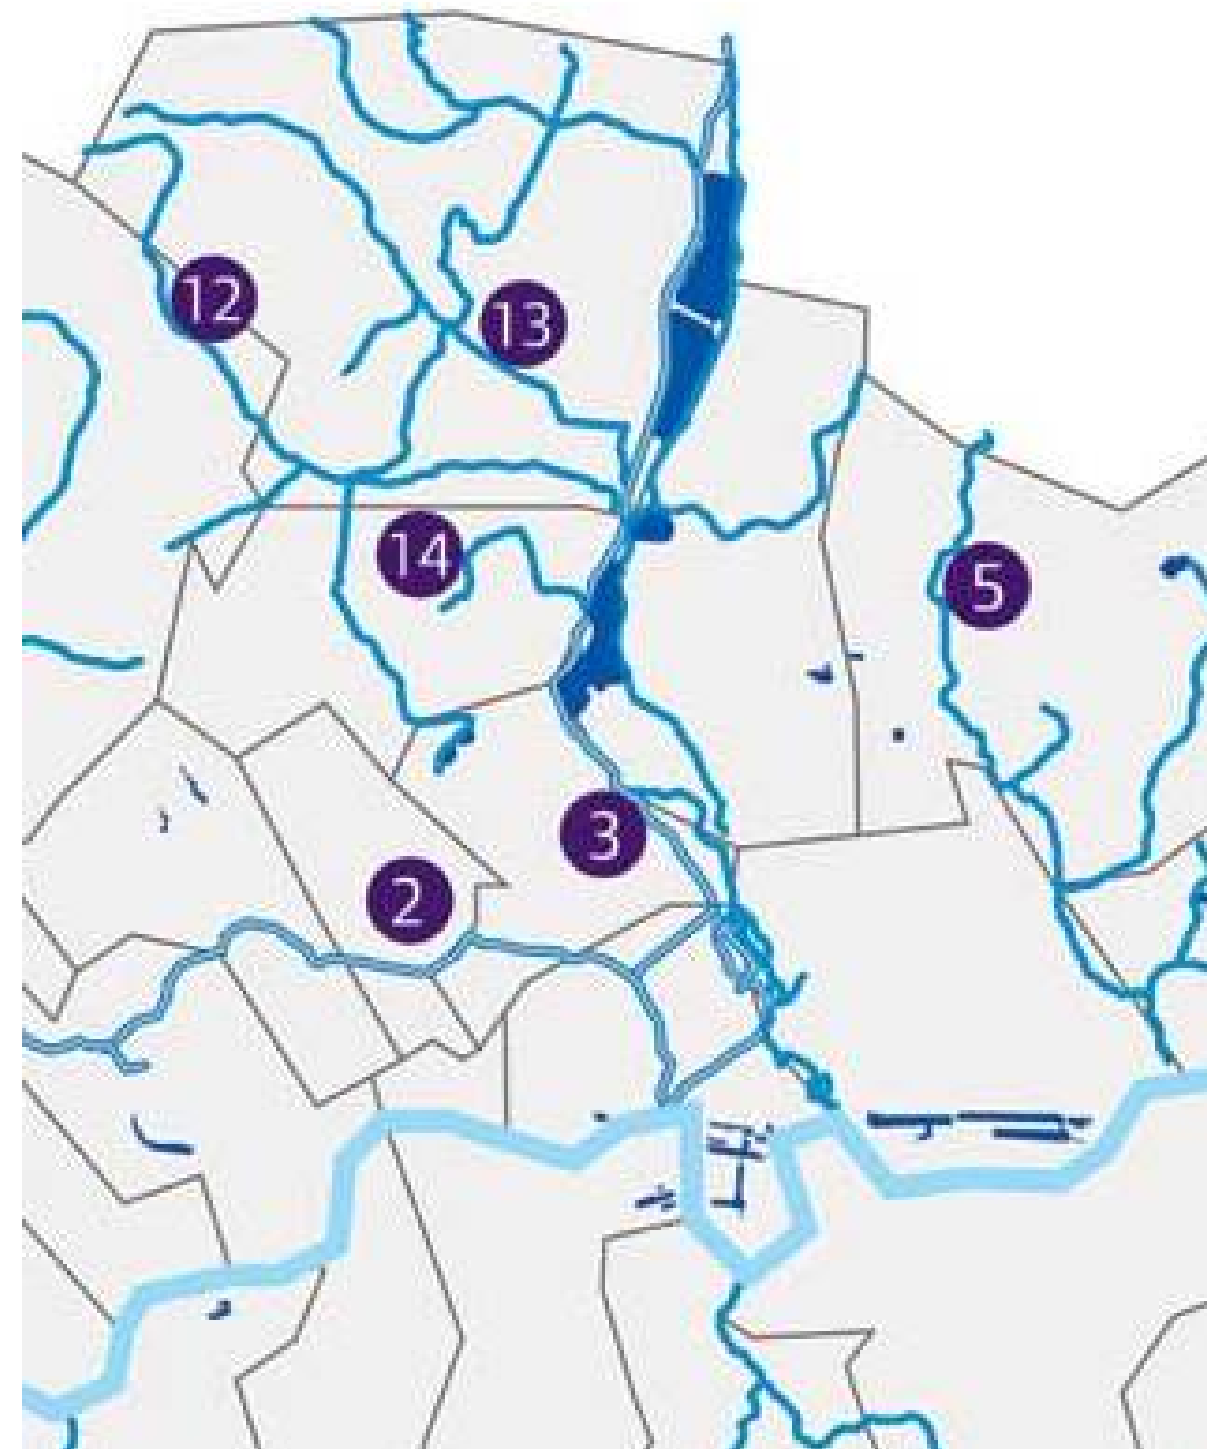
**D.3 – HYDROLOGY – GREATER LONDON SURFACE WATER FEATURES (PARTIAL)**

Diagram: GLA, The London Plan – consolidated with alterations since 2004 (2008)  
[www.london.gov.uk/thelondonplan](http://www.london.gov.uk/thelondonplan)
