Phase 2a Site Investigation and GQRA

**277a Gray's Inn Road
London
WC1X 8QF**

(Ref. TJ2824AR1v1.0)

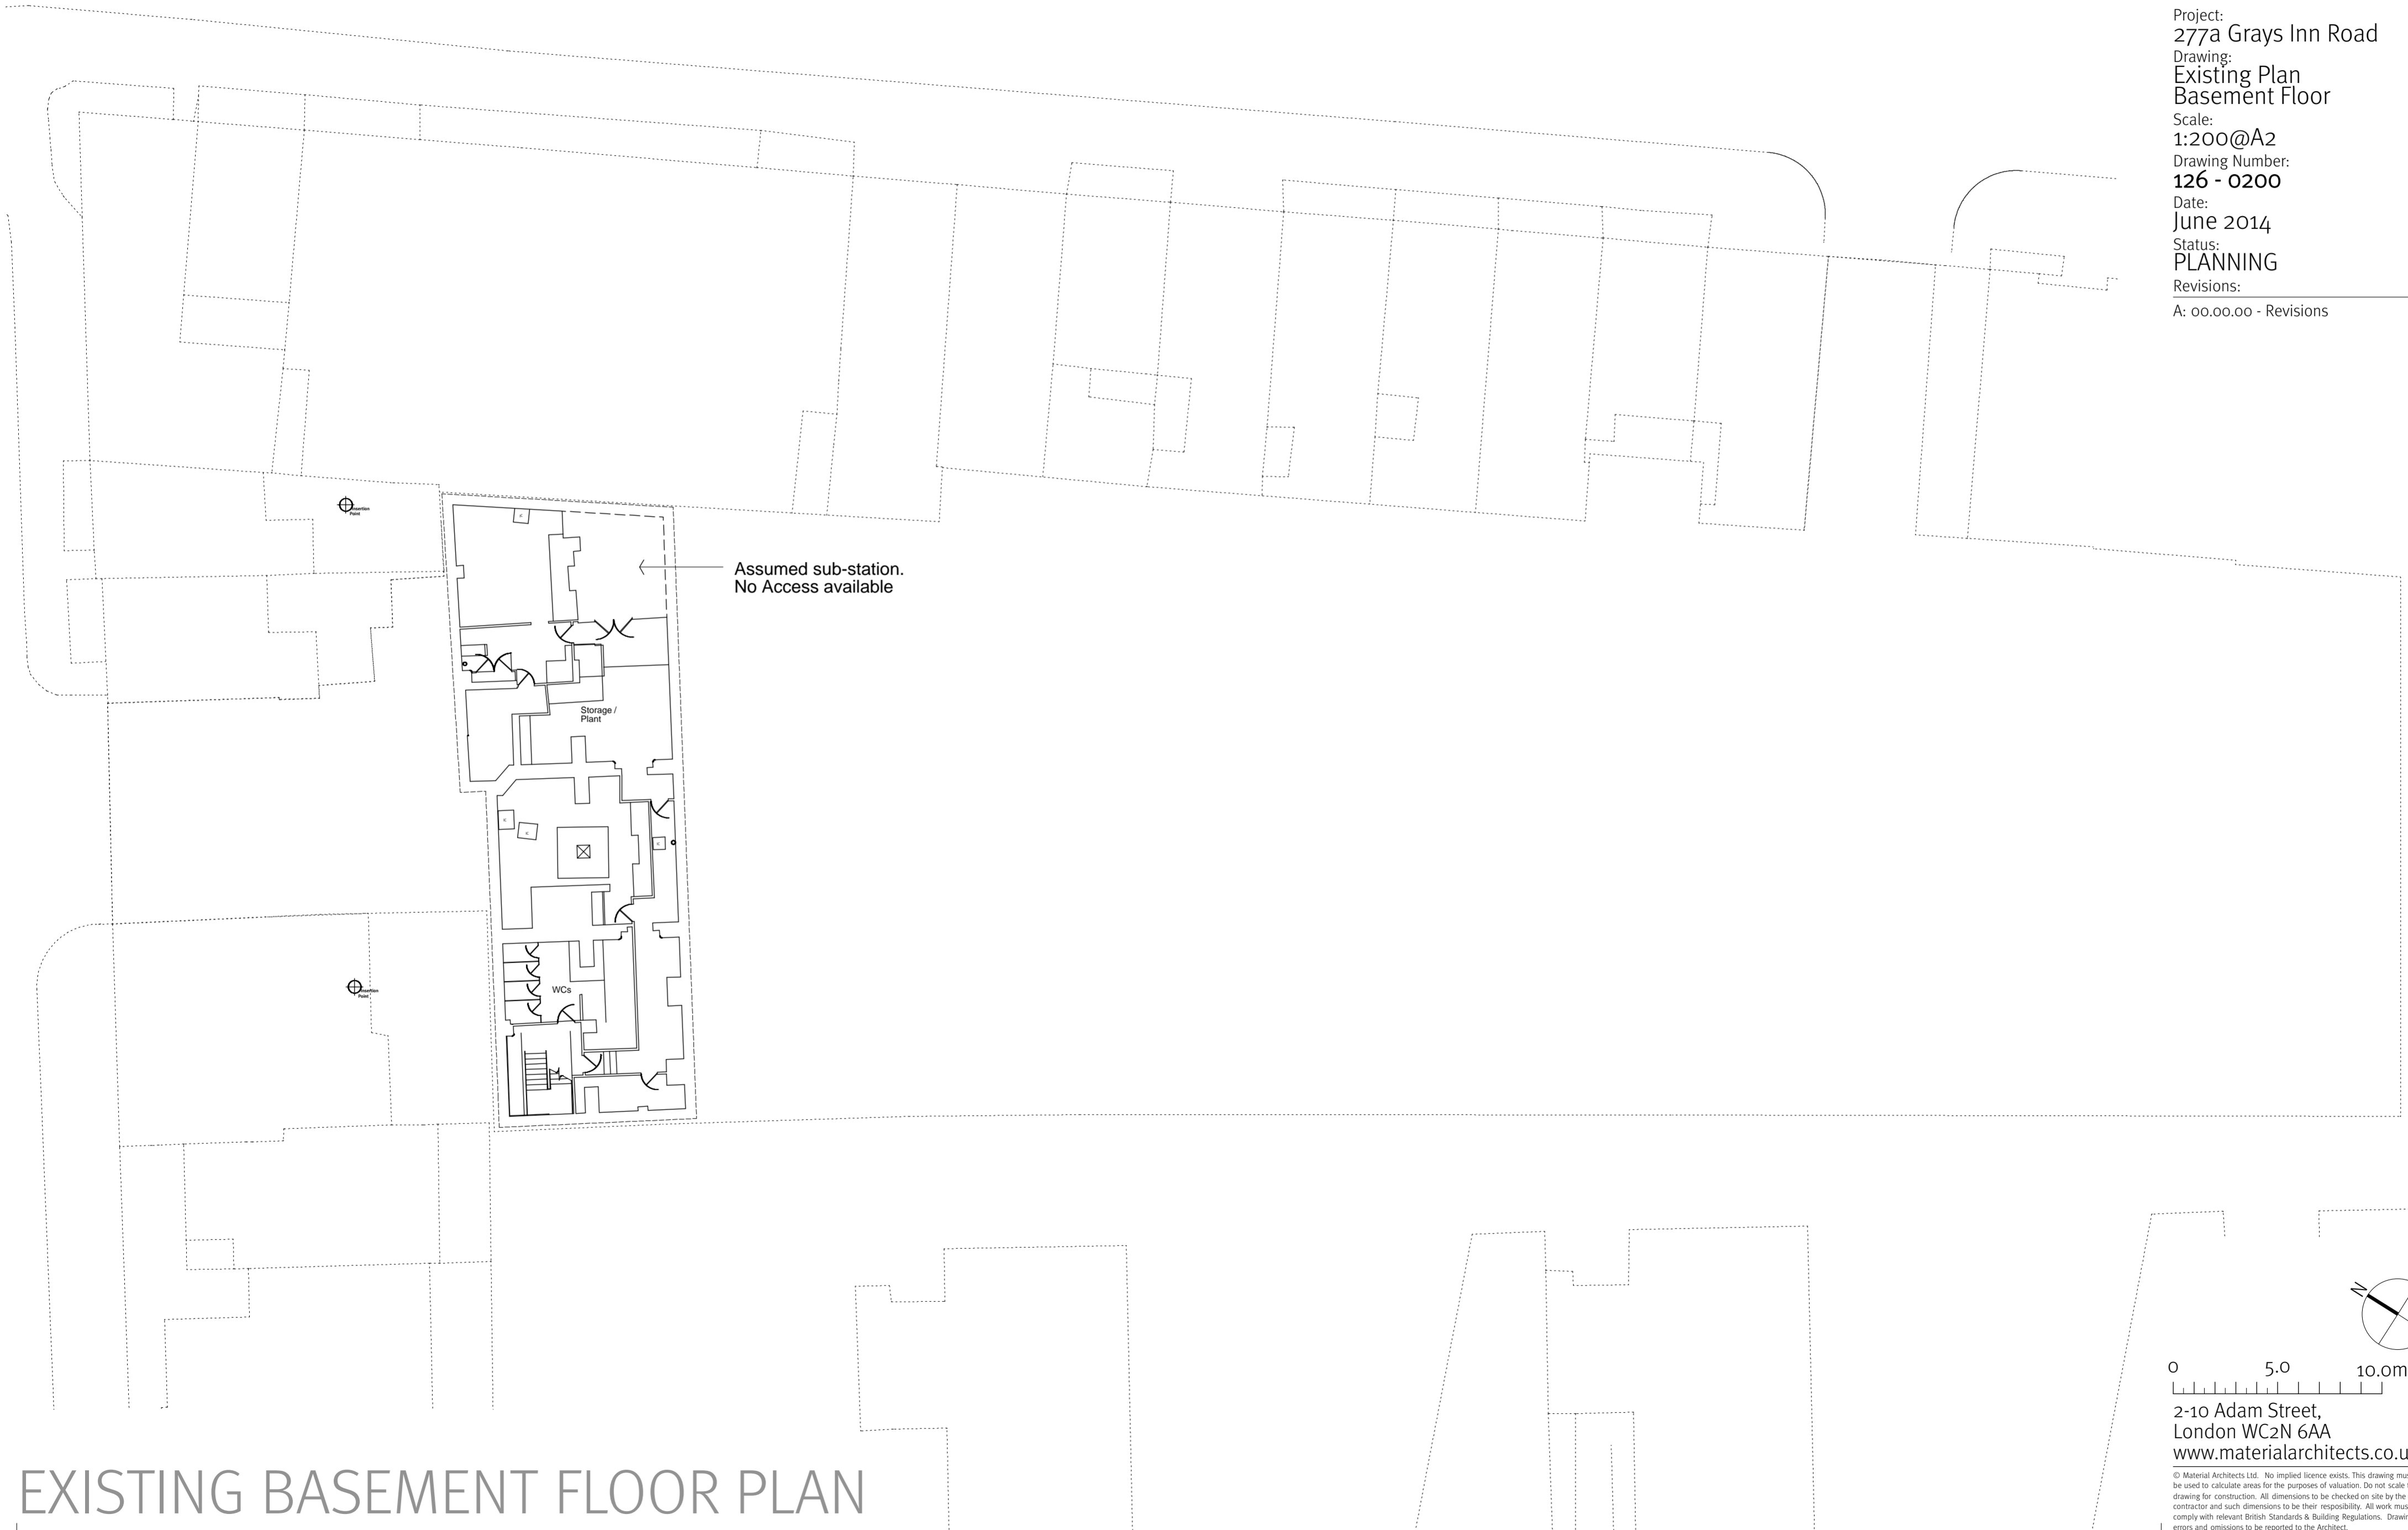
EXISTING BASEMENT FLOOR PLAN

Project:
277a Grays Inn Road
Drawing:
Existing Plan
Basement Floor
Scale:
1:200@A2
Drawing Number:
126 - 0200
Date:
June 2014
Status:
PLANNING
Revisions:
A: 00.00.00 - Revisions

Below part of the N section of the site there is a basement approximately 10m wide. The basement floor is circa 4.25m below the ground level across the site at 14.90mAOD. The basement is constructed from a series of brickwork walls supporting brickwork arches and appeared to have been used for storage, toilets, changing rooms and showers.

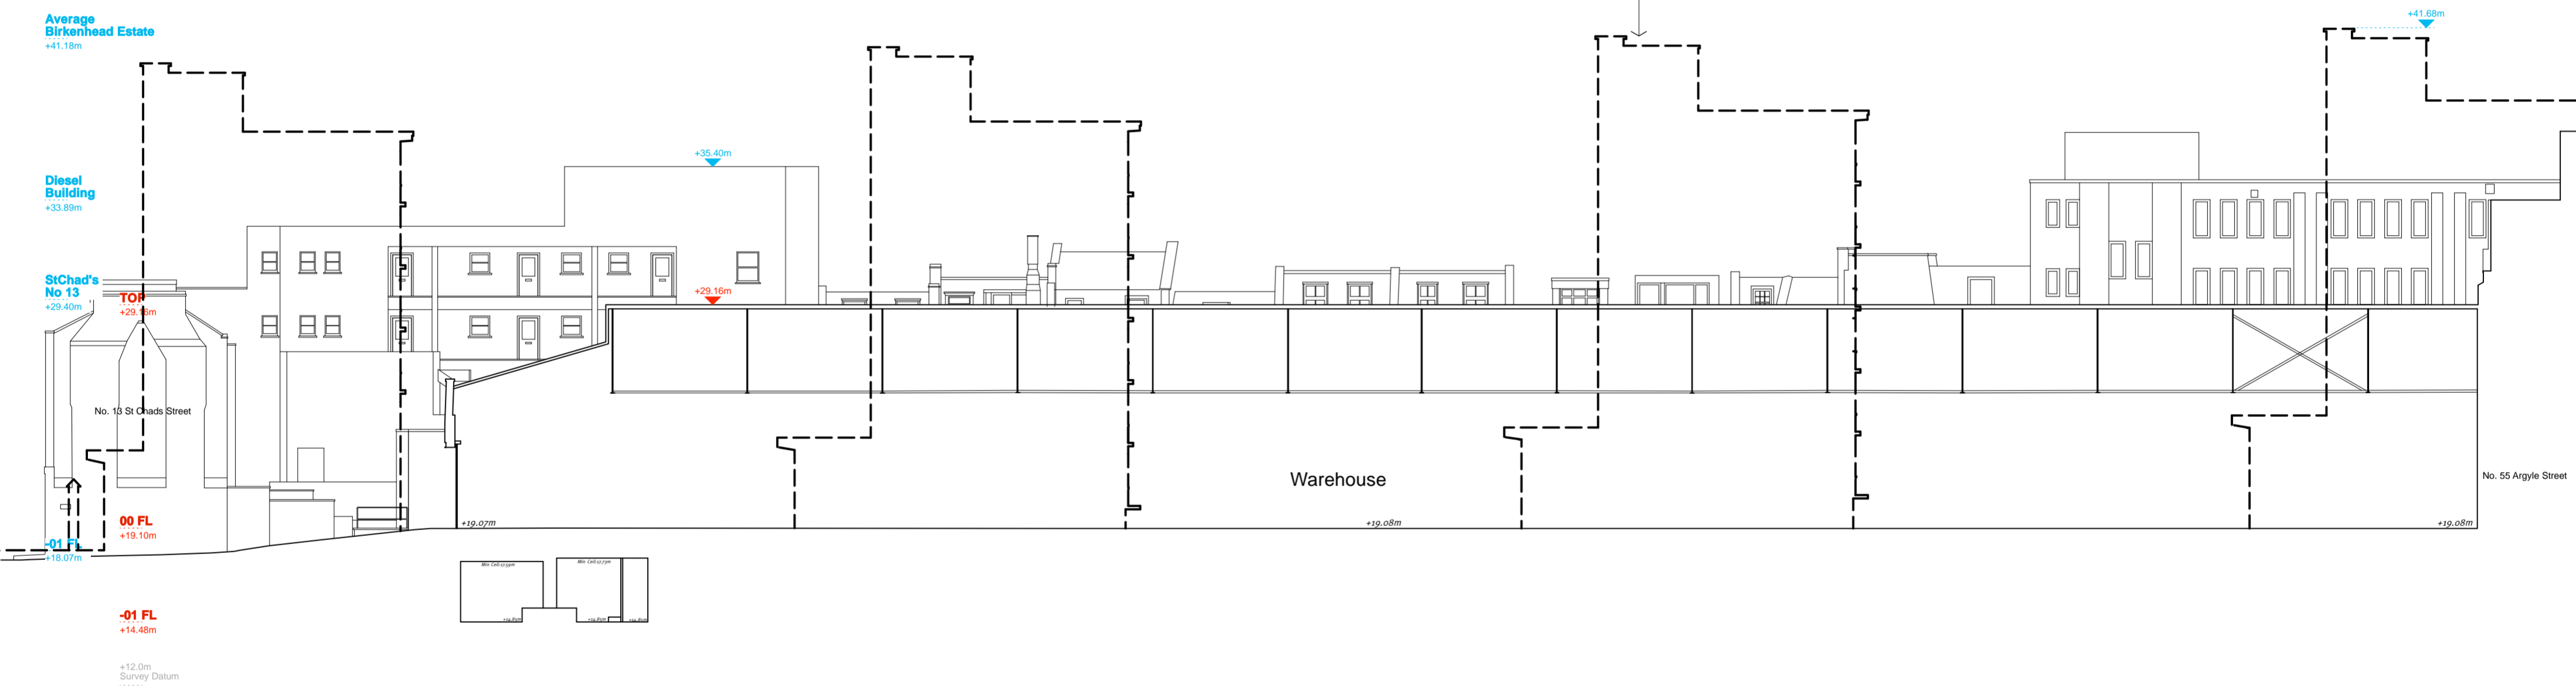
EXISTING LONGITUDINAL SECTION (Looking East)

Birkenhead Estate in
the foreground shown
dotted

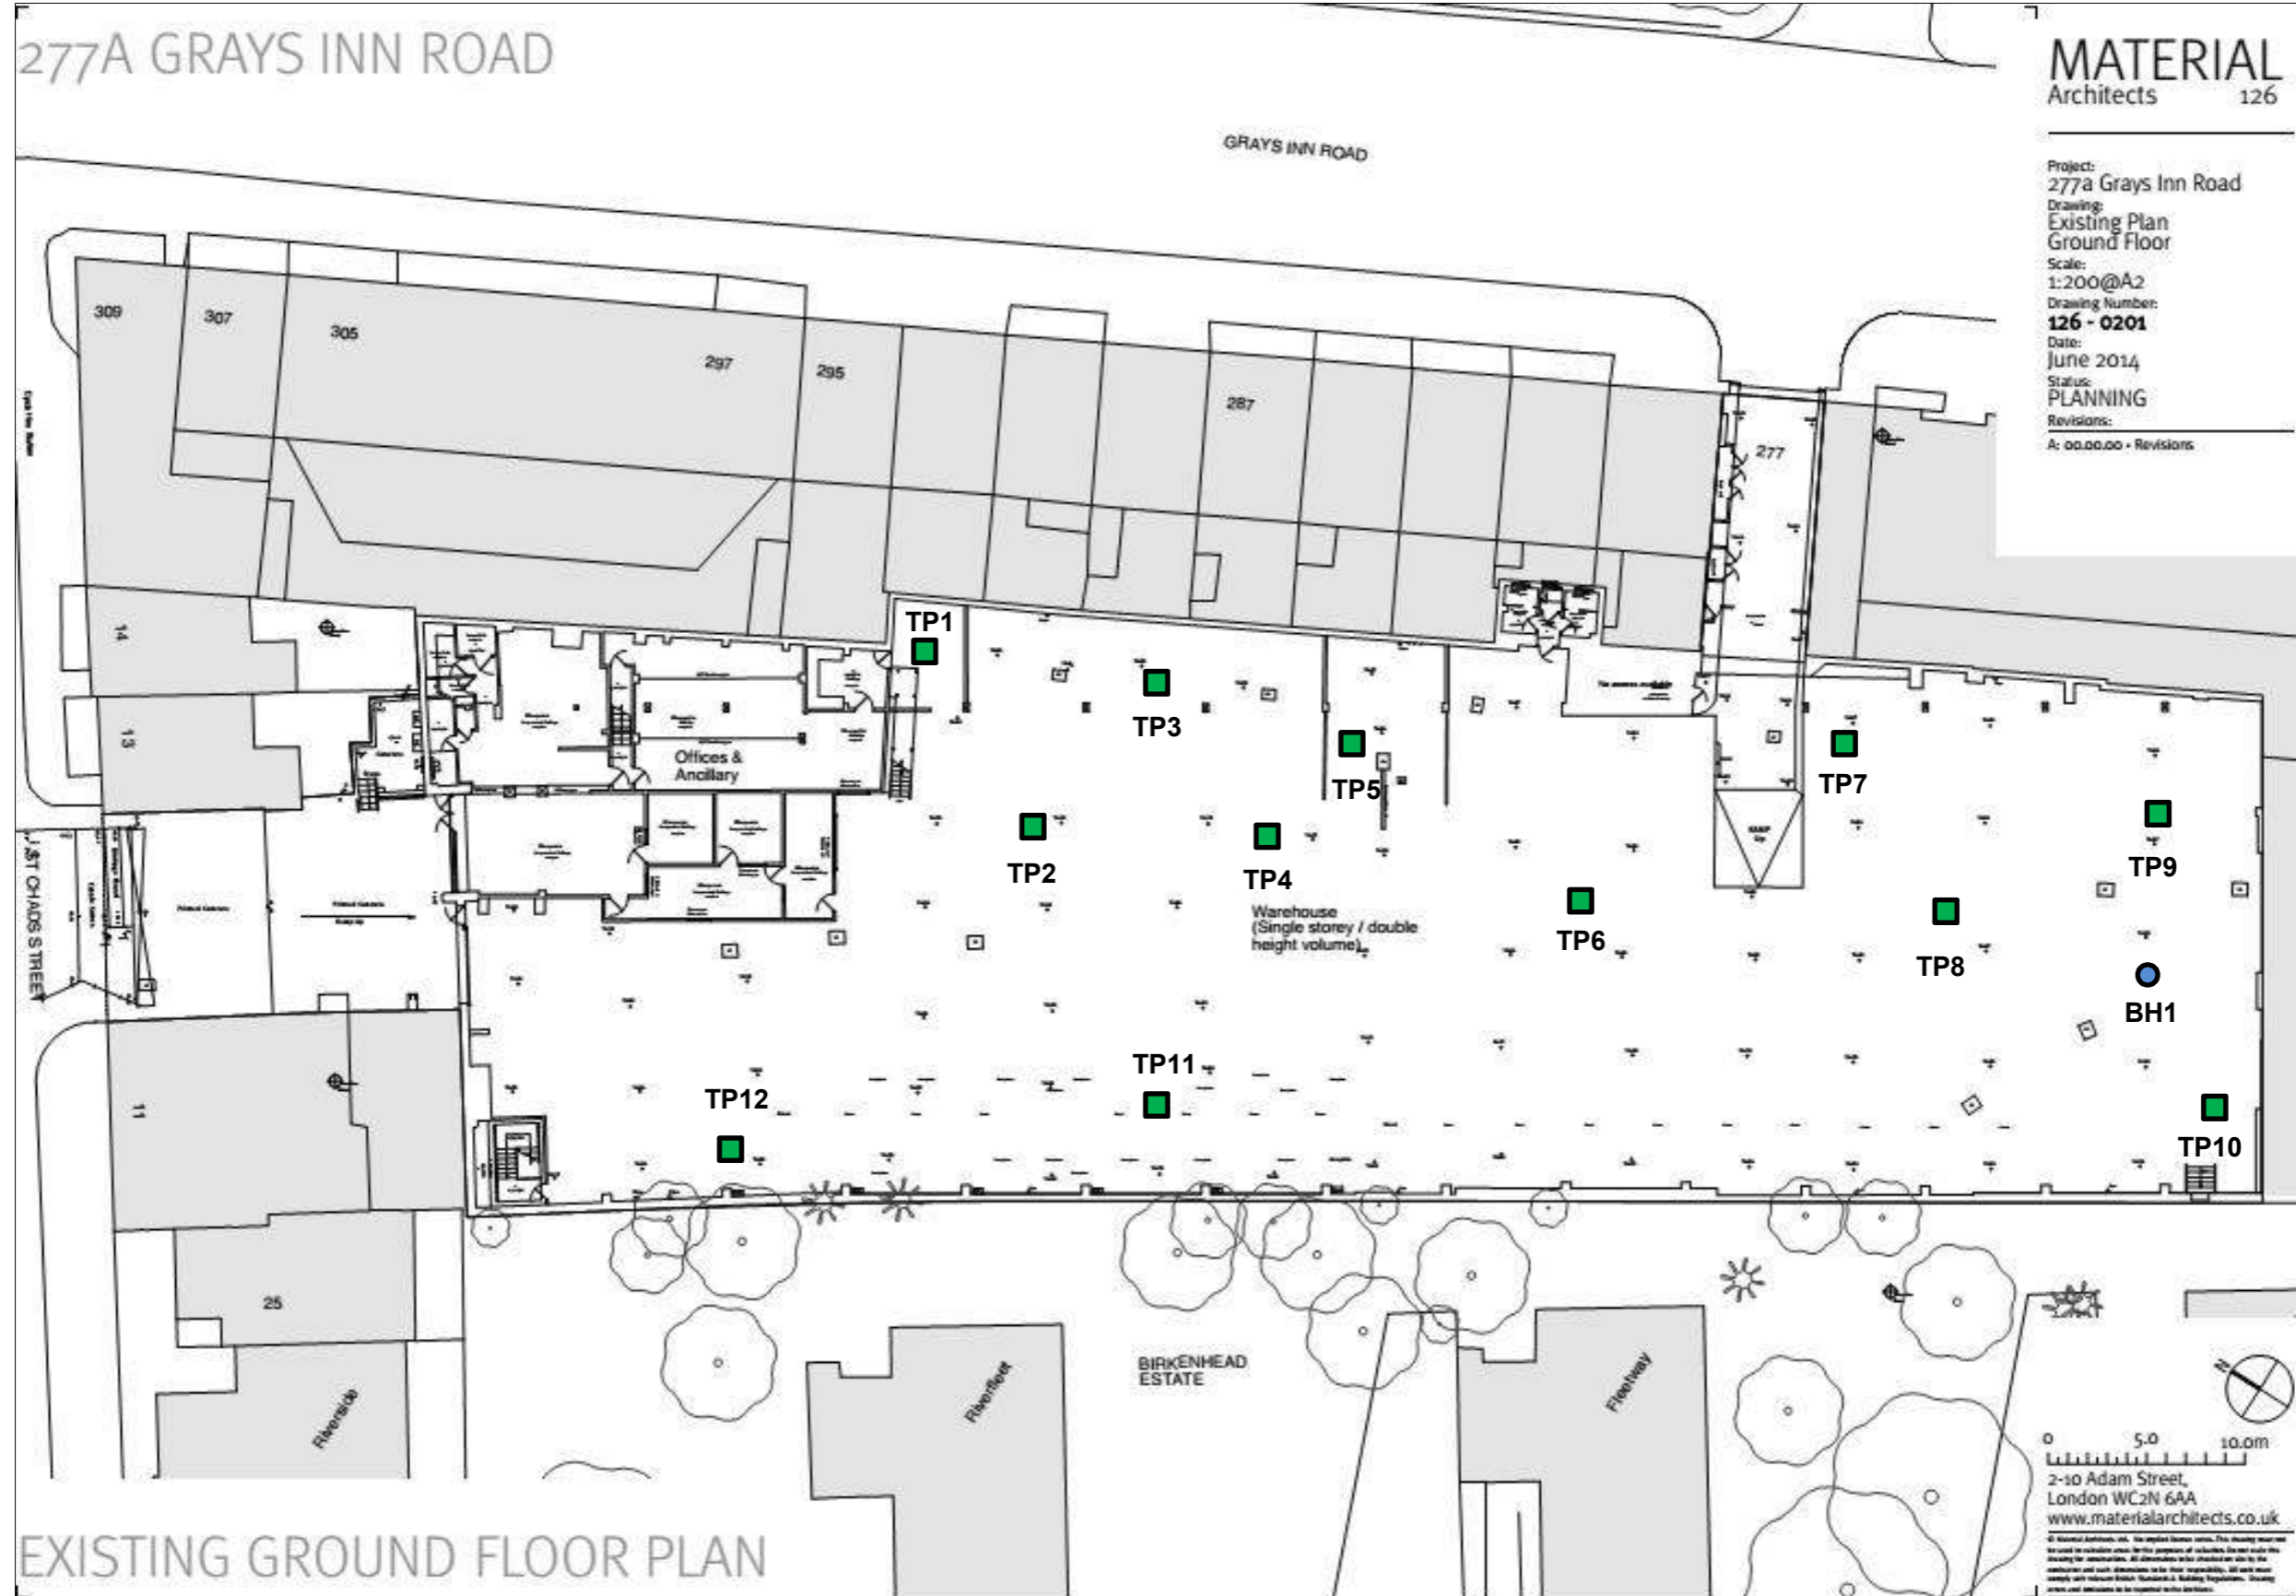
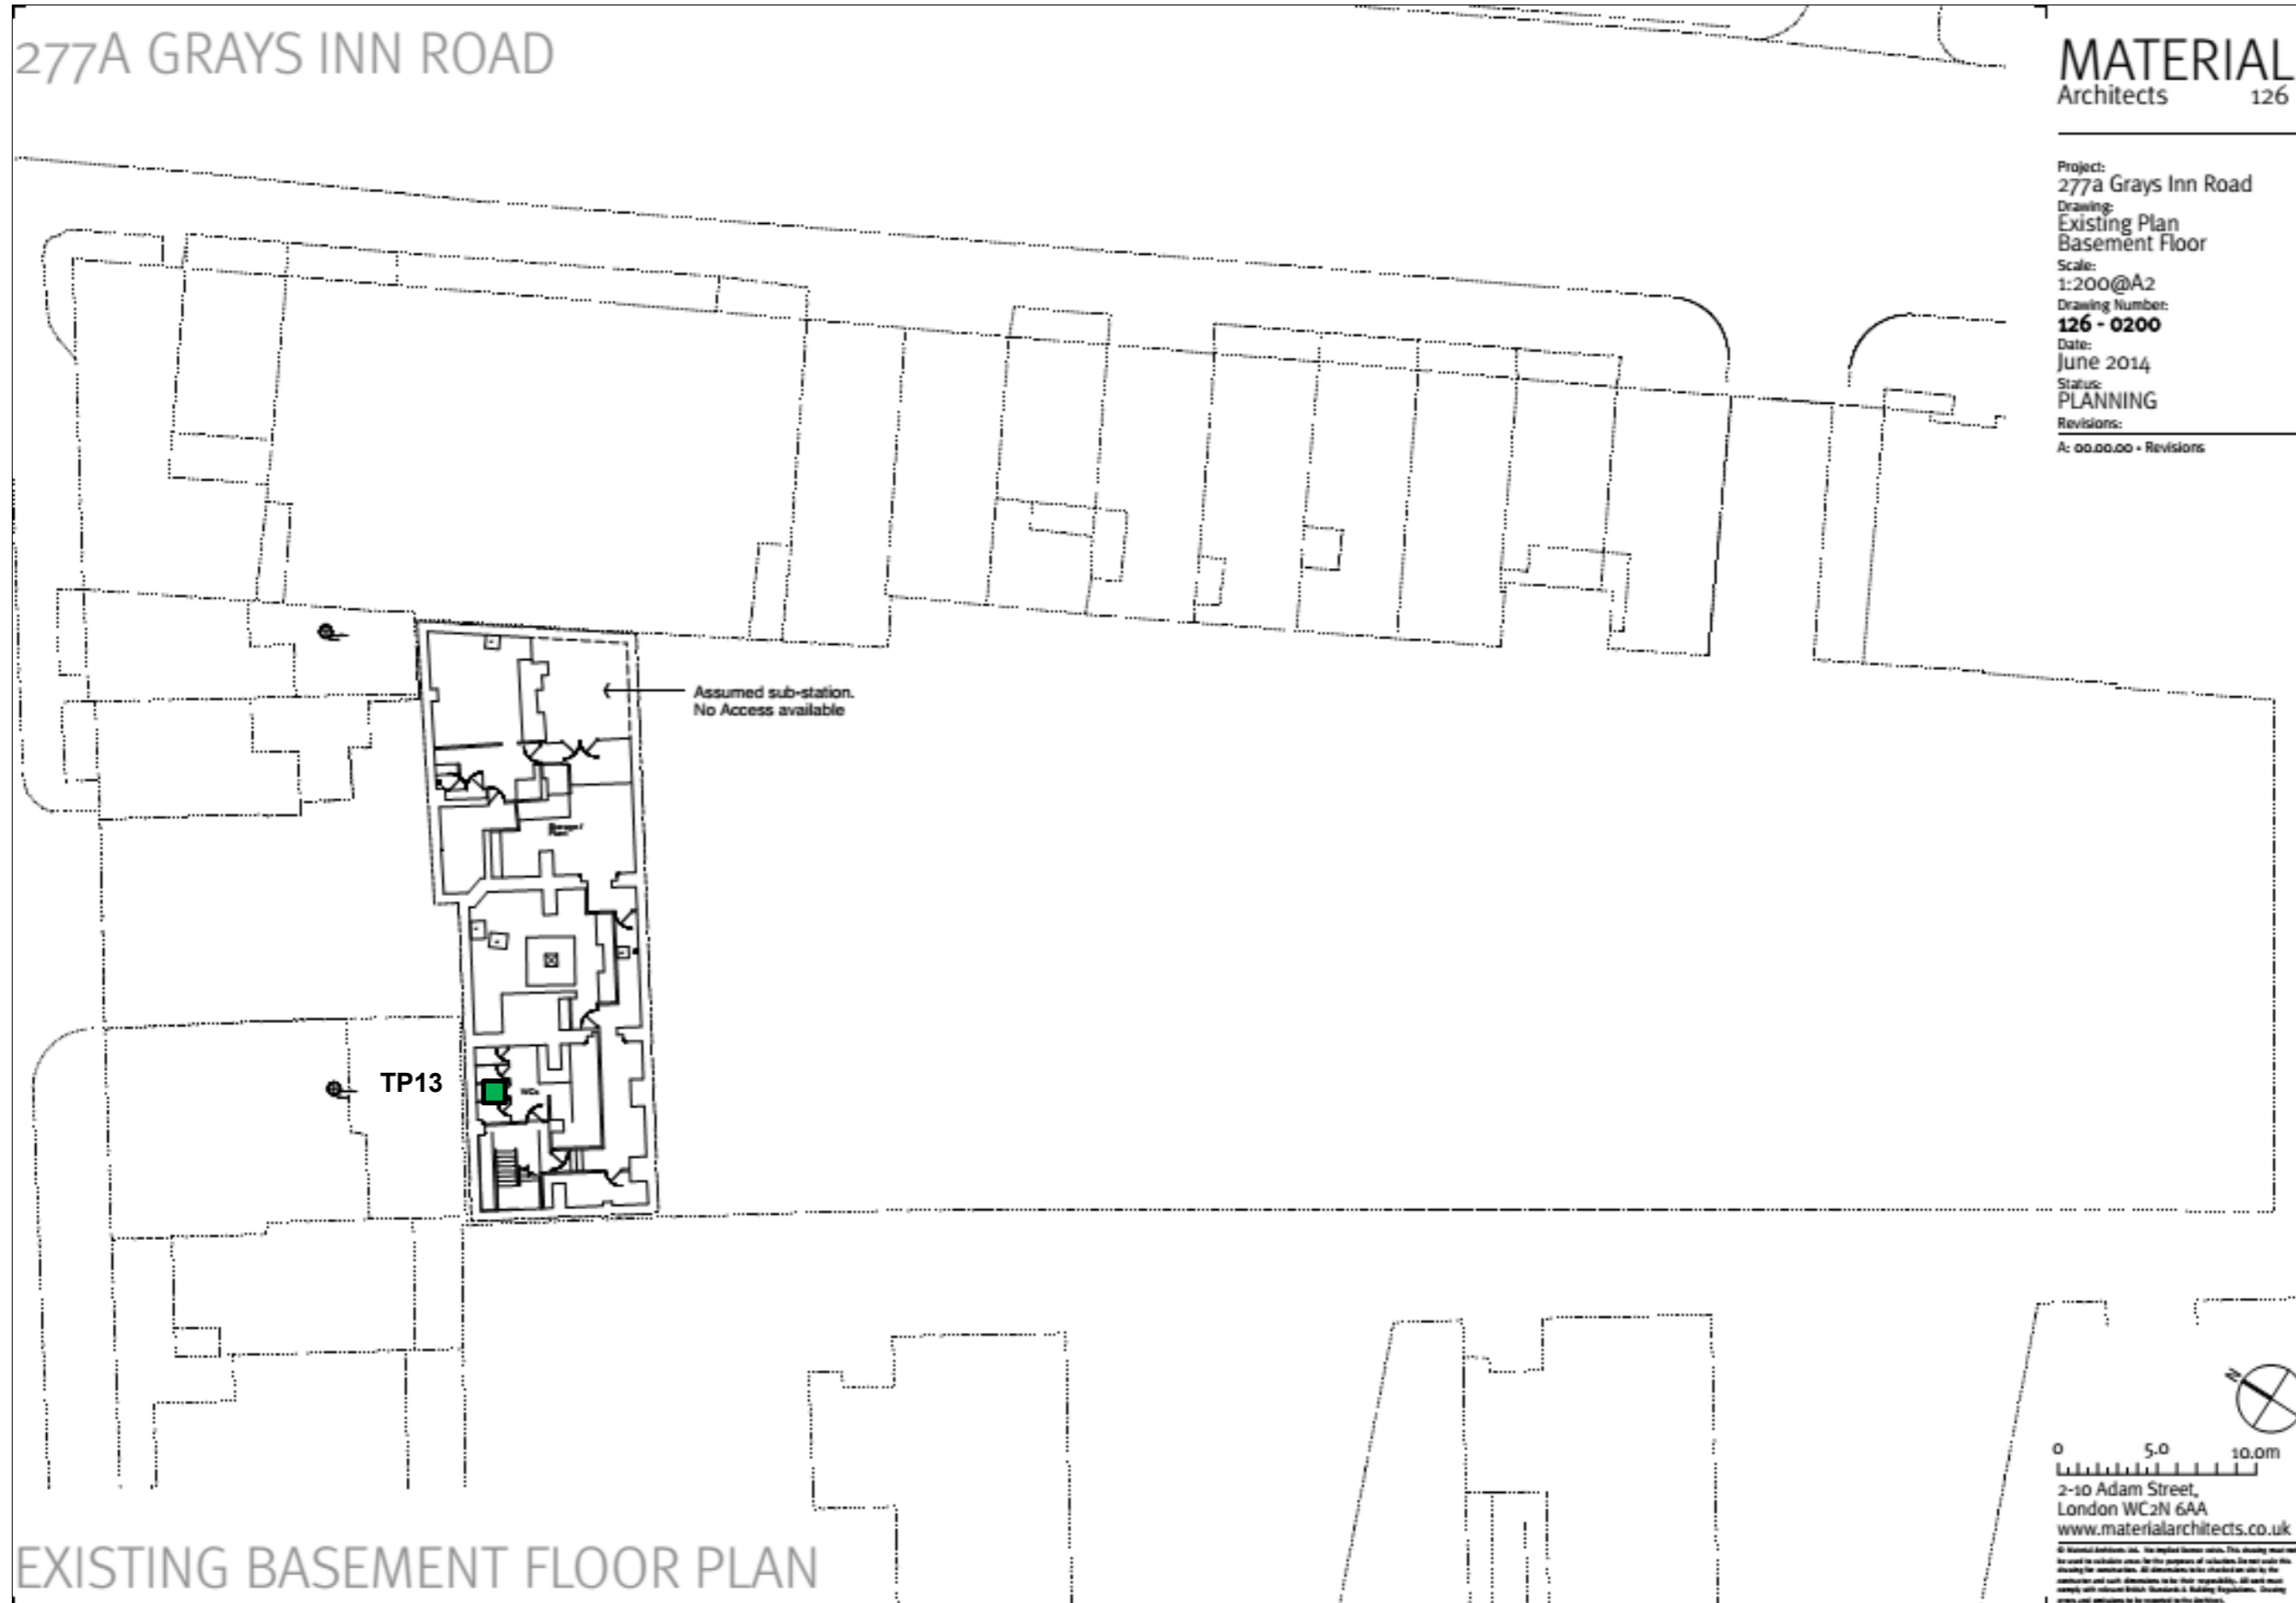
Exploratory Hole Location Plan

The locations for the investigation were scanned with a CAT in order to minimise the risk of damage to underground services. Where necessary, the final positions of the exploratory holes were moved in order to avoid buried services. The intrusive investigation was subsequently carried out in accordance with BSI (2013b) on 09/12/2104. An annotated exploratory hole location plan is presented in Figure 3.

There was a thick layer of reinforced concrete across the entire site. The only exceptions to this were at TP8 and TP9 where the ground surface had been previously disturbed and broken out, presumably in connection with a previous investigation. Below the hardstanding was a circa 2.1m thick layer of made ground. In general, the made ground comprised a layer dominated by rubble (MG2) with a deeper layer of sandy, gravelly silt (MG3).
