Client: Mr Khalid Zaky
Project: 14F Avenue Road
Title : Basement layout

Basement Method Statement

14F Avenue Road NW8 6BP

GROUND INVESTIGATION REPORT

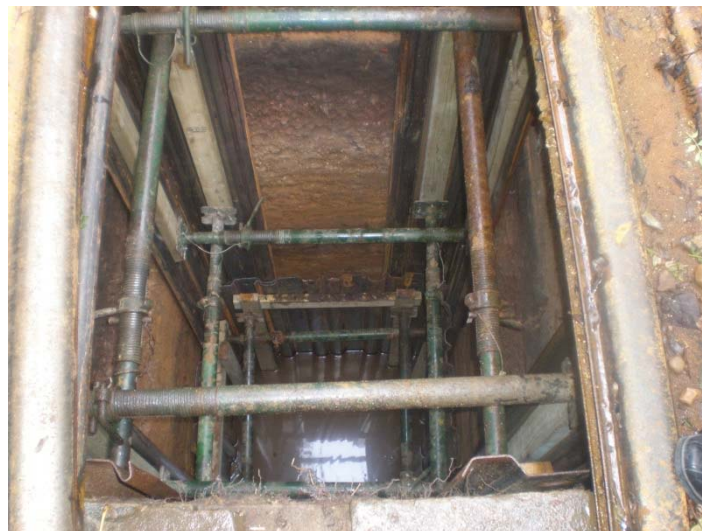
Figure 2 Propping

- 4.4. Back propping of rear face. Rear face to be propped in the temporary conditions with a minimum of 2 Trench sheets. Trench sheets are to extend over entire height of excavation. Trench sheets can be placed in short sections as the excavation progresses.

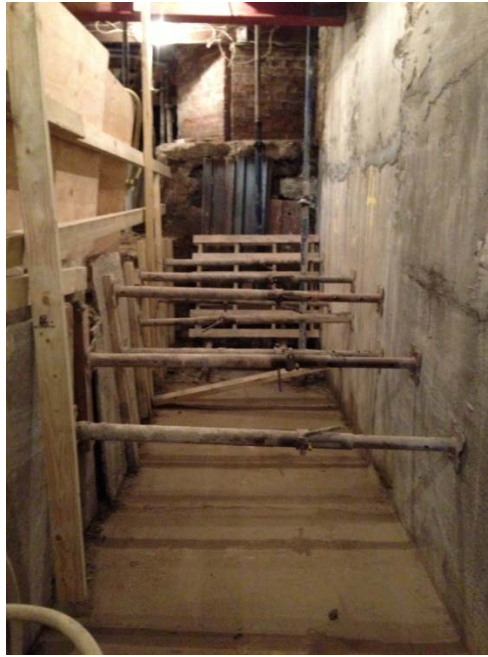
- 4.4.1. If the ground is stable, trench sheets can be removed as the wall reinforcement is placed and the shuttering is constructed.
- 4.4.2. Where soft spots are encountered leave in trench sheets or alternatively back prop with precast lintels or trench sheeting. (If the soil support to the ends of the lintels is insufficient then brace the ends of the PC lintels with 150x150 C24 Timbers and prop with Acrows diagonally back to the floor.)

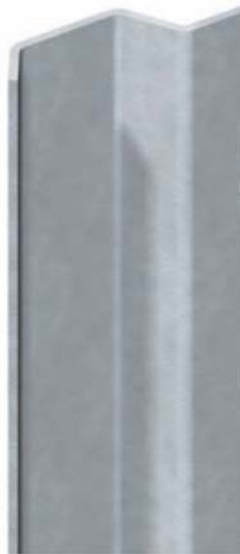
Effective width per sheet (mm)	330
Thickness (mm)	3.4
Depth (mm)	35
Weight per linear metre (kg/m)	10.8
Weight per m ² (kg)	32.9
Section modulus per metre width (cm ³)	48.3
Section modulus per sheet (cm ³)	15.9
I value per metre width (cm ⁴)	81.7
I value per sheet (cm ⁴)	26.9
Total rolled metres per tonne	92.1

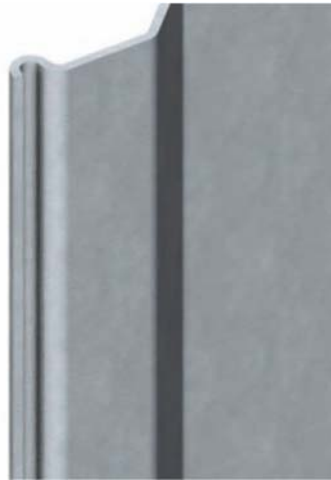
Effective width per sheet (mm)	400
Thickness (mm)	6.0
Depth (mm)	50
Weight per linear metre (kg/m)	21.90
Weight per m ² (kg)	55.2
Section modulus per metre width (cm ³)	101
Section modulus per sheet (cm ³)	40.34
I value per metre width (cm ⁴)	250
I value per sheet (cm ⁴)	101
Total rolled metres per tonne	45.659

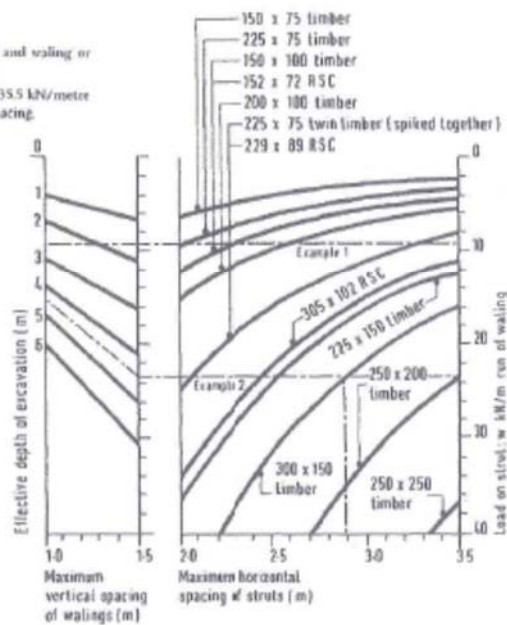
Use for:
 Granular soils
 Mixed soils
 Short term trenches in clay
 (see notes opposite)

Note:
 For standard Speedshore hydraulic strut and waling or equivalent use the curve for 229 x 89 RSC.
 Heavy duty Speedshores have a capacity of 35.5 kN/metre run of waling at 3.2m horizontal strut spacing.

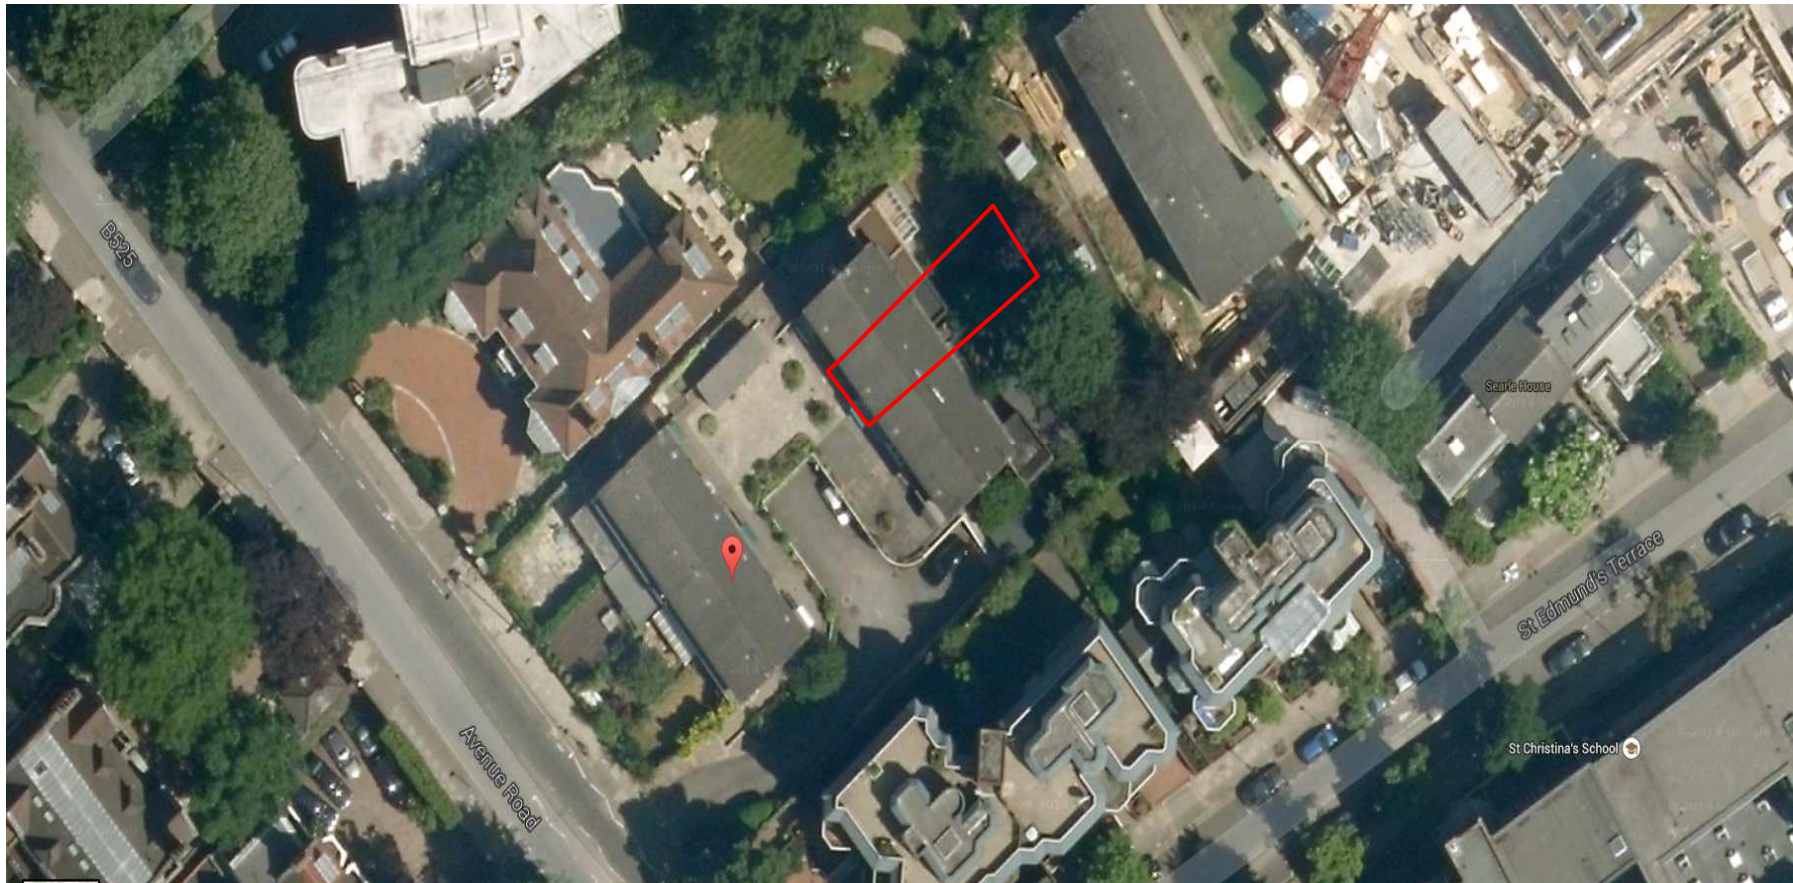
Project: 14F Avenue Road, Primrose Hill, London NW8 6BP		<p>Figure 2</p>
Client: Khalid Zaky c/o Croft Structural Engineers Limited	Date: December 2014	
Site Development Area	Ref: GWPR1072

**Approximate Site Boundary**

The site was occupied by a mid terrace three to four storey brick built residential house. A single raised pedestrian terrace was noted to front the property at an elevation of ~3.0m above the tarmac access road off Avenue Road. A sunken garage structures was noted to the south-west of the property. A single storey rear extension was noted beyond which there was a grassed garden. Mature and semi-mature trees were noted along the north-eastern boundary of the site. A topographic survey of the site is shown in Figure 2. An aerial view of the site is provided within Figure 3.
