## Basement Impact Assessment & Site Investigation Report

Site: 18 Grove Terrace, NW5 1PH

Project Reference: J11987

## Site Investigation Report

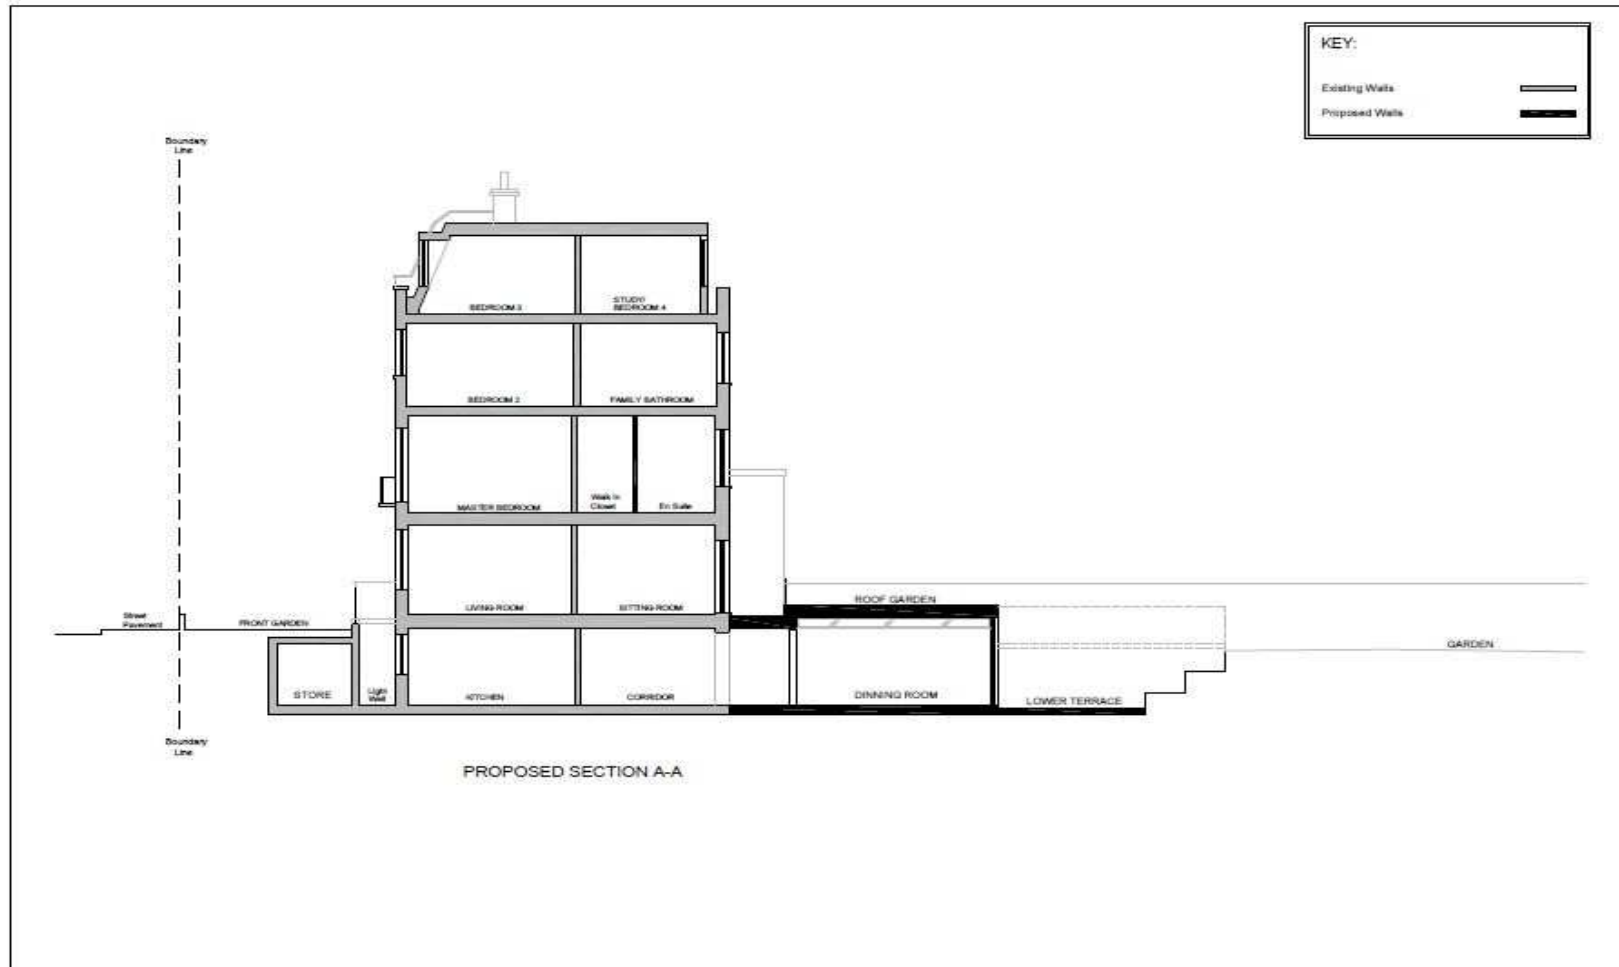
The proposed works include the construction of a basement for a dining room and roof garden extending out from the rear lower ground floor level of the subject property into the garden area together with an open lower terrace area. Figure 2 illustrates the proposed basement/lower terrace area.

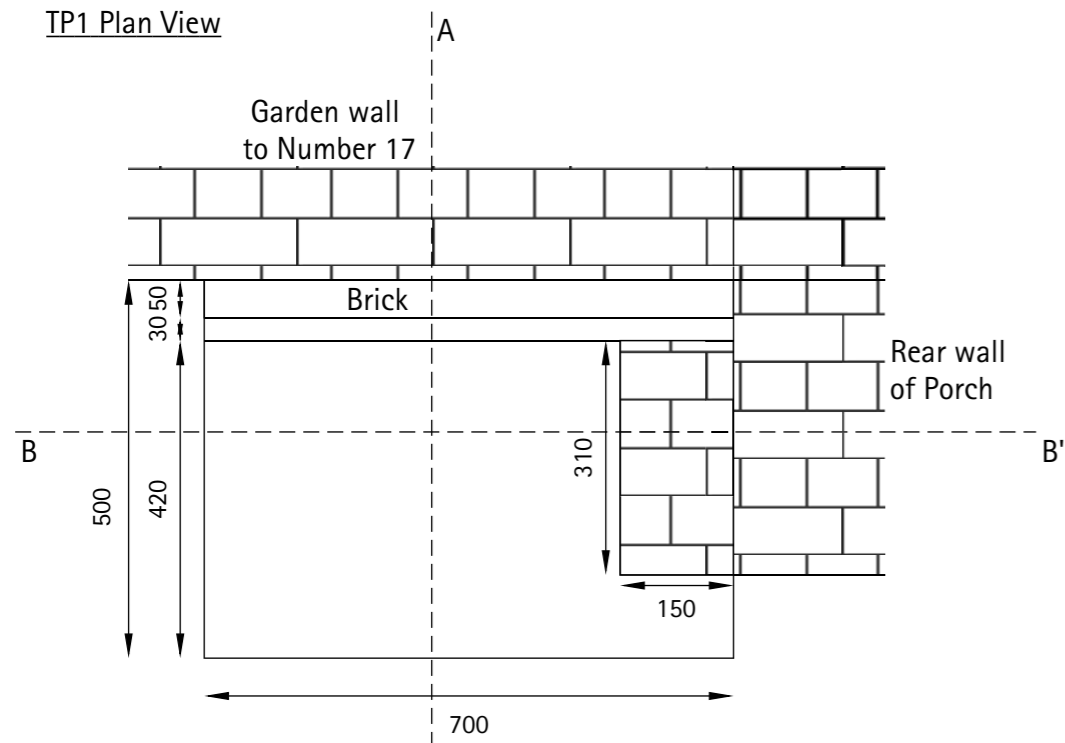
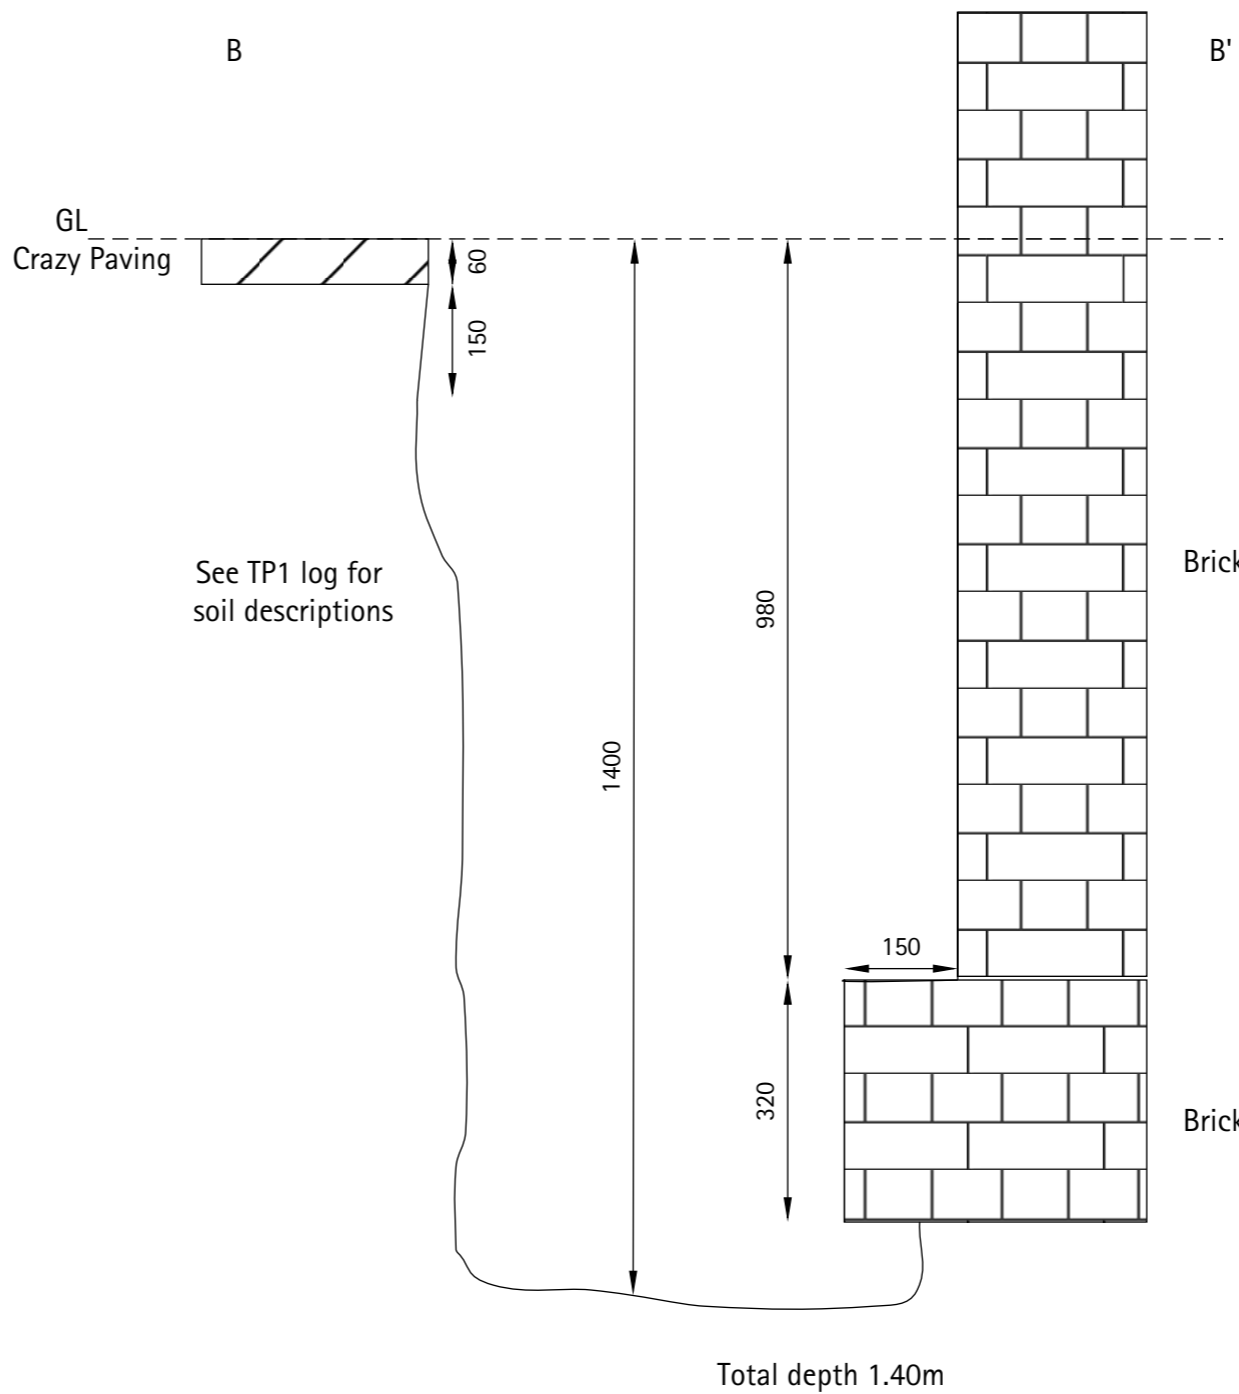
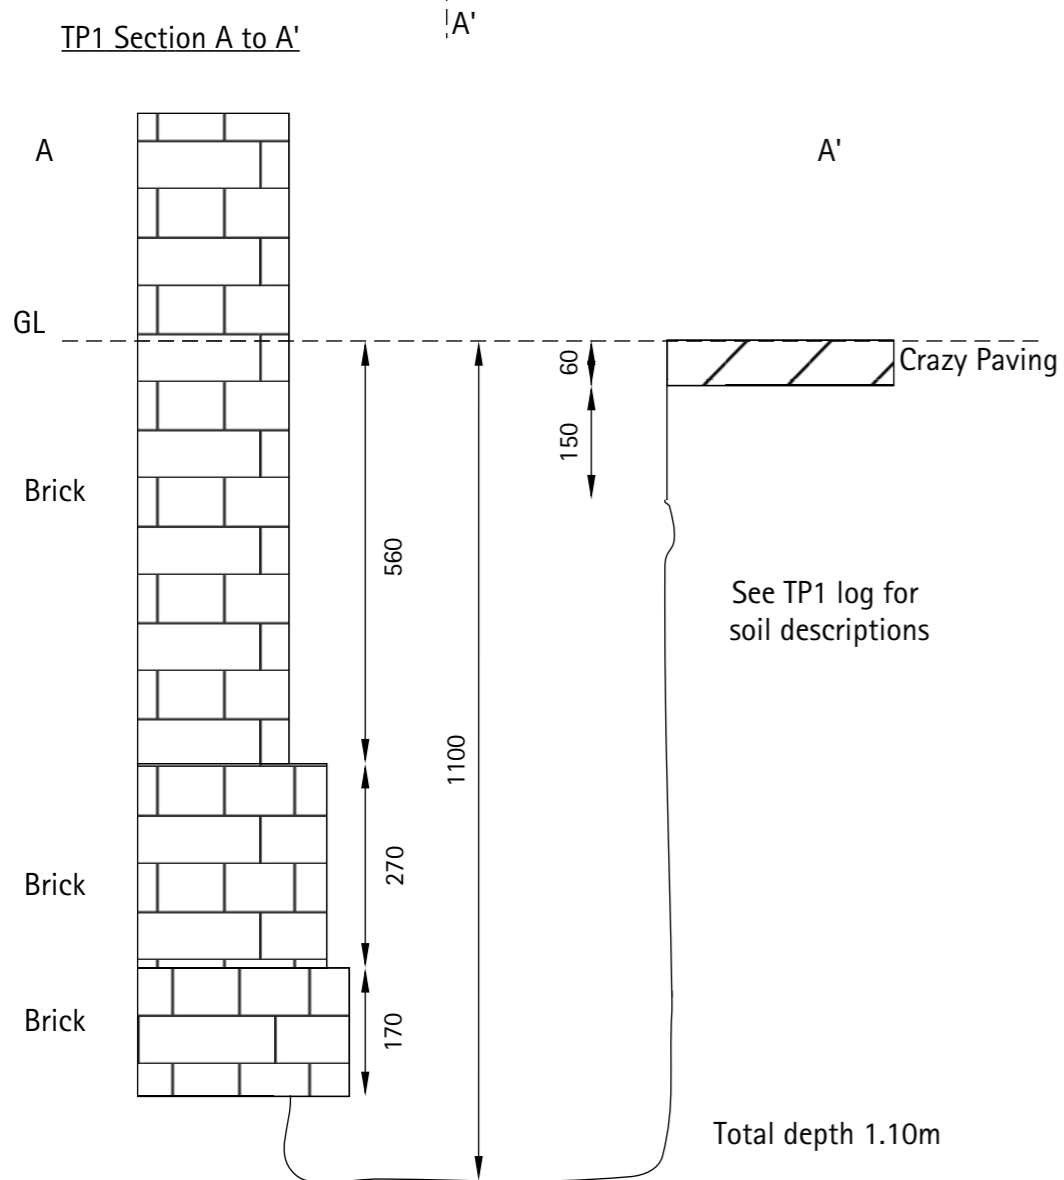
TP1 Plan View

A series of hand excavated pits were carried out to establish the rear porch foundations and the adjacent boundary walls. Cross sections showing our findings are given in Appendix A.

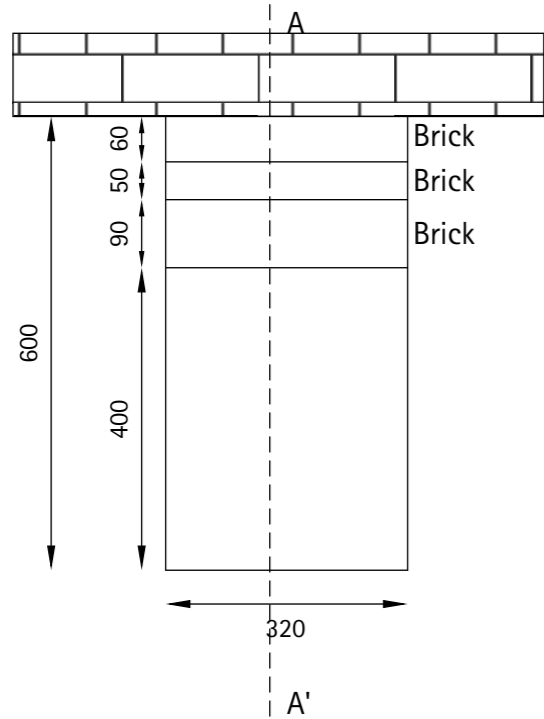
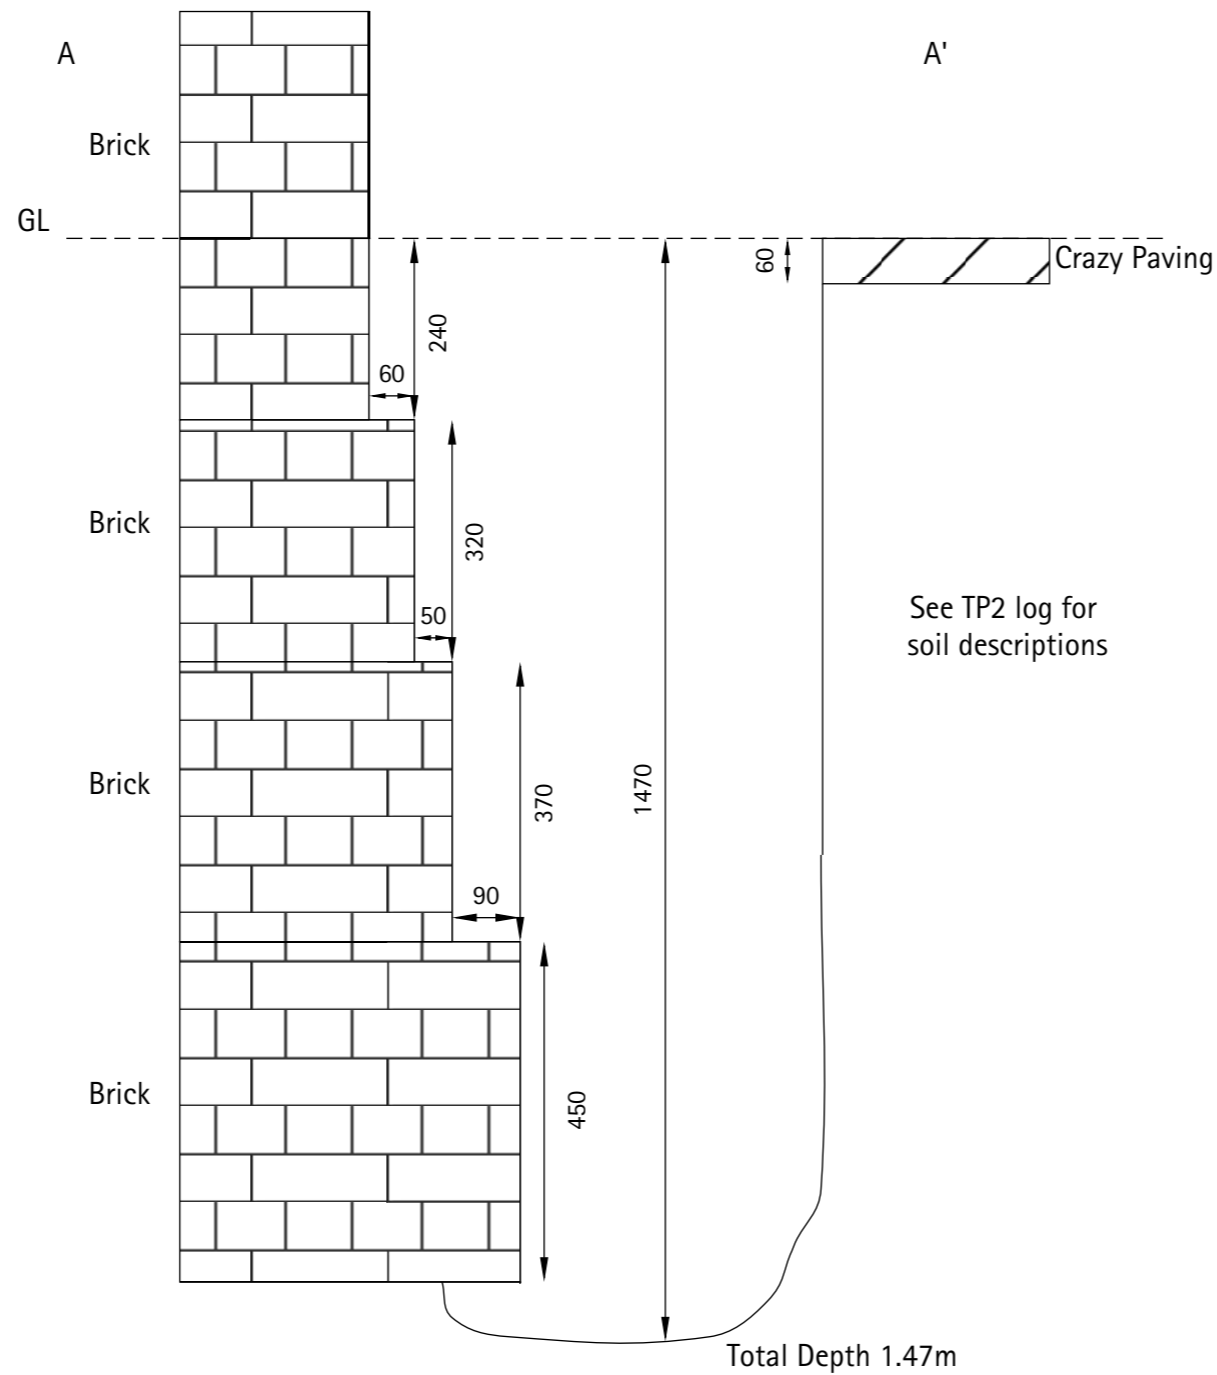
TP2 Plan View

Garden Wall with Number 19. Near to basement

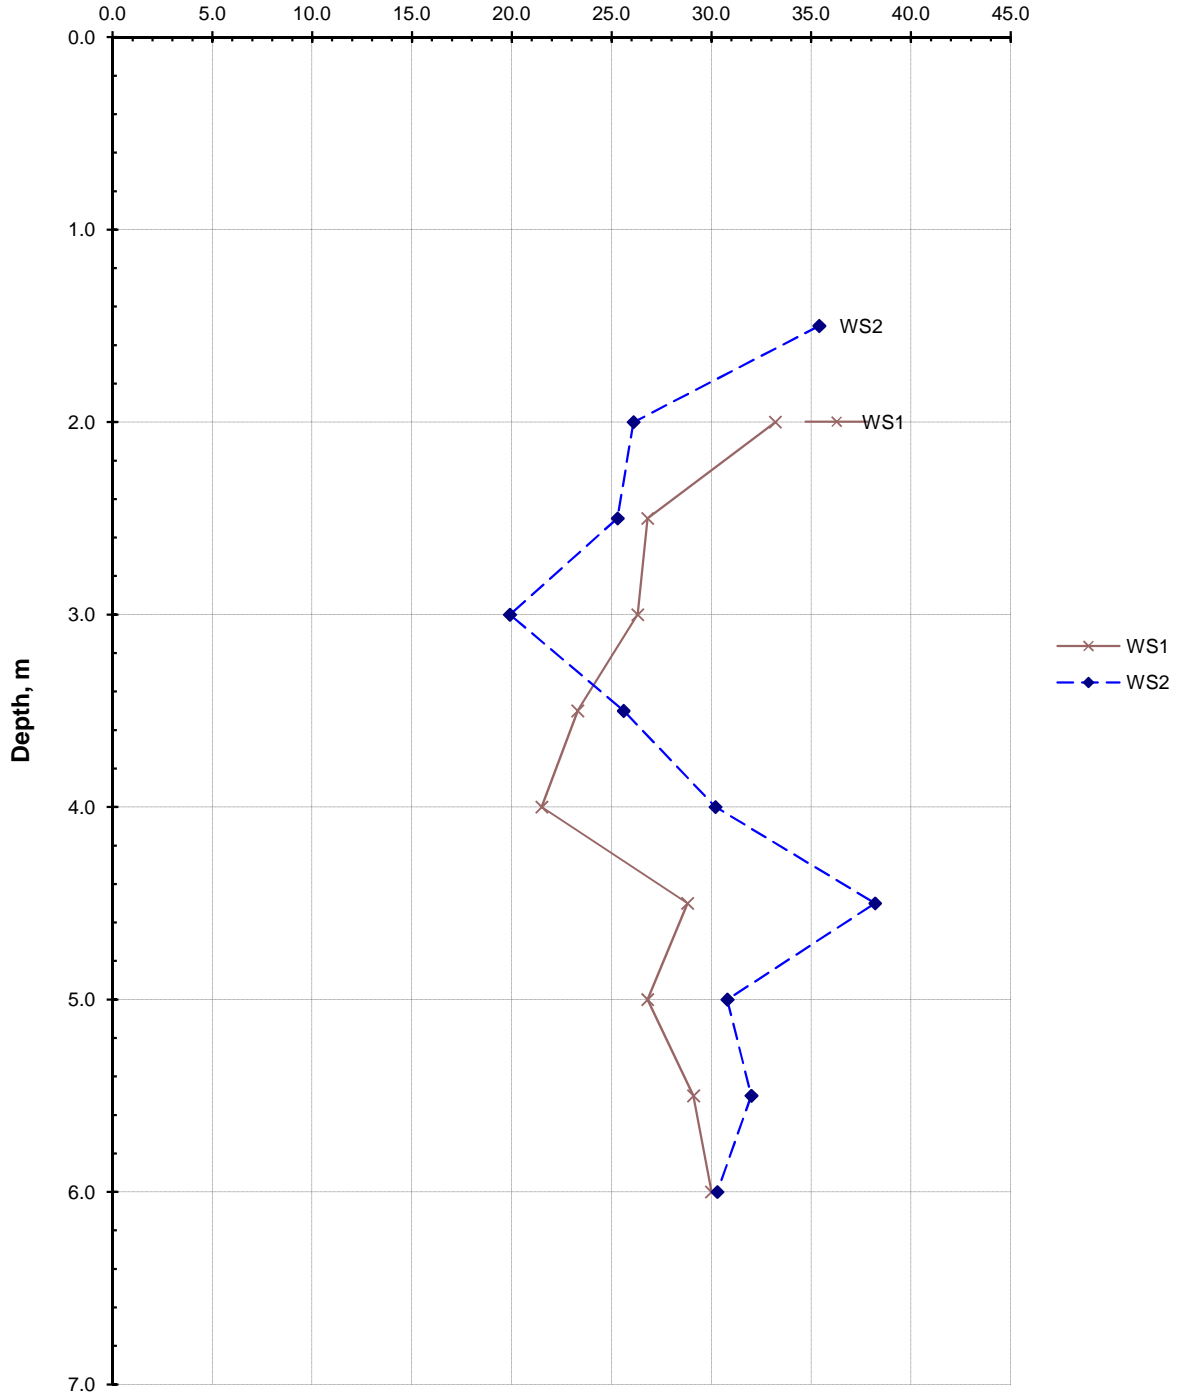
### Moisture Content vs Depth

Figure MC1 (Appendix C) shows a plot of moisture content versus depth for both test locations. Figure MC2 and MC3 (Appendix C) has been plotted with respect to the above criterion.

Referring to figure MC1, and within the upper 3.2m, the moisture contents in WS2 are typically lower than those recorded within WS1.

Below a depth of 3.2m, the moisture contents within WS1 are lower than those recorded within WS2. It is noted that WS1 is more remote from the adjacent vegetation than WS2 and therefore below 3.2m the results are somewhat contradictory. The moisture content profiles within both holes converge at a depth of 6.0m

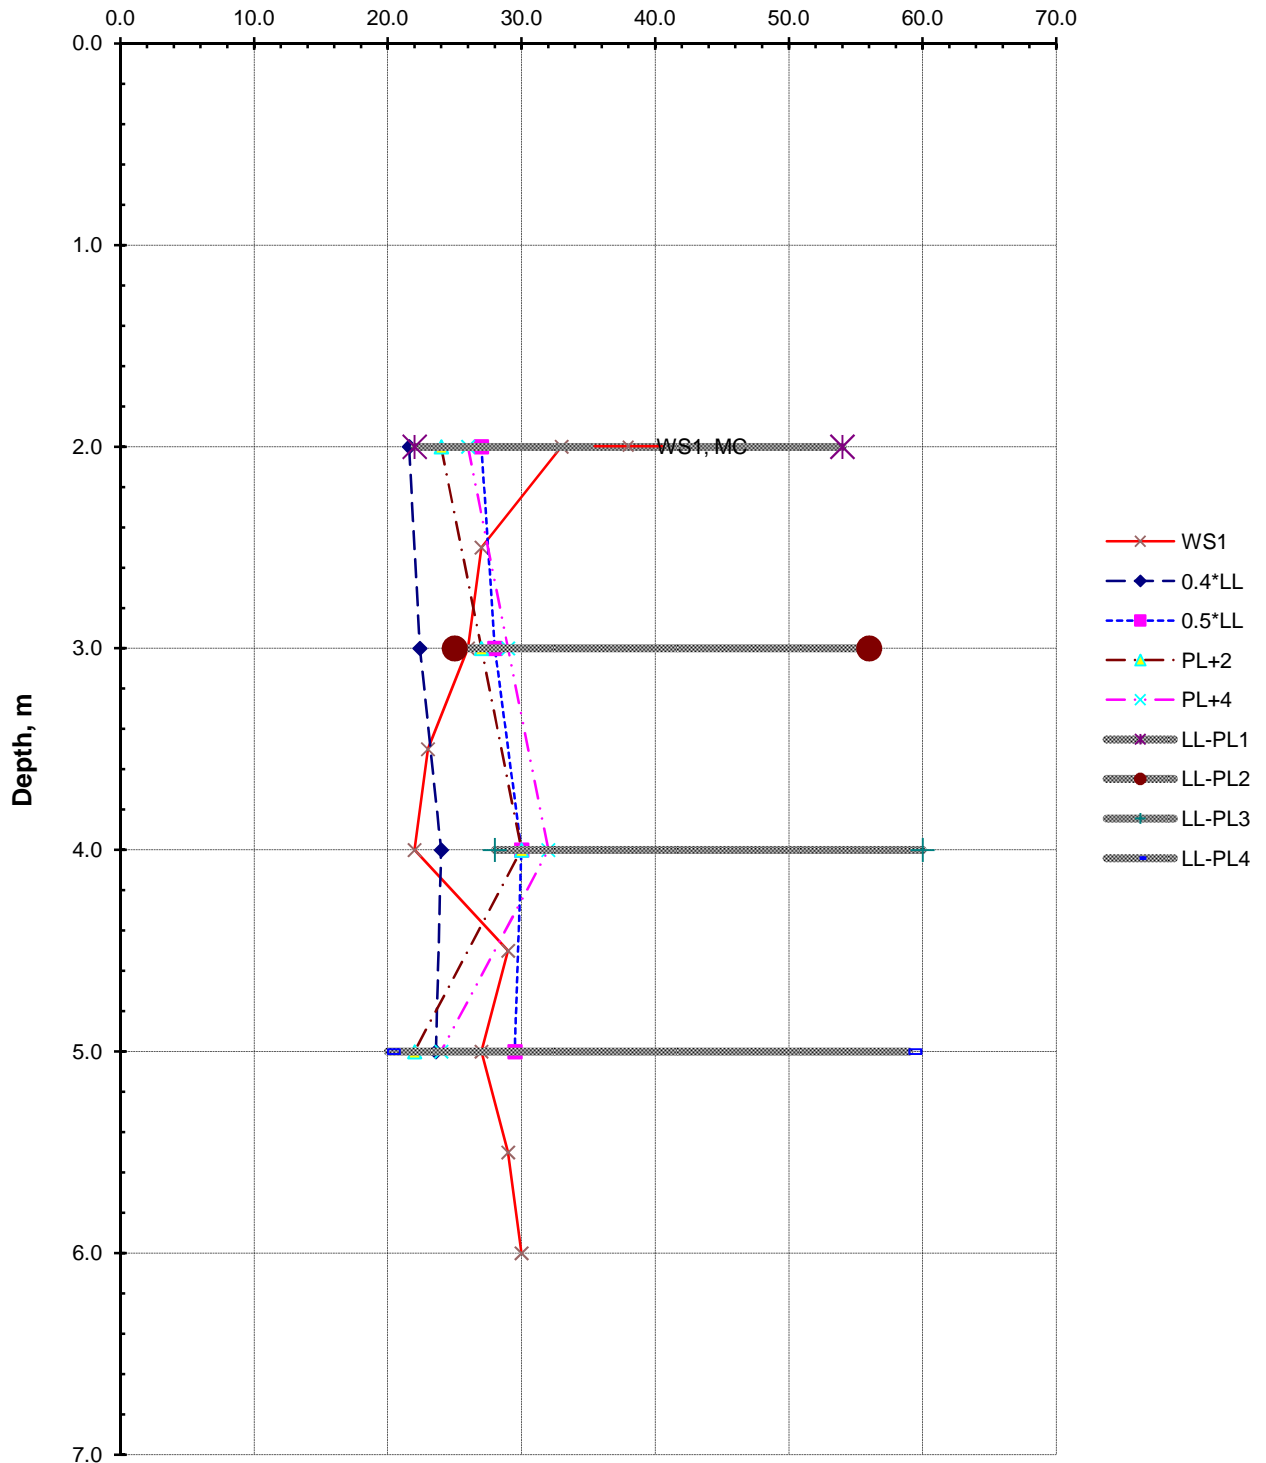
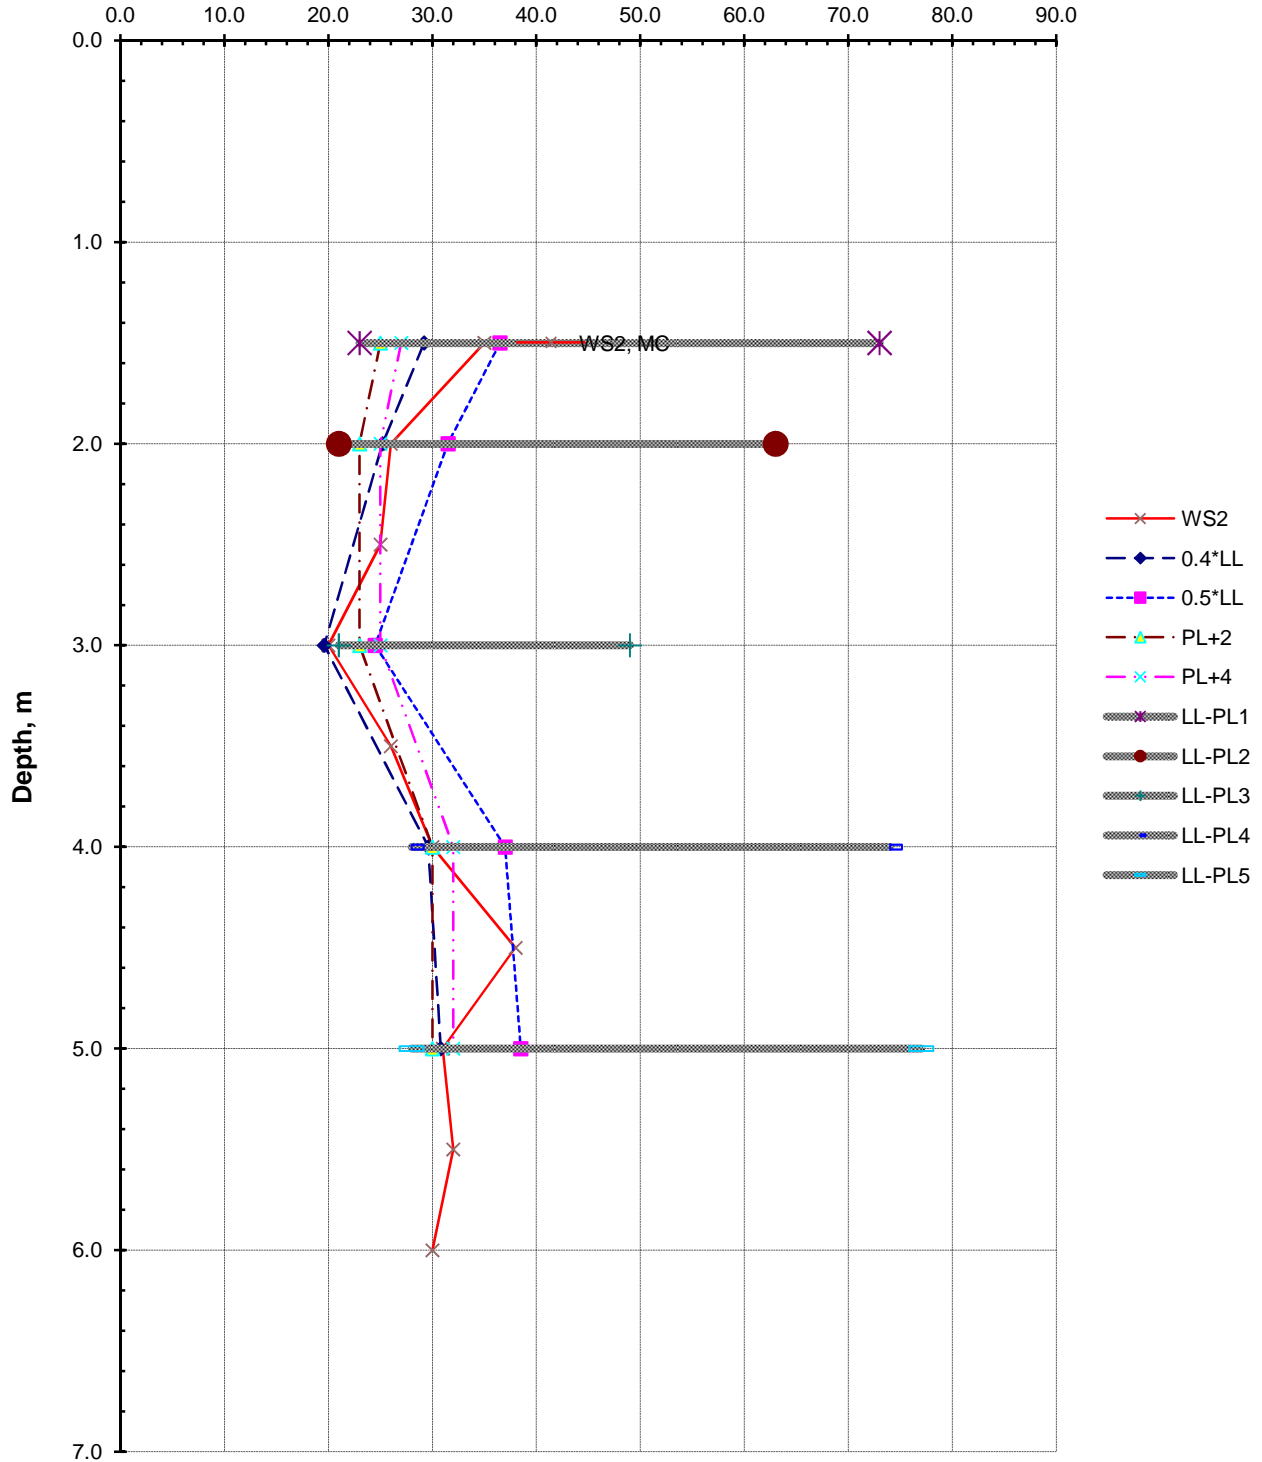
## Moisture Content and Atterberg Limit Tests vs Depth

Referring to Figures MC2 and MC3, and using the above desiccation criterion, in our opinion, there is no conclusive sign of significant desiccation within the upper 3.0m in either borehole. The tests indicate possible signs of desiccation within WS1 between 3.0–4.2m. As noted above, WS1 is located in an area which was more remote from the trees within the garden than WS2, and therefore, in this instance, the use of the criteria is not definitive proof of desiccation being present at depth in WS1.
