## **New Homes on Regent's Park Estate**

SD10 Ecology Assessment

### Ecology Assessment

**Desk Study and Extended  
Phase 1 Habitat Survey and  
External Building Inspection  
for Bats Regent's Park Estate**

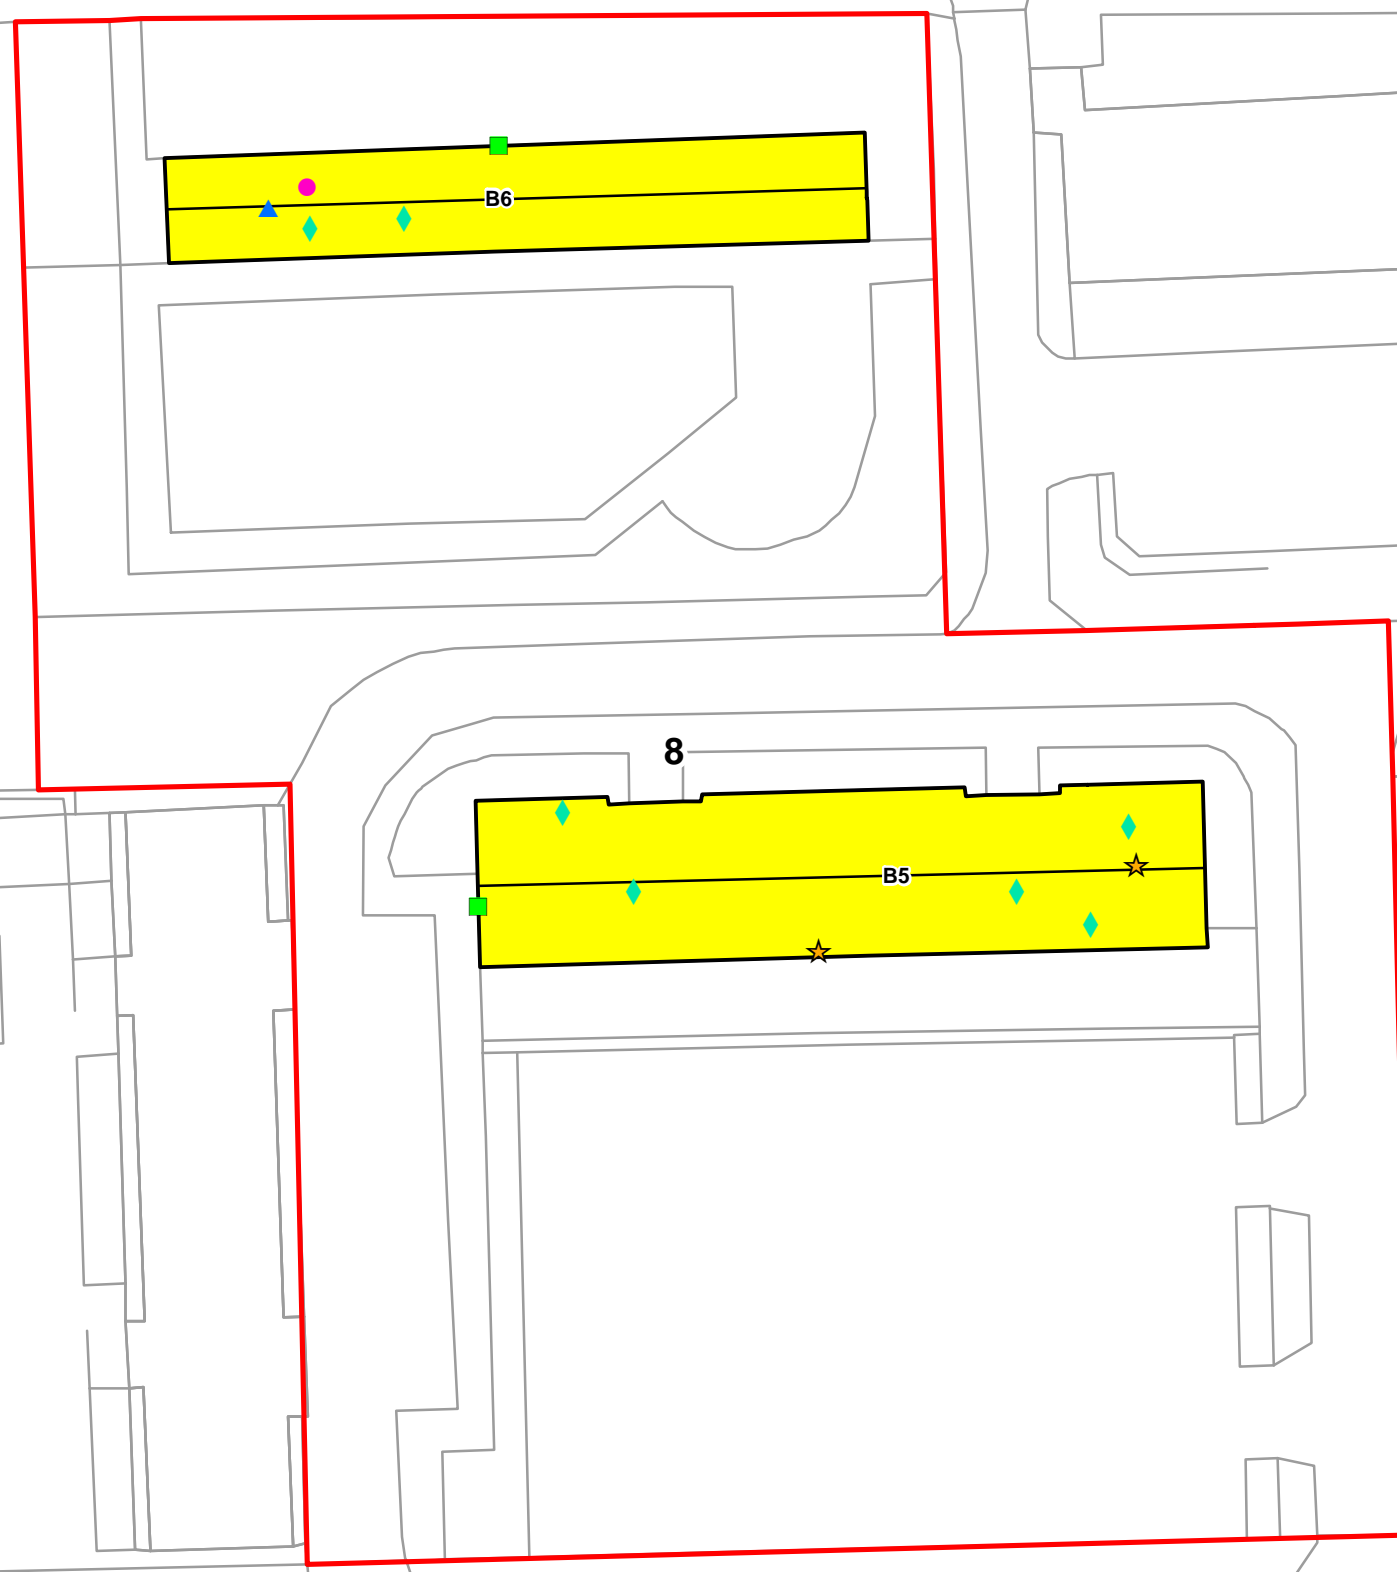
Figure Title  
External Building Inspection  
for Bat Results  
Site 8

- Damaged ridge tile
- Drainage hole
- ▲ Gap under ridge tile
- ★ Gap under tile
- ◆ Missing tiles

- Low
- Site Boundary

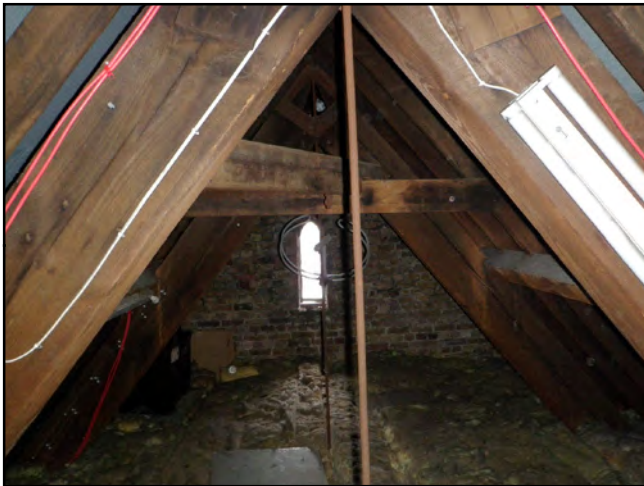
Photograph 3:  
 St. Bede's Hall within the elevated tower section to the south of the building.
