6 NUTLEY TERRACE, GREATER LONDON

DAYTIME BAT SURVEY

Report No: RT-MME-118690-02

Date: January 2015

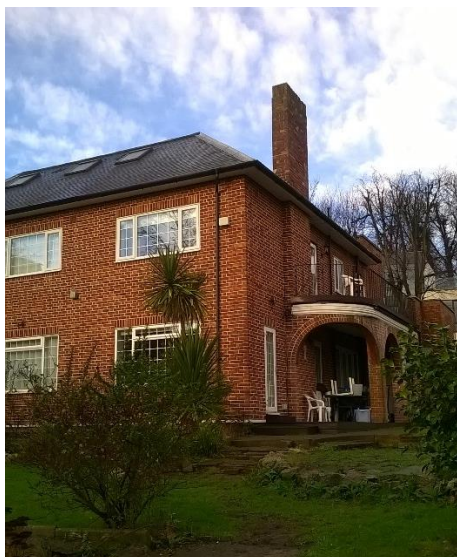
The main house on site was a modern two-storey brick structure with a concrete tiled flat-topped pyramid roof (Plates 4.1 and 4.2). A small pitched section with a hipped end extended north from the north eastern corner of the main roof.

Plate 4.1: 6 Nutley Terrace viewed from the South.

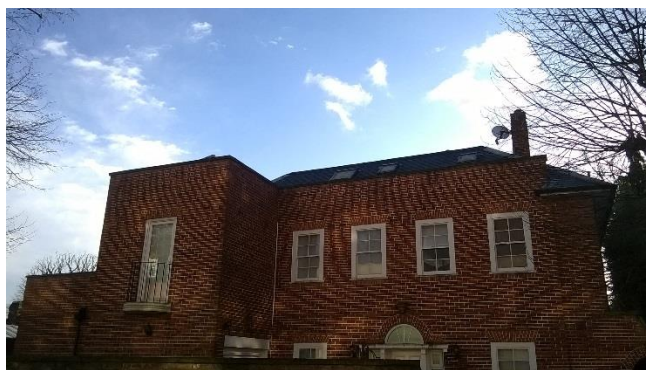
Plate 4.1: 6 Nutley Terrace viewed from the North.

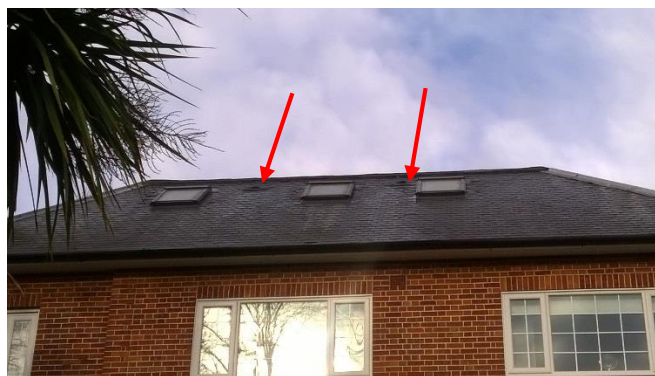
A number of skylights were installed into the pitched elevations of the roof. A number of roof tiles were slipped and broken on the northern and southern elevations, in particular around the skylights on these elevations (Plate 4.3). Areas of the southern elevation appeared to have been patched with roofing felt

where tiles had been removed. The lifted and missing tiles provide potential ingress points for roosting bats but due to their height these features could not be fully inspected at the time of the survey.

Plate 4.3: Missing and slipped tiles of southern elevation.

It is recommended that an endoscope survey of the missing and lifted tiles noted on the southern elevation is carried out (from an extendable moving platform or scaffolding). This will also allow an assessment of the flat roofed section. If all these features are fully accessed and surveyed, and no bats or evidence of bat activity (in the form of scratch marks, feeding remains, grease marks, urine staining or droppings) are found, then works can commence as planned as no bat roost is present. However, if any areas are inaccessible, evidence of bat activity is identified, or it is not possible to conclusively state that bats are not present then it will be necessary to undertake the bat activity surveys outlined in Option 2.

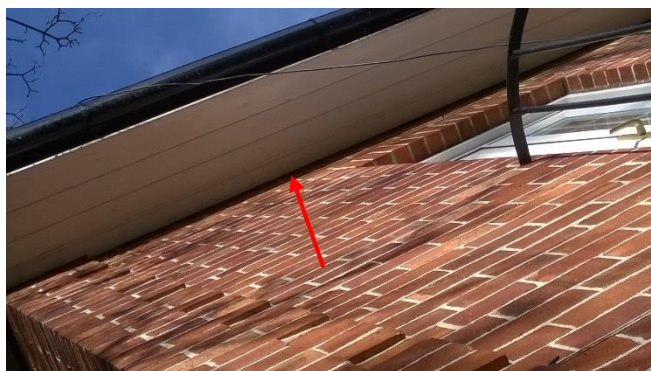
uPVC soffits and plastic guttering were present on the east, south and western elevations of the building. The soffit was in good condition, but occasional gaps were present between the soffit and brickwork of the walls (Plate 4.4). When inspected with a high powered torch and binoculars these were found to be heavily cobwebbed, indicating no recent faunal use.

Plate 4.3: Gap between soffit and brickwork.
