DESK STUDY & GROUND INVESTIGATION REPORT

25-26 Redington Gardens
London NW3

Client: 25-26 Redington Gardens LLP

J15031

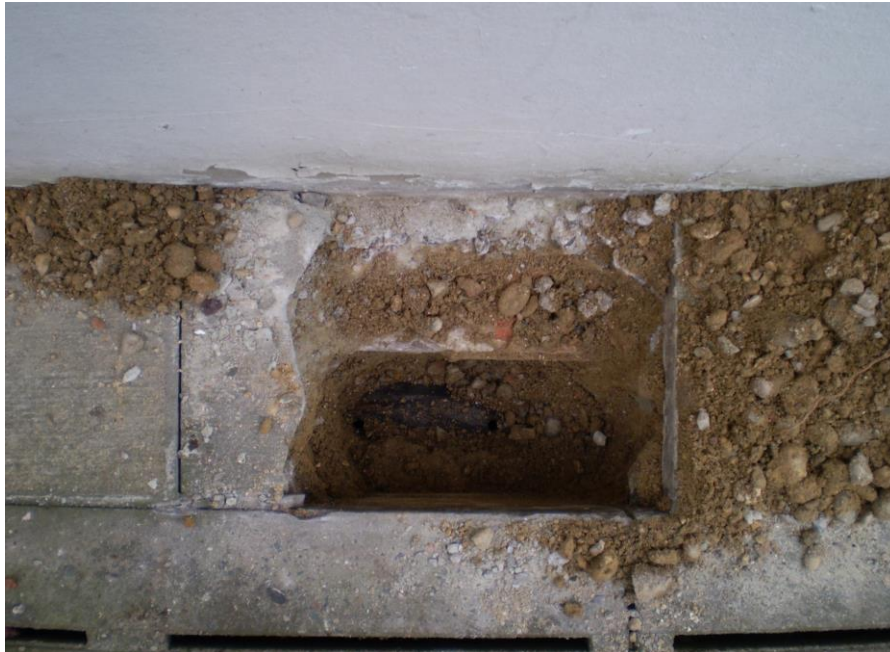
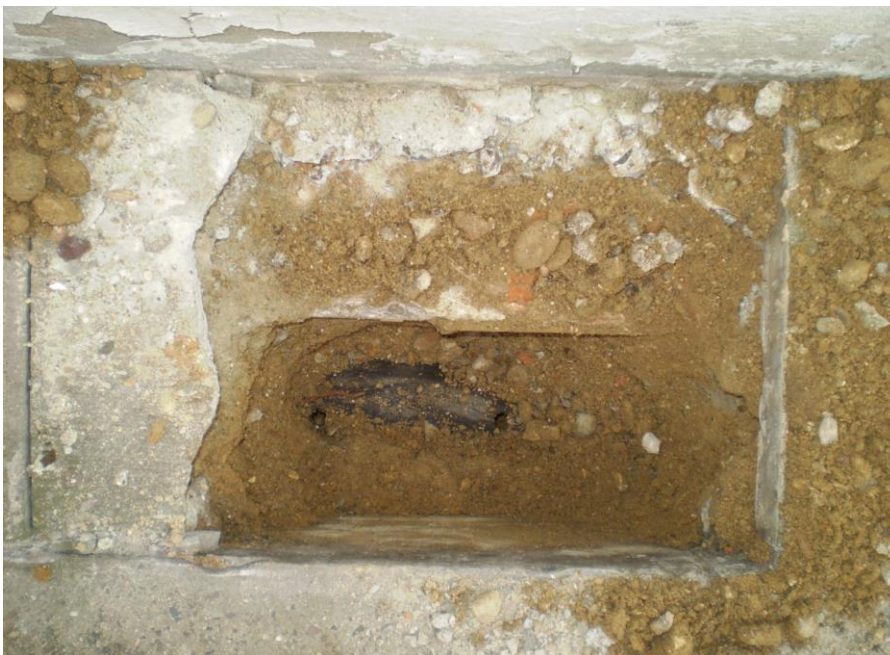
Remarks: Pit terminated at 300mm due to pipe. Unable to extend horizontally due to concrete drain to the south.
