Camden Geological, Hydrogeological and Hydrological Study
Areas of landslide potential

**Camden Geological, Hydrogeological
and Hydrological Study**
Typical underpinning construction sequence

Job Name
73 - 75 AVENUE ROAD

Desk Study and Ground Investigation Report

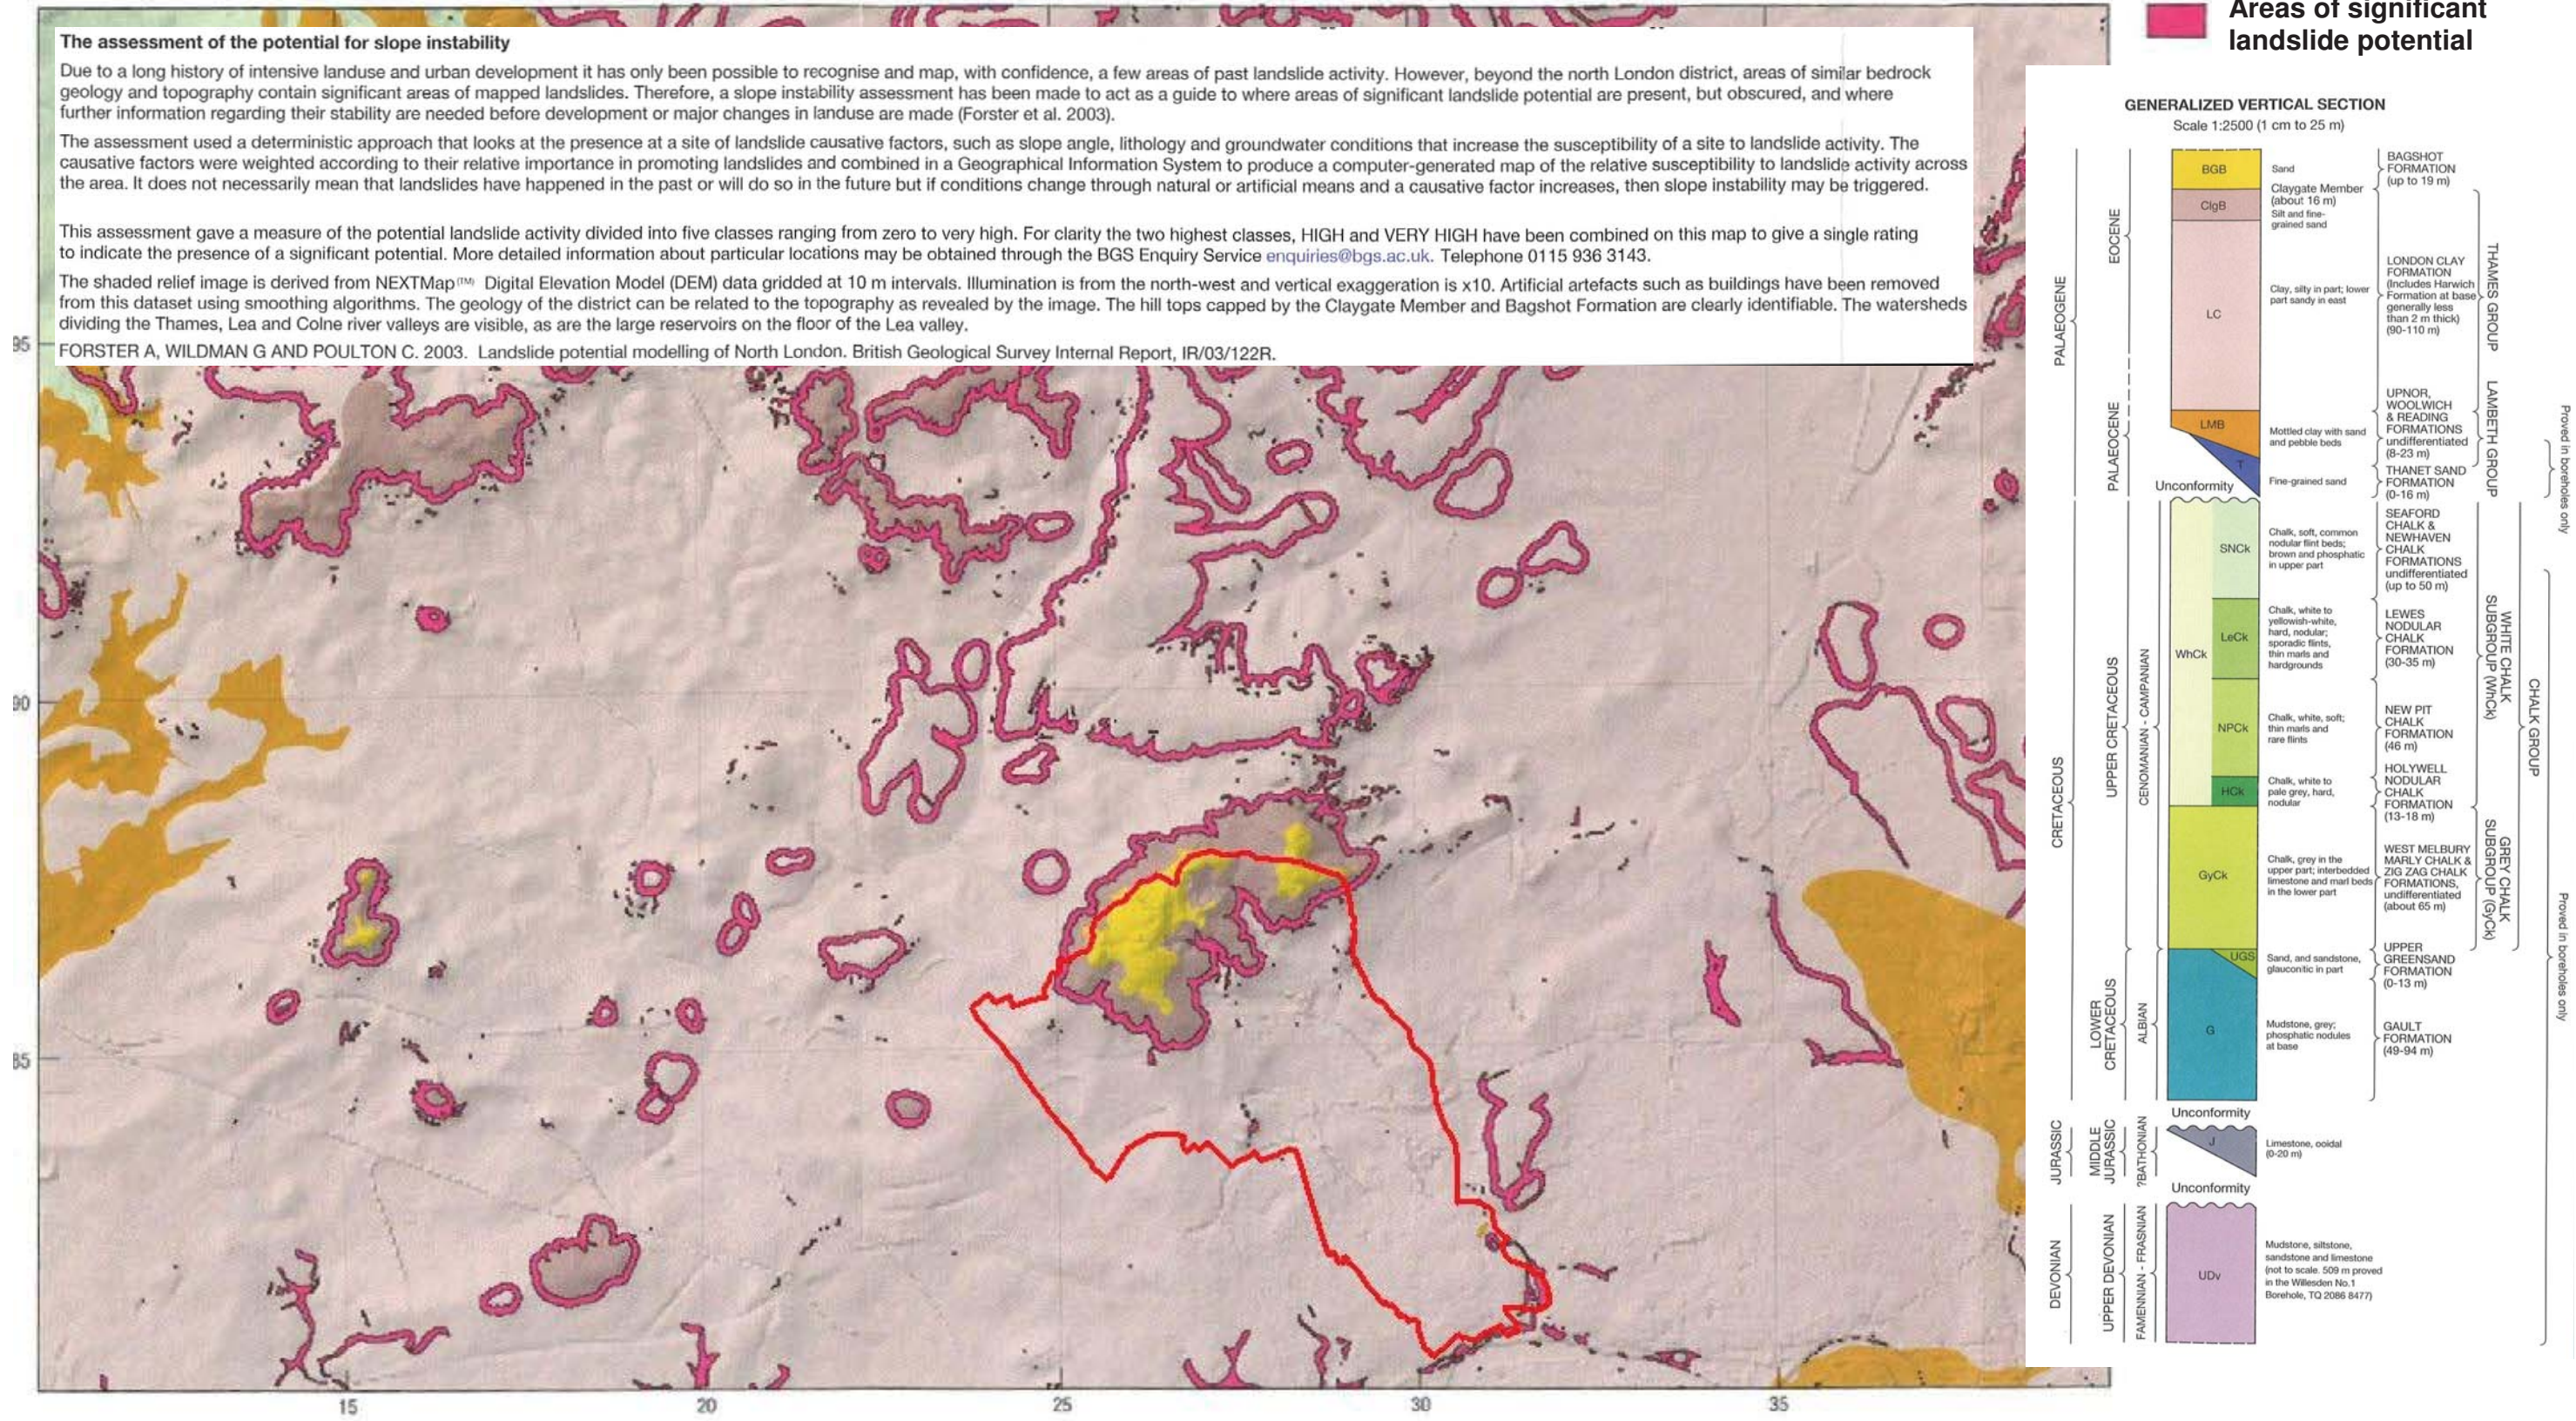
Areas of significant landslide potential

This assessment gave a measure of the potential landslide activity divided into five classes ranging from zero to very high. For clarity the two highest classes, HIGH and VERY HIGH have been combined on this map to give a single rating to indicate the presence of a significant potential. More detailed information about particular locations may be obtained through the BGS Enquiry Service enquiries@bgs.ac.uk. Telephone 0115 936 3143.

The shaded relief image is derived from NEXTMap™ Digital Elevation Model (DEM) data gridded at 10 m intervals. Illumination is from the north-west and vertical exaggeration is x10. Artificial artefacts such as buildings have been removed from this dataset using smoothing algorithms. The geology of the district can be related to the topography as revealed by the image. The hill tops capped by the Claygate Member and Bagshot Formation are clearly identifiable. The watersheds dividing the Thames, Lea and Colne river valleys are visible, as are the large reservoirs on the floor of the Lea valley.

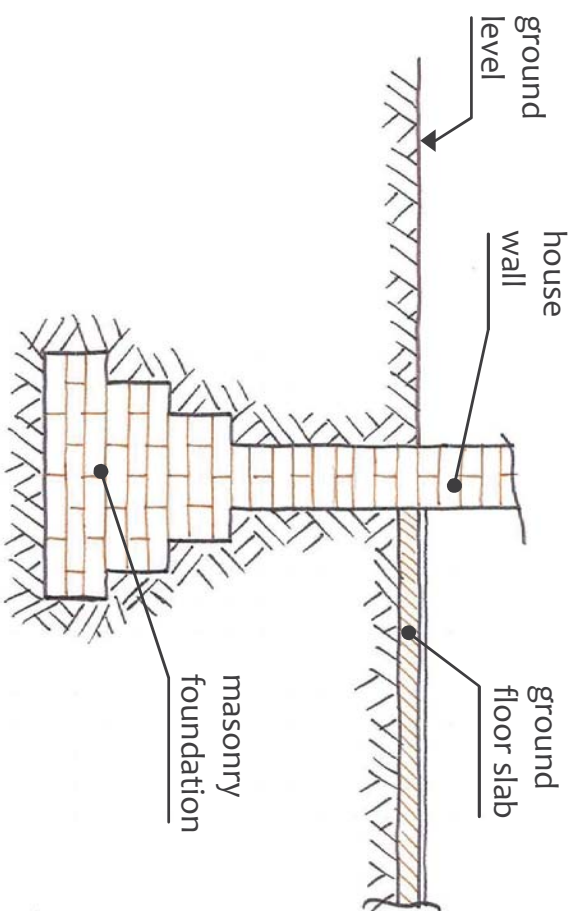
Stage 0: original foundation, typical of houses

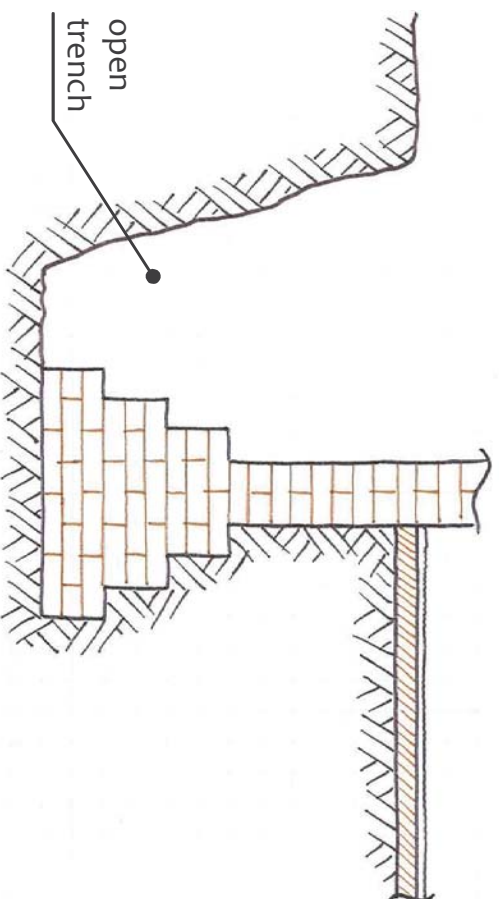
Stage 1: exposure of original foundation by digging a short trench along a section of the wall to be underpinned

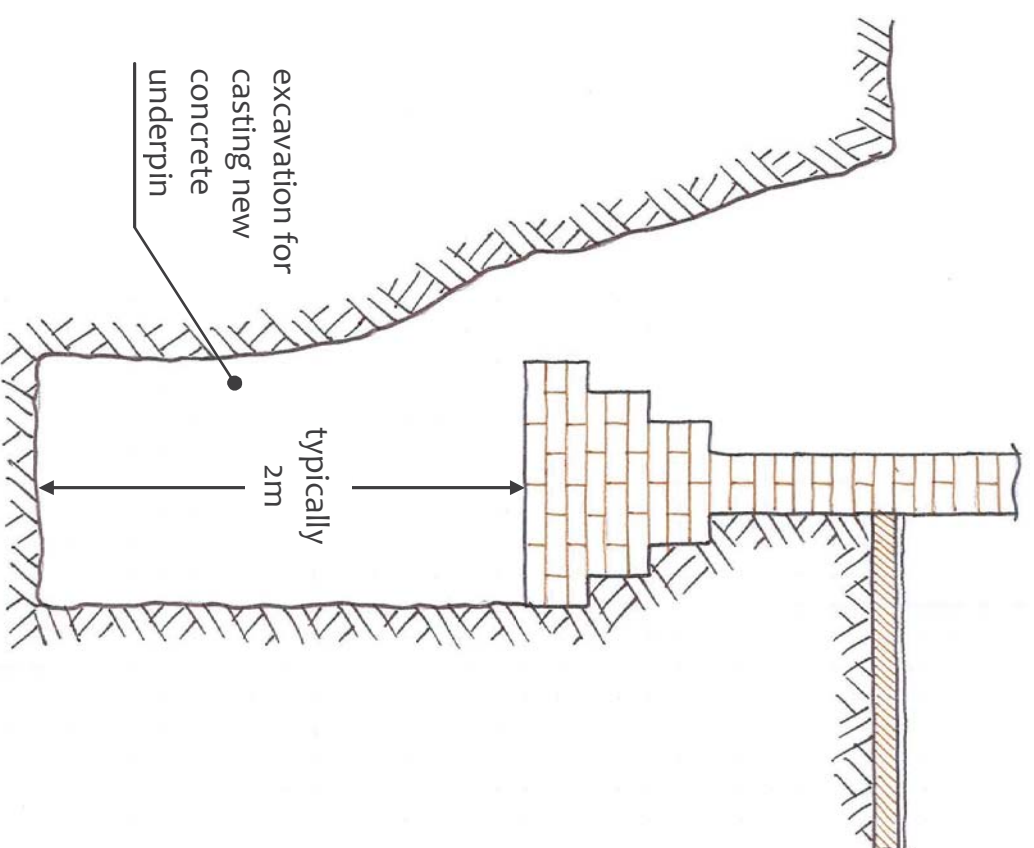
Stage 2: excavation of pit to form underpin: see Fig. 2.1b for details

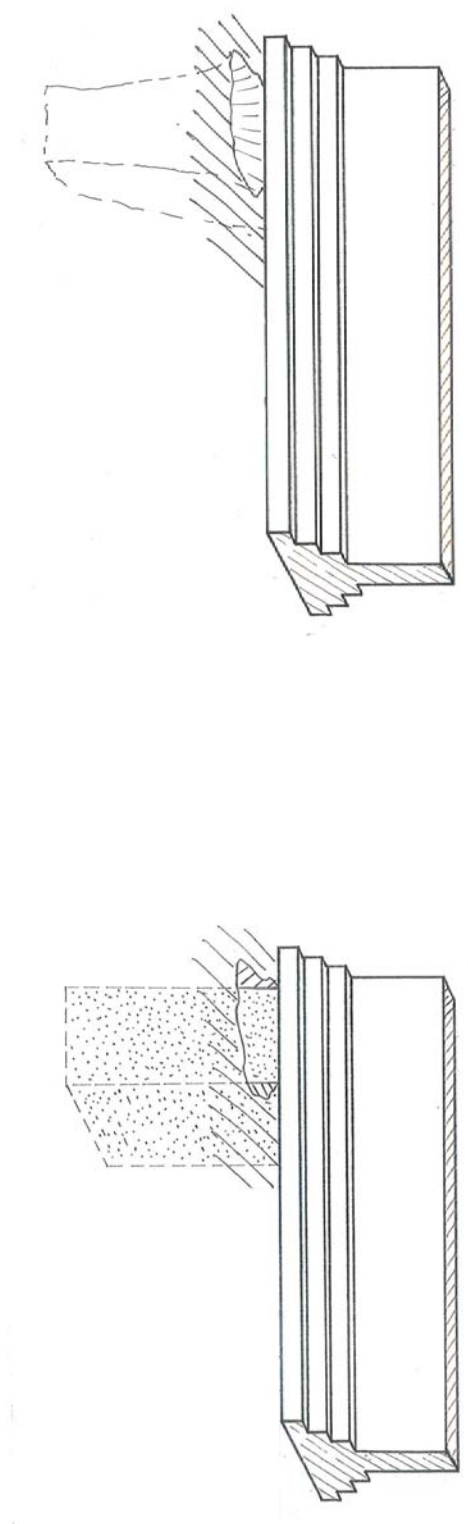
Stage 2a: excavation and concreting of initial section

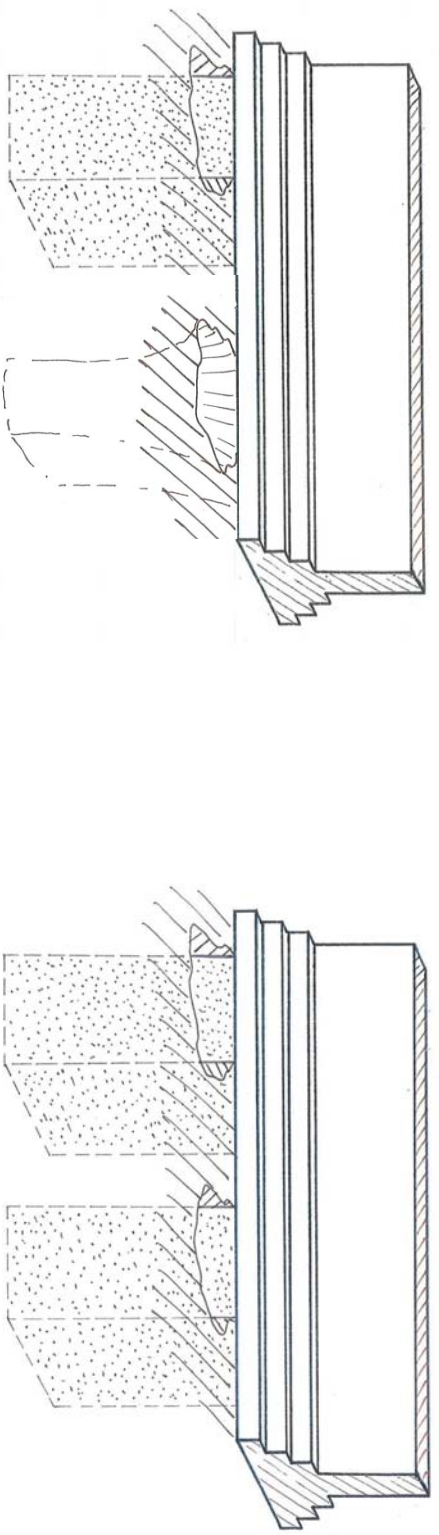
Stage 2b: excavation and concreting of another section, not adjacent to first one

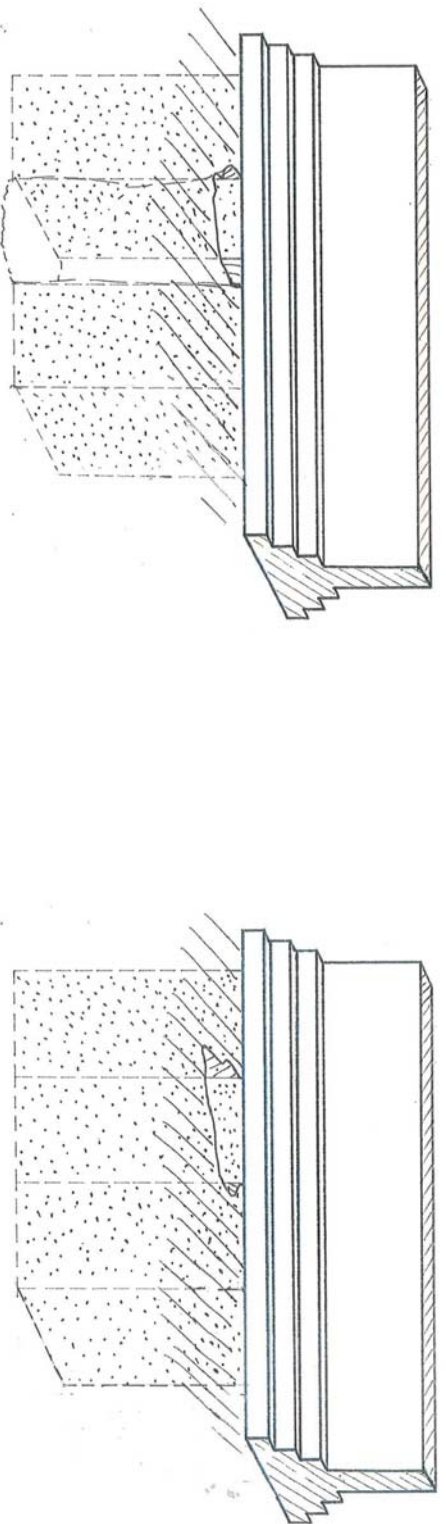
Stage 2c: excavation and concreting of an intermediate section, to form contiguous rows of underpin
