DESK STUDY & BASEMENT IMPACT ASSESSMENT REPORT

44 Gloucester Avenue
London
NW1 8JD

J14367

January 2015

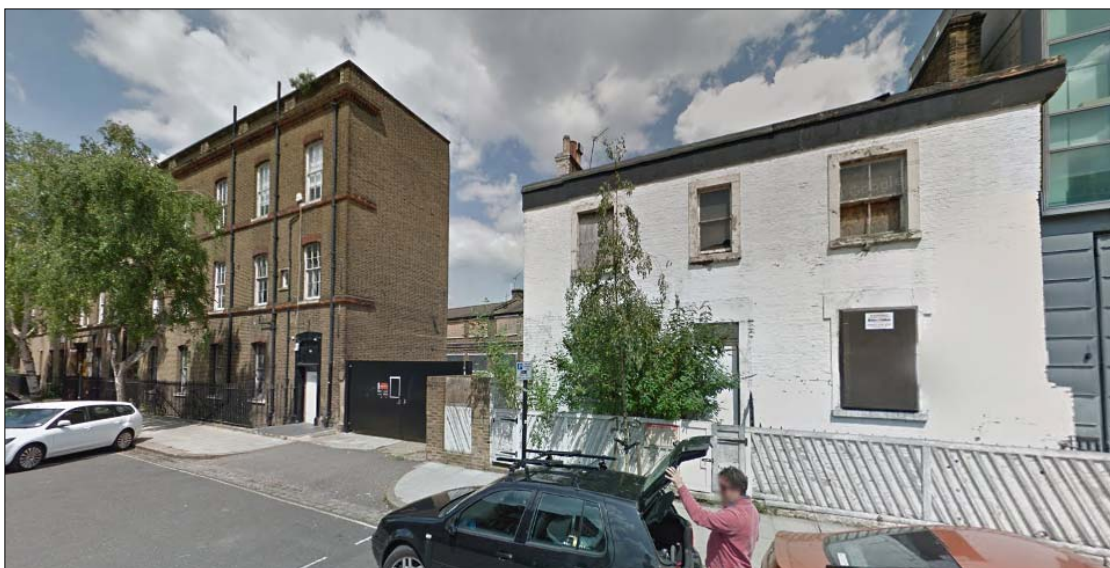
View of the front of the site from Gloucester Avenue, looking north.
