Arboricultural Impact Assessment

Tree Protection Plan

187 Kentish Town Road, London NW1.

**Proposals: 5 Storey Redevelopment of 187 Kentish
Town Road**

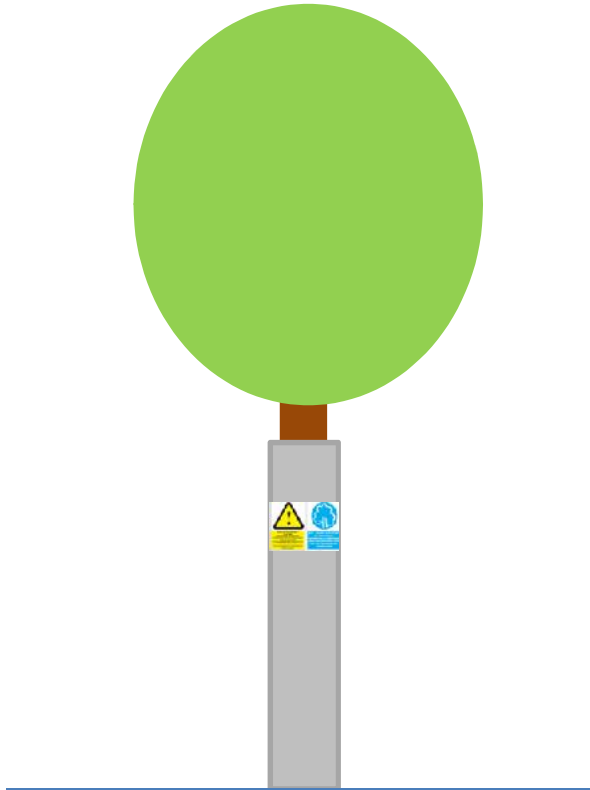
Tree protection will consist of a timber constructed box, to be positioned and braced in place around both of the trees. The box is not to be attached to any part of the tree at any point and should be at least 50mm away from the any part of the stem.

Tree Number	Proposed Works	Reason
T1 and T2	Construct temporary timber box around clear section of stem of each tree. Construction techniques must be non-evasive to the tree. Attach sign similar to that in Appendix D.	To avoid mechanical or physical damage to lower tree parts during nearby construction activity
	Following removal of the scaffolding and completion of project the trees are to be Inspected by an Arboricultural Consultant.	<ol style="list-style-type: none">1. To assess any potentially damaged branches which may require reactive pruning works.2. To assess the general appearance of the trees and consider any further work which may be necessary, such as washing down foliage from dust.3. To assess any alterations within the

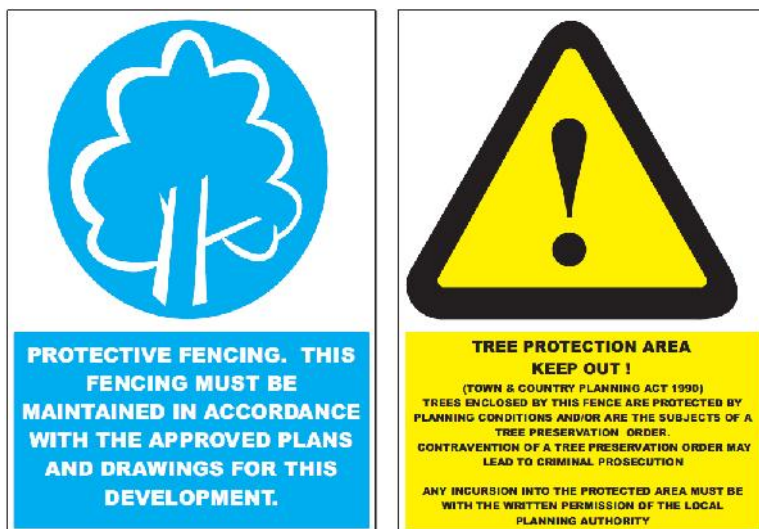
A sign, similar to that shown below will be firmly attached to the outside of the timber box around each tree.

- The CEZ will be clearly identified (see construction exclusion zone sign example, below)
