British Thoracic Society, 17 Doughty Street

HERITAGE IMPACT ASSESSMENT

Issue 1
June 2015

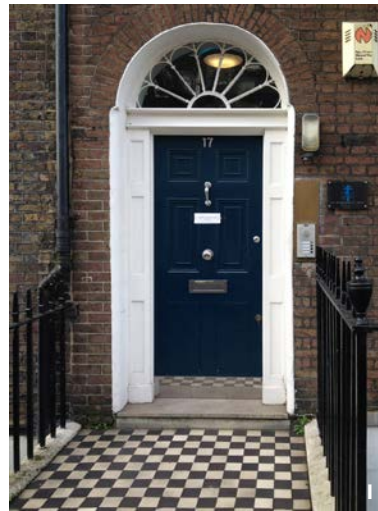
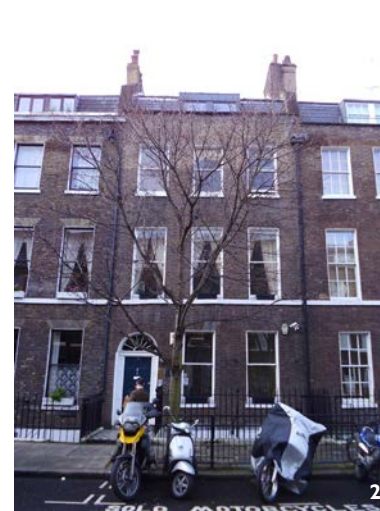
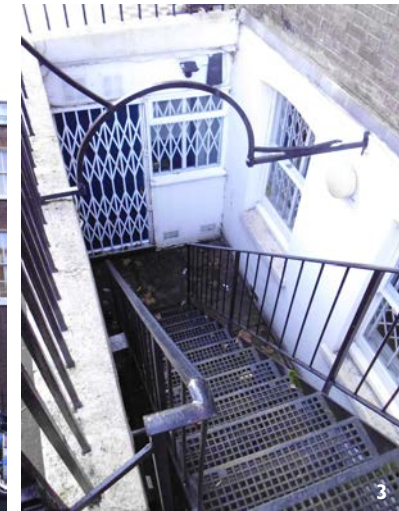
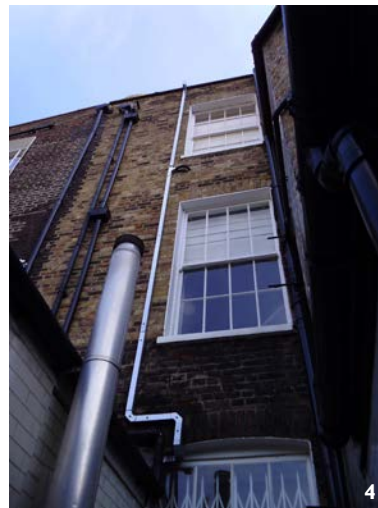
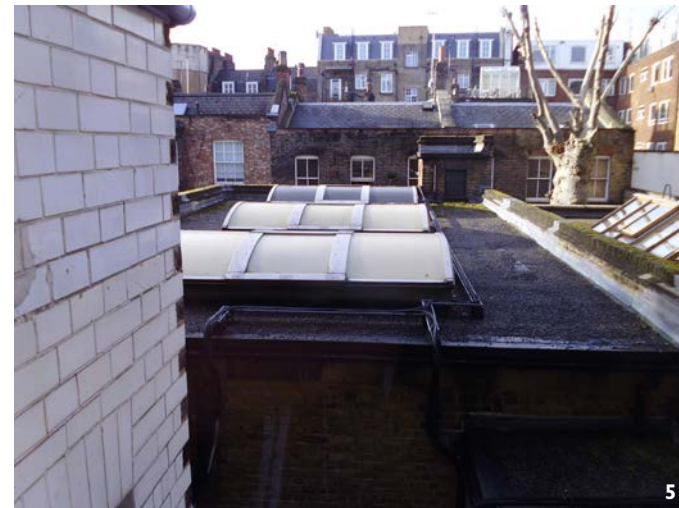
- 1 A detail of the entrance door, with sunburst-light fanlight above
- 2 No. 17 Doughty Street, viewed from the east
- 3 The basement, viewed from the street above
- 4 A view of the western (rear) elevation
- 5 The roof of the 1930s western extension

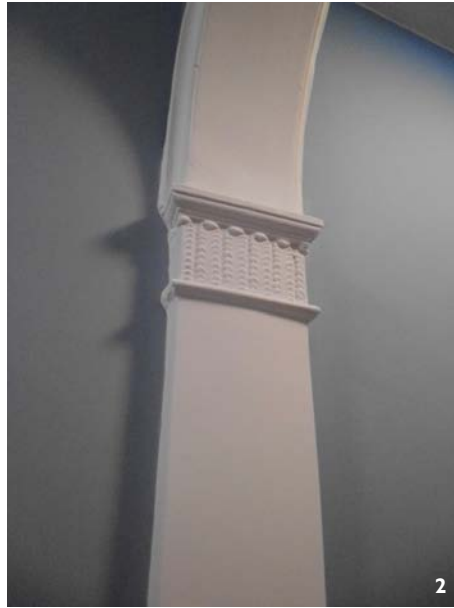
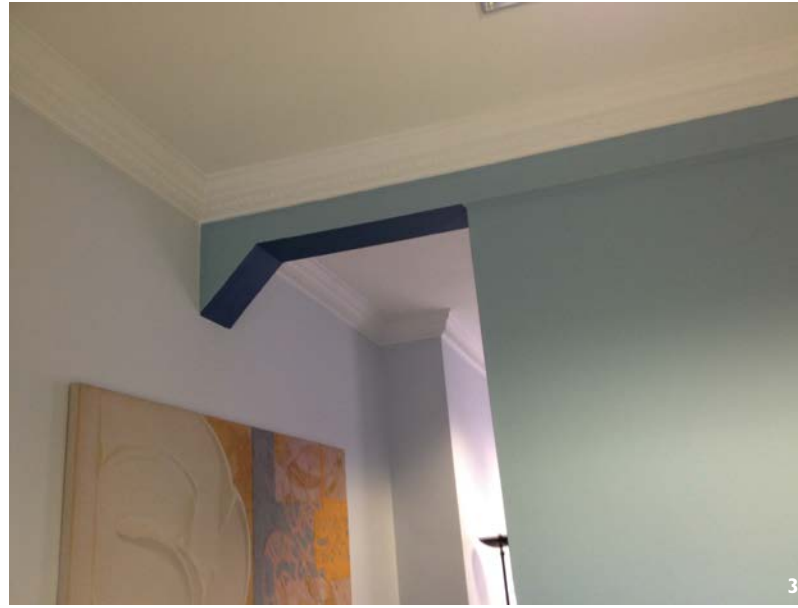
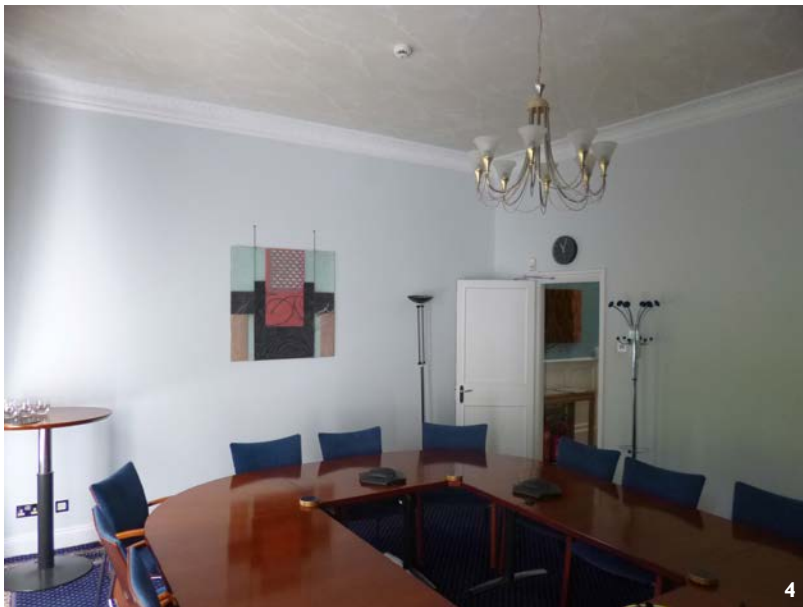
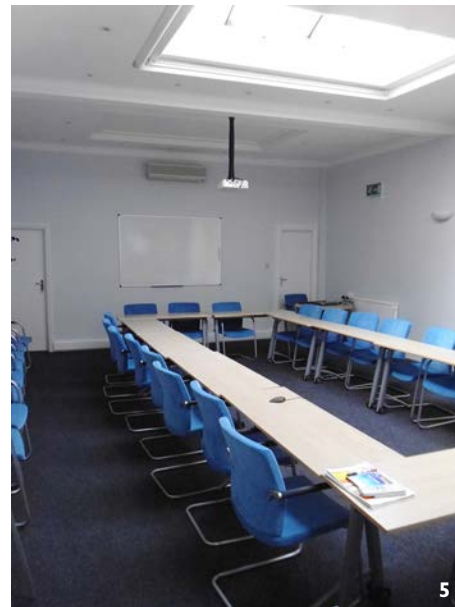
- 1 The ground floor entrance hall, viewed from the stairs to the west
- 2 A detail of the entrance hall arch
- 3 A ground floor cornice detail
- 4 The first floor front room, with original cornice details
- 5 The heavily modernised interior of the 1930s extension

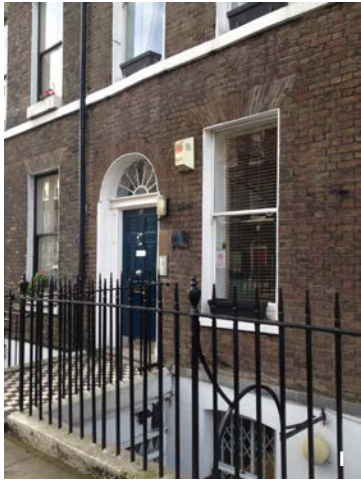
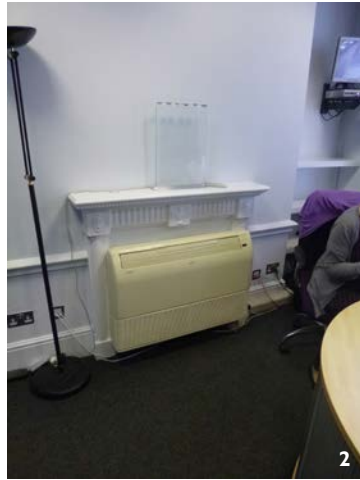
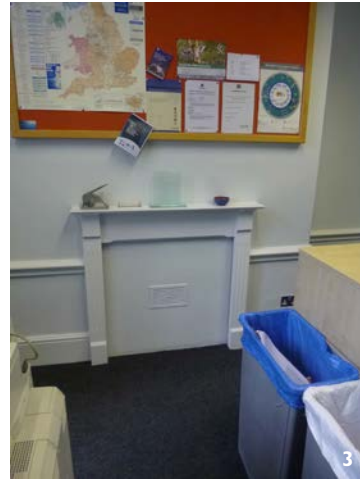
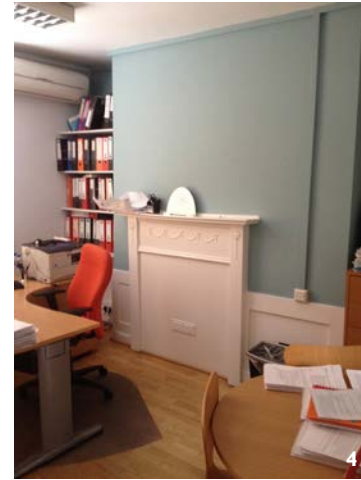
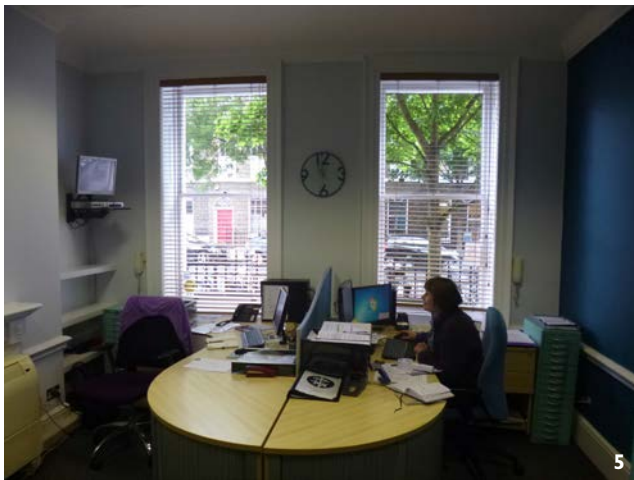
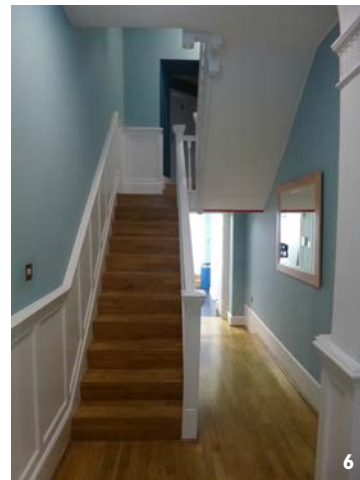
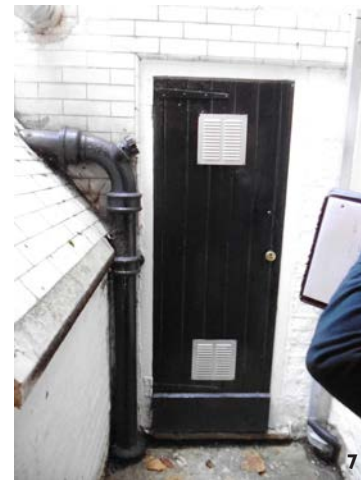
- 1 A view of the front elevation, standing today much as it was first completed in the 1790s
- 2 Detail of fireplace, ground floor east room
- 3 Detail of fireplace, ground floor west room
- 4 Detail of fireplace, second floor west room
- 5 A view of the ground floor east room, looking east
- 6 The staircase, which is primary although it has been heavily altered
- 7 An eighteenth-century plank and rail door on the ground floor, western external elevation

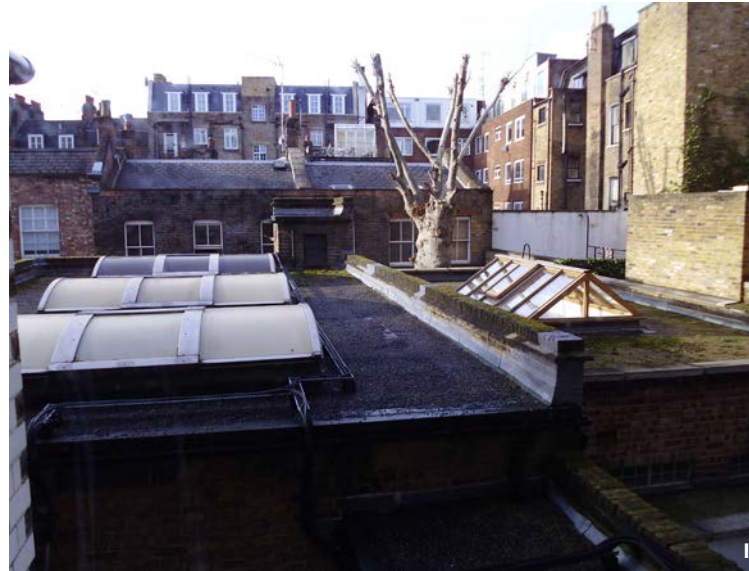
- 1 The roof of the 1930s range, which has been altered significantly in the later twentieth century
- 2 A view of the 1930s western external elevation, with white glazed tiling
- 3 The interior of the 1930s range, with a later twentieth-century decorative scheme

This work was executed in a contemporary 1930s style, including the insertion of Crittall windows for example, by an architect called Laurence King, possibly the architect of the same name noted for his church architecture. These 1930s plans also confirm that the current staircase is in its primary location, and that, broadly, the rooms throughout the primary two-cell eastern range are also in their primary arrangement.

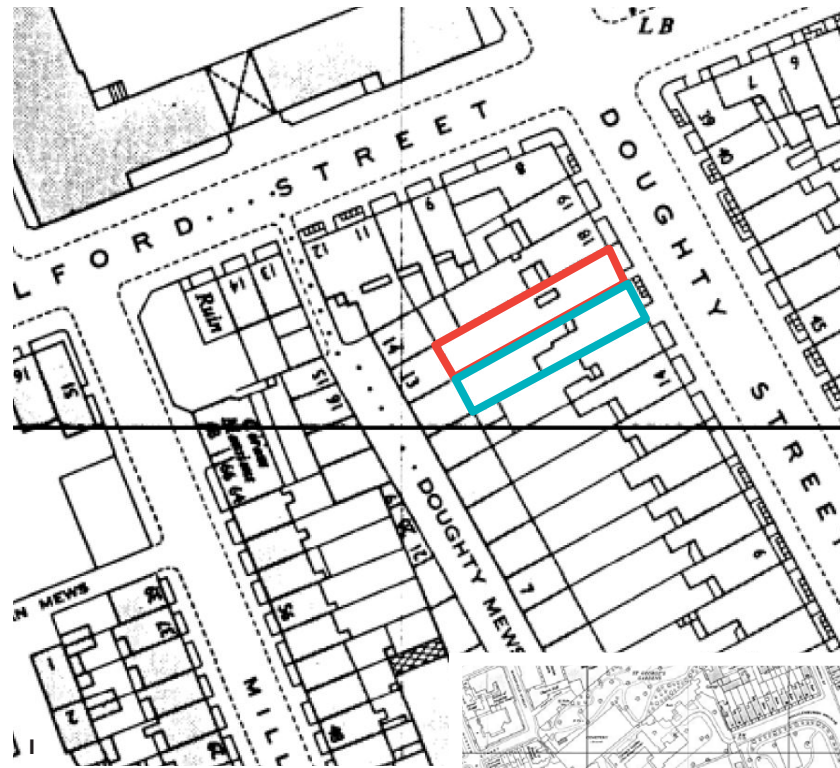
- 1 The extended site as it was first depicted in the 1952-53 OS map (with No.17 marked in red and No.16 marked in blue.)
- 2 The wider area as depicted in the 1952-53 OS map (with site marked in red)

The first OS map to show the 1930s western addition to the site also dates to the early 1950s. This clearly shows the altered relationship of No. 17 to the mews building at the western edge of the site. It also shows the site of the now-demolished Foundling Hospital, which was opened as Coram's Fields, a park exclusively for the use of children, in 1936.

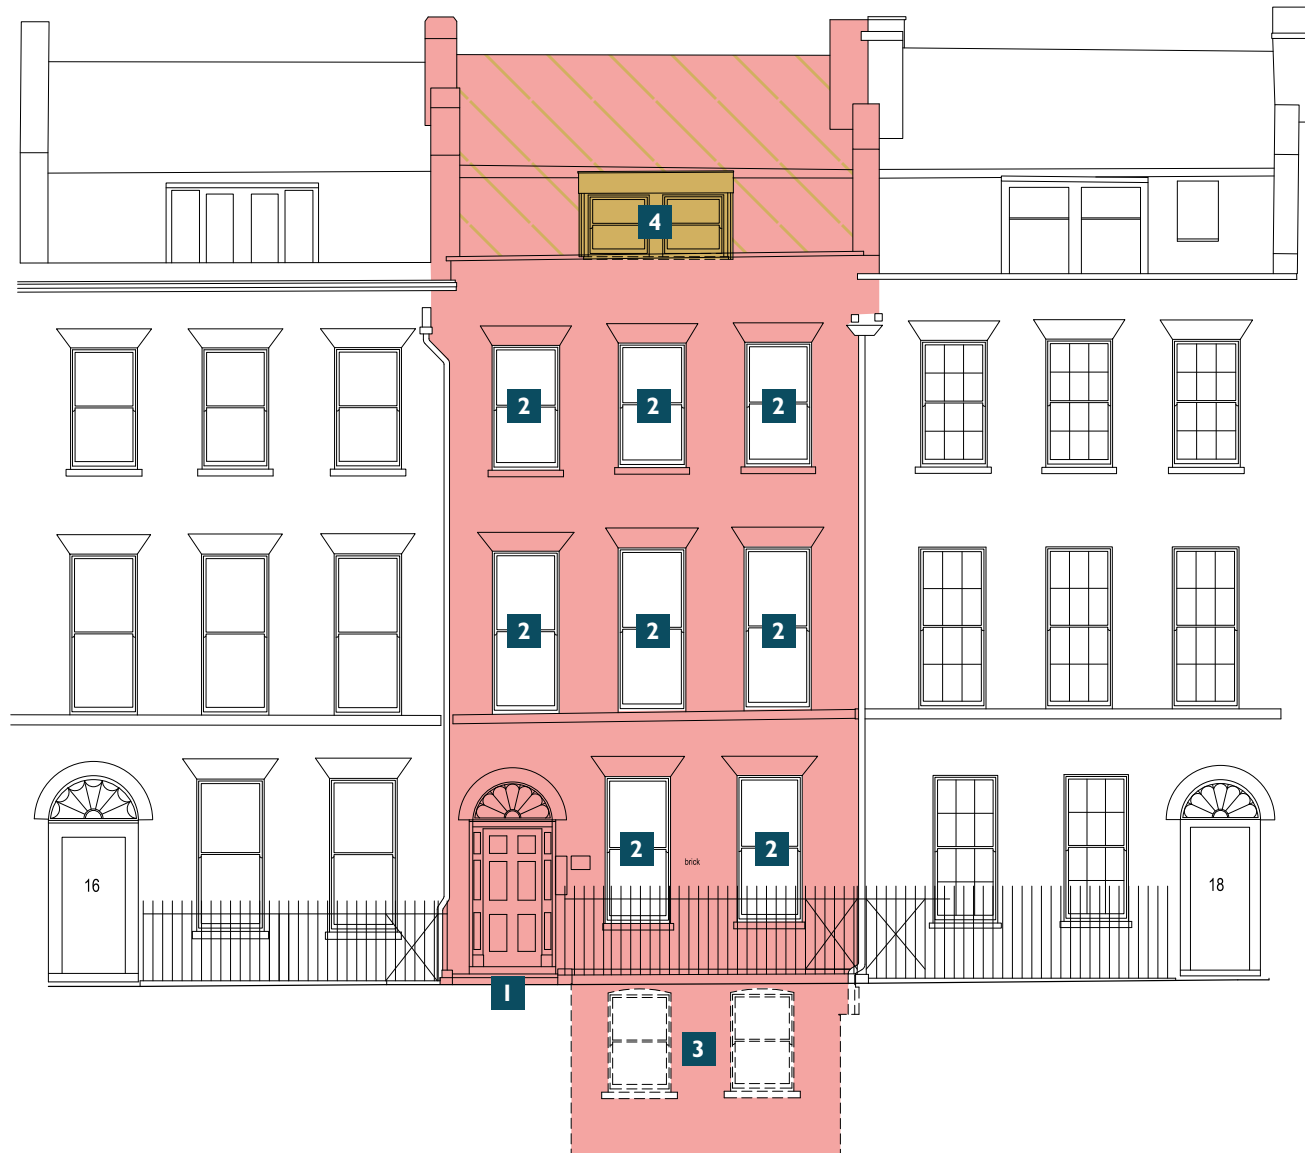
FRONT ELEVATION

- 1792
 - 1938
 - 1954
 - Later twentieth century (post 1971)
- 1** Post 1960s chequered tiles replacing historic surface treatment.
 - 2** All windows are modern timber replacements, in a late nineteenth century style.
 - 3** Basement area heavily treated with insensitive uPVC windows and metal security shuttering.
 - 4** Mansard roof and modern dormer window all late twentieth century in style, although mansard form appears to follow the historic roof style and may contain some historic fabric.
