# KNAPP HICKS & PARTNERS LTD

32027A/L/003/RJM  
26<sup>th</sup> June 2015

## **BASEMENT IMPACT ASSESSMENT – ADDENDUM 6 ANTRIM GROVE, NW3 4XR**

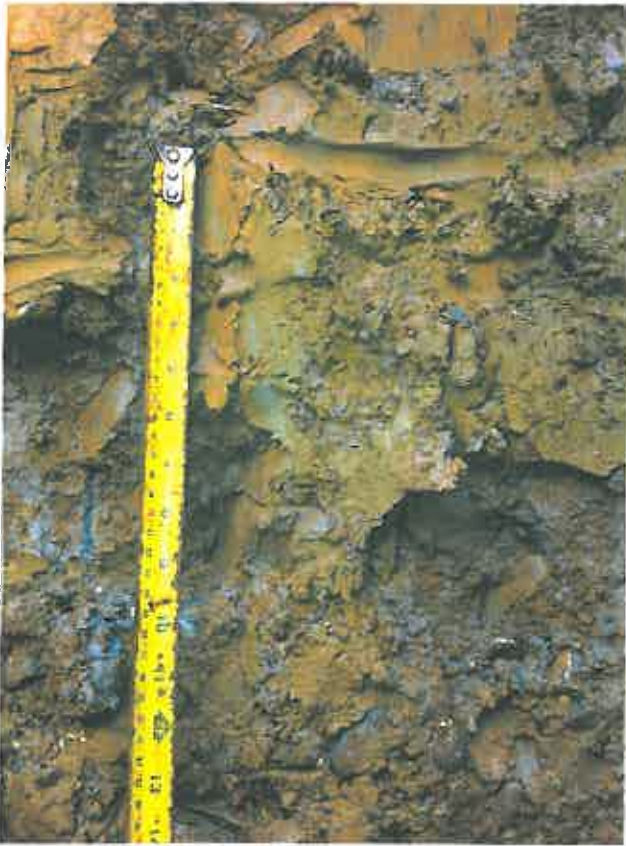
TP1(2015) 1.0m-1.2m Head Deposits (note occasional flint gravel and stable condition)

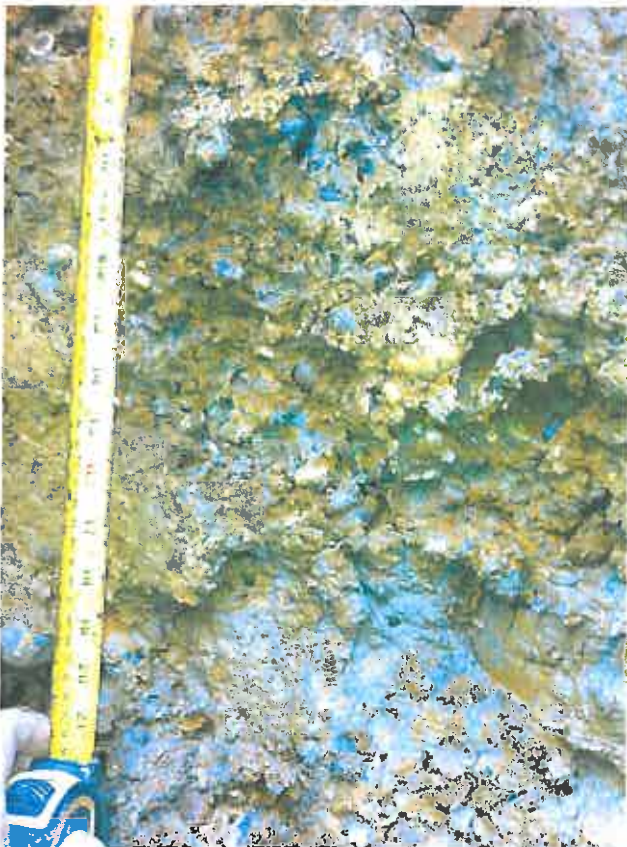
TP1(2015) – View of gravelly clay layer. Note dampness due to slow seepage.

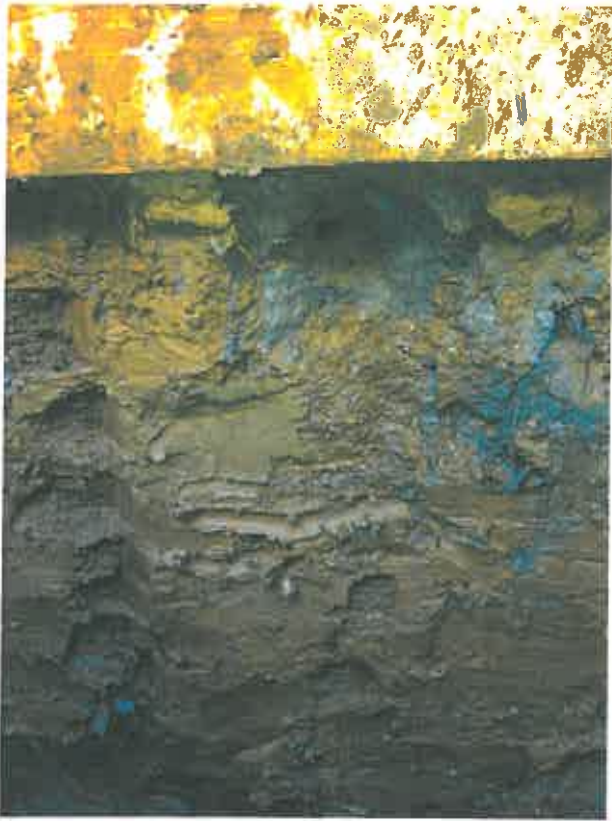
TP1(2015) – View of clay at approx. 3.0mbgl

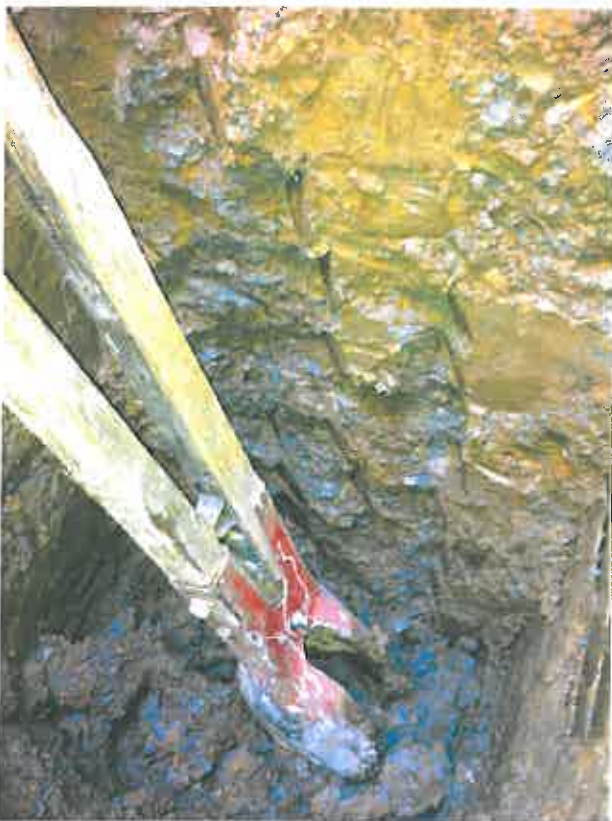
TP1(2015) View of clay at base of excavation

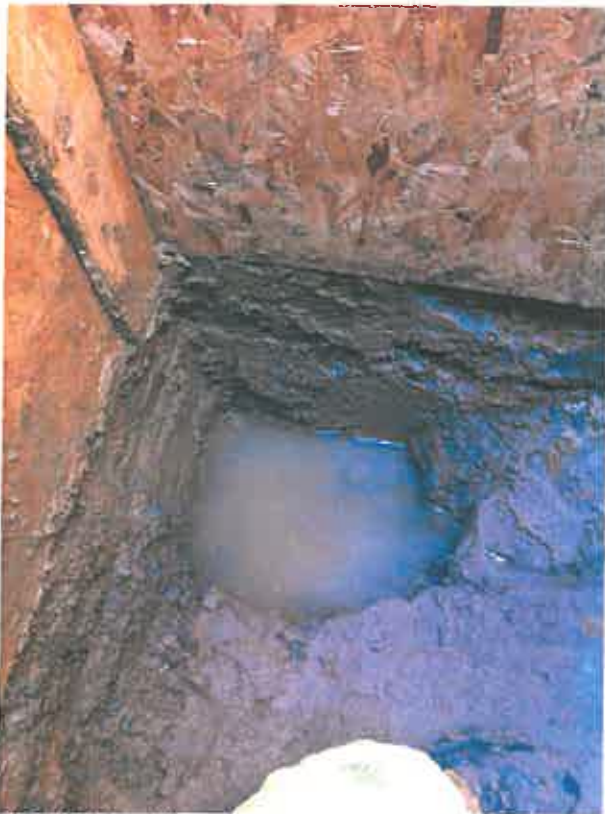
TP1(2015) – View of sump in base of pit. Typical quantity of water accumulated overnight.

Based on these observations, it is considered that groundwater inflows during construction excavation may reasonably be managed by sump pumping on condition that the rates of inflow, and the quantity of silt in the groundwater, are continuously monitored.

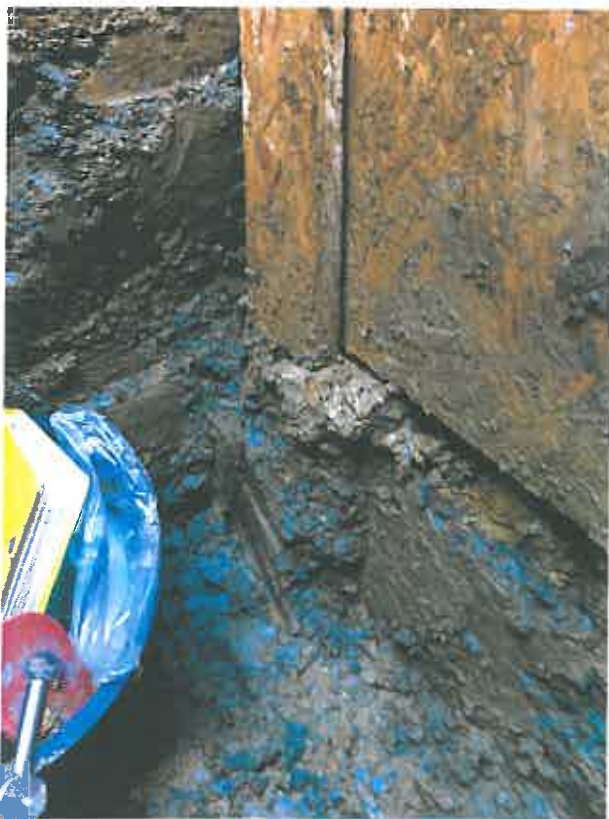
TP1(2015) – View of base of excavation.  
Note wet ground was as a result of heavy rainfall in addition to seepage.

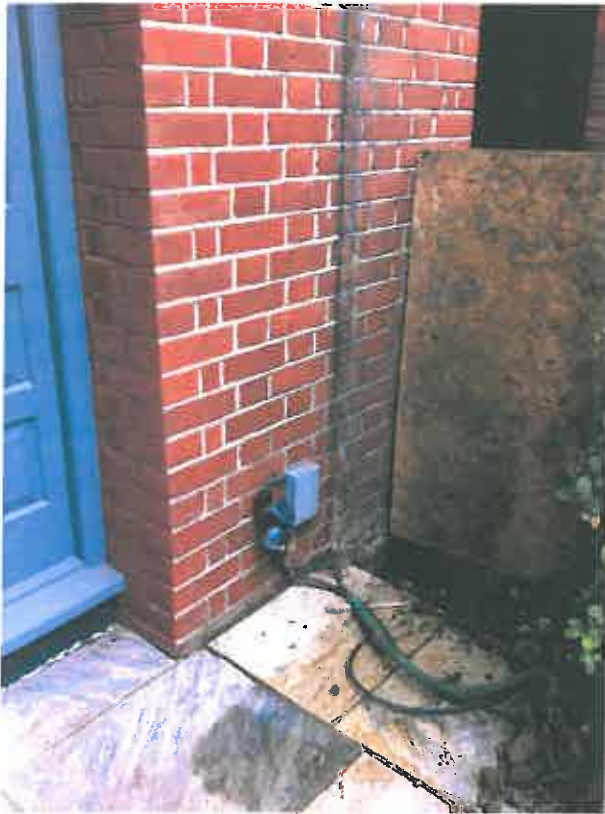
TP2(2015) – View of pit location at front door at boundary wall with No4

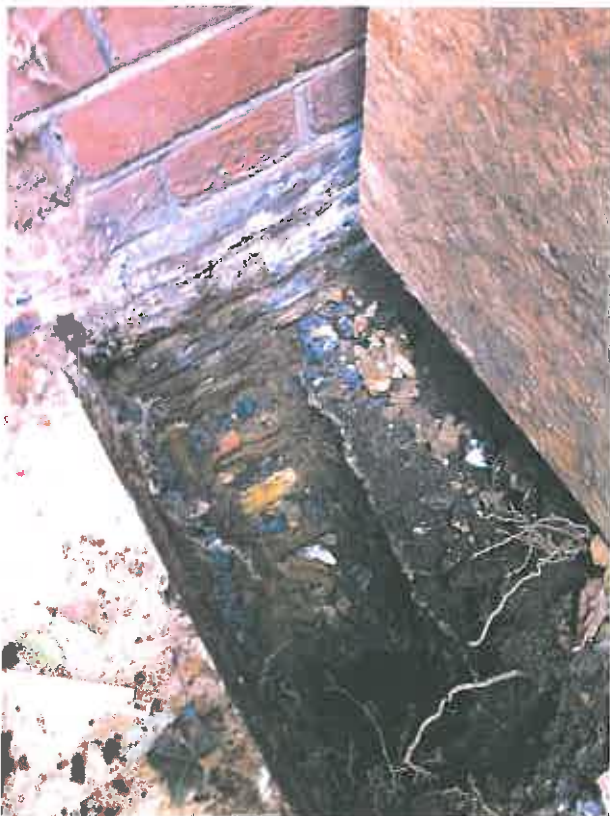
TP2(2015) – View into pit showing brick corbel and underlying rubble foundation

TP2 (2015) has confirmed the existing foundations as being a brick corbel constructed on a compacted clinker rubble footing. This is typical of the properties on Antrim Grove and compares closely with the foundations encountered at 8 Antrim Grove. The proposed method of construction described in the attached Basement Construction Plan (Appendix E) will ensure that any variation in the foundation details will be confirmed well in advance of any bulk excavation.

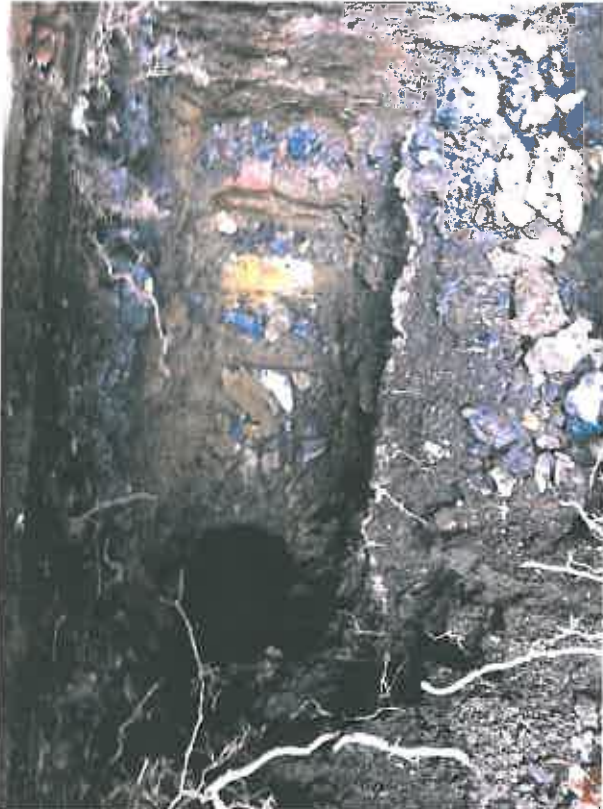
TP2(2015) – View of pit. Note hand augered extension below base of foundation.

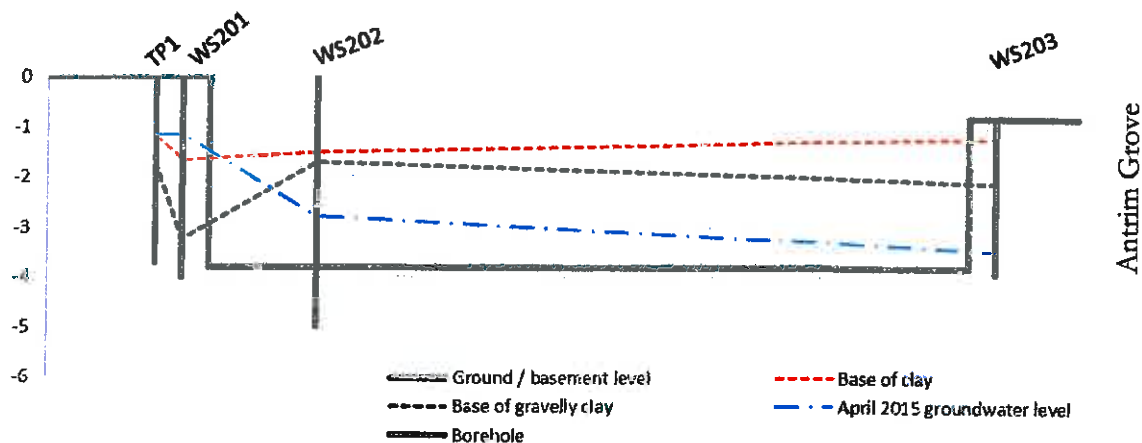
**Figure 3.3 Schematic north-west to south-east cross-section**

A schematic cross-section is presented as Figure 3.3, which shows the planned depth of the basement floor and slab, maximum observed groundwater levels and the lithological sequence observed. This drawing makes it clear that the likely reason that the water level in standpipes nearest Antrim Grove respond slowly to groundwater is that WS202 and WS203 have their tips in the clay, and WS201 has its tip in the (unusually deep) gravelly clay. TP1 may have a good vertical hydraulic connection because it has been backfilled with arisings rather than completed with, for example, a bentonite seal.

A south-eastward slope of the water table (i.e. with the topography) is expected (and is what is observed, though the borehole levels may not have reached equilibrium in April 2015). The water table most likely intersects a sewer or road drain somewhere down-gradient, where the groundwater discharges. (There is a sewer along Antrim Grove which may gain water if it is below the water table.) Flow in the low permeability head deposits is nevertheless likely to be rather low.

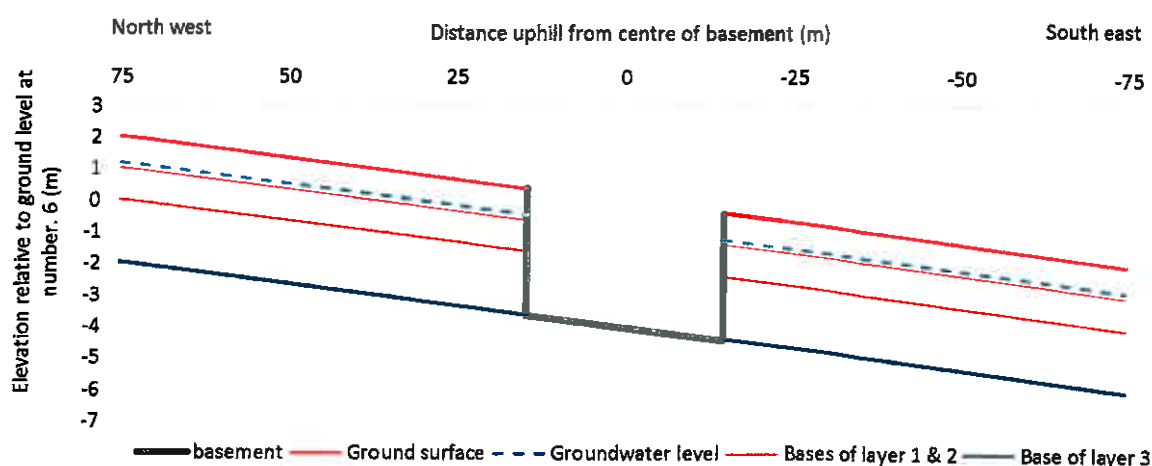
Figure 4.1 Section through the model (post-development)

A summary section through the centre of the model, from north west to south east, is shown in Figure 4.1.

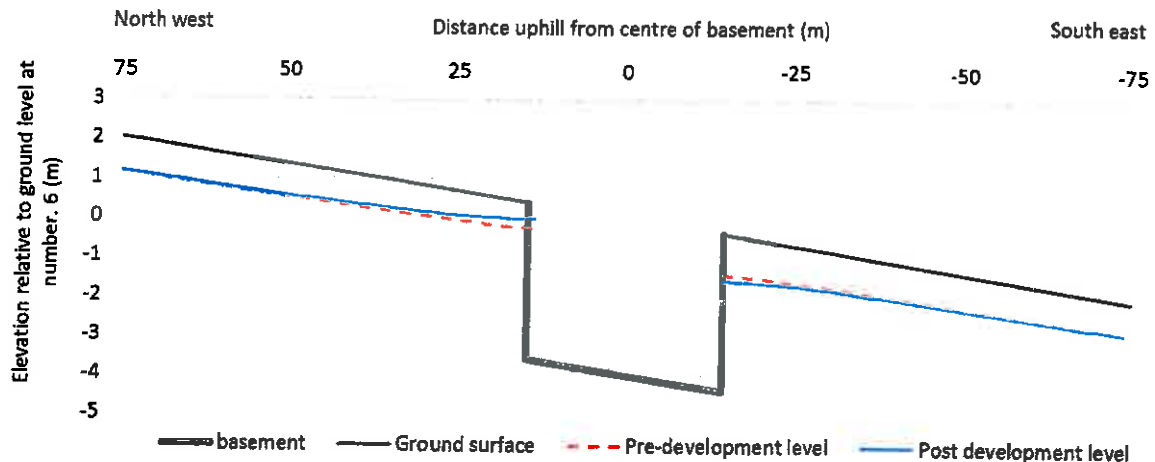
**Figure 4.5 Section showing expected groundwater levels before and after basement extension**

Given that the groundwater levels adjacent to the existing concrete-lined basements at numbers 8 and 10 are probably about 0.85 m below ground level a rise of only 0.25 m would not bring the water table to within a significantly closer distance of the ground surface. Modelled effects of basement construction on the water table are shown in detail in Figure 4.5, which is a section line through the centre of number 8.
