## SITE REPORT

Project:	41-42 Chester Terrace, London NW1
Date of Visit:	23 <sup>rd</sup> April 2015
Surveyor:	John Hoath
Client:	Sherlock Interiors
Reason for Visit:	Sample paint stripping
Inspection area:	South elevation pilaster capital and cornice
Weather:	Fine and Sunny

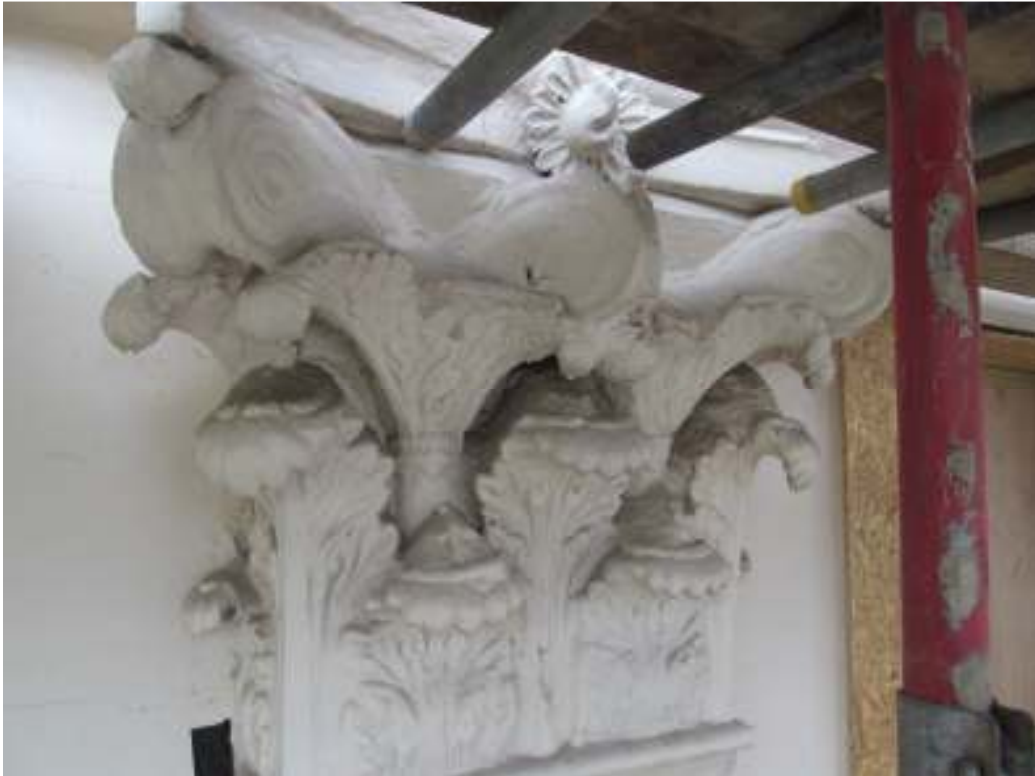
During the trials it was observed that there were a multitude of paint types built up in layers possibly from the original lime based colour wash. It was observed also that a variety of paint types and colours were evident. The latter layers appear to be oil or polymer based or masonry paint. None of which would be particularly breathable.

Bird preventative gel was also present on the upper surfaces of the Acanthus leaves of the capitals, this had been subsequently covered with a paint system, which has made this system ineffective.

**South Elevation Capital prior to application.**

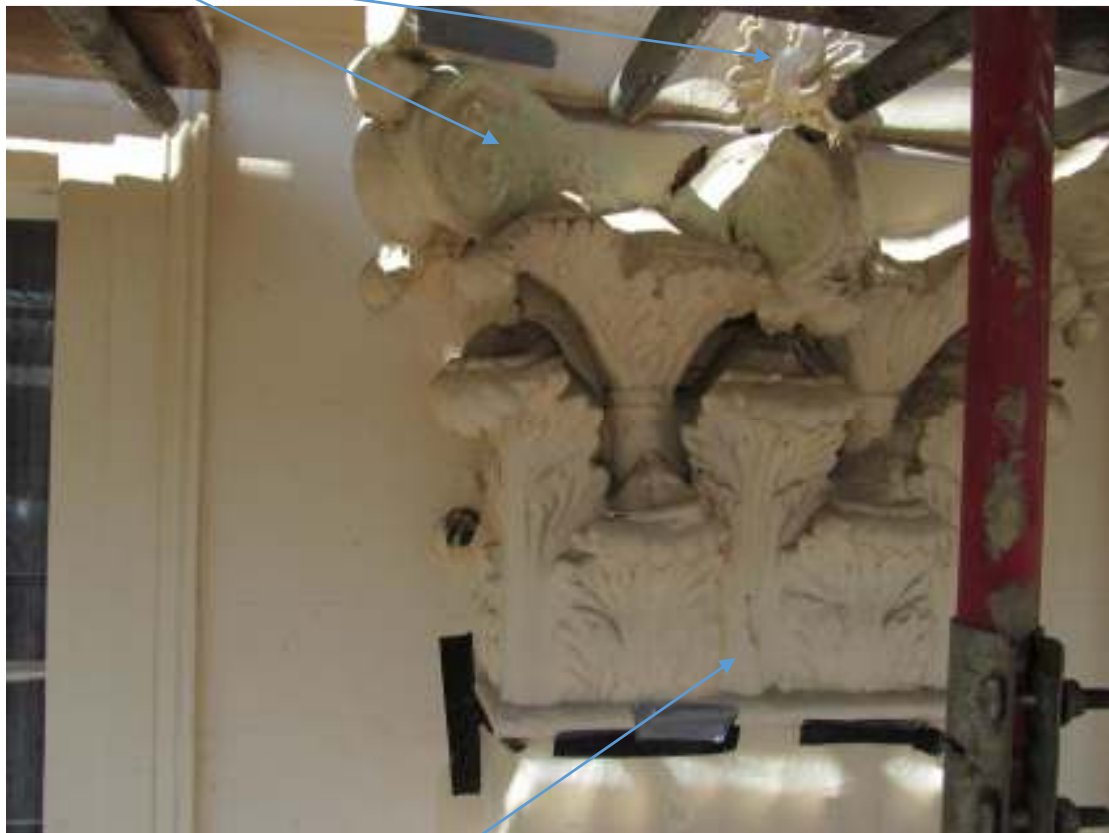
#### Sample 1

Sample	Area	Component	Product	Notes
1	Pilaster Capital	Volute/fleuron	Tavec 201	Little effect after dwell time
2	Pilaster Capital	Lower leaf	Kling Strip	No effect after dwell time
3	Pilaster Capital	R H side upper leaf	PS Acrylic	No effect at all
4	Pilaster Capital	RH side lower leaf	PS Poly/alkyd	Slight effect after dwell time
5	Soffit	Rosette	RNB 710	Moderate affect after dwell time
6	Soffit	8 <sup>th</sup> Modillion	PS Poly/alkyd	Extremely effective after dwell time
7	Soffit	7 <sup>th</sup> Modillion	Tavec 201	Little effect after dwell time
8	Soffit	6 <sup>th</sup> Modillion	Strippers 4F	Little effect after dwell time

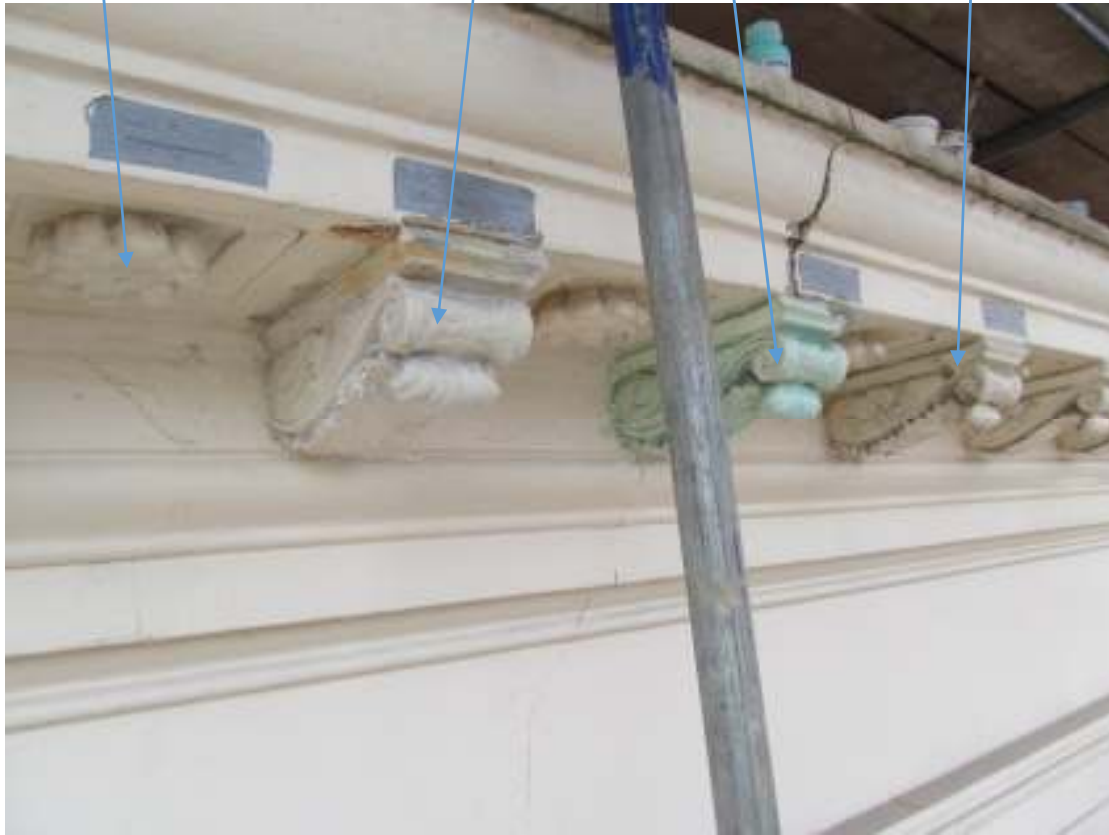
Application of chemical paint softeners

The products were applied to the various components with a brush and covered with polythene for 4 hours so as to prevent moisture escaping too quickly.

Following which a variety of implements such as spatulas were used to remove the softened paint where possible. This was followed by rinsing off with cold water pressure washing.

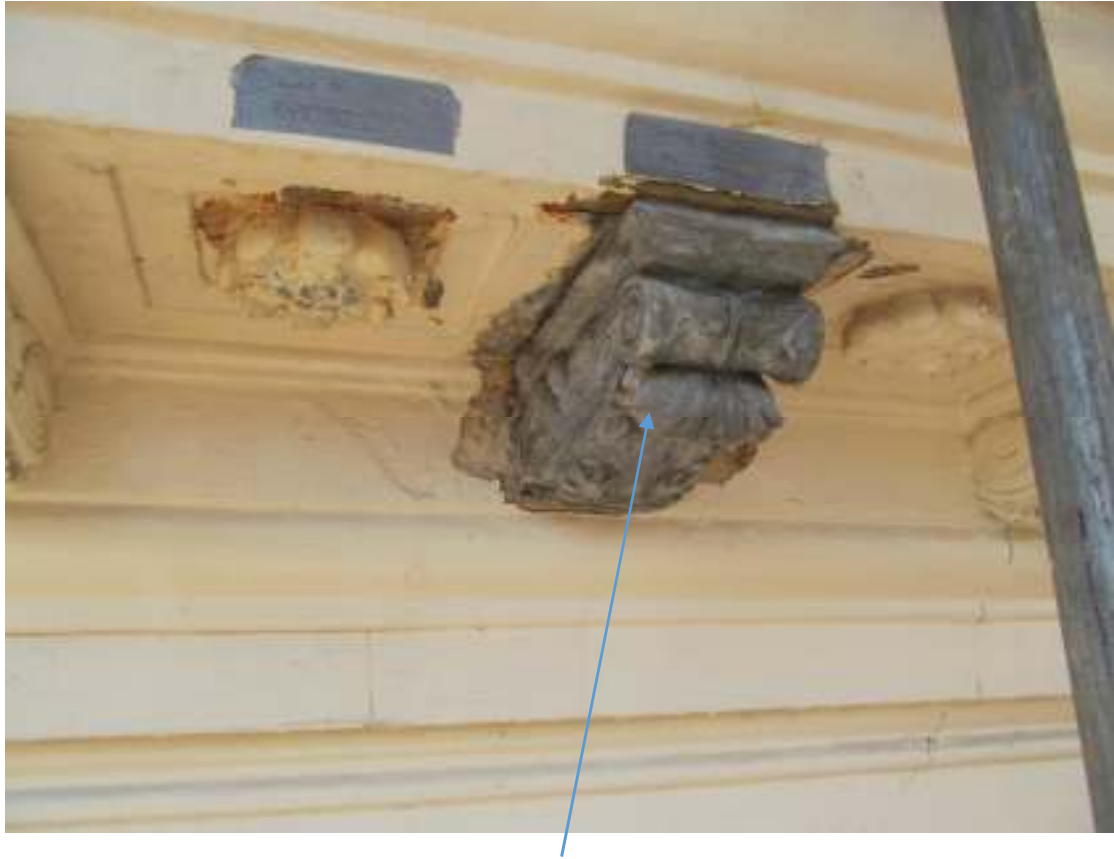
**Most effective trial result sample 6**

During this trial it was noted that the most effective paint stripping sample was carried out on the 8<sup>th</sup> Modillion bracket using PS Poly/Alkyd softener.

Most of the products used would be successful to a greater or lesser degree depending upon longer dwell times. The pigeon gel could be removed with the aid of super-heated water, (steam), the ease and effectiveness of the paint stripping products would also be enhanced by the use of steam.

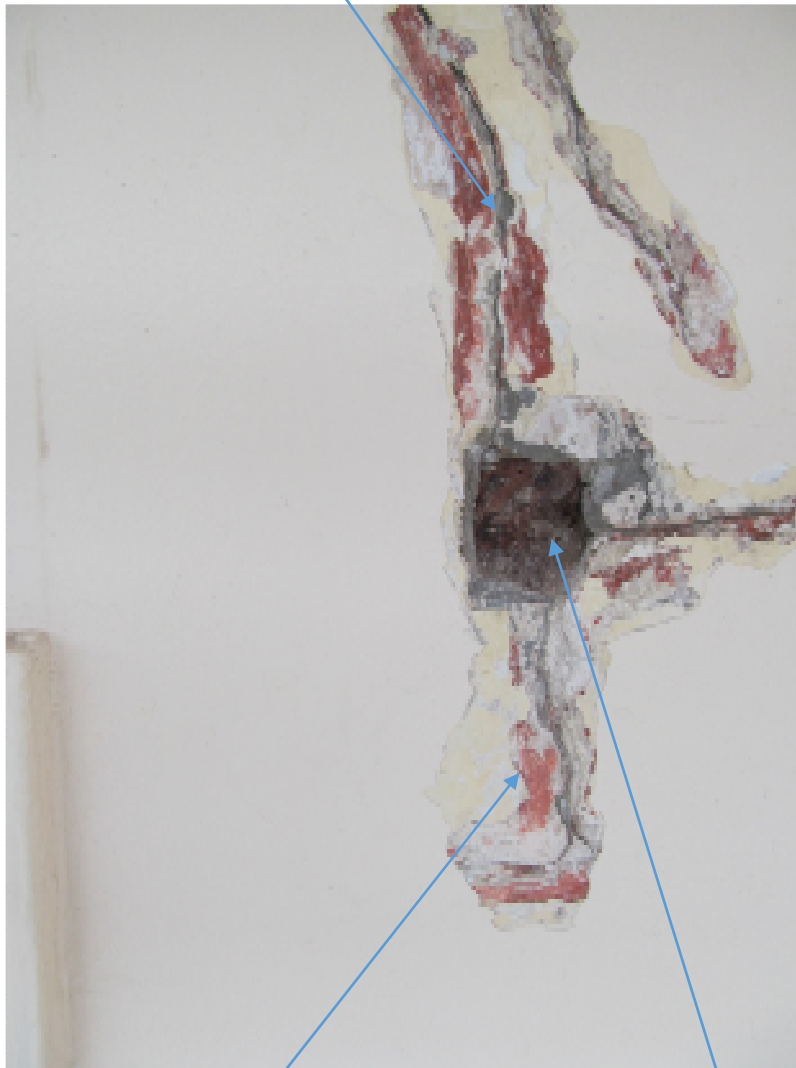
A sample of stucco render was taken from the upper storey on the south elevation, where loose and cracking was evident.

**Cracking which had been over filled with proprietary filler**

**Evidence of previous paint colours**

**Sample of loose render removed for analysis**

This is to be sent for analysis for the future repairs.
