## APPENDIX 1: AERIAL PHOTOGRAPHY

### **APPENDIX 2 - PLANS**

# Vicar's Road Tree Planting Bacton Low Rise - DHO Site

Produced for Rydon Construction Ltd January 2015

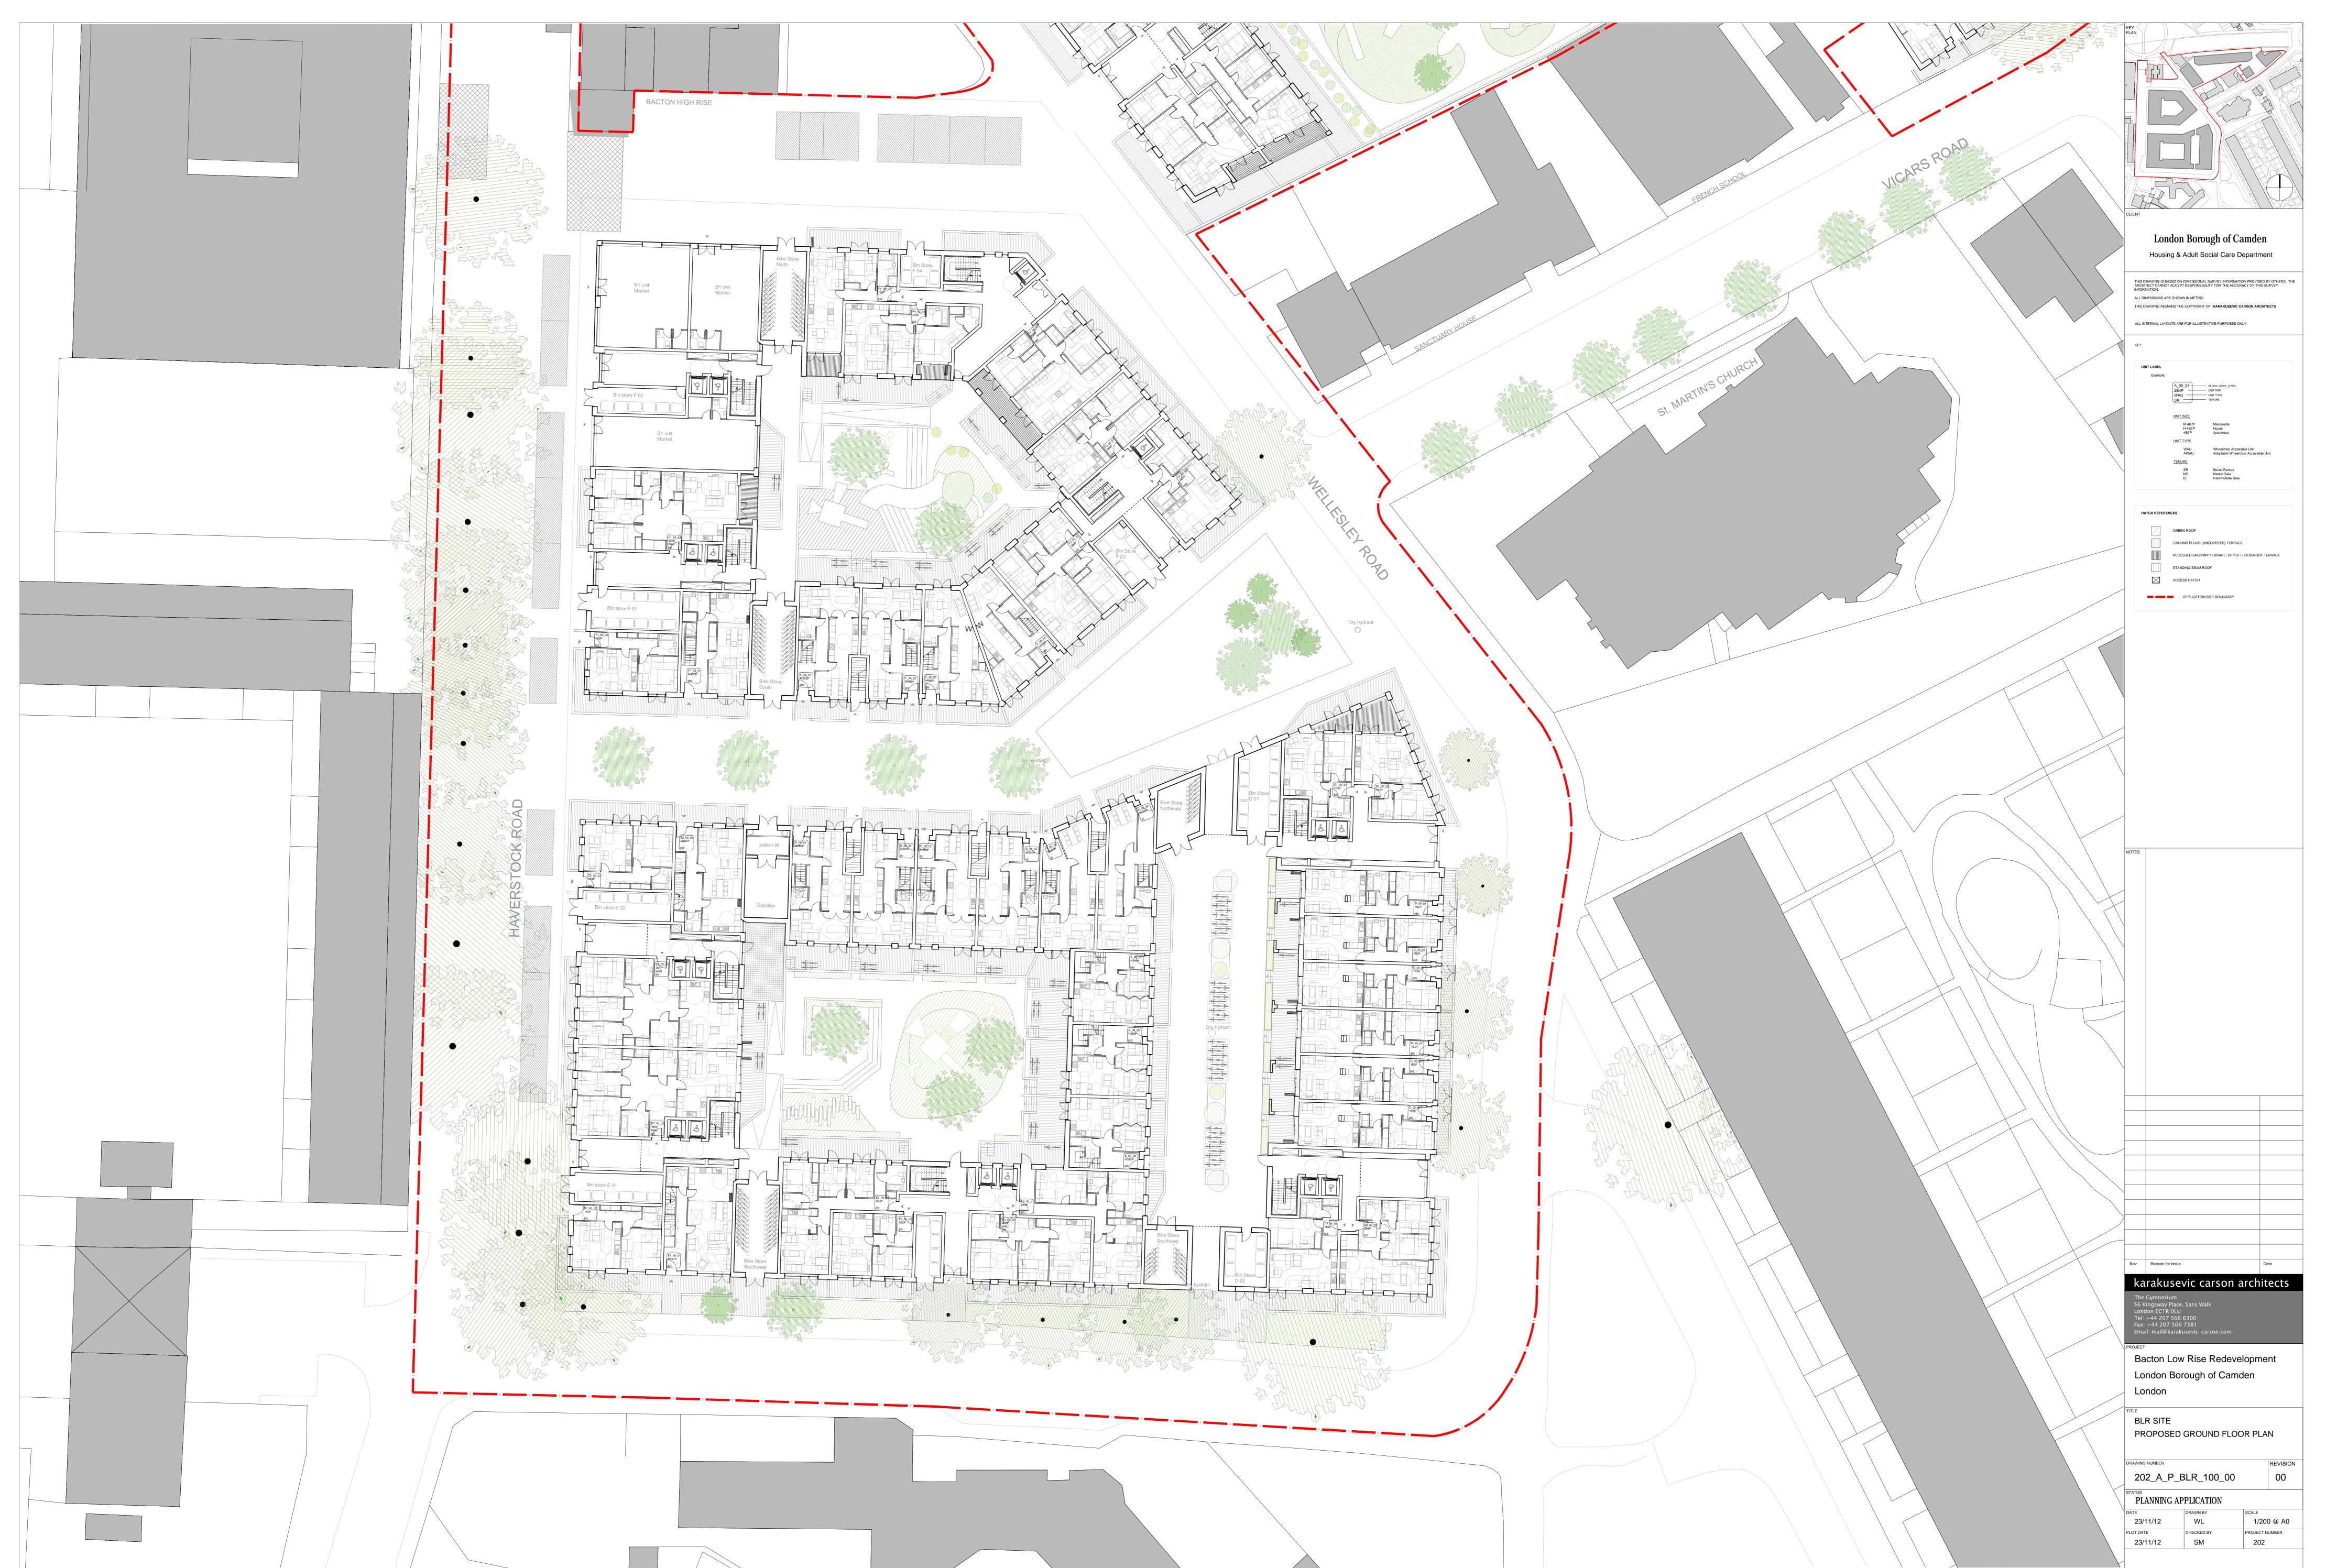
job			drawn:	date:
BACT	ON LOW RIS	GW	09/13	
drawir			scale:	job no:
GENE SITE I DHO S		1/200 @ A0 1/400@ A2	1952	
exceeds t	imensions to be cheche quantities in any ched. for all other purposes, this drawing is	drawing no. GA-SP-L00	rev. as below	
revisio	ons			
rev.	date	description	issued by	checked by
P1	25.09.13	Issued for comment/approval	GW	MS
P2	31.01.14	External Works added	GW	RR
P3	21.02.14	Building Control Issue	GW	RR
P4	17.04.14	20 VR boundary line updated	GB	RR

Preferred external rain water pipes shown Preferred expansion joint locations based on Ancon mark-ups dated 02.06.14 Fall arrest layout based on Walksafe by Latchways dated 07.05.13: Project reference number 4782-06 Rev A Door reference numbers as per SC-IO to follow Door x-x measures 300mm clear on pull side of door Indicative service riser dimensions (details to be provided) by M&E engineer)

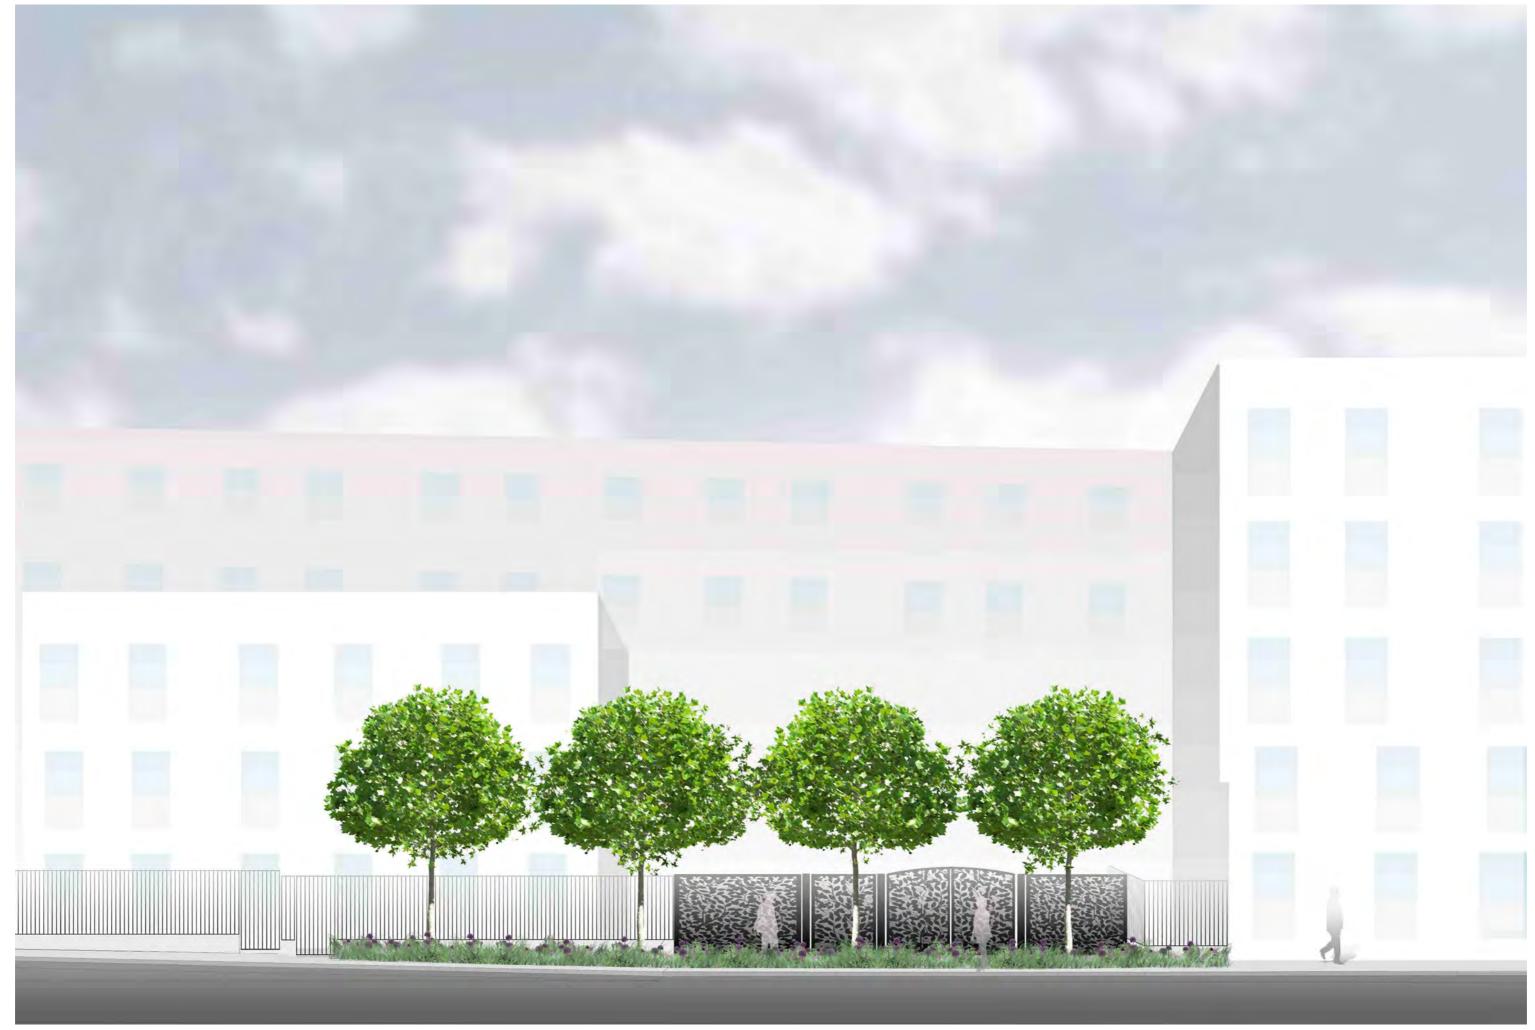
Visual showing replacement Platanus x hispanica (London plane) trees with proposed ornamental entrance gates. Trees are under planted with ornamental grasses and herbaceous planting

Under planting includes low maintenance evergreen ornamental grasses with pockets of herbaceous and bulb planting for seasonal colour and interest

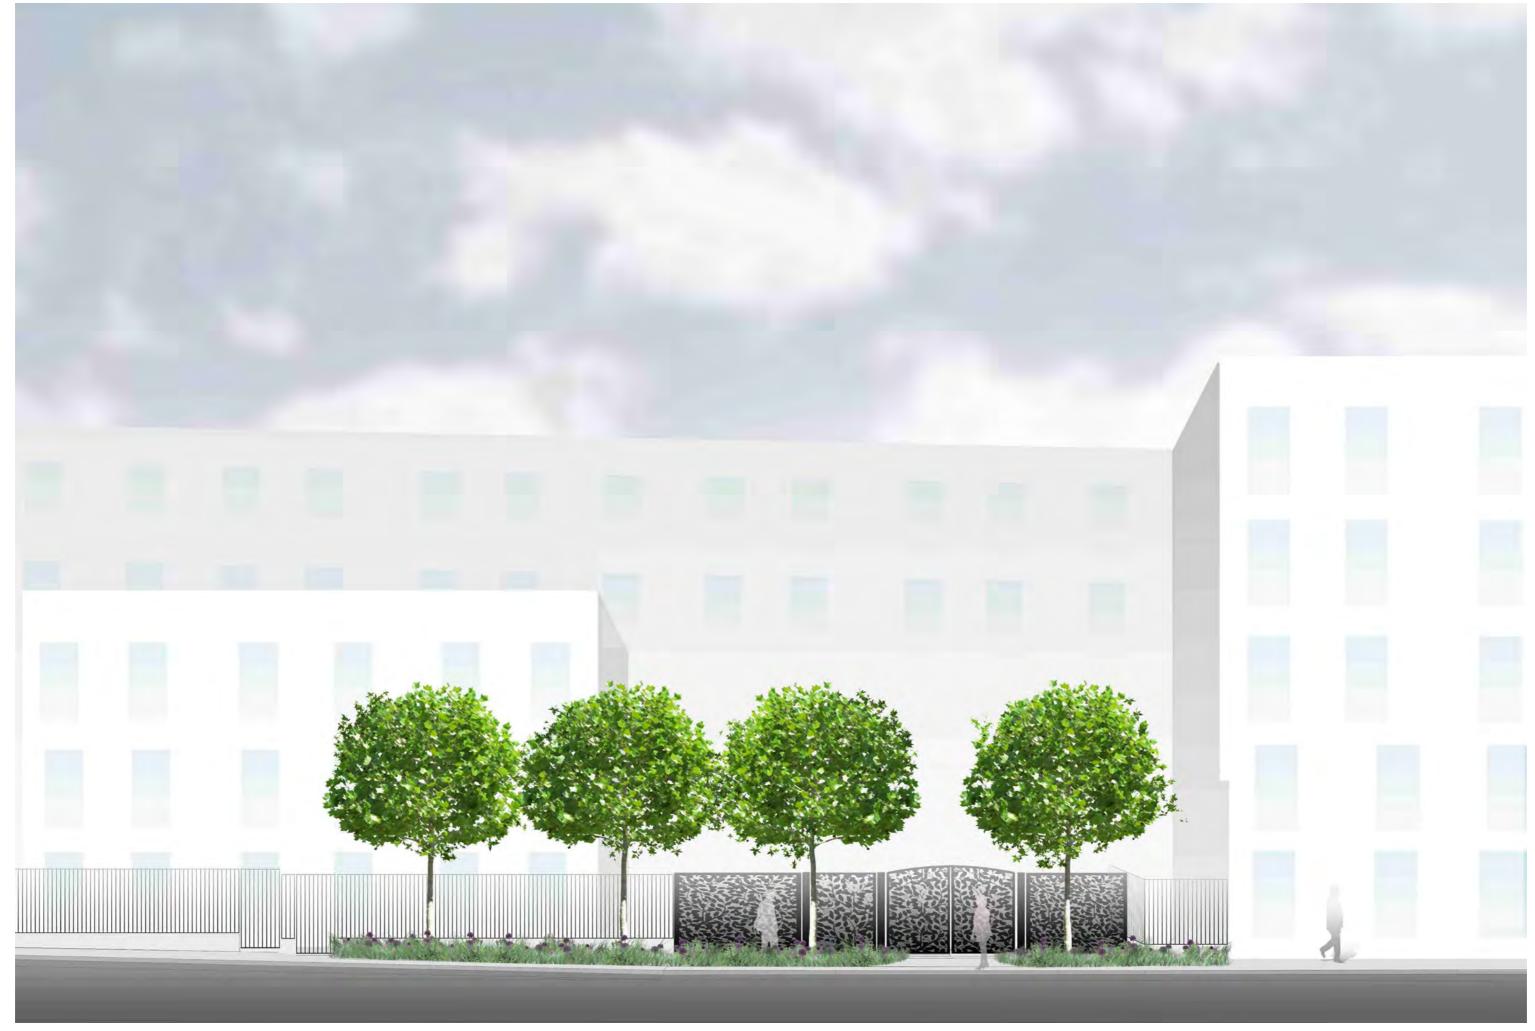
Visual showing replacement Platanus x hispanica (London plane) trees with proposed ornamental entrance gates and crossover. Trees are under planted with ornamental grasses and herbaceous planting
