Camden Stables Market
London
NW1
United Kingdom

**Camden Stable Market
Provender Stores**

Drawing Title
**PROVENDER STORES
UNAUTHORISED REMEDIAL WORKS**

October 2014 Drawing No B-WP-01

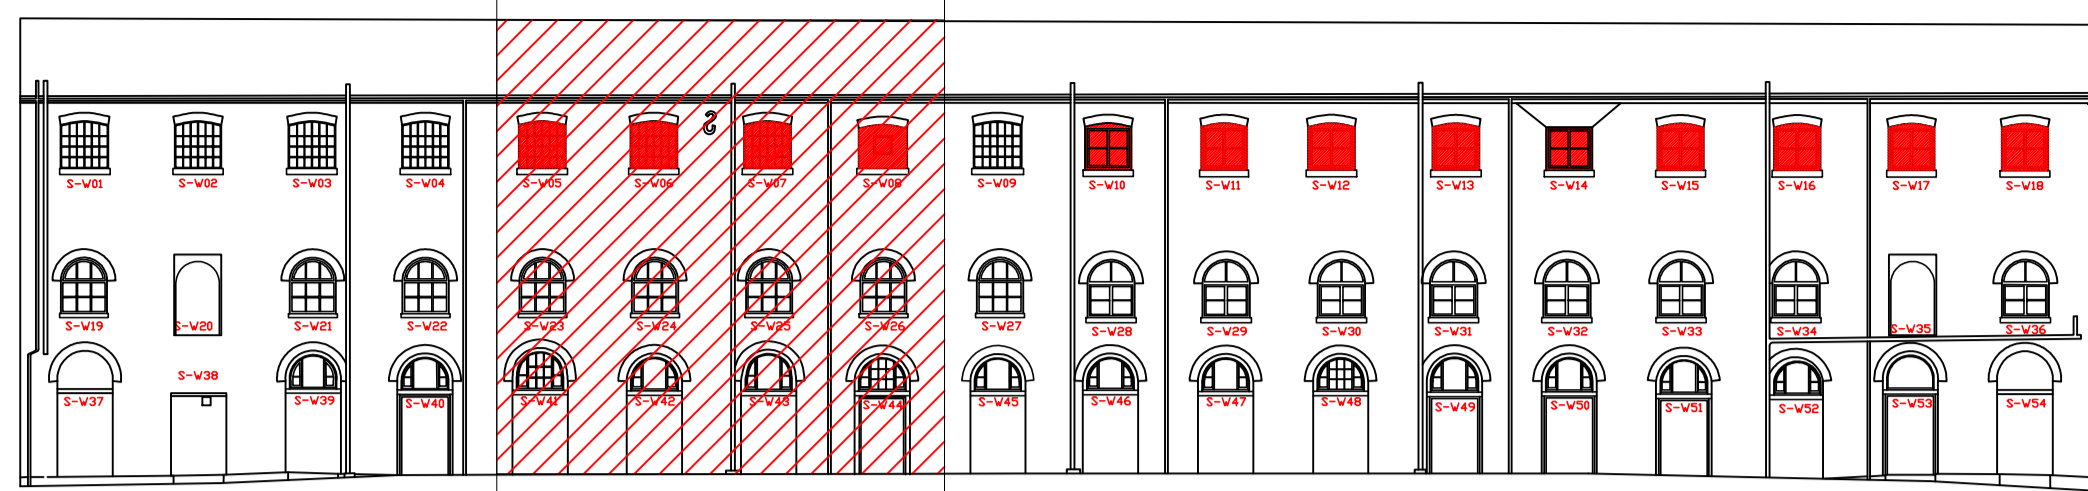
SOUTH ELEVATION

Windows of this type highlighted in red are proposed to be replaced. Those not hatched are to be refurbished. The hatched area is that part of the building affected by fire damage.

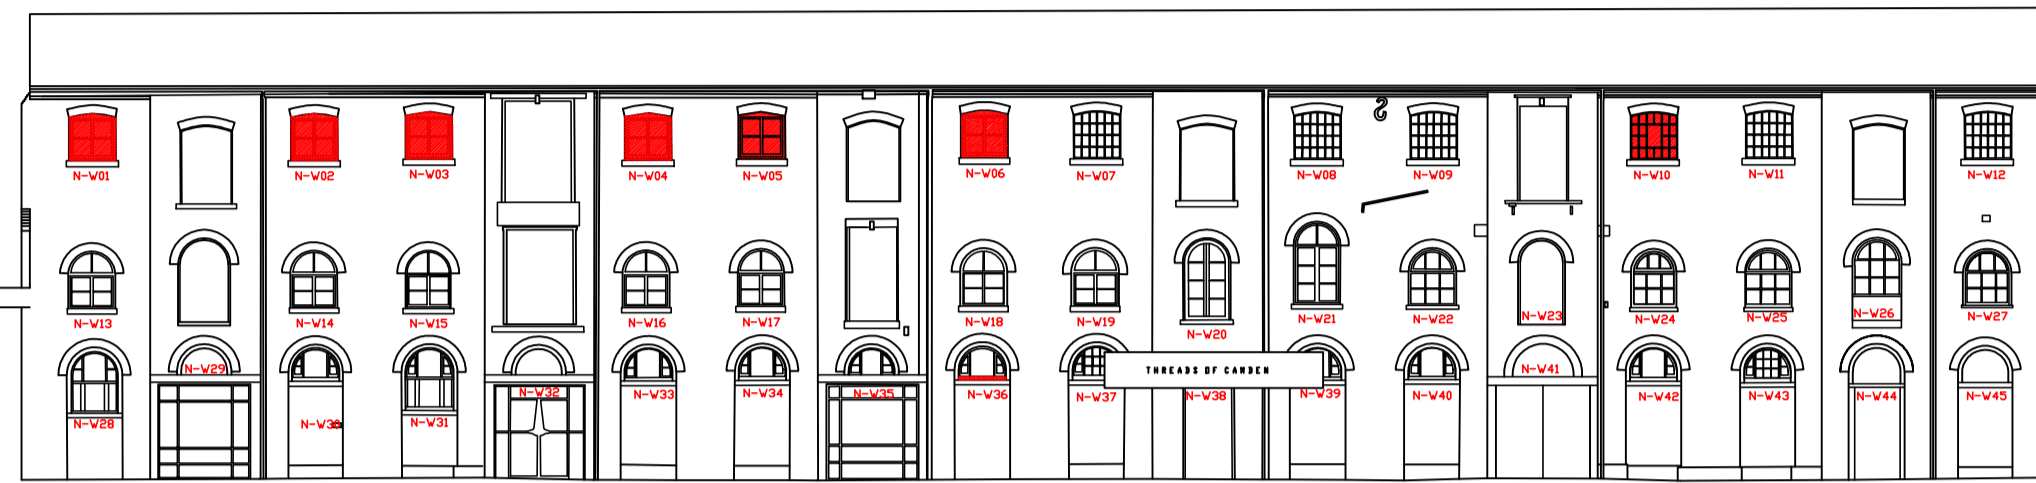
NORTH ELEVATION

Windows of this type highlighted in red are proposed to be replaced. Those not hatched are to be refurbished.

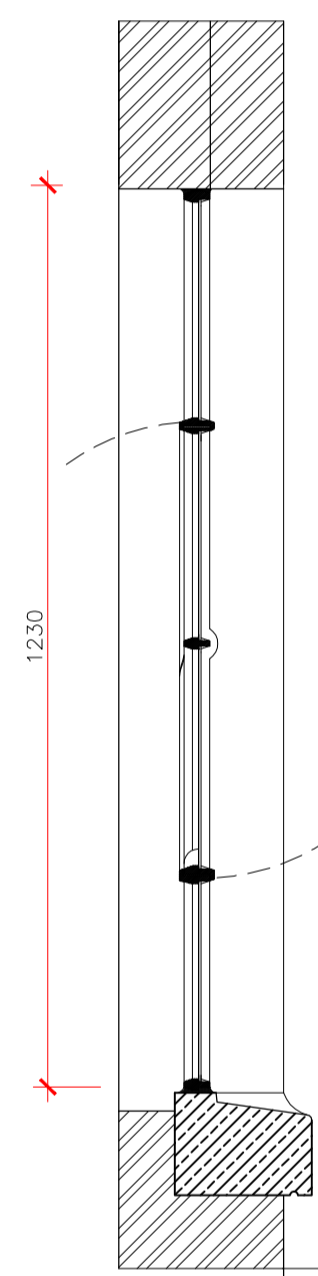
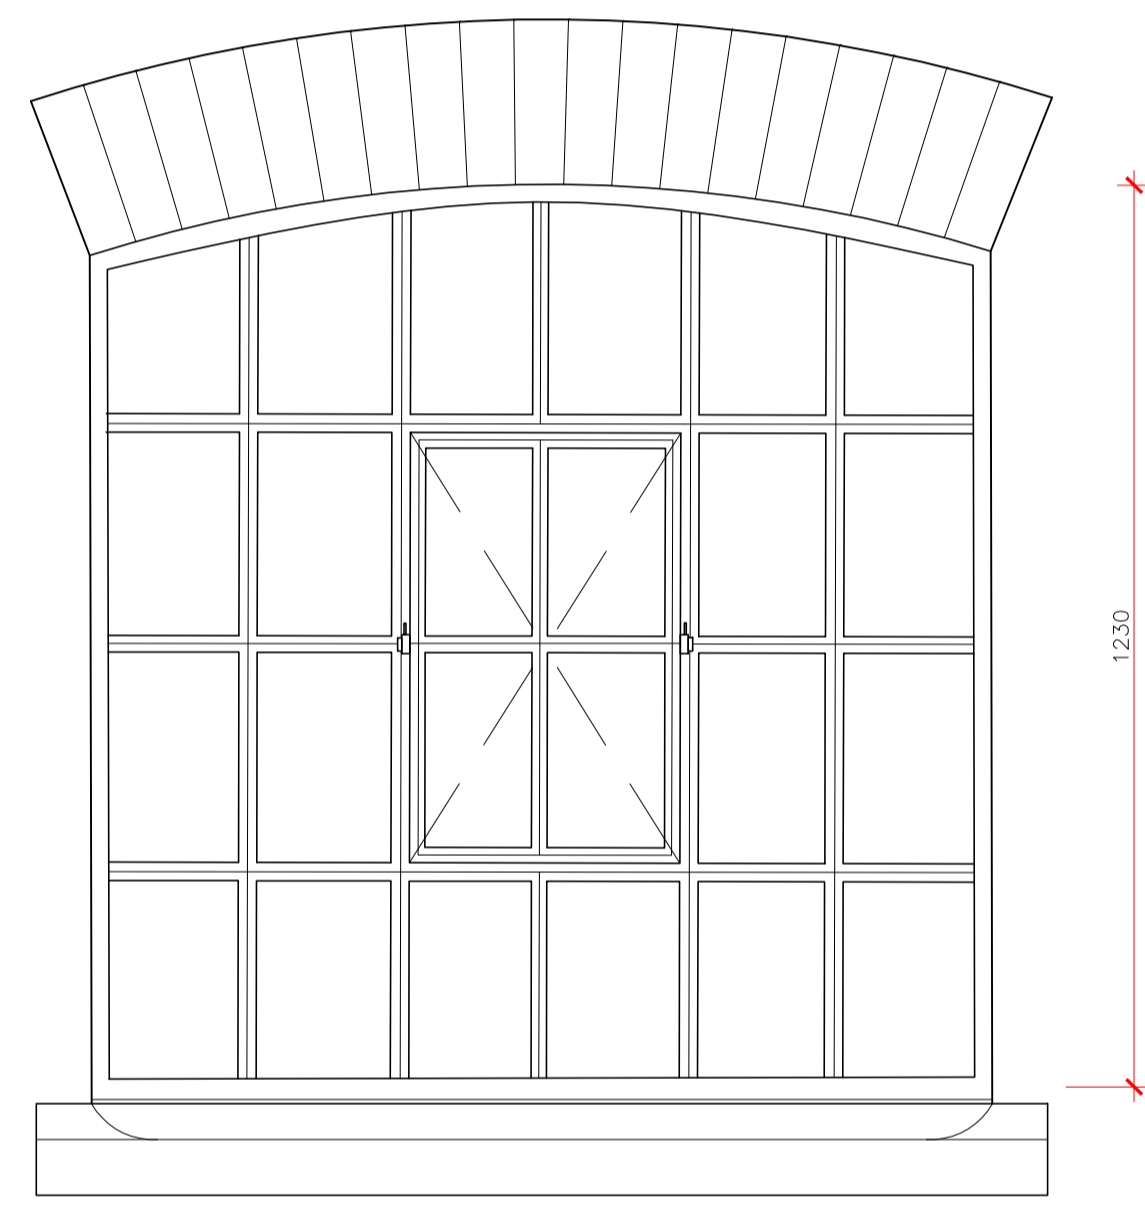
Existing cast iron window with central pivot light - Scale 1:10

Section

Elevation

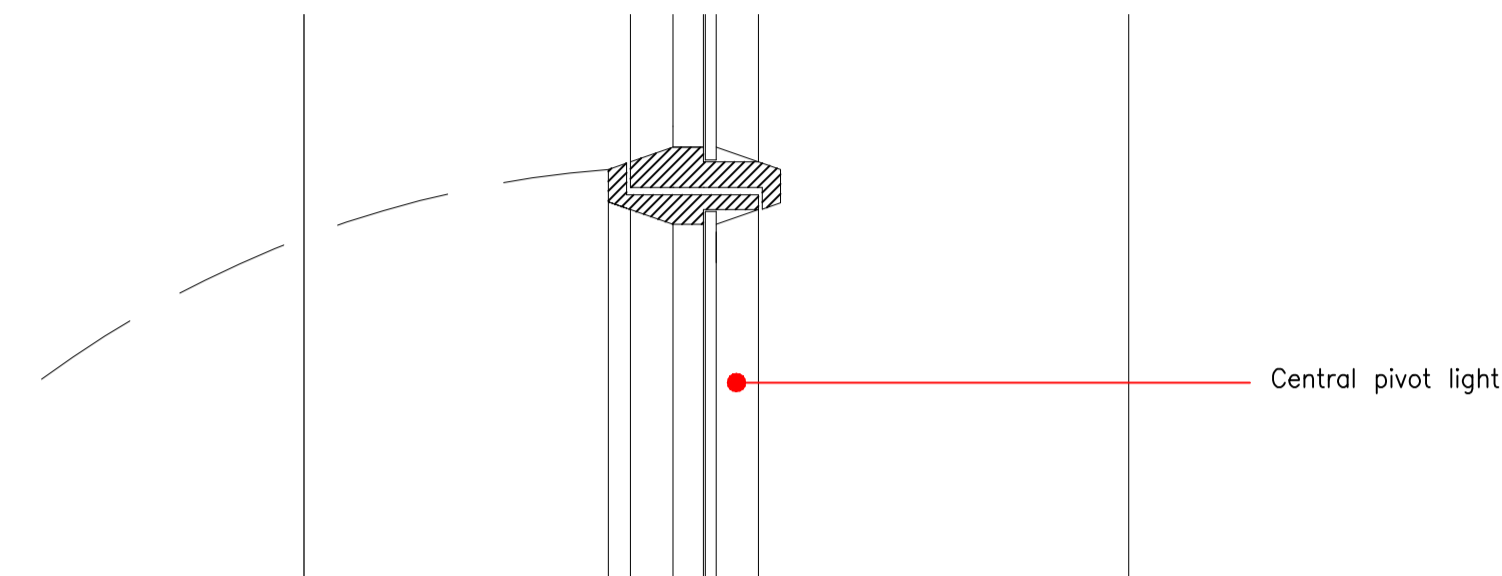
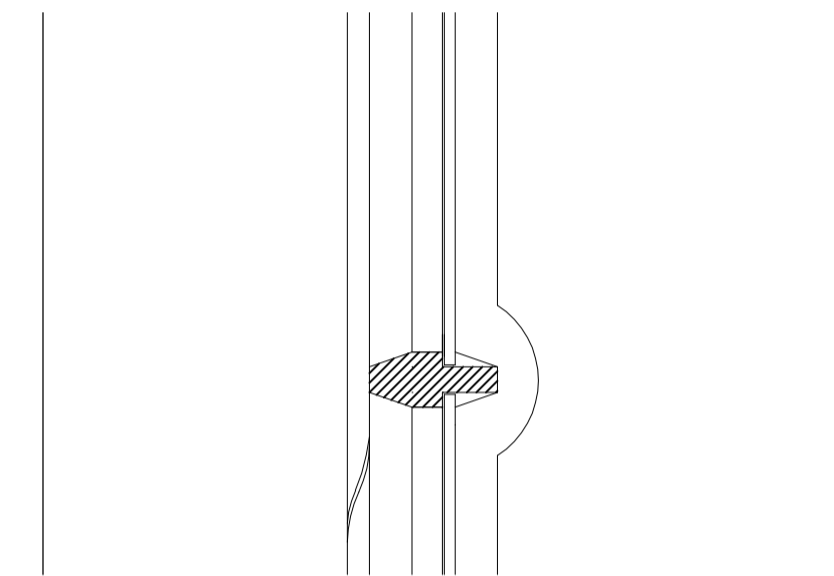
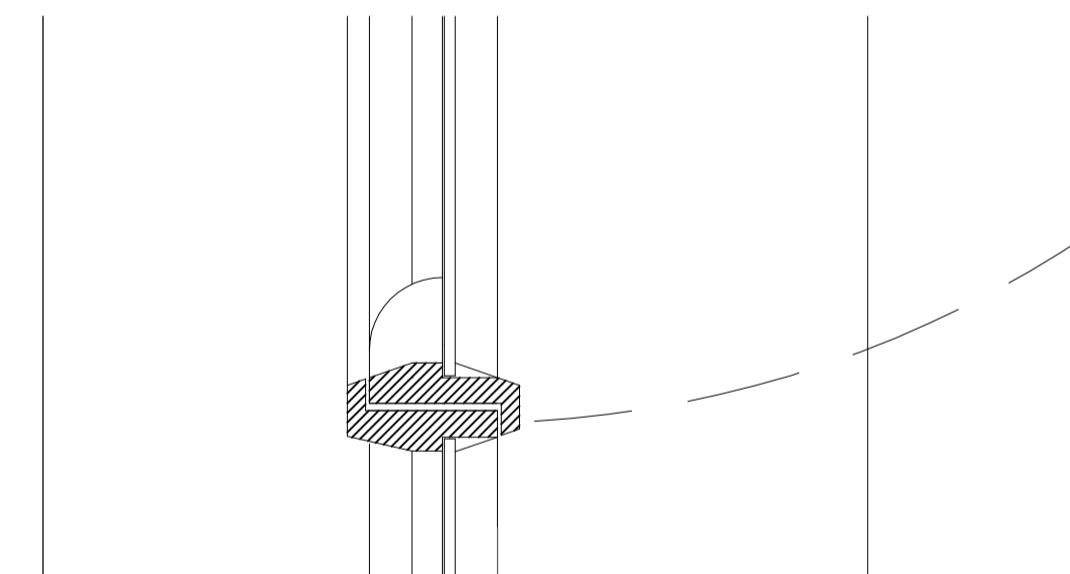
Existing cast iron window with central pivot light - section Scale 1:2

Curved brick arch lintel.

NOTE: Any gaps between window and brick reveals are to be tightly packed with oakum and pointed up with hydraulic lime mortar to finish.

Fixed light window.

Central pivot light.

Stone subsill.

Note:
Window profiles are to match existing and to be agreed by design team prior to any manufacture following stripping of existing windows.
