**Camden Stable Market
Provender Stores**

Drawing Title
**PROVENDER STORES
UNAUTHORISED REMEDIAL WORKS**

October 2014 Drawing No
B-WP-02

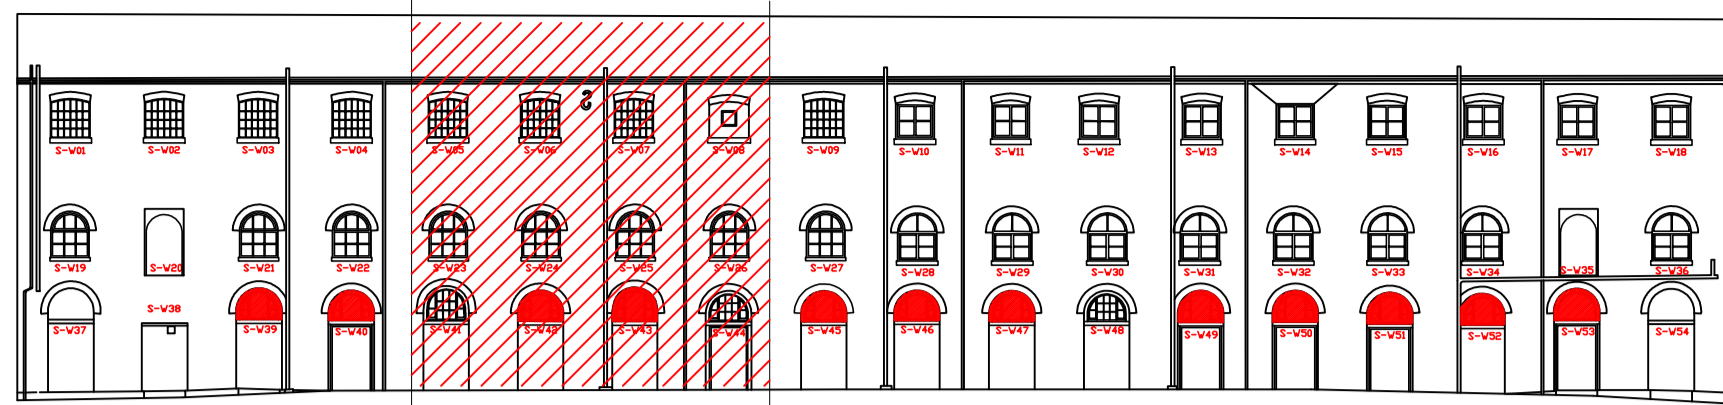
SOUTH ELEVATION

Windows of this type highlighted in red are proposed to be altered as part of this application. Those not hatched are to be refurbished. The hatched area is that part of the building affected by fire damage.

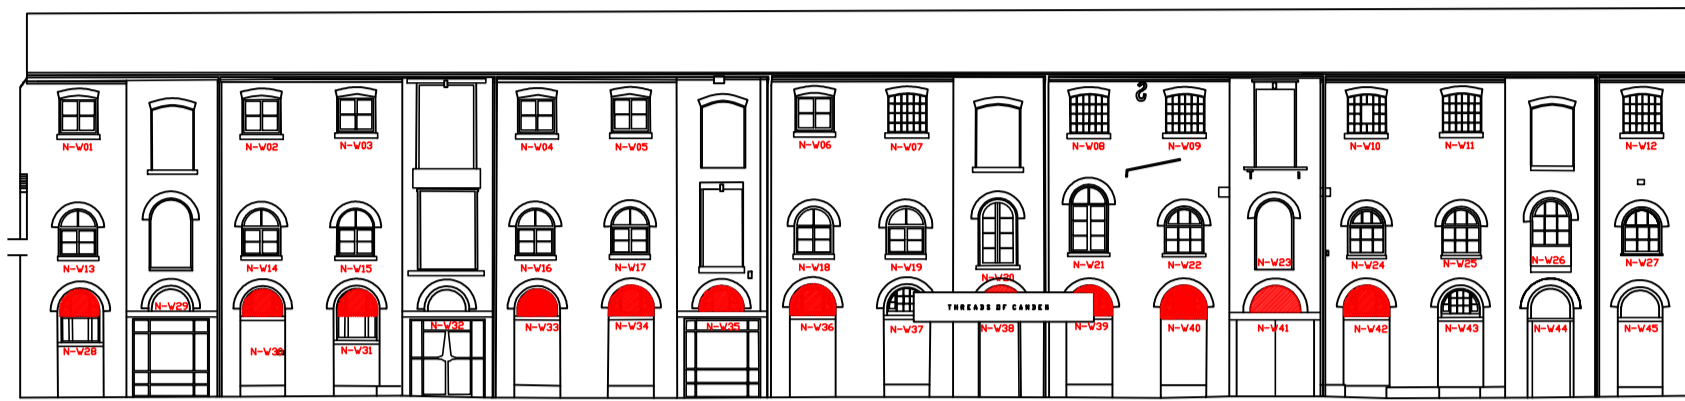
NORTH ELEVATION

Windows of this type highlighted in red are proposed to be altered as part of this application. Those not hatched are to be refurbished.

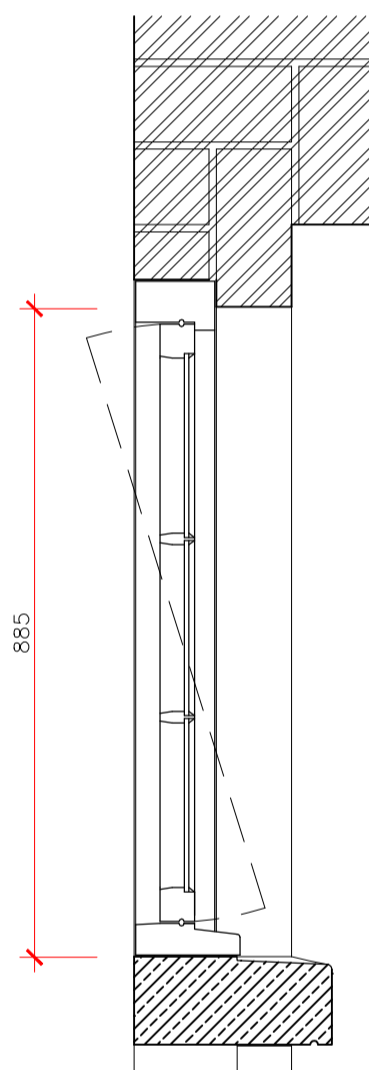
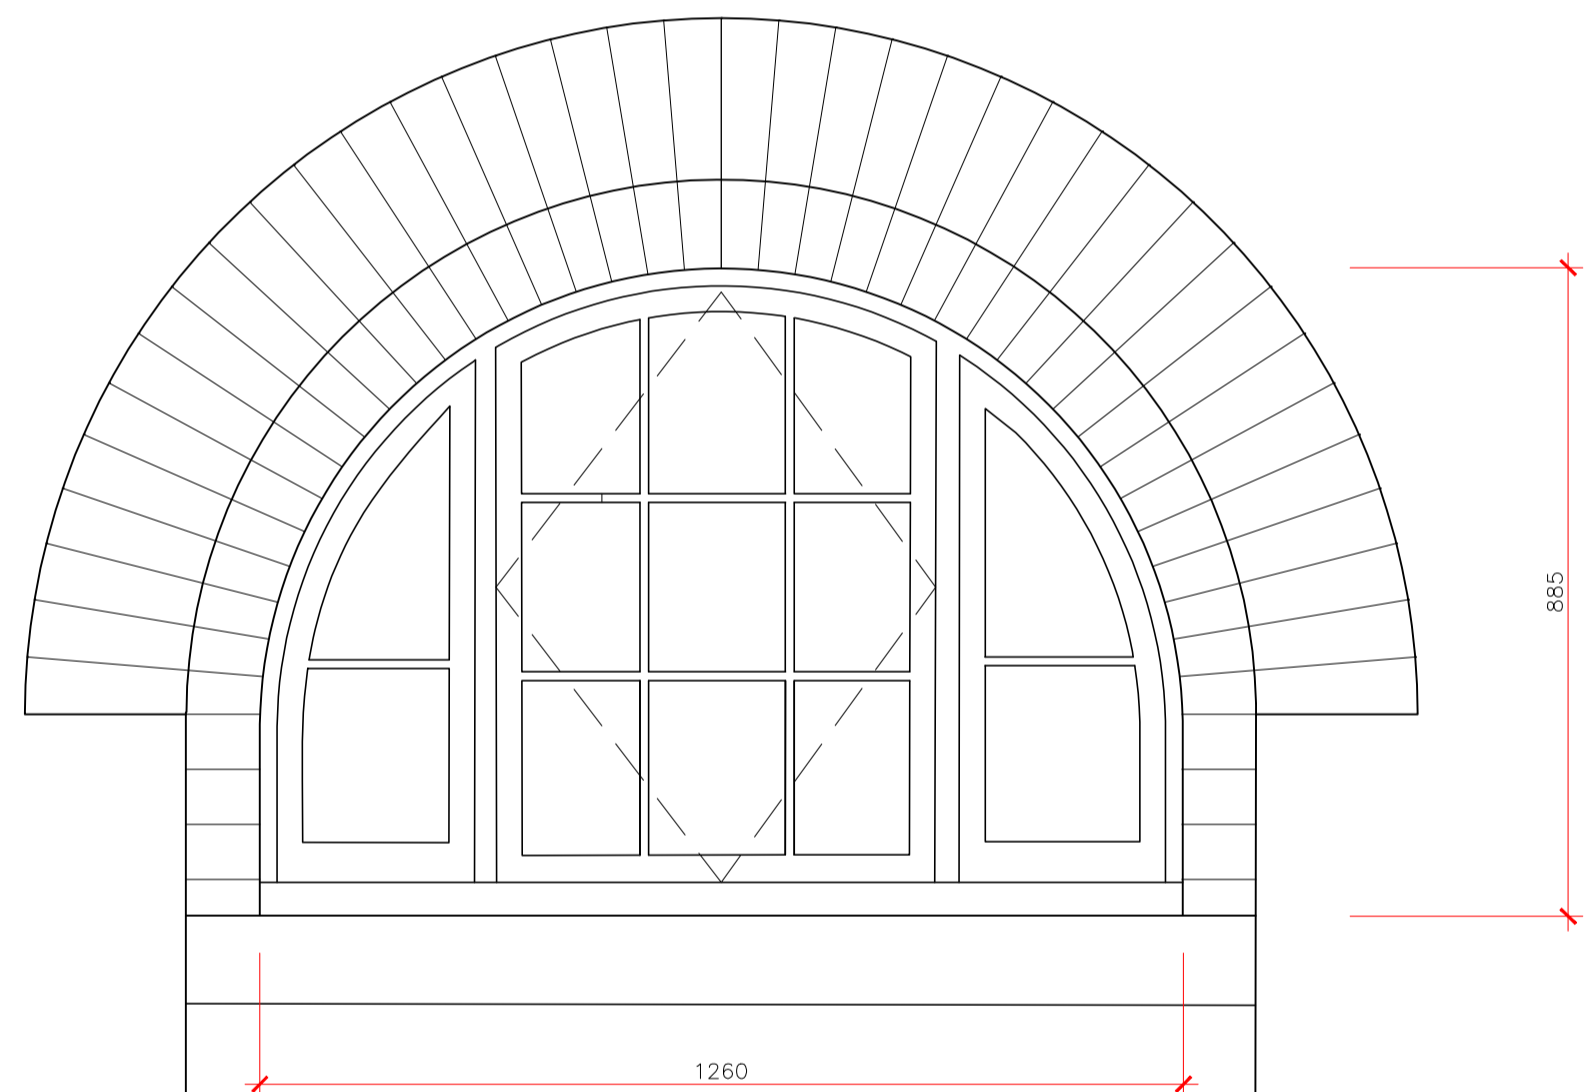
**Existing fixed light / opening casement timber window -
Scale 1:10**

Section

Elevation

Note:
Window profiles are to match existing and to be agreed by design team prior to any manufacture following stripping of existing windows.
