**Camden Stable Market**  
**Provender Stores**

Drawing Title  
**PROVENDER STORES**  
**UNAUTHORISED REMEDIAL WORKS**

October 2014                      Drawing No                      B-WP-03

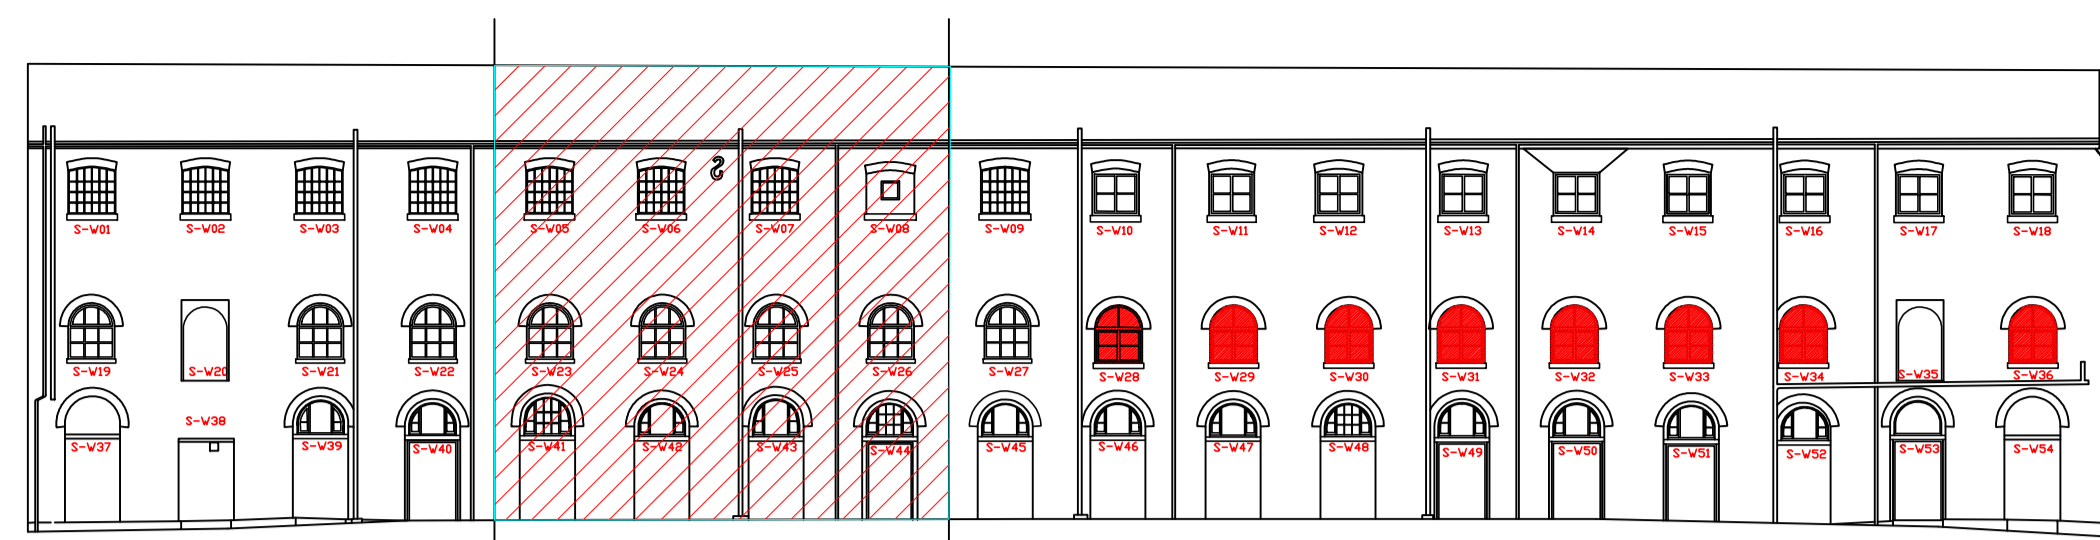
**SOUTH ELEVATION**  
Windows of this type highlighted in red are proposed to be replaced.

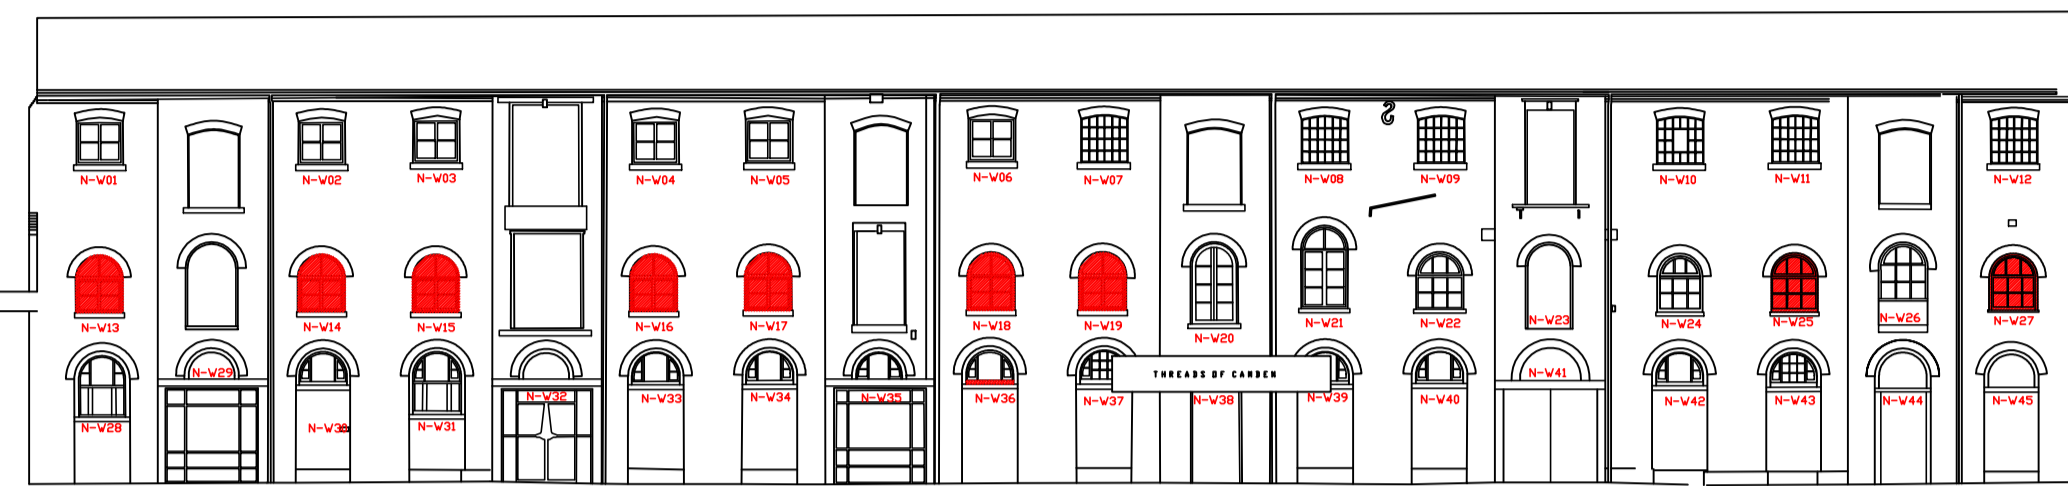
**NORTH ELEVATION**  
Windows of this type highlighted in red are proposed to be replaced.

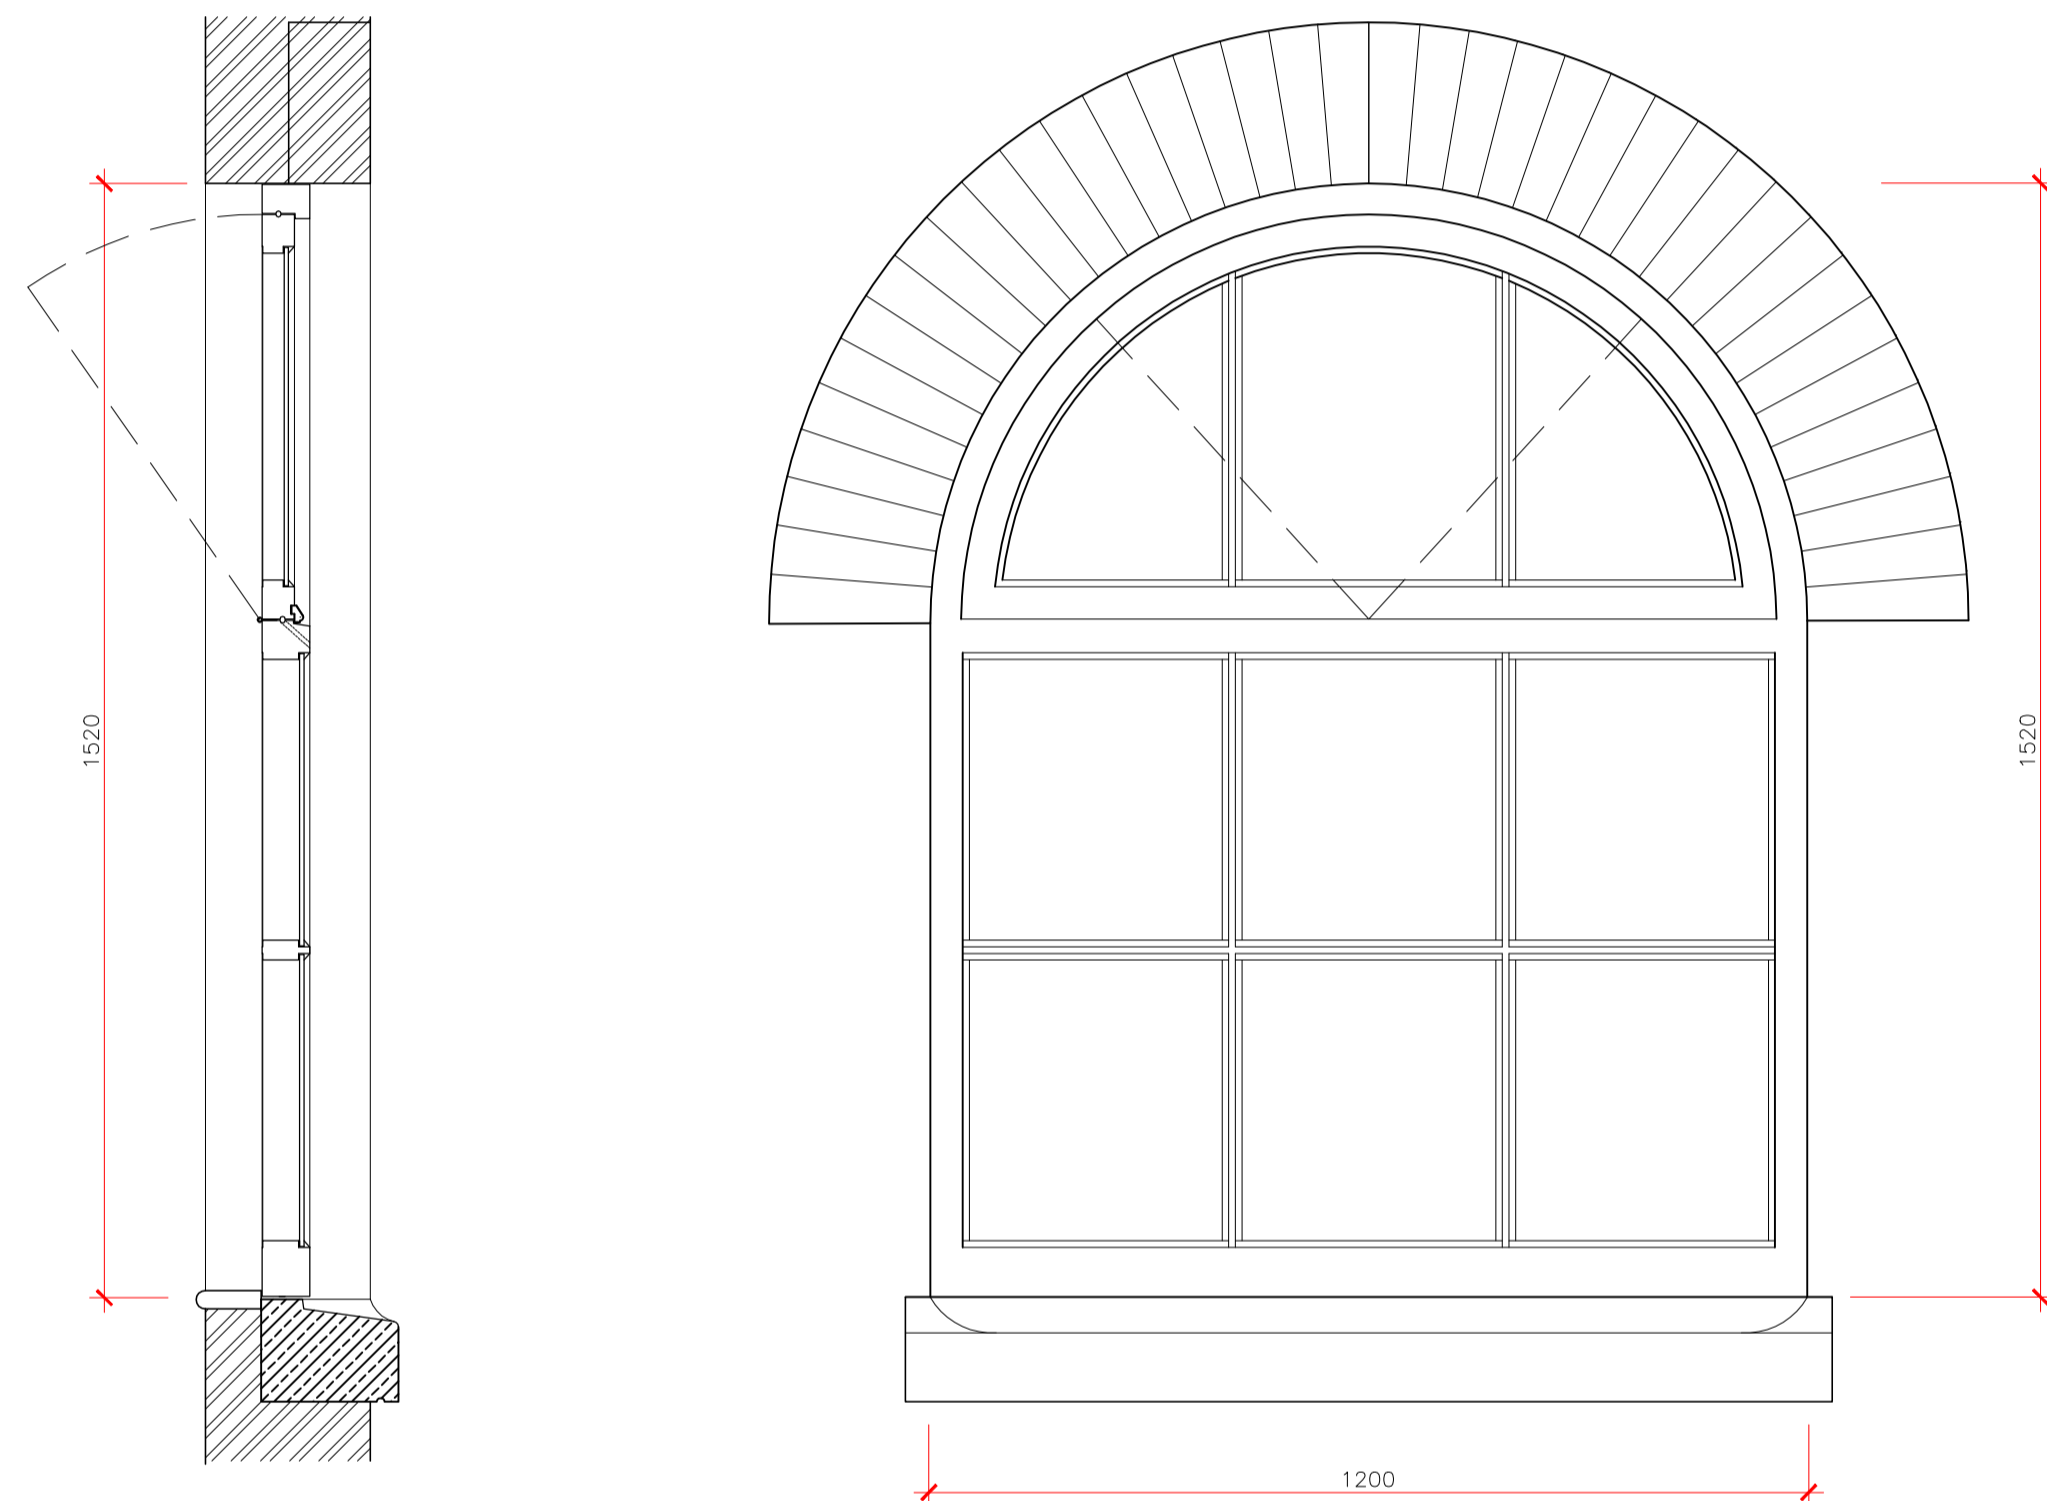
**Section**                      **Elevation**  
**Existing fixed light / opening casement timber window -**  
**Scale 1:10**

**Note:**  
Window profiles are to match existing and to be agreed by design team prior to any manufacture following stripping of existing windows.

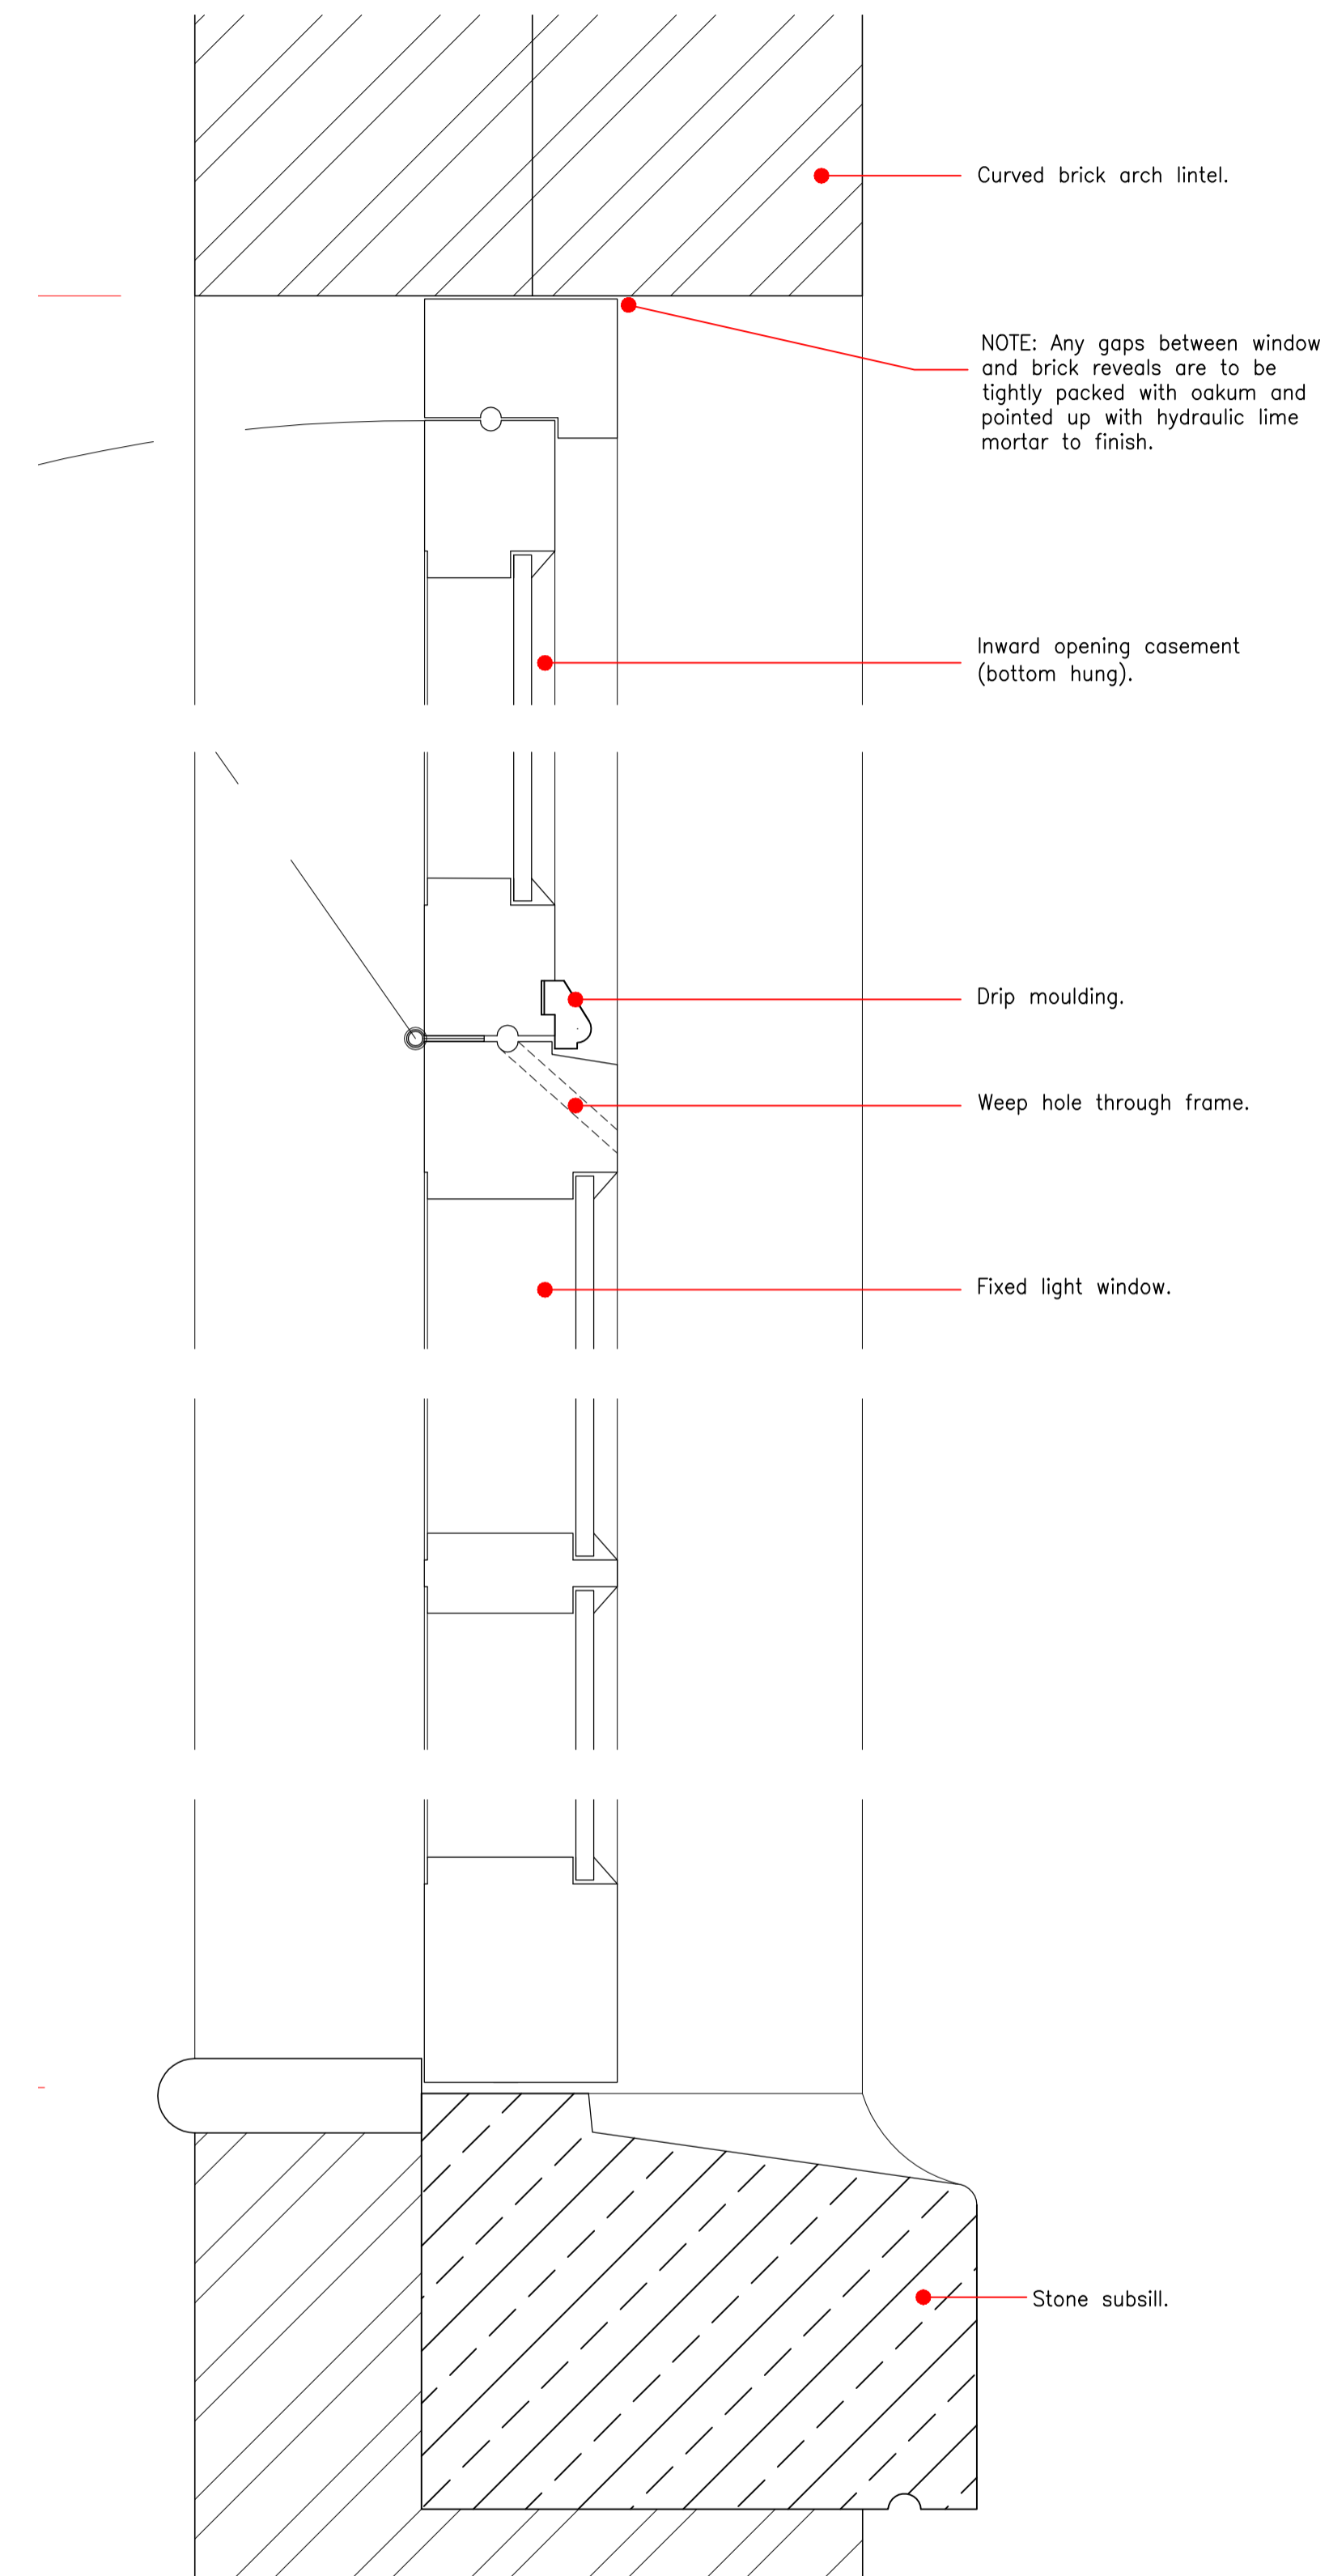
**Existing fixed light / opening casement timber window - section**  
**Scale 1:2**
