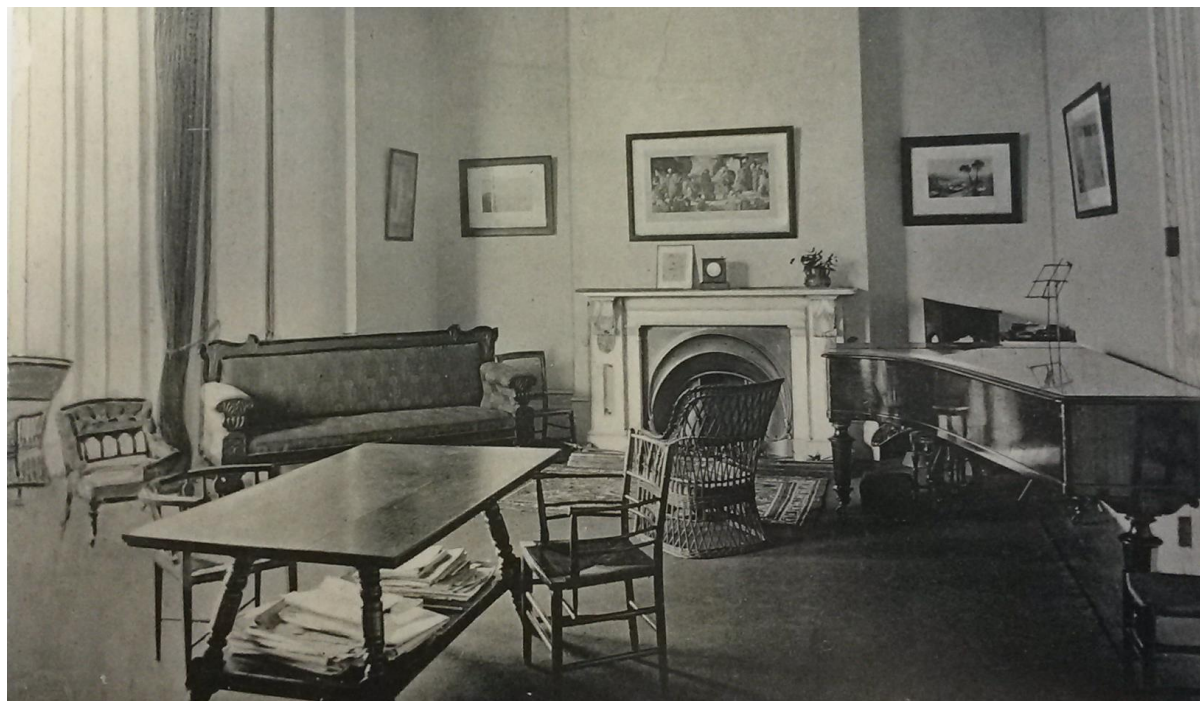
**Figure 57.** A photograph of the ground floor front bowed room in Kidderpore Hall which was used as a student's common room from 1905-1912.

- 3.78 Original plans for Kidderpore Hall have not been found. The earliest comprehensive general arrangement plans showing the layout of the property are provided in the set drawn up by Casson Condor Architects for the proposed refurbishment in 1966. The ground floor plan of the property is shown at Figure 58, which shows the layout of rooms at the ground floor level largely as they exist today. Six rooms lead off the entrance hallway, with the grandest reception room (Room 11) to the north west of the house, where the large bay window provides an aspect into the garden. It is known that this room was used as a student common room from the years 1905-12 when Westfield College occupied the site. A photograph of this room dating from c. 1905 is included at Figure 57, which shows the existing fireplace in situ.

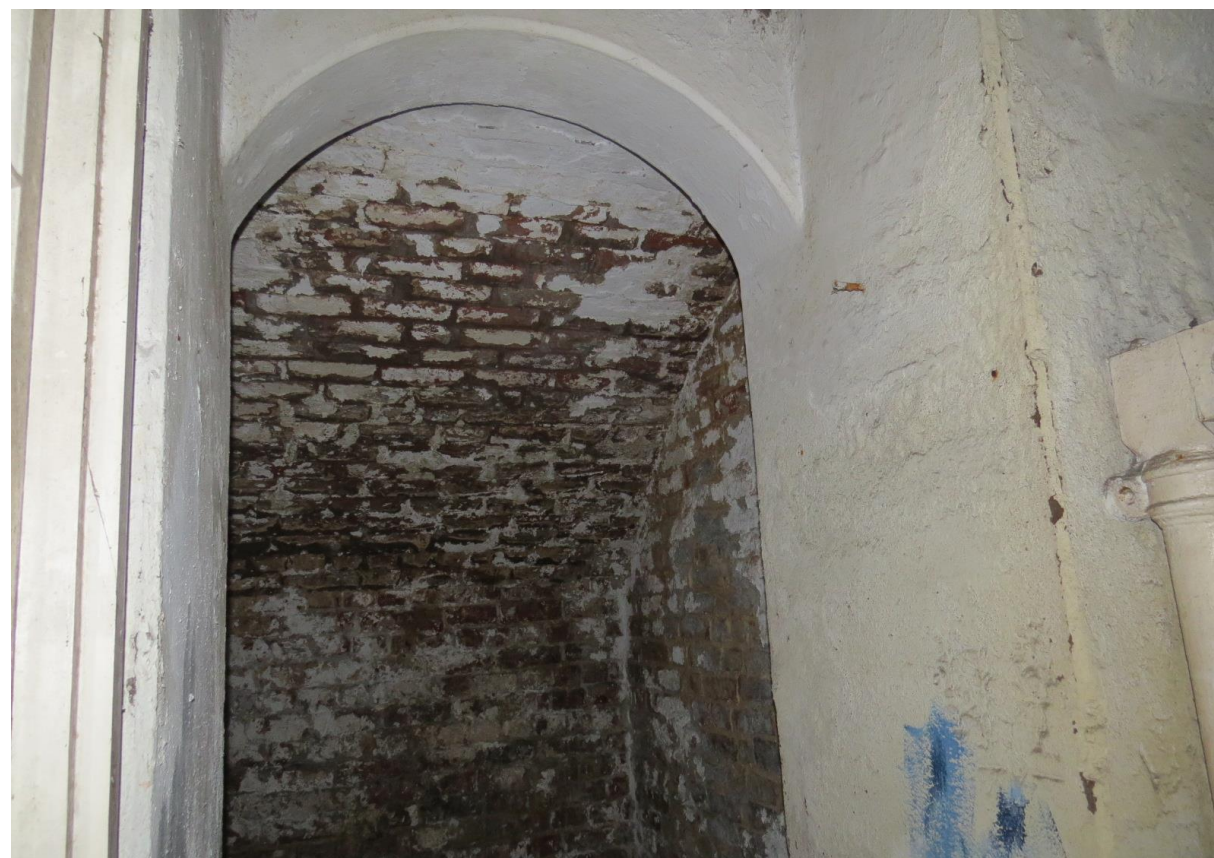
**Figure 64.** A photograph of one of the vaults at the basement level of Kidderpore Hall located underneath the pavement.

- 3.86 The basement areas of Kidderpore Hall are currently the location of storage rooms and toilet facilities and can only be accessed from Bay House, not from Kidderpore Hall. This floor level does not possess interior architectural features which contribute to the significance of the building, albeit the original vaults underneath the pavement to Kidderpore Avenue remain intact.

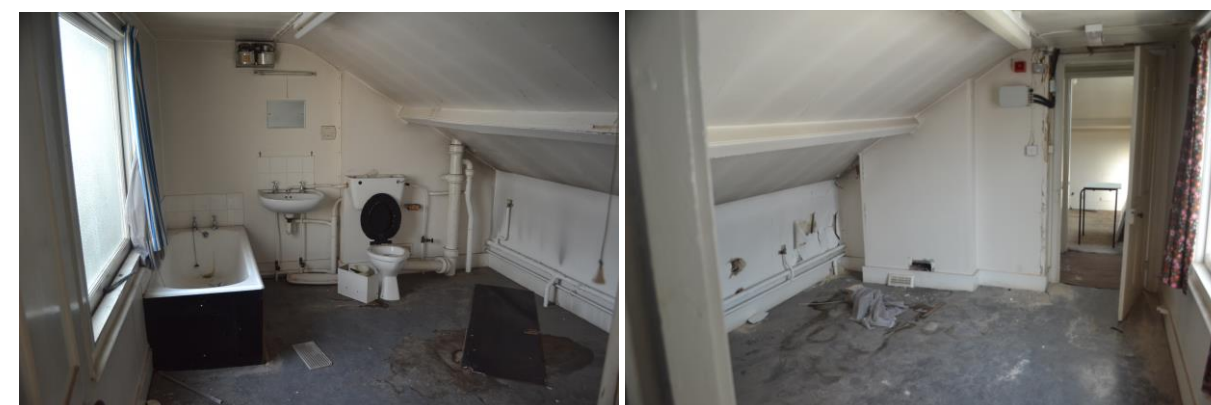
**Figure 65.** A photograph of a typical bathroom (left) and former bedroom (right) at the second floor level.

- 3.84 The rooms at the second floor level are within the roofspace. These rooms have not been maintained in recent years and the quality of these interiors is degraded. A photograph of a typical room and bathroom at the second floor level is shown at Figure 65.

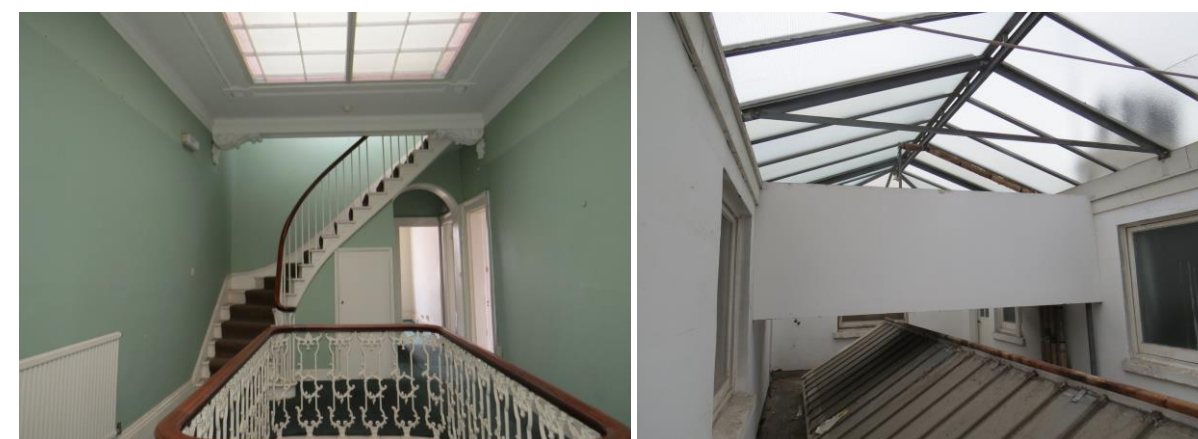
**Figure 66.** A photograph of the decorative skylight seen from a location on the first floor level landing, and the second floor level, and the structure located over the skylight at the second floor level.

- 3.83 The planform at the second floor was originally laid out for the occupation of the staff who served the family in Kidderpore Hall. Access is provided to this floor level by two staircases, both of which lead from the first floor level to the top of the building, one of which is enclosed adjacent to the principal staircase. The staircase leading from the first to the second floor level is shown in Figure 66.

- 3.85 The rooms at the second floor level are located around the central rooflight which allows light in from the A frame truss structure. This is a later, harmful addition which detracts from an appreciation of this central space. No original plans have been found for the detail of how this area was originally laid at the second floor level.

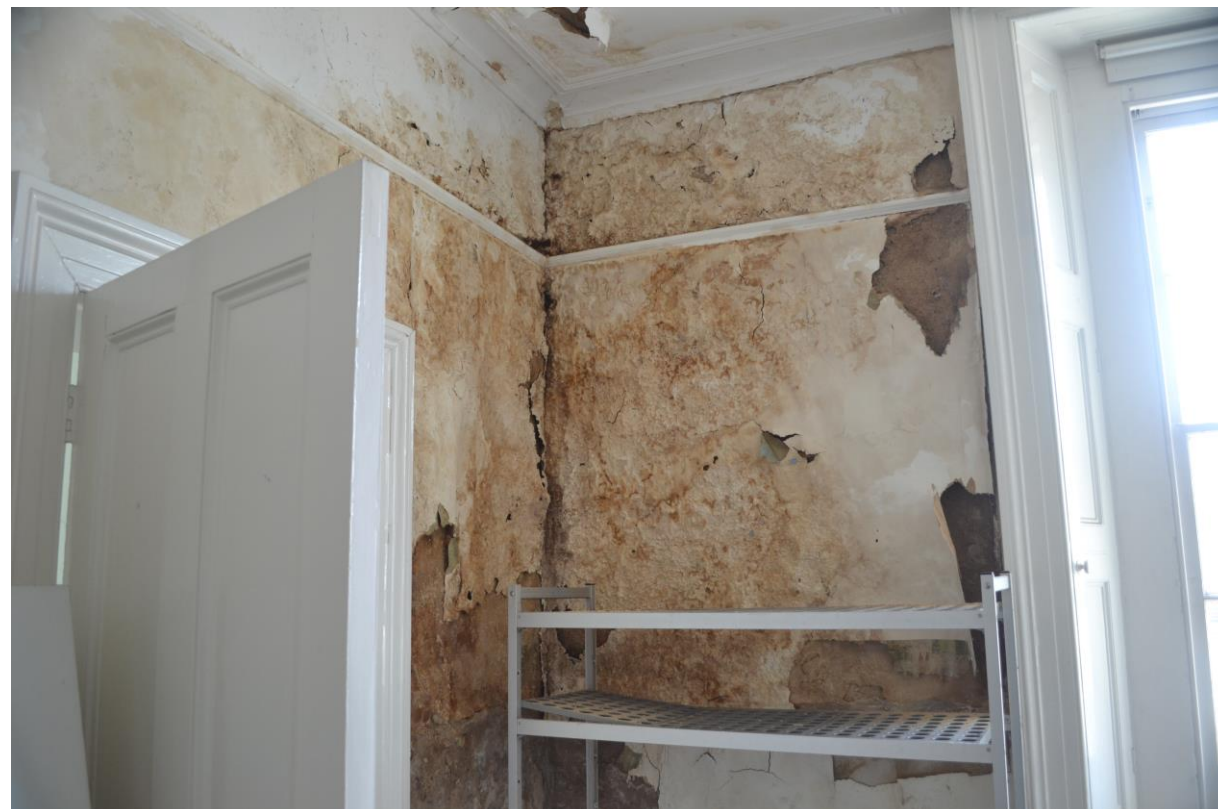
**Figure 68.** An image of the damage caused by water ingress at the first floor level.

- 3.87 Kidderpore Hall has not been in a sustained, active use for a period of ten years. The fabric of the building has suffered from lack of maintenance and in some rooms, the quality of some of the interiors has been thoroughly degraded by the effects of water ingress. Photographs of the degraded interiors are shown at Figure 68.

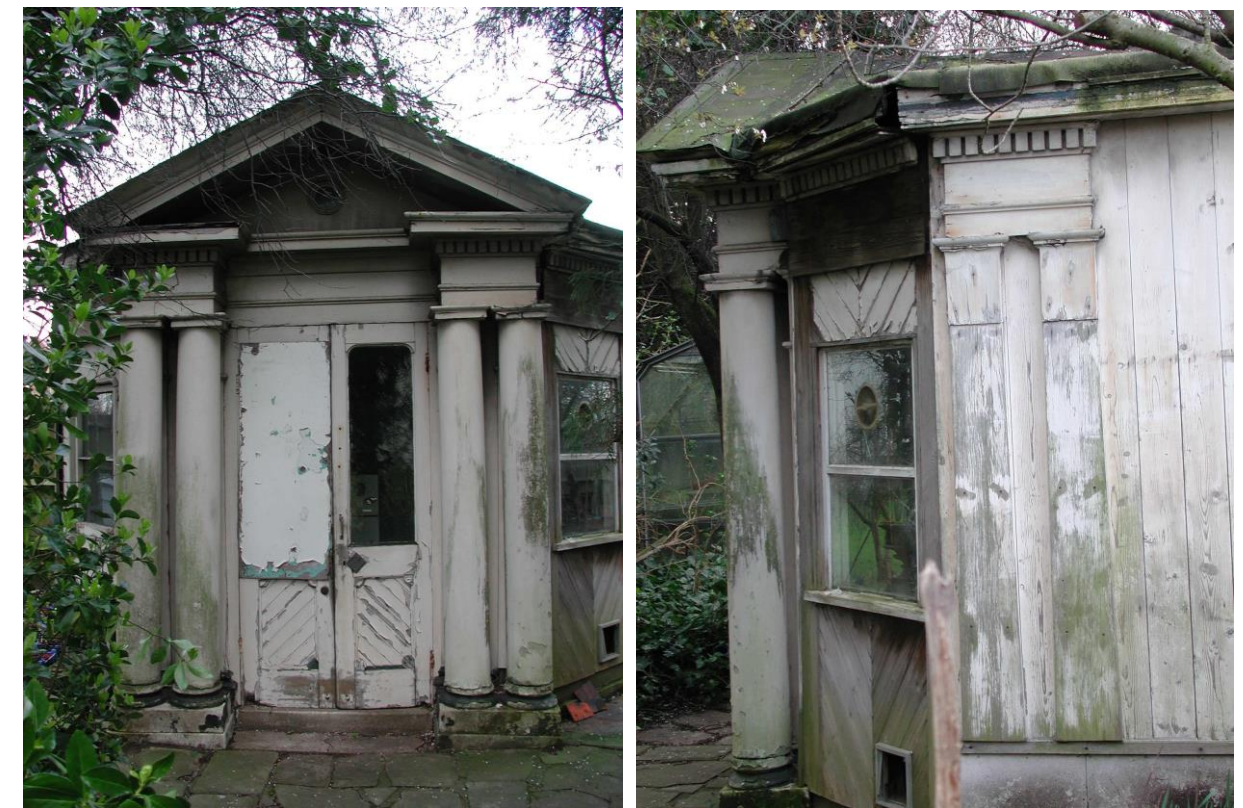
**Figure 71** A photograph of the Summerhouse taken in 2002. These give an indication of the physical state of the building 13 years ago.

3.95 The Summerhouse is currently supported by scaffolding and is in a state of disrepair. The structure is clearly unstable and entry is not possible. This is a listed building at risk of being lost as a result of decay and neglect. It is not included on Historic England At Risk Register.

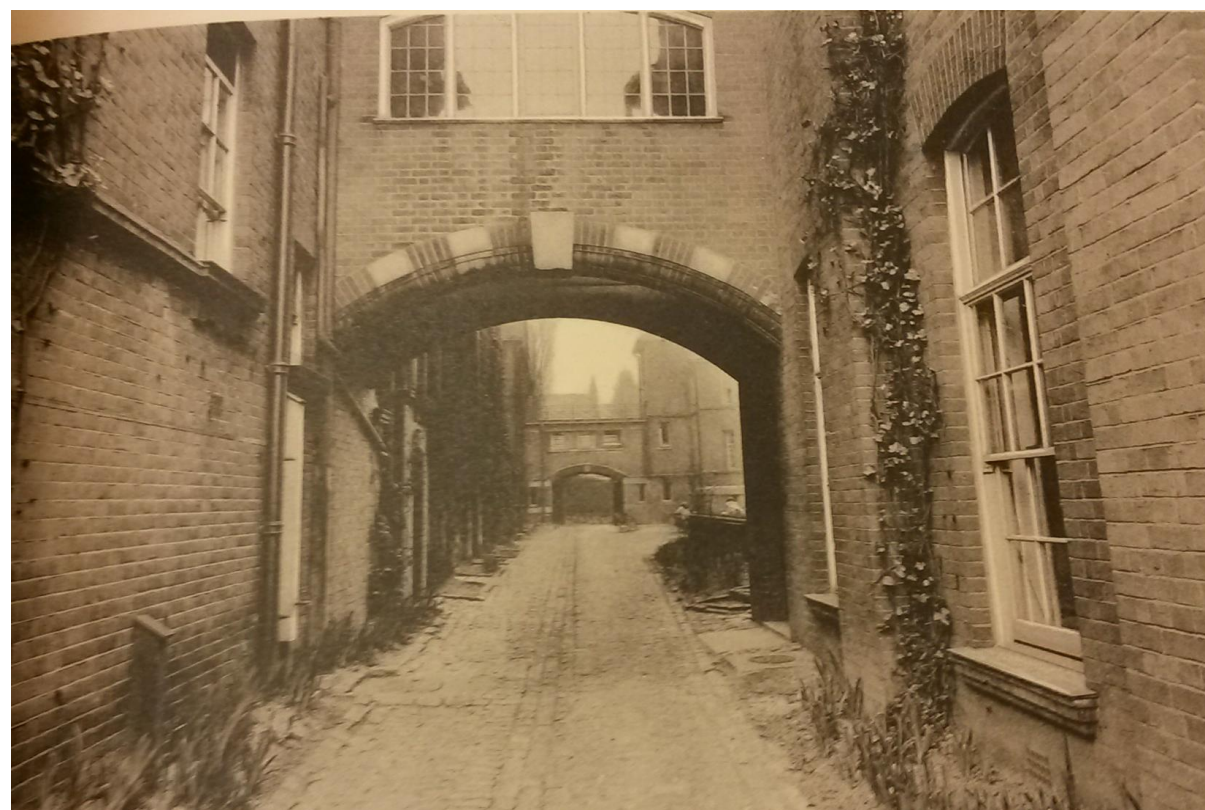
**Figure 89.** A photograph of the bridge structure which provided the original link between Skeel Library and Maynard Wing.

- 3.119 The sketch plan showing the proposals to build Skeel Library in 1903 is included at Figure 13. This plan shows the frontage of the completed Maynard Wing as set back from that of Kidderpore Hall, with a narrow bridge connection between them which would have allowed an observer to read the new Skeel building and Maynard as separate buildings in the streetscene.
- 3.120 The photograph of the elevation of the Westfield site as seen from Kidderpore Avenue, taken c. 1929, shows that this was the case. The original extent and design of the archway over the cobbled walkway, referred to as the 'Bridge of Sighs' by J Sondheimer, and mentioned in the list entry summary, can be seen in the photographs at Figure 88 and Figure 89.

- 3.121 The original extent of the bridged link between Skeel and Maynard is now obscured by the later extension to the dining wing of Maynard, which was completed at a date after 1934, as shown by comparing the historic maps of 1934-5 and 1953-4 and the proposed site plan for the construction of Lord Cameron Hall, which was drawn up in 1934. This is also labelled on the plan of the College as dating from 1935, shown in Figure 38. This extension served to infill the elevation of the original Maynard Wing (1891) and Skeel Library so that a continuous elevation to Kidderpore Avenue is now read.

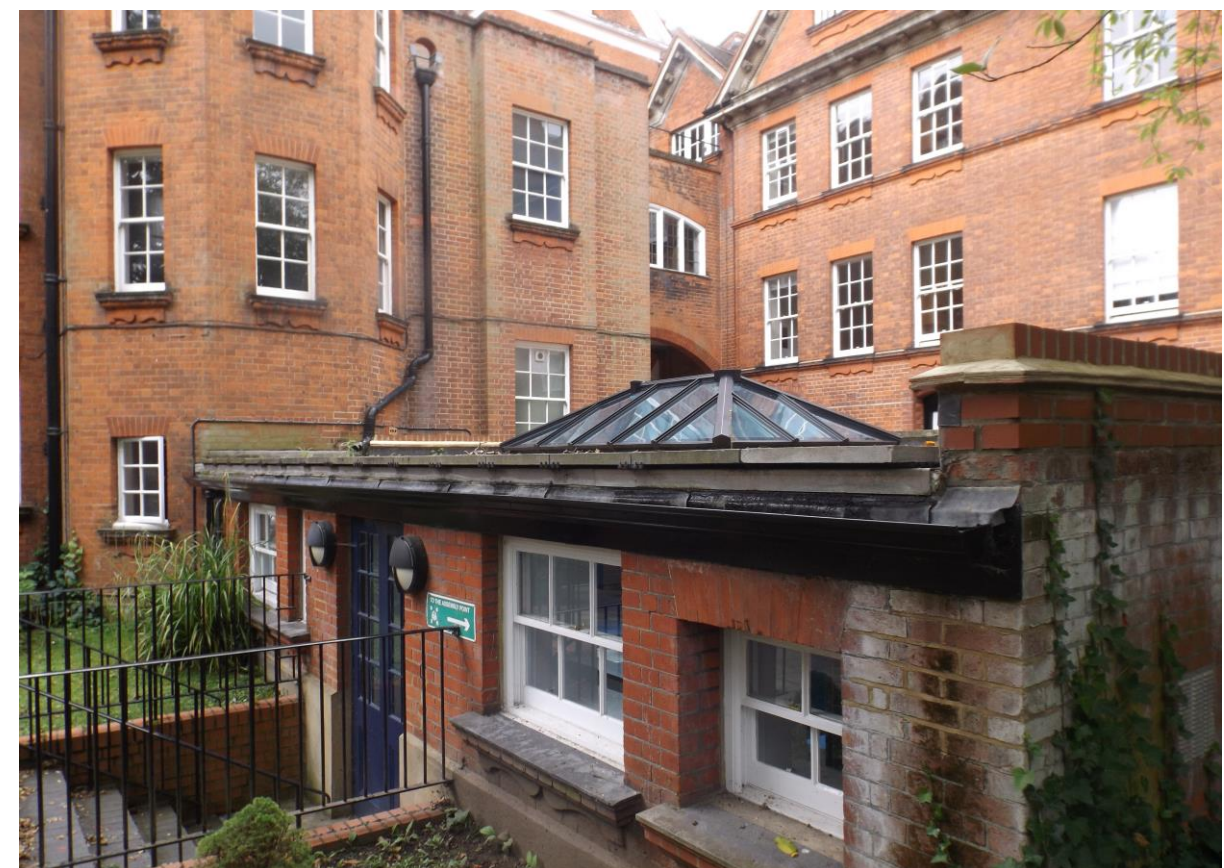
**Figure 91.** The single storey extension to the rear of the former Skeel Library.

- 3.123 Similarly the single storey extension to the rear of Skeel Library is a latter addition and is understood to have been built post 1915 according to photographs of the tennis court and the historic plan of the site. This single storey building has a squat appearance owing to the size of the openings for the fenestration, which create a lateral emphasis on the east elevation.

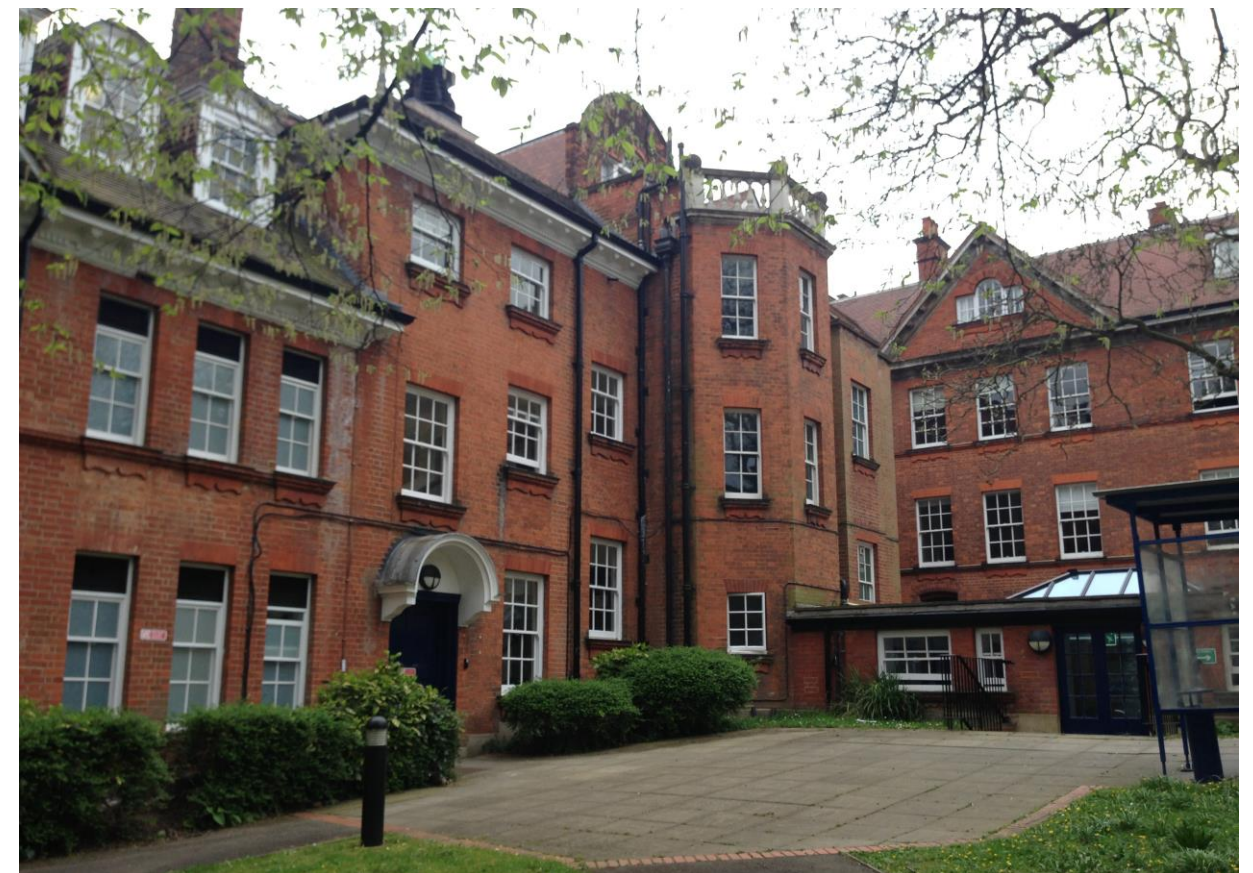
**Figure 92.** A photograph of the rear elevation of Dudin Brown with the canted bay structure containing the original staircase to the former Skeel Library.

- 3.131 Circulation in Skeel is provided by way of the main central staircase to the rear which is contained within the bay window, and the secondary staircase from the second to the third floor rooms. A balcony space exists above the bay staircase, which is not readily accessed.

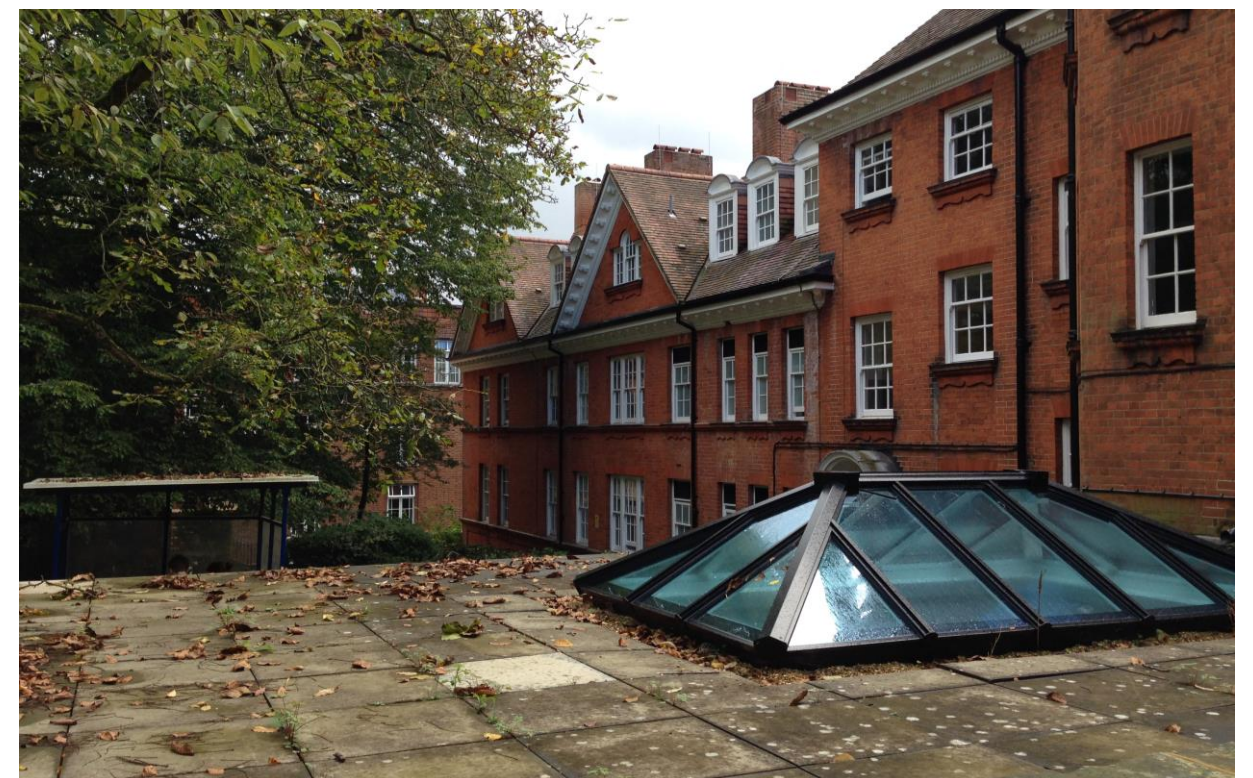
**Figure 93.** A photograph of the roof of the single storey extension to the rear of Skeel Library and the protruding rooflight.
