Basement Impact Assessment

Site | 36 Flask Walk
London
NW3 1HE

Our Ref | BIAREV/5568

Chelmer Site Investigation Laboratories Ltd

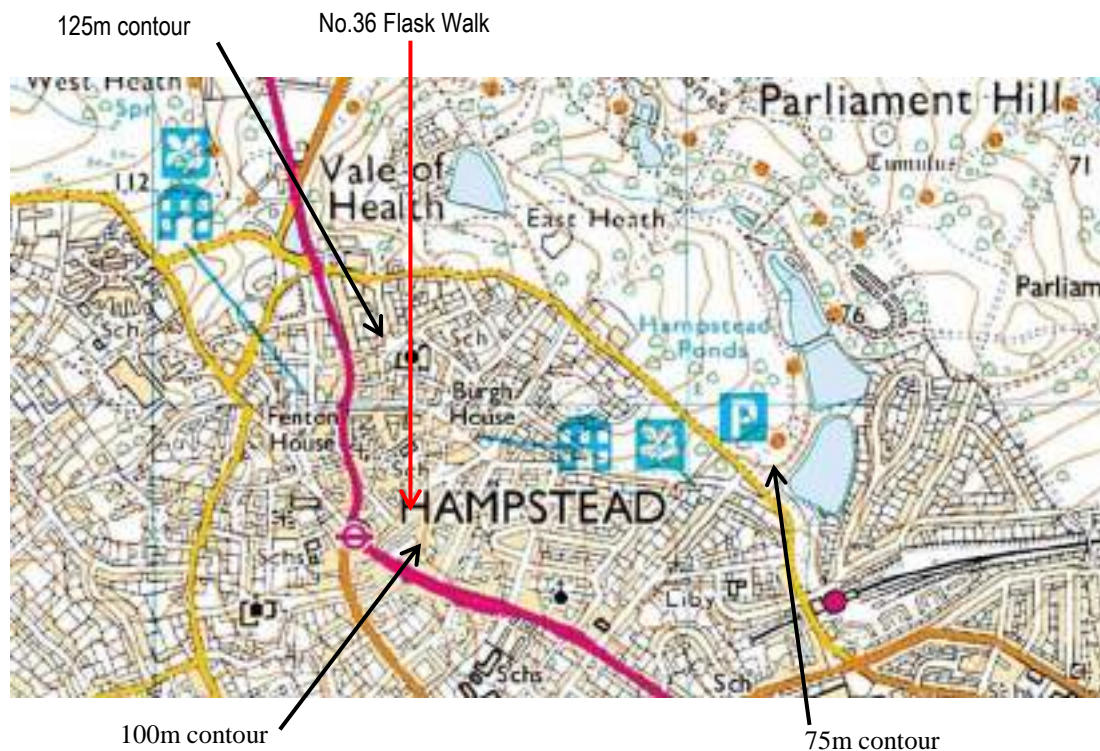
Figure 2: Enlarged extract from 1:25,000 Ordnance Survey map showing site location.

2.3 No.36 Flask Walk is situated on an east-facing slope, on the south-west side of a weakly developed valley which leads down to the former alignment of the river Fleet. Willow Road broadly follows the bottom of this valley to the east of Flask Walk, as illustrated by the contours on Figure 2. The contours on the 1:25,000 scale Ordnance Survey (OS) map indicate an overall slope angle within the immediate vicinity of the site of approximately 4.5° to the east (measured between the 105m and 100m contours). Considerable variation in the slope angle can be found both above and below the site, with measured slope angles ranging from 3.4° (between the 100m and 90m contours downslope) to approximately 8° (between the 110m and 115m contours upslope). However, Figure 16 of the Camden GHHS (Camden Geological, Hydrogeological and Hydrological Study by Arup,

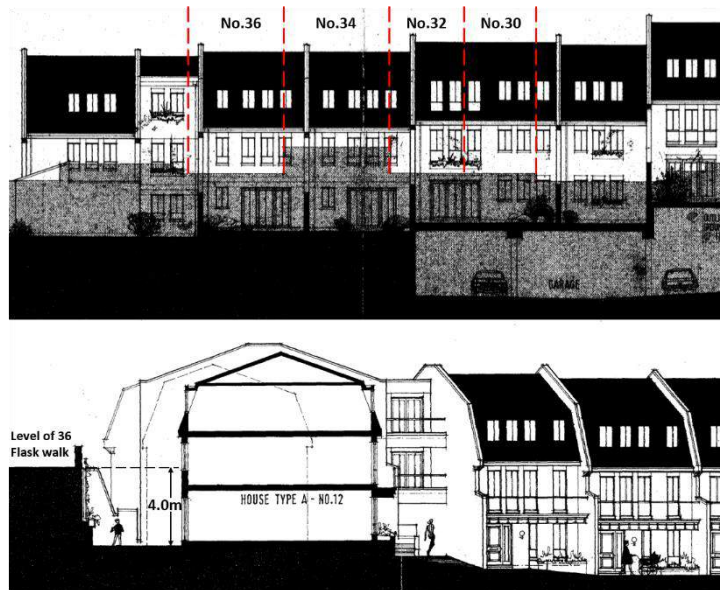
Figure 3: Extracts from Spencer Walk cross sections A-A (top) and V-V (bottom), showing the difference in level between the Spencer Walk development and rear of No's 30-36 Flask Walk (shaded area)

- 2.4 To the south of Flask Walk is the Spencer Walk development (Figure 1), which was constructed after No's 30-36 Flask Walk, during the 1980's (Application E6/15/A/33430, see paragraph 2.7 below). A level difference of 4.0m was recorded between the rear patio of No.36 Flask Walk and the adjoining rear garden to No.19 Spencer Walk (Figure 3), although the topographic survey by On Centre Surveys shows a difference of approximately 3.3m. Figure 3 also shows that a single storey basement carpark exists beneath No's 1-17 Spencer Walk, adjacent to the communal garage beneath No.30 and part of No.32.

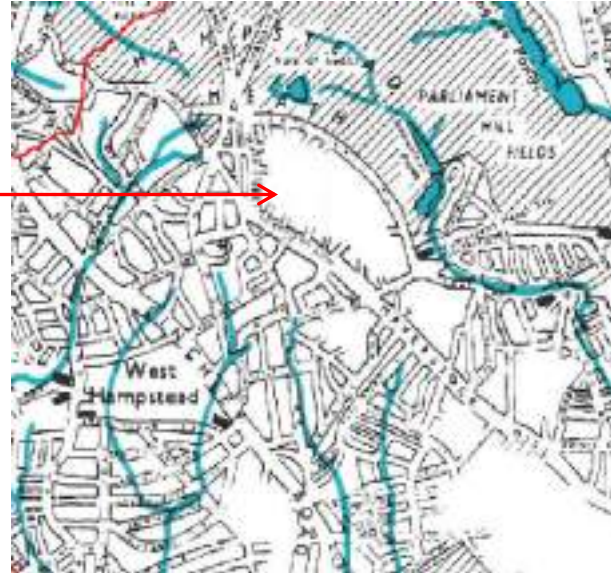
Figure 5: Extract from Figure 11 of the Camden GHHS (Arup, 2010) showing former watercourses, based on Barton (1992).

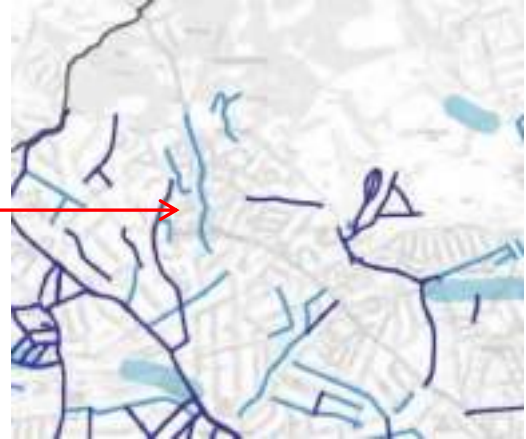
Figure 6: Extract from Figure 15 of the Camden GHHS (Arup, 2010) showing roads which flooded in 1975 (light blue), in 2002 (dark blue), and 'Areas with potential to be at risk of surface water flooding' (wide light blue bands).

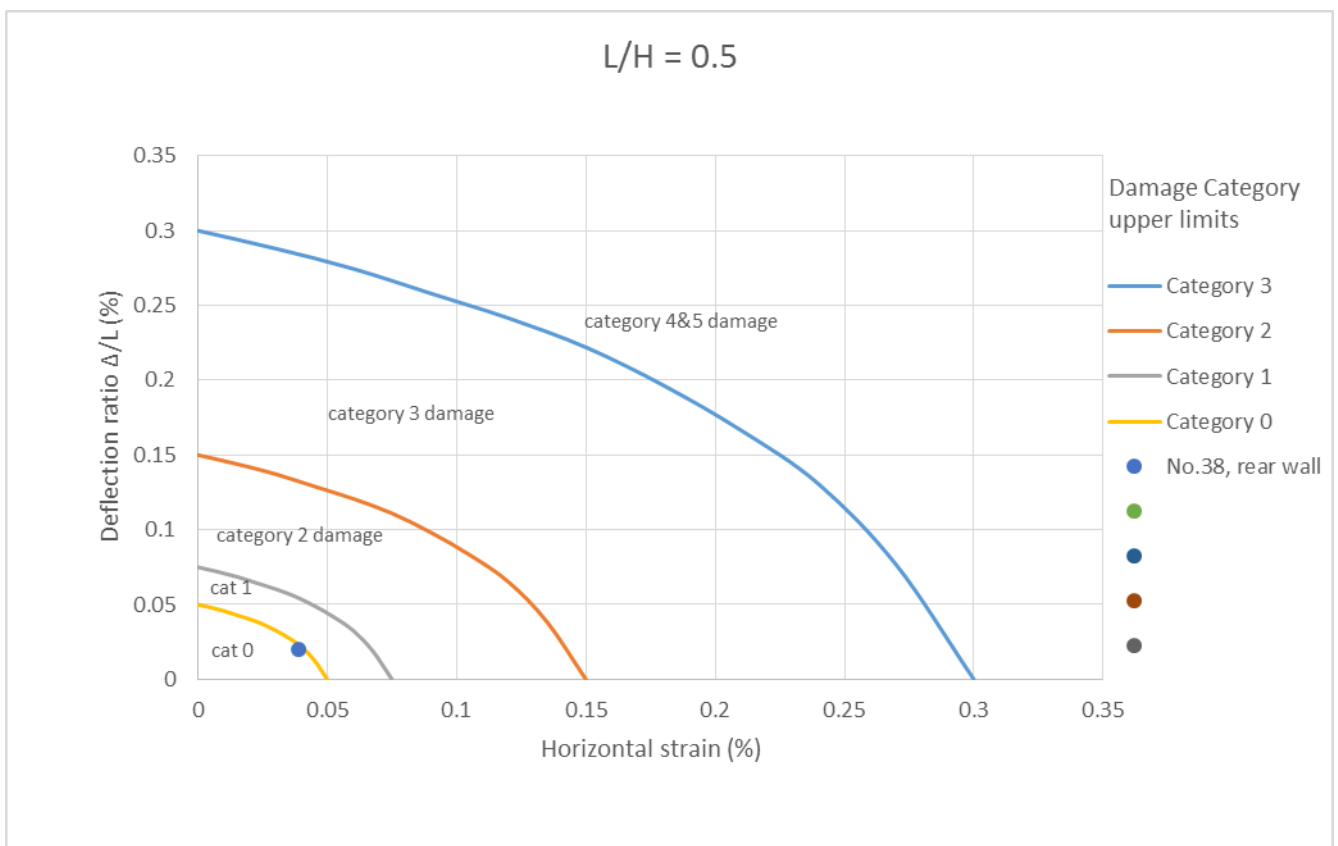
Figure 10: Damage category assessment for rear wall of No.38, the critical location.

10.6.6 The settlement of the 36/38 party wall predicted by the PDISP analysis must be added to the settlement resulting from relaxation of the ground alongside the excavation. The predicted settlements directly beneath this party wall were 3.5-4.0mm with allowance for monolithic behaviour at the ends (see Figure D5). The 4.0mm value at the rear end of the party wall, combined with the greater width of that part of No.38, represents the least favourable state, which gives 6mm total predicted settlement of the ground below the rear part of No.38. The settlement profile is expected to be convex, so the combined ground movement profile gave a maximum deflection, with a worst case ratio of 17%, $\Delta = 1.02\text{mm}$, which represents a deflection ratio, $\Delta/L = 1.99 \times 10^{-4}$ (0.020%).

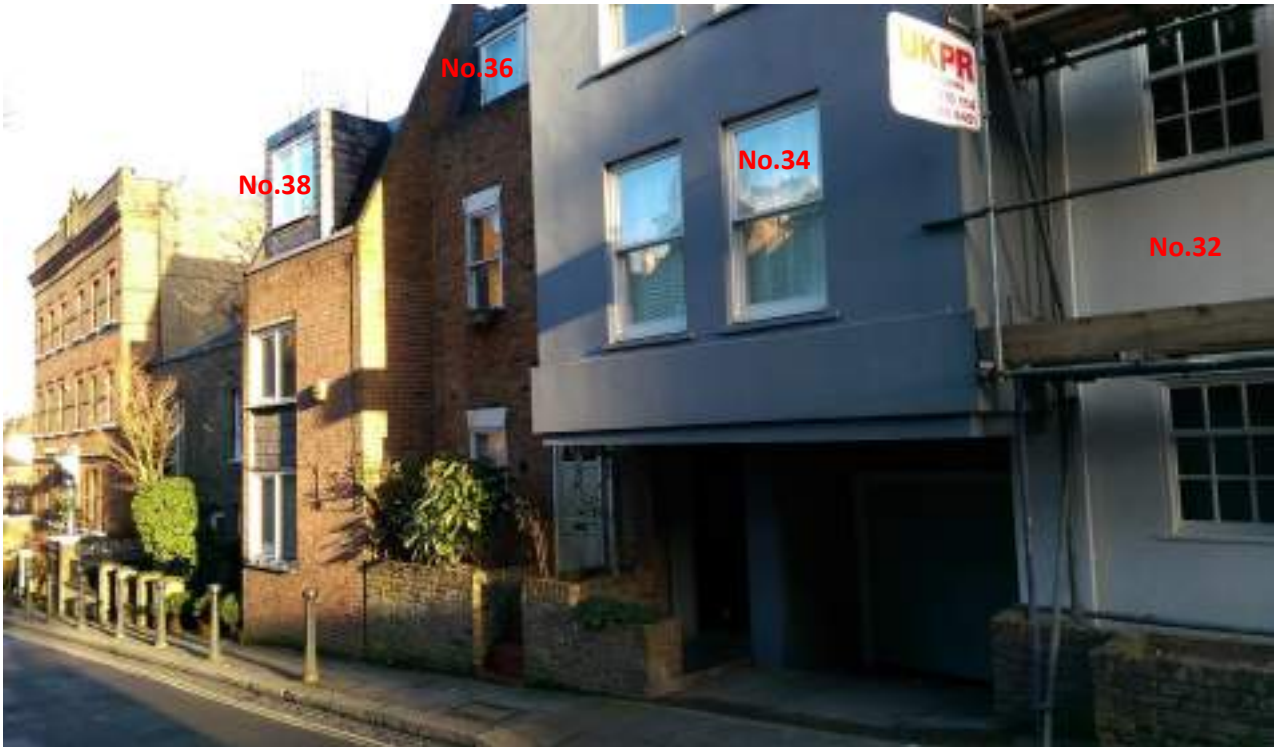
Photo 1: Front elevation (street scene) looking east. No.36 Flask Walk is a 3 storey terraced house with a mansard roof. There is a communal covered parking area which is shared by No's 30-36, and can be accessed via the garage door and ramp located beneath the adjoining No.34.

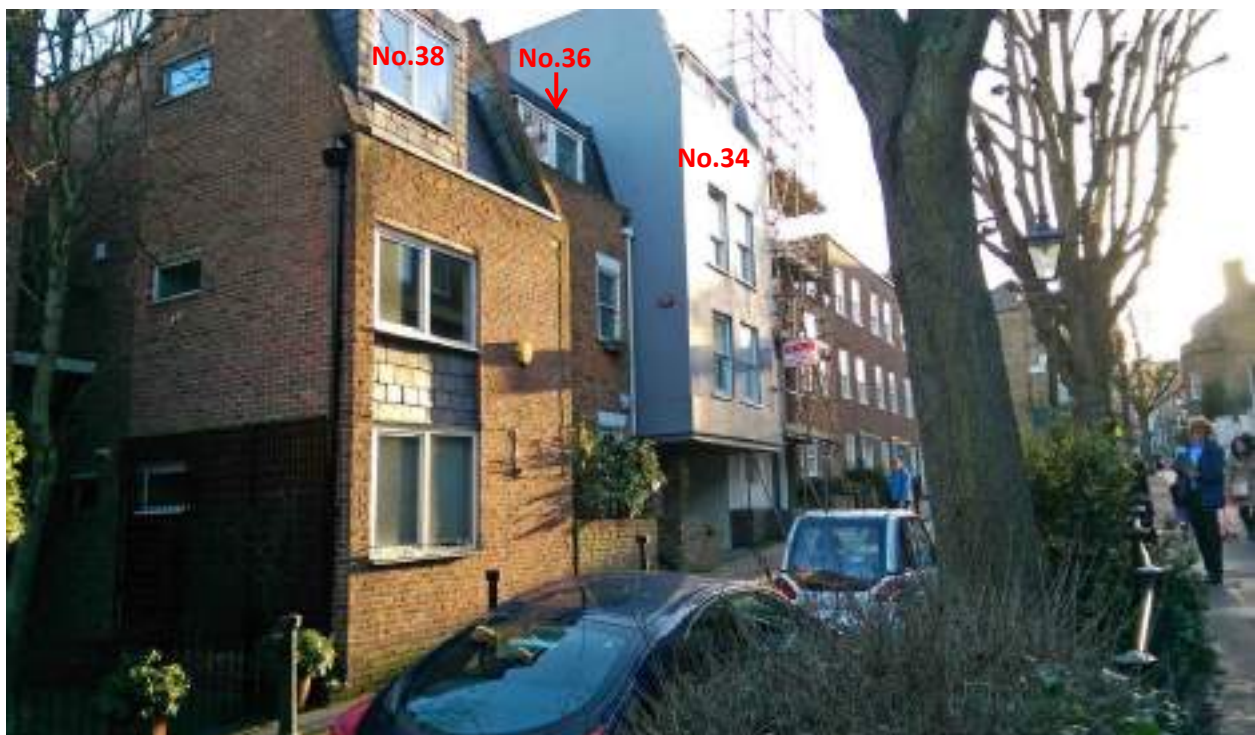
Photo 2: Front elevation (street scene) looking south-west. No.36 is situated on the south-east side of Flask Walk, between No's 34 & 38. Note the north-eastwards fall of the Flask Walk carriageway.

- 2.1 No.36 Flask Walk is a three storey terraced house (see cover photo) within the Hampstead Conservation Area, in the London Borough of Camden. Flask Walk can be accessed at both its north-east end, where it adjoins Well Walk and New End Square, or at its south-west end where it adjoins Back Lane, for vehicular access, and Hampstead High Street across a pedestrianized section. No.36 is situated on the south-east side of Flask Walk, adjoining No.34 to the south-west and No.38 to the north-east (as shown in Figure 1 and Photos 1 & 2 in Appendix A), and is bounded to the south-east by the rear garden to No.19 Spencer Walk.

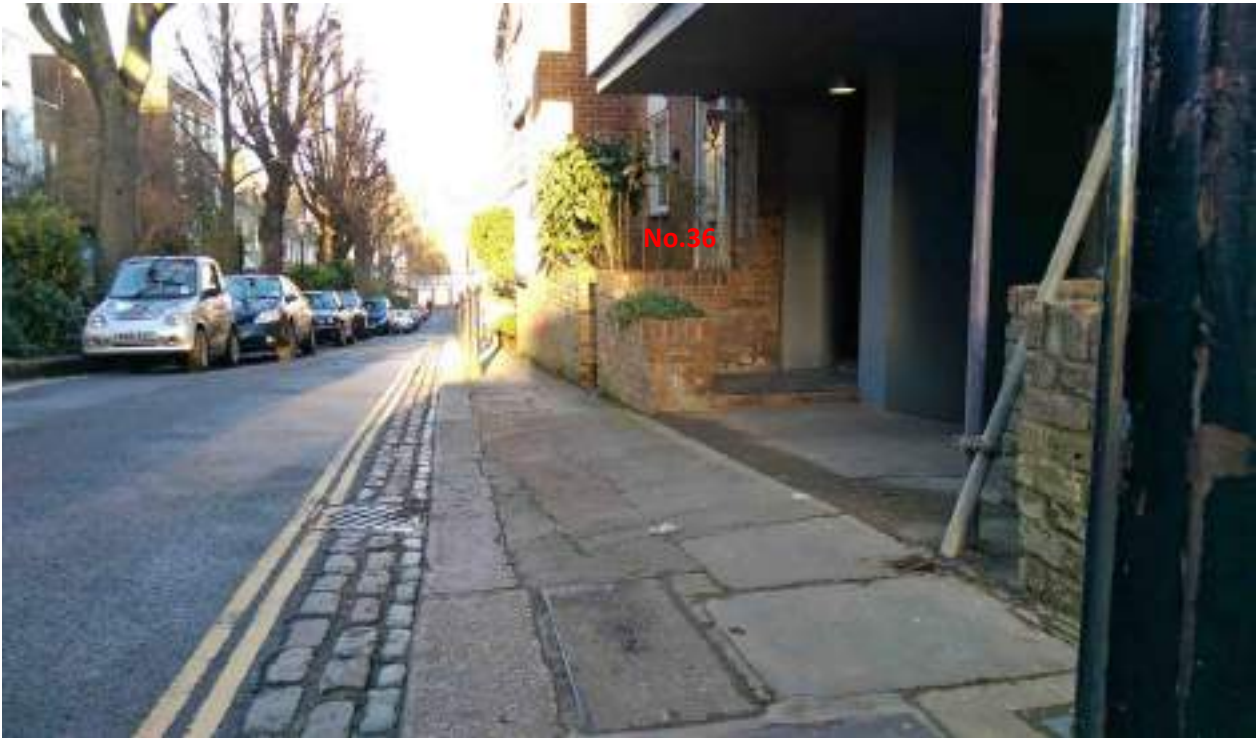
Photo 3: The footway falls gently towards the carriageway in front of the property, and falls more steeply towards the carriageway at the cross-over to the communal parking area.

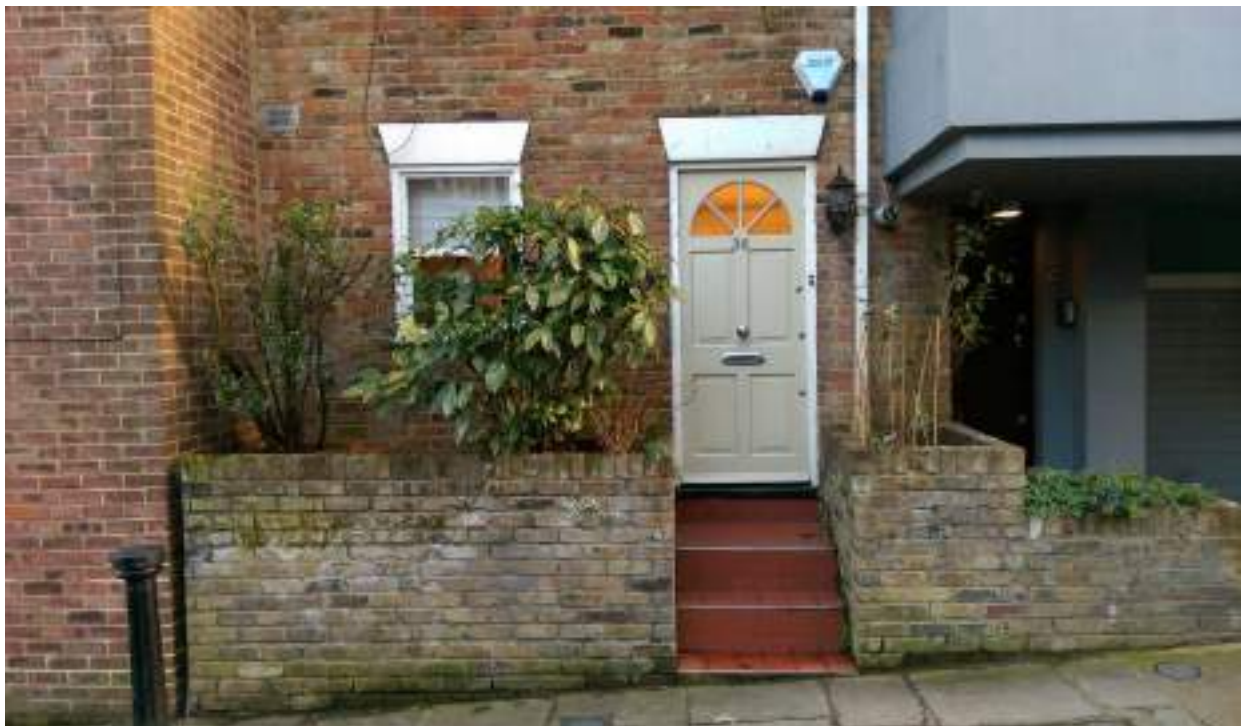
Photo 4: At the front of the property there are two raised planting areas, and a short flight of steps which lead up from the footway.

- there are brick walls surrounding the raised planting areas (see paragraph 2.6)..
- 5.4 The surface water catchment for the raised planting areas at the front of No.36 must be restricted exclusively to direct rainfall, and any drains which discharge into it, by the relatively high enclosing brickwork walls. Some infiltration is likely to occur in these areas as they consist of soft landscaping, although it is inferred that these may be constructed on original paved surface (see Paragraph 9.8), and hence whether recharge to the aquifer is possible. However, even if they have no bases, recharge is likely to be minimal given that the underlying Made Ground and natural soils were all clays.

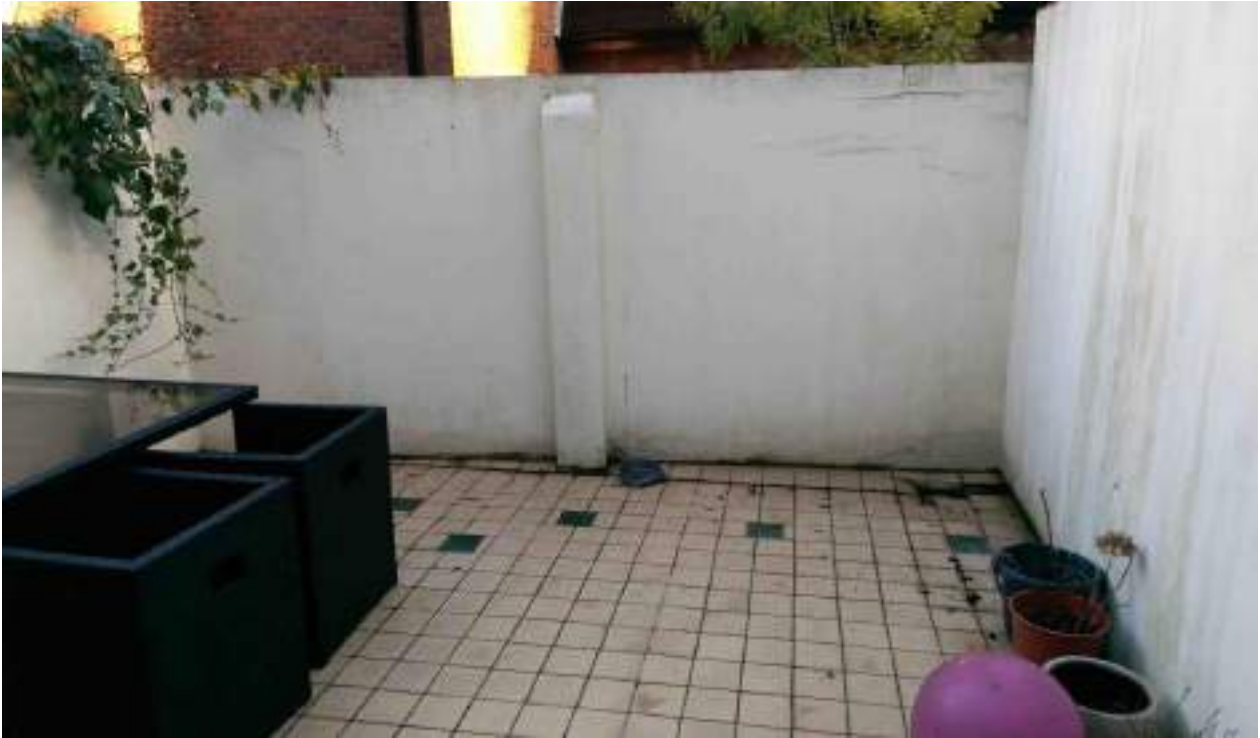
Photo 5: To the rear of the property there is a courtyard patio area which is bounded by high rendered walls on all sides, and surfaced with tiles.

- 5.5 The rear patio area to No.36 is bounded by high rendered boundary walls, therefore the surface water catchment for this area is also restricted to direct rainfall, and any drains which discharge into it. There will be no run-off from or to the neighbouring patio areas because the patio is fully walled. The rear patio area to No.36 is a suspended deck (surfaced with tiles), so infiltration will be nil.

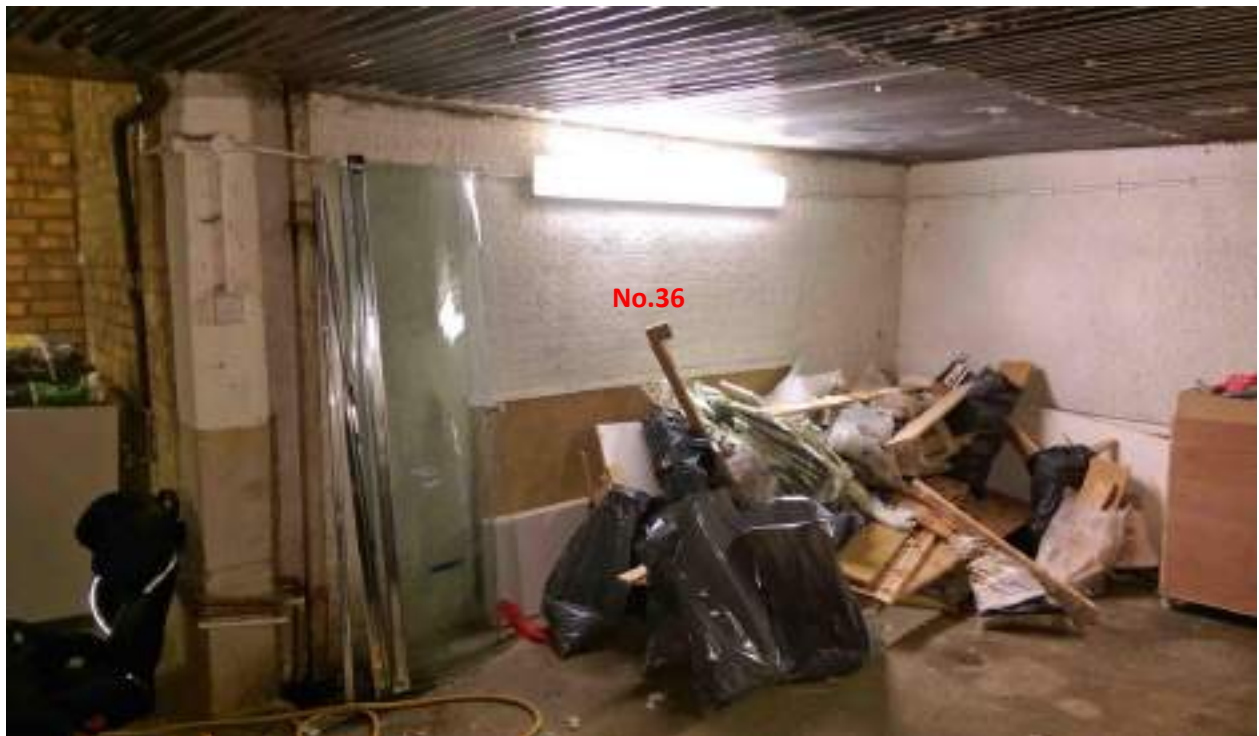
Photo 6: The communal parking area is located behind No.36, underneath the patio area (photo 5). The depth of the proposed basement will exceed that of the parking area, therefore the rear wall of No.36 will need to be underpinned. Note concrete pillar on left.

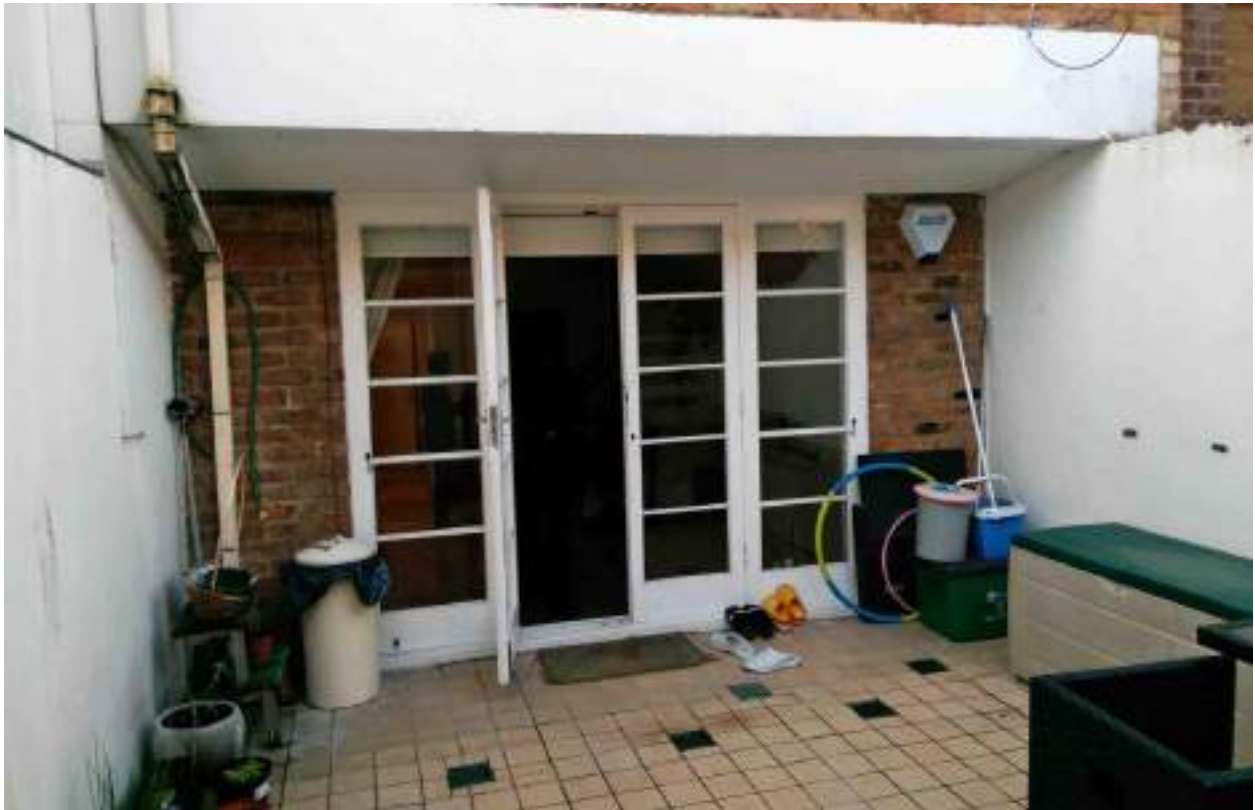
Photo 7: To the rear of the property a concrete beam can be found spanning the width of the house, resting on the No.36/34 and No.36/38 party walls. This beam transfers the load of the rear wall onto the party walls.

- 2.7 Minor cracking was noted around the east end of the beam which carried the rear wall above the patio. This beam appeared to be supported off reinforced concrete (RC) sections of the party walls; the 34/36 party wall projected out from the RC column seen in the communal garage below (see Photo 7) so this part of the building appeared to have a concrete frame.

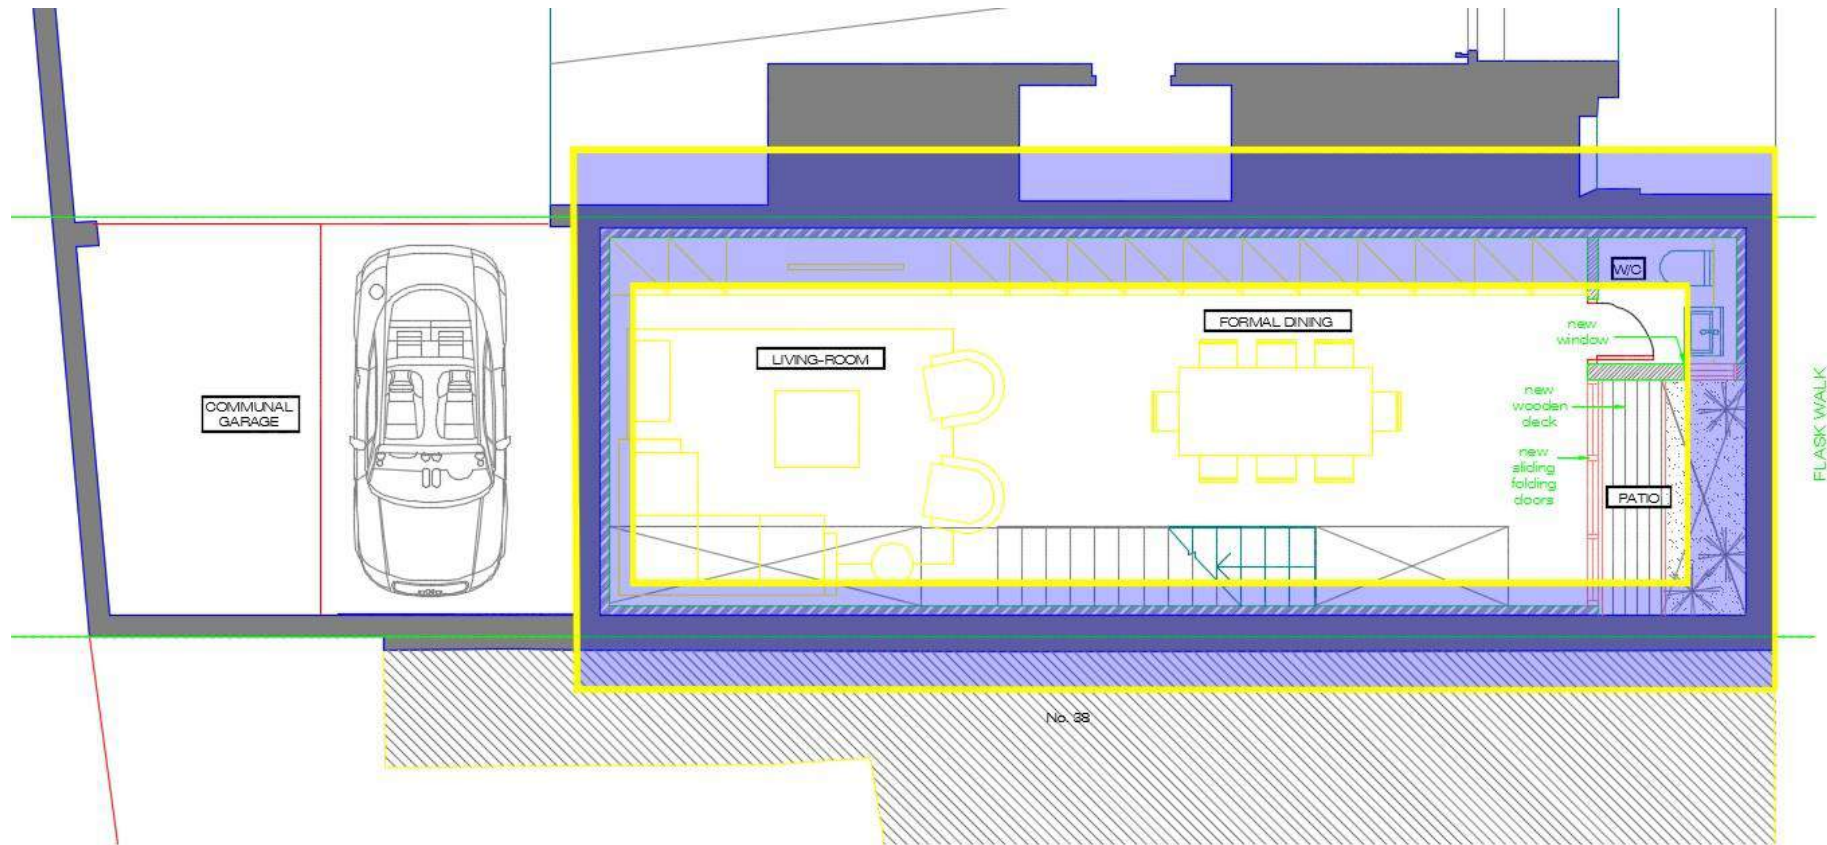
Figure D1. Layout of the proposed basement foundation plan
