A6. PERS AUDIT

PERS Audit

Iceni Projects

Traffic Surveys UK was appointed Icen Projects to prepare a PERS Audit of the pedestrian environment surrounding a development site on Gordon Road in the London Borough of Camden. The site is bound by Gordon and Endsleigh Place with Euston Train Station to the North of the site.

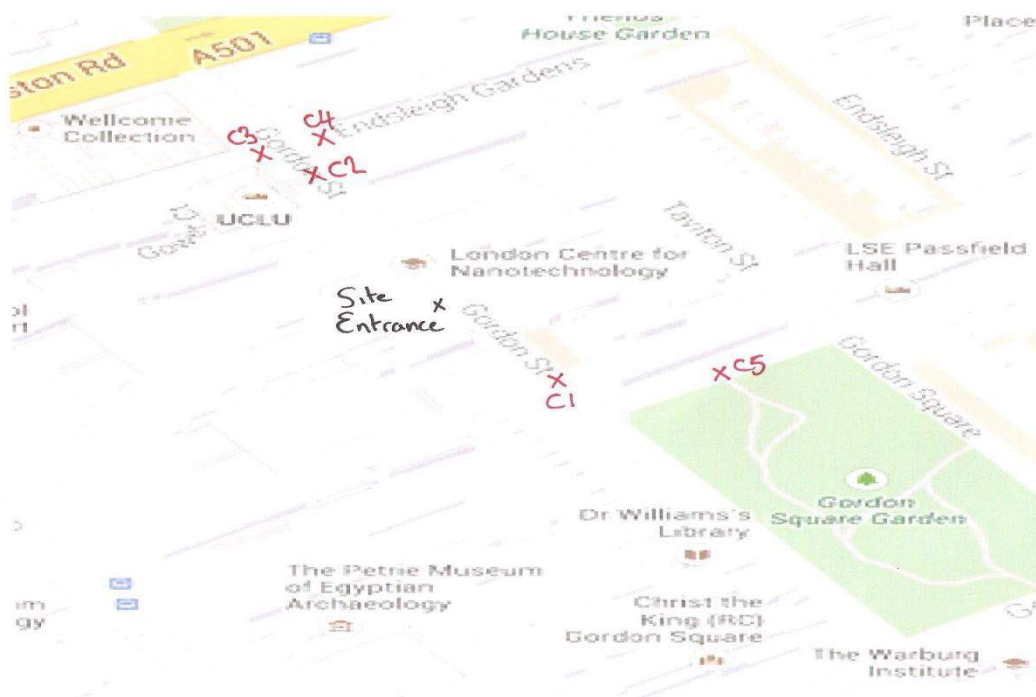
Illustration A: Features

All features assessed were scored as green (positive overall). The results of the PERS audit therefore indicate that the pedestrian environment around the site is generally of a good quality. This was reflected in green scores for the routes assessed. There were some minor maintenance issues highlighted on routes which would benefit from routine maintenance due to seasonal foliage and gum residue.

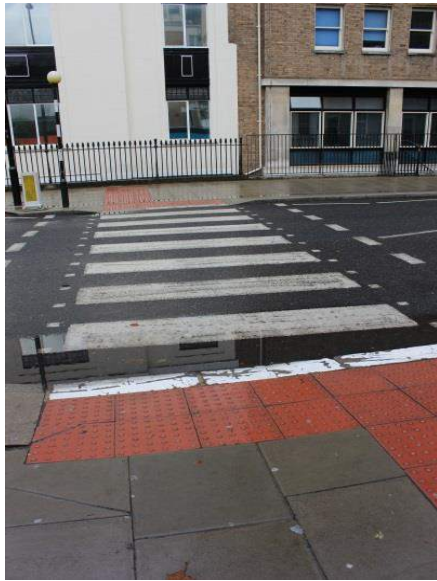
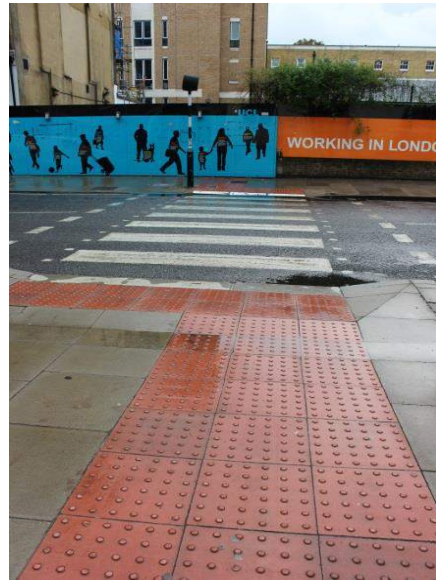
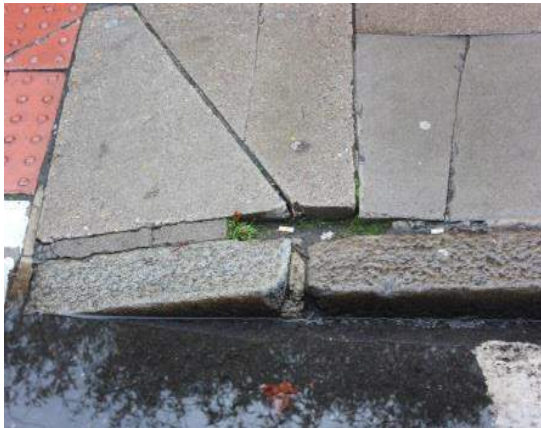
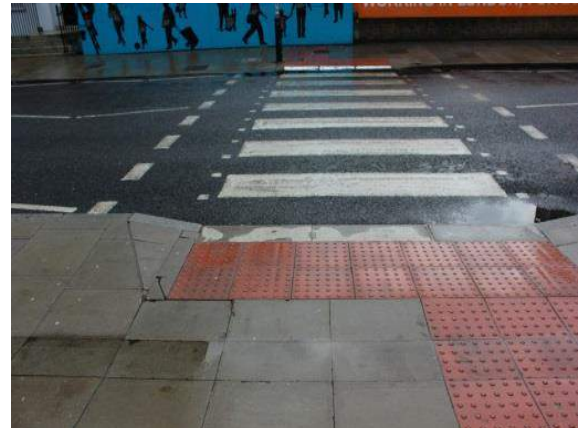
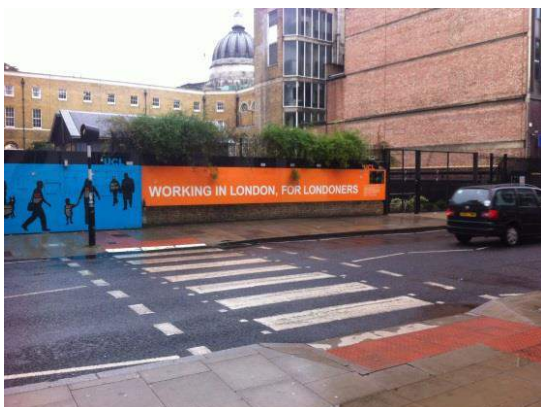
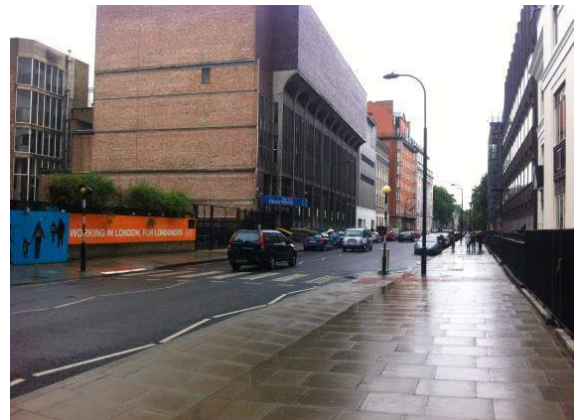
Plate 1
C1 Gordon Street South

3.2.2 The majority of crossings provide appropriate and safe crossing for the level of pedestrian movement at each location. C5 (Endsleigh Place) failed to give pedestrians a sufficient crossing capacity throughout with barely enough width for wheelchair users. All Zebra crossings had good capacity and had good performance. However C1 need maintenance due to ponding occurring on entrance and exits.

3.2.5 Tactile paving and dropped kerbs are provided at all crossings and were generally in a good state of repair. However at C1 the dropped kerbs need maintenance and improved draining and rainfall leaves ponding. C3 showed cracked and uneven tactile slabs that need

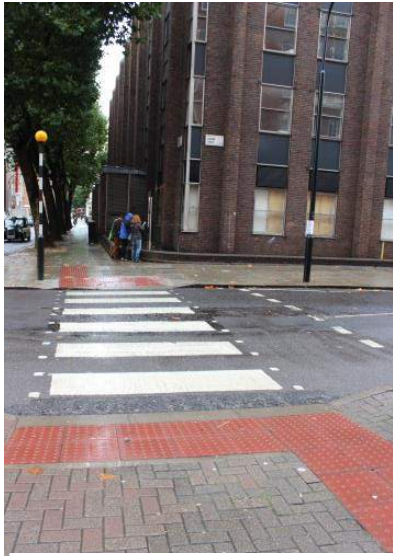
C2 Gordon Street North

*on observation cars speeding on road.
poor drainage & seasonal foliage.*

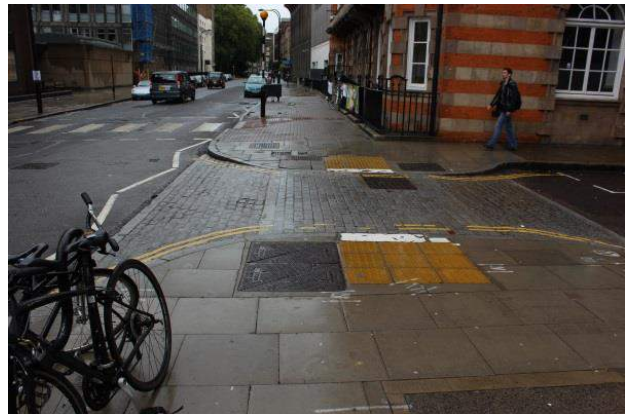
C3 Gower Place

replacing and multiple trip hazards with the surface quality across the crossing. This is would be especially dangerous for wheelchair users and sensory impaired people.

3.2.6 The road surface around most crossing was generally in good condition and the surface was even and easy to navigate except that of C3 which has already been highlighted.

5.1.6 C3 would benefit from increased maintenance to remove trip hazards and repair the damaged tactile at the crossing. Additionally a change on surface on the road at the crossing point would make the crossing safe for sensory impaired people and wheel chairs users.

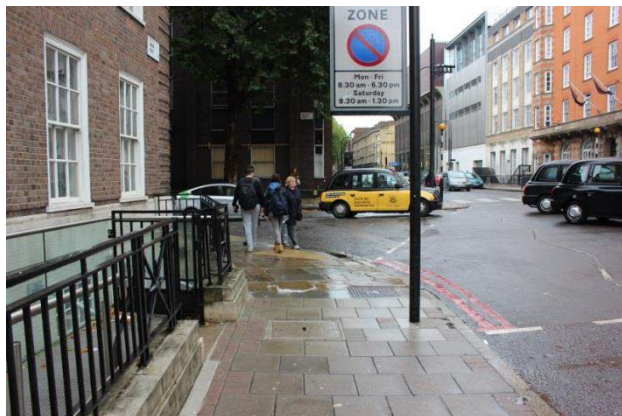
C4 Endsleigh Gardens

4.1.2 The results show that the majority of the crossings assessed achieved a high green score and were therefore positive overall with no particular issues of concern raised by the audit. However C4 raised issues due to the safety of the crossing for the pedestrians and received an 'amber' score. C5 also scored a low percentage figure but this was due to the deviation from the desired line.

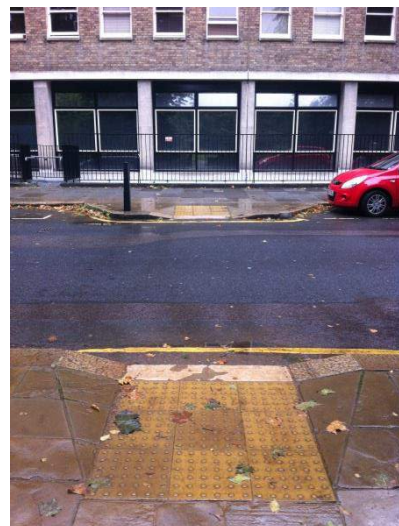
C5 Endsleigh Place

3.2.3 The majority of crossing coped with capacity for the location with C5 the only one to be viewed as insufficient. It should also be noted that multiple pedestrians cross the roads at points along the street and not a designated crossing points.

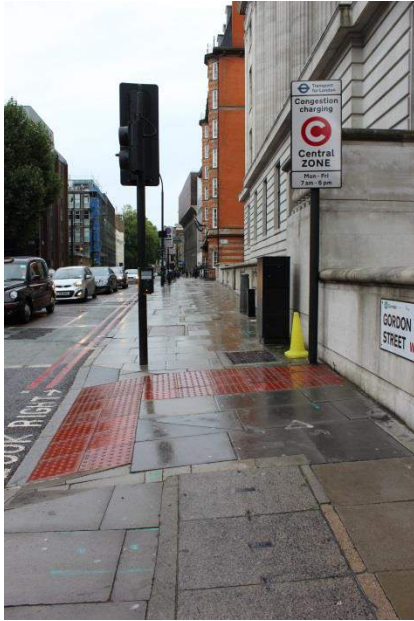
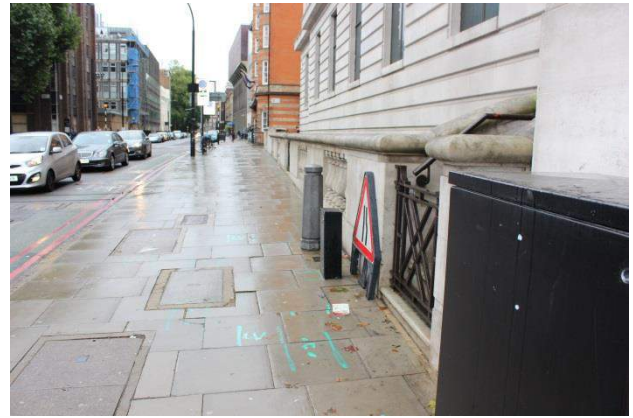
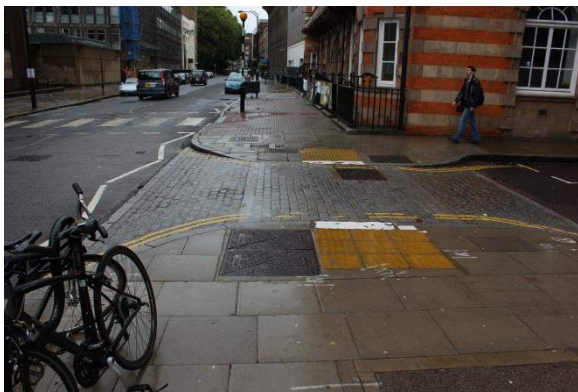
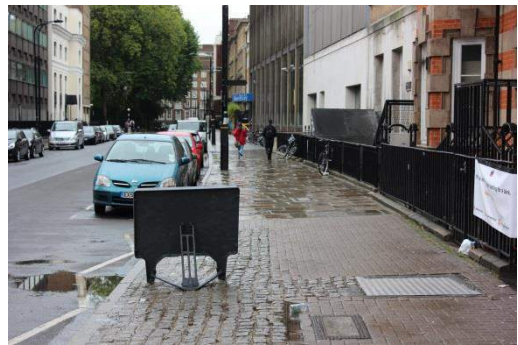
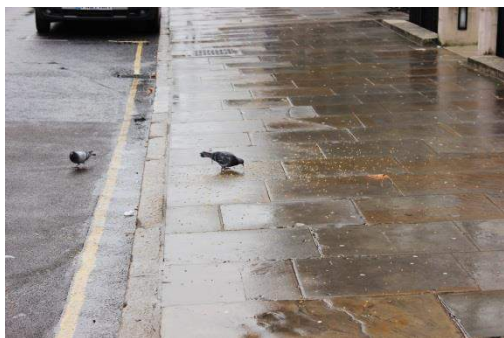
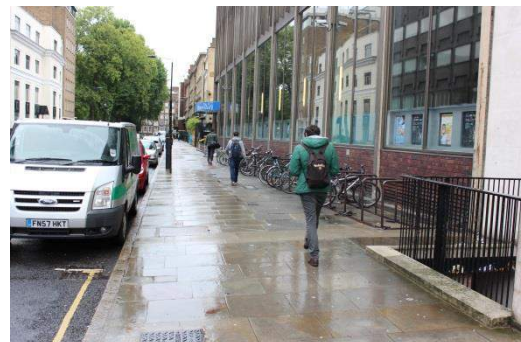
Plate 3
Route 1

4.2.2 Increased seasonal foliage due to survey taking place in autumn is seen in R4 which is big contributor to its low score. The foliage makes the footway slippery and dangerous to the pedestrians and cleaning is of vital importance. Additional concerns were raised in R1 where bird food was placed on the paths (see plate 3)
