**New Homes on  
Regent's Park Estate**

SD10 Ecology Assessment

## Regent's Park Estate

### Ecology Assessment

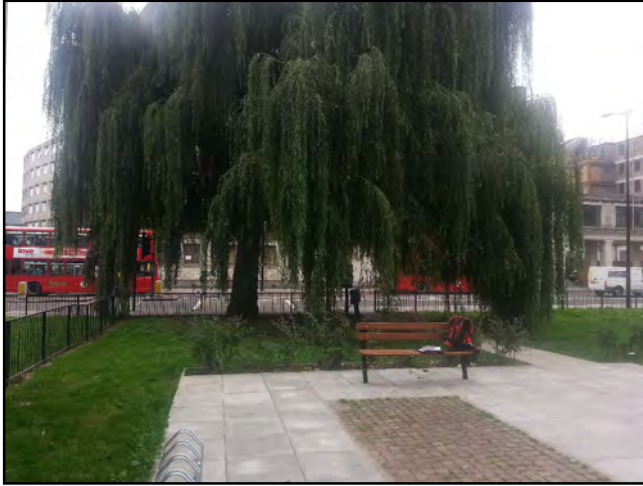
Photograph 1:  
North-west corner of Site 2.

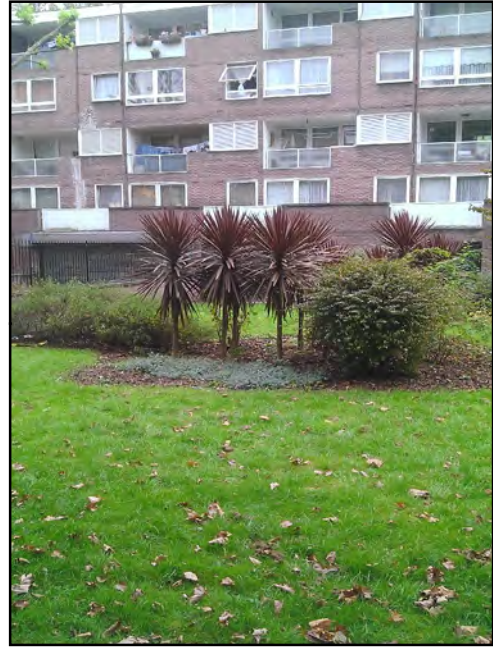
Photograph 2:  
Amenity grassland in Site 5 as viewed from the east.

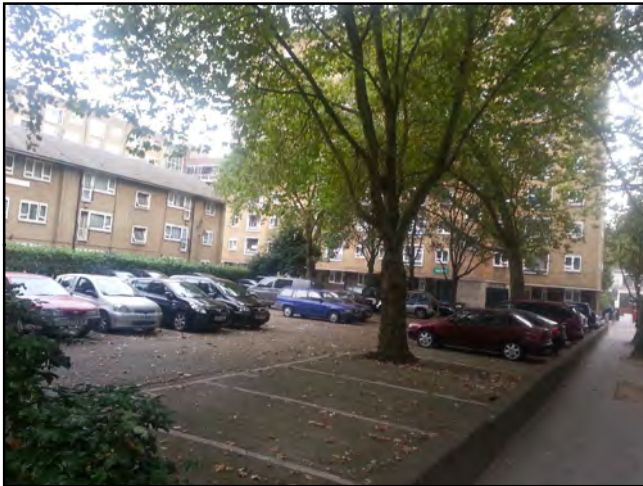
Photograph 3:  
Site 8 viewed from the south.

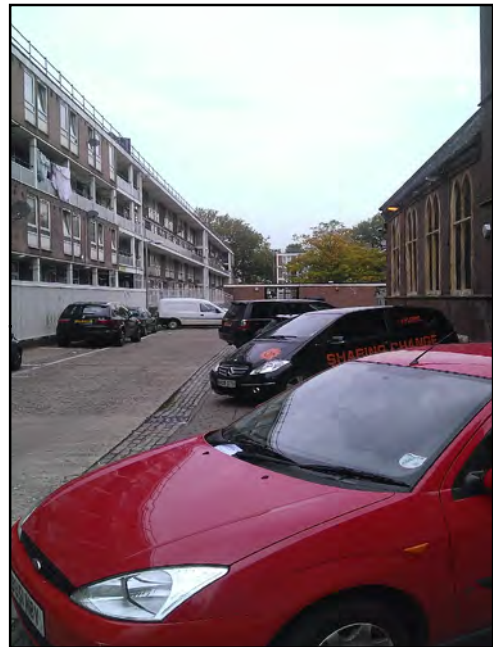
Photograph 4:  
Site 11 viewed from the east.

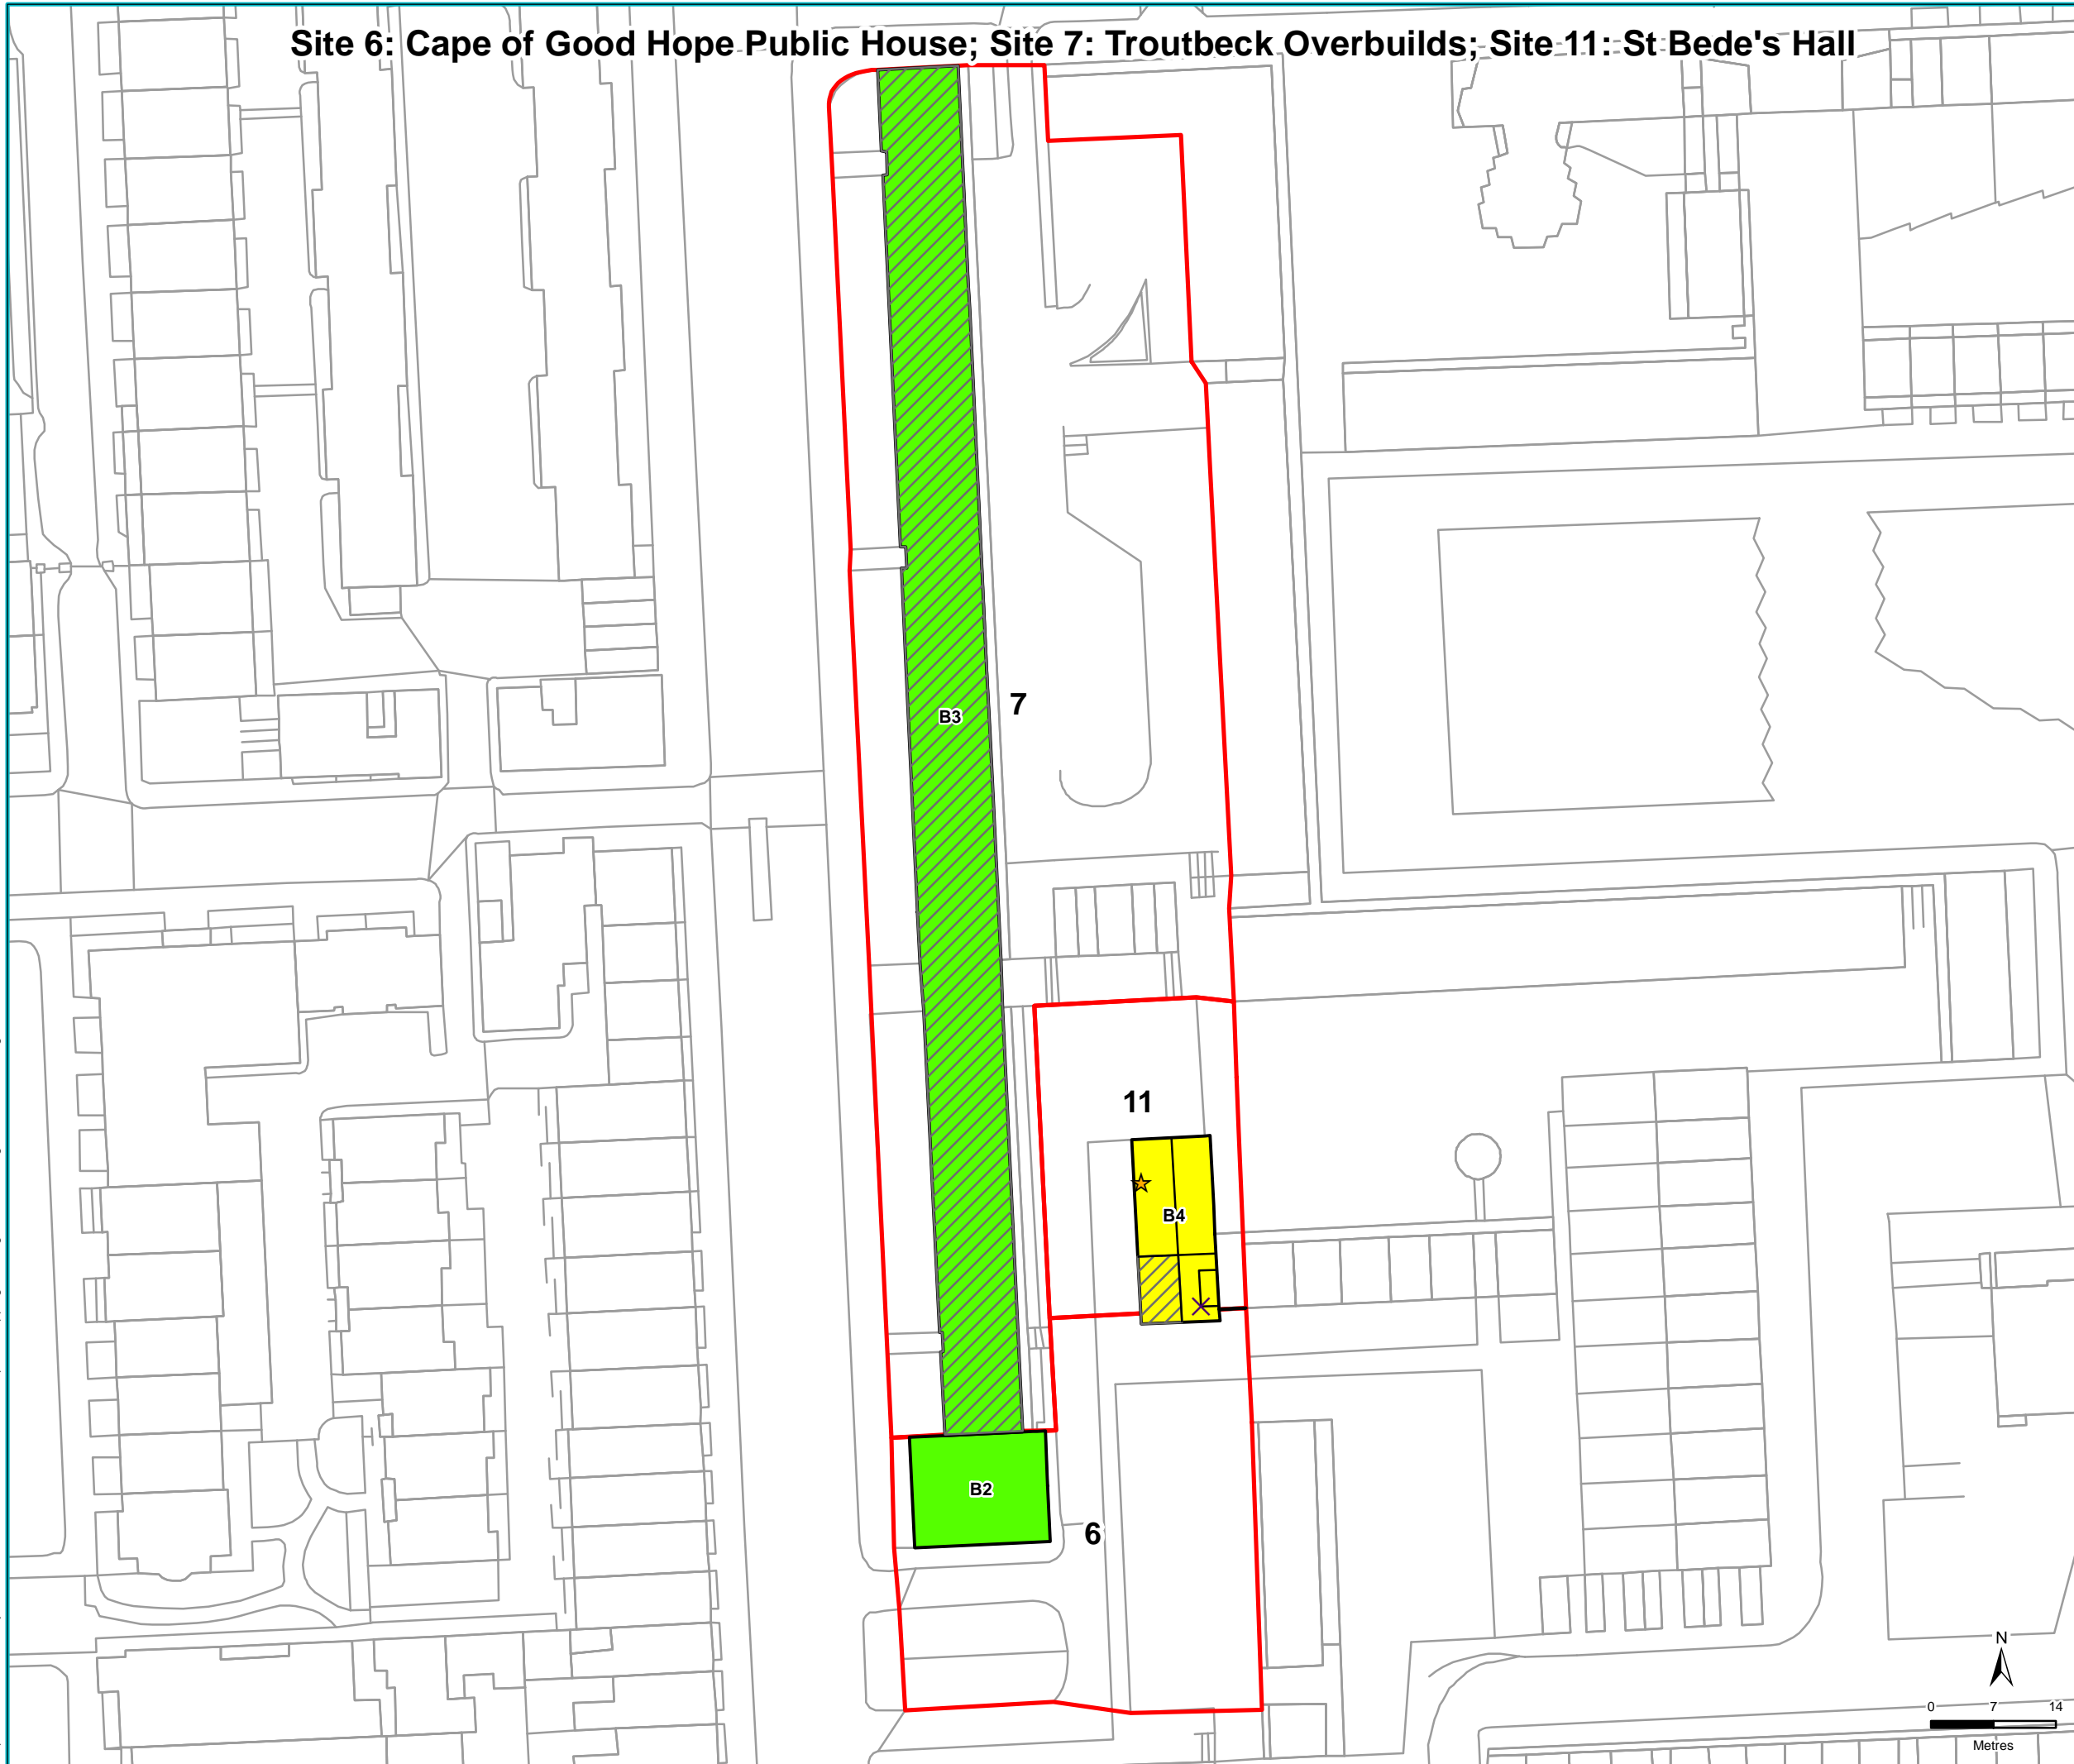
Figure Number  
4b

Figure Title  
External Building Inspection  
for Bat Results  
Site 6, 7 and 11

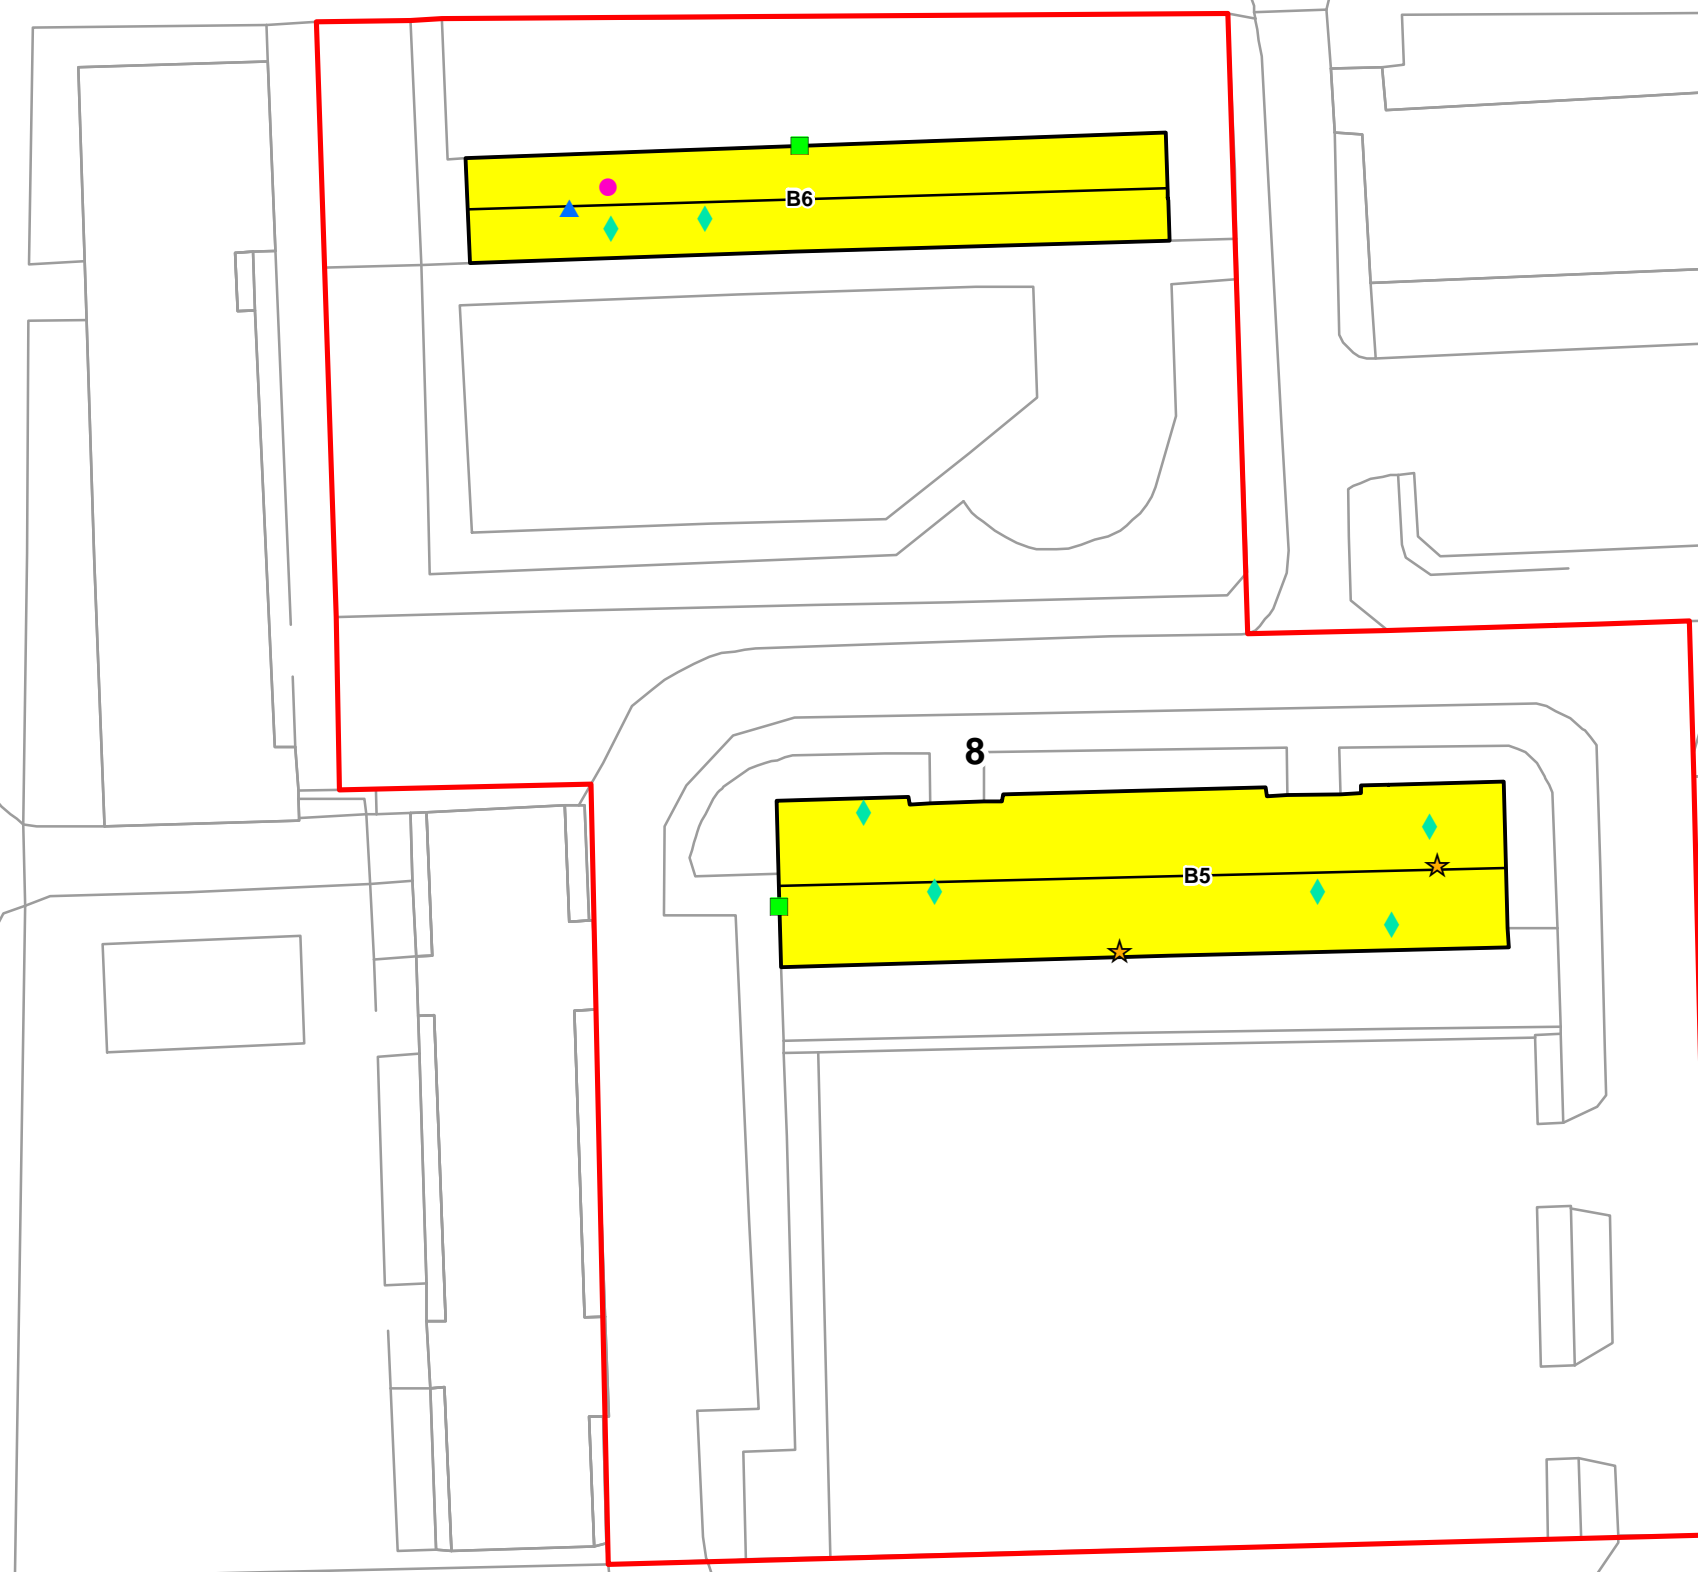
Figure Number  
4c

- Damaged ridge tile
- Drainage hole
- ▲ Gap under ridge tile
- ★ Gap under tile
- ◆ Missing tiles

Figure Title  
External Building Inspection  
for Bat Results  
Site 8

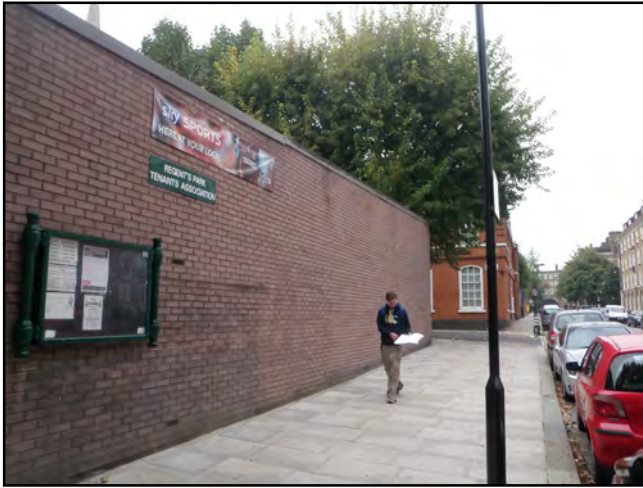
Photograph 1:  
Building 1 (including the Dick Collins Community Hall) was assessed as having negligible potential to support roosting bats.

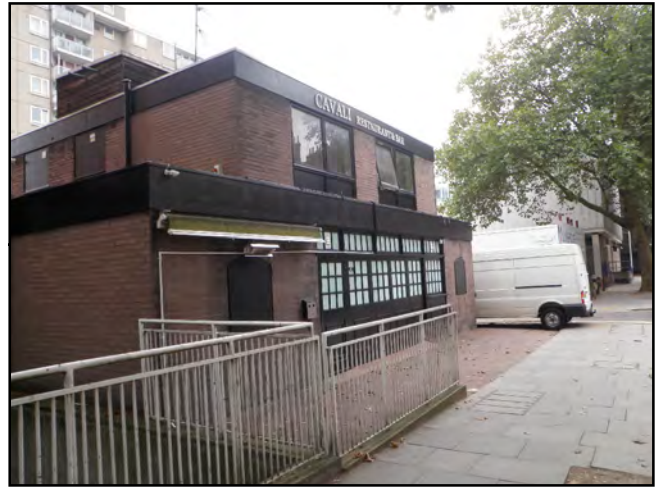
Photograph 2:  
No features suitable for roosting bats were identified on Building 2 (Cavalli Restaurant and Bar).

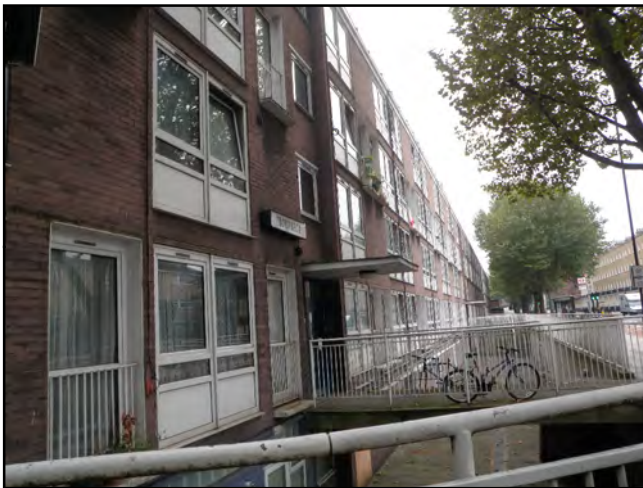
Photograph 3:  
The Troutbeck Overbuilds (Building 3) was also assessed to have negligible potential to support roosting bats.

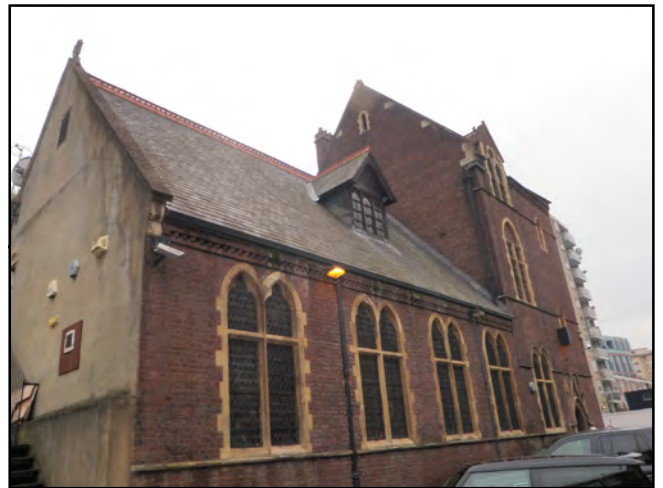
Photograph 4:  
St Bede's Hall (Building 4) is a former church, structure assessed as having low overall potential to support roosting bats.

1.3.1 If it is necessary to demolish or significantly modify buildings St Bede's Hall, Newby Overbuilds, Staveley Overbuilds and Victory Public House assessed to have low potential to support roosting bats, further survey is recommended to determine the presence or likely absence of this species group. In line with best practice guidelines, at least two dusk and/or dawn return to roost bat surveys of the buildings should be undertaken spaced at least a month apart, prior to works commencing. These surveys should be undertaken between May and August inclusive and in September weather dependent. Should roosting bats be found to be present at the site it would be necessary to obtain a European Protected Species Licence (EPSL), informed by an appropriate mitigation strategy.

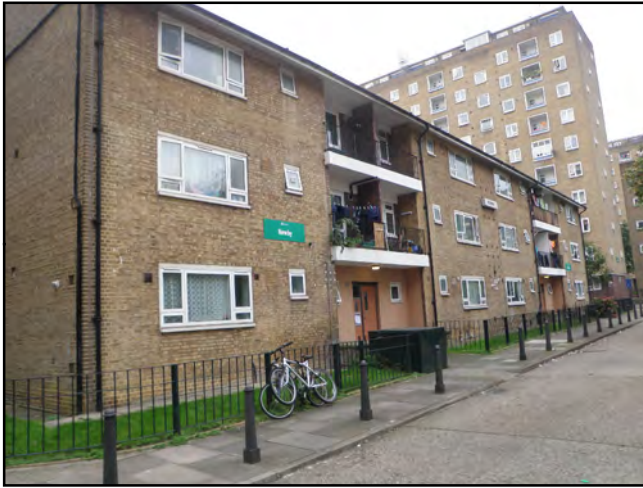
Photograph 5:  
Due to the presence of features including missing roof tiles, the Newby Overbuilds (Building 5) were assessed to have low overall potential to support roosting bats.

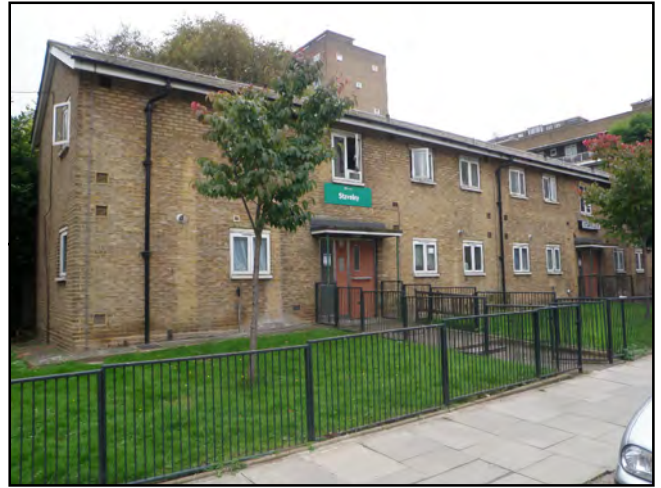
Photograph 6:  
Suitable roosting features, including a lifted ridge tile, were identified on the Stavely Overbuilds (Building 6), which was also assessed to have low potential to support roosting bats.

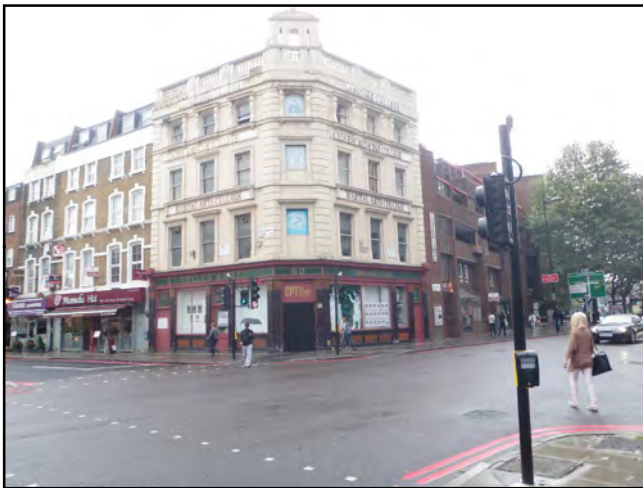
Photograph 7:  
The Camden People's Theatre (Building 7) was assessed to have negligible potential to support roosting bats.

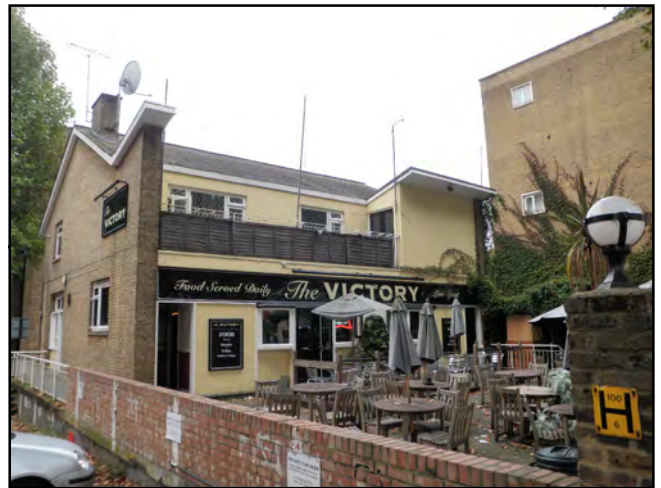
Photograph 8:  
Missing and loose roof tiles were recorded on the roof of the Victory Pub (Building 8) which was assessed as having low potential to support roosting bats.

- 3.1.8. As it was not possible to arrange access for an internal inspection of Plot 8 The Victory Pub (formally Site 10), it is recommended that an internal inspection is undertaken prior to demolition works to Plot 8 The Victory Pub. Any demolition works should be undertaken following a 'Working Method Statement' (WMS). The WMS would detail how the works should proceed with caution to include that all features suitable for use by bats be removed using hand tools under the supervision of a Natural England bat licence holder. Should a bat roost or evidence of a bat roost be discovered, it would be necessary for works to halt immediately and Natural England be consulted on how to proceed, as if bats are disturbed or a roost damaged or destroyed, an offence will have been committed under national and European legislation.

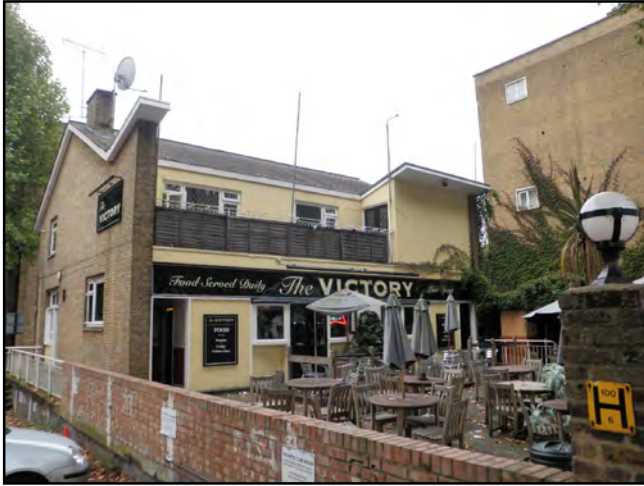
Photograph 1:  
 The Victory Public House is a functional public house assessed as having low potential to support roosting bats.

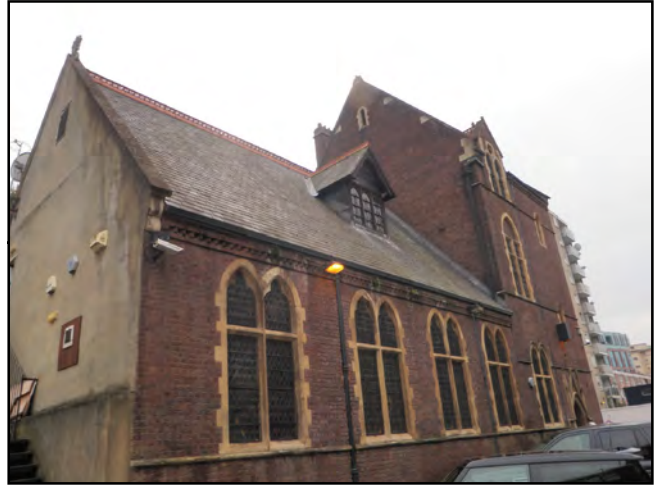
Photograph 2:  
 St. Bede's Hall is a converted church assessed as having low potential to support roosting bats.

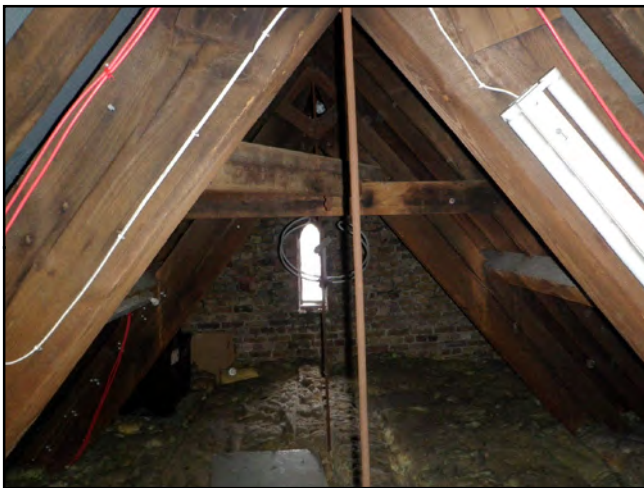
Photograph 3:  
 St. Bede's Hall within the elevated tower section to the south of the building.

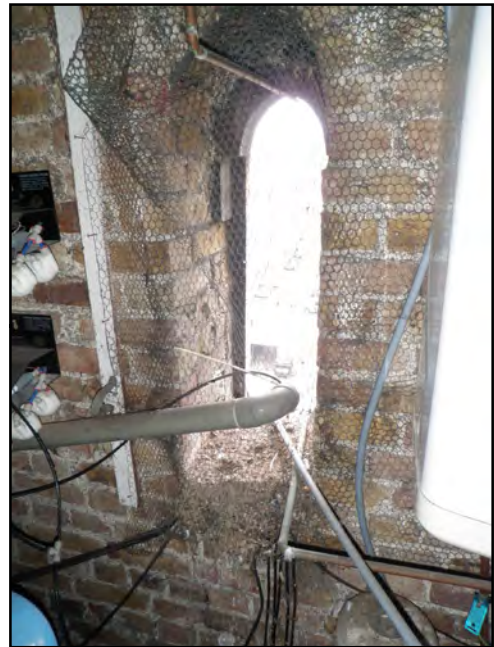
Photograph 4:  
 St. Bede's Hall evidence of breeding birds within the elevated tower section to the south.

- 3.1.4. Plot clearance involving removal of trees, hedgerows, introduced shrub and buildings should be undertaken outside of the breeding birds season, i.e. site clearance and demolition should be undertaken in the period September to February, inclusive. If this is not possible, the demolition of the buildings and clearance of vegetation should take place under an ecological watching brief in the presence of an ecologist. This would involve checking for nests immediately prior to, and during demolition and clearance. If an active nest is found, works will be stopped in that area and an exclusion zone put in place until the nest is no longer active.
