GEO-ENVIRONMENTAL SITE INVESTIGATION 102 CAMLEY STREET, LONDON

REC REFERENCE: 20698P1R0

MAY 2014

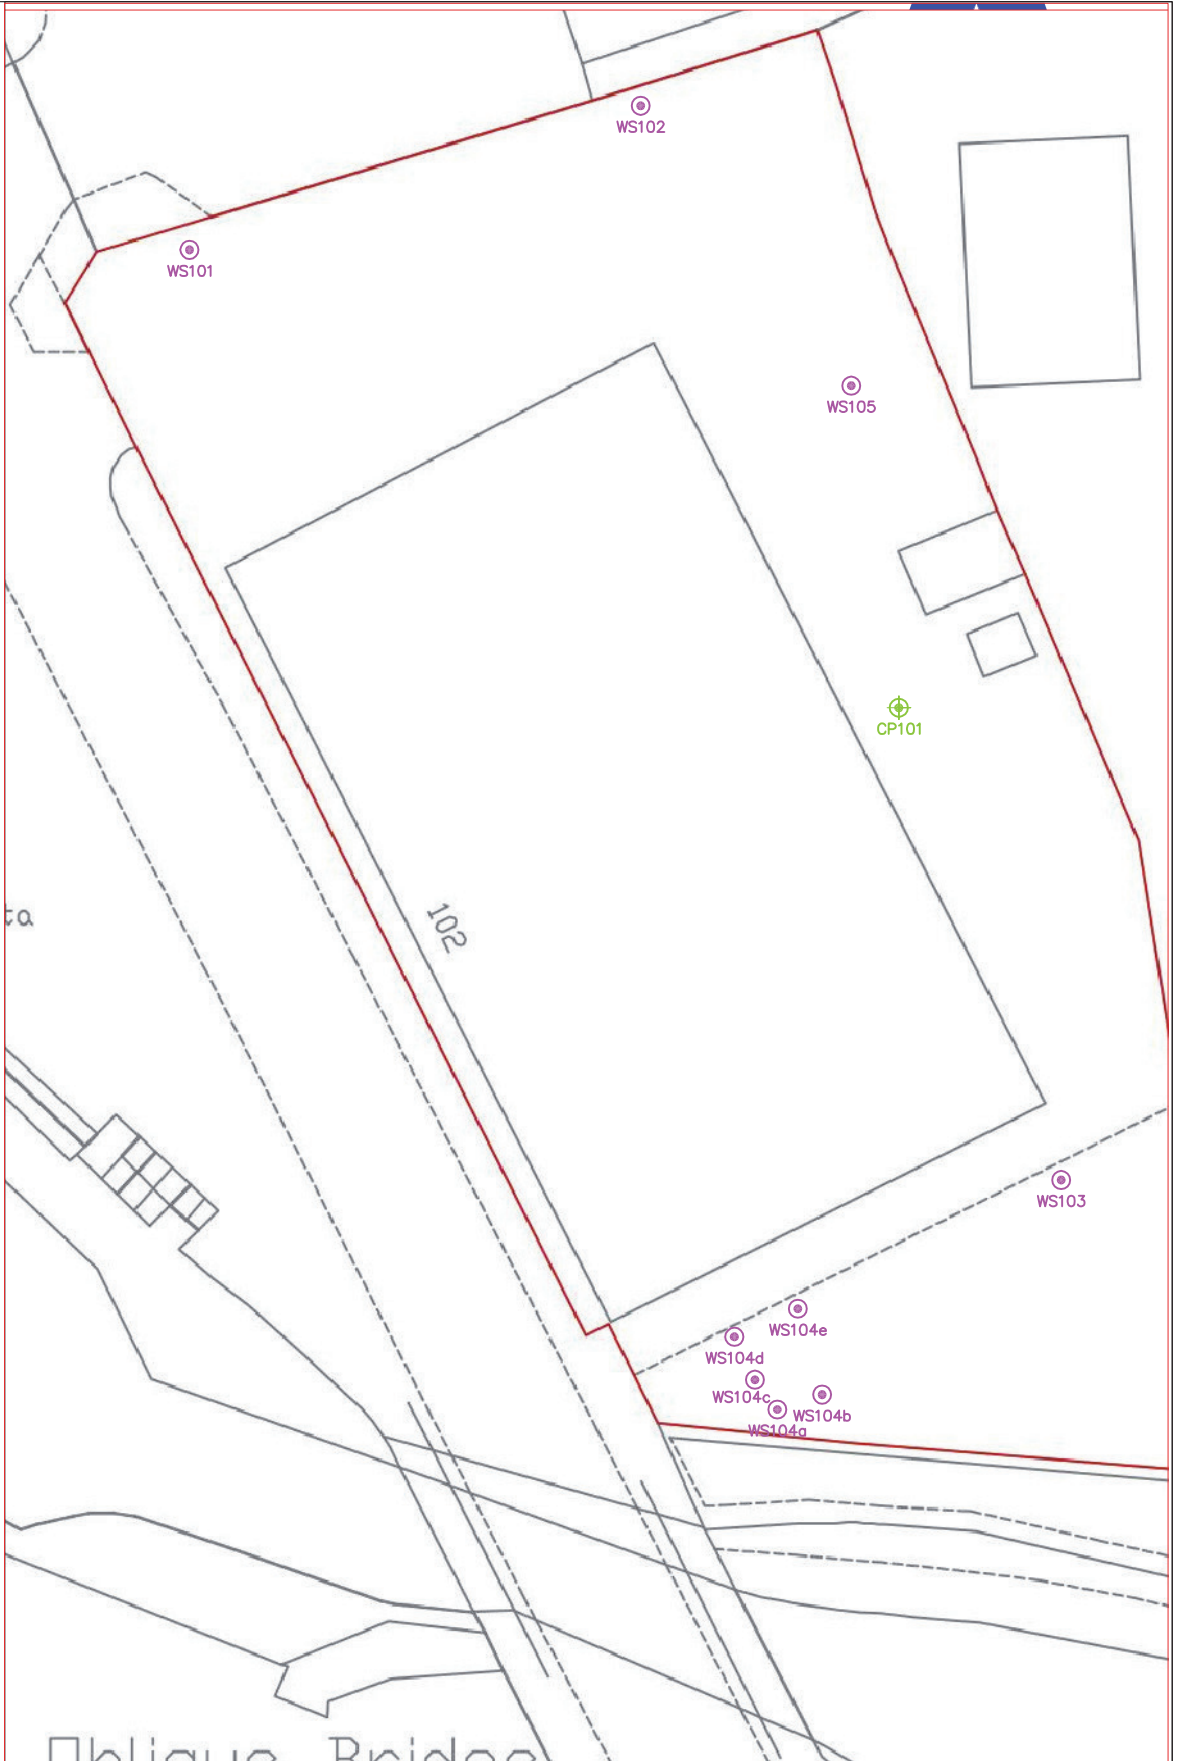
CP101
 Approximate Cable Percussive
 Borehole Location

The sample locations are illustrated in Figure 2 (Appendix III).

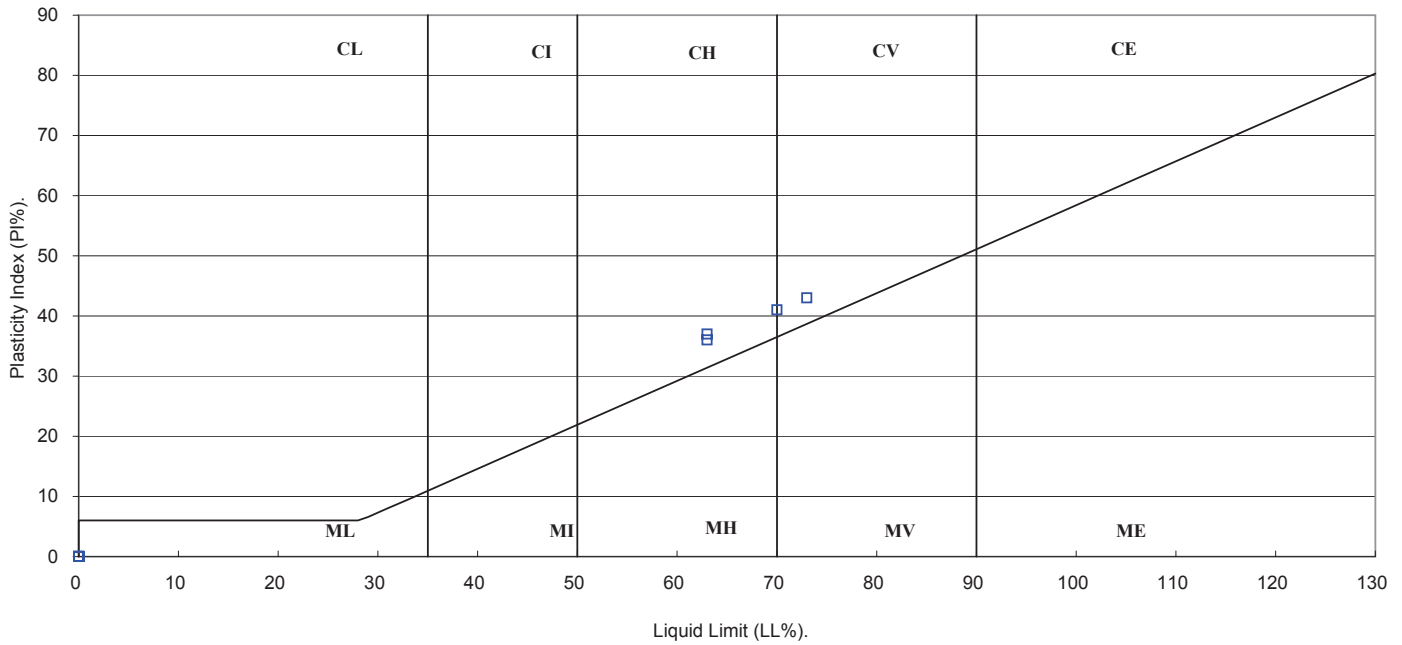
PLASTICITY CHART FOR CASAGRANDE CLASSIFICATION.

(B.S.5930 : 1999)

Location	Depth (m)	Natural Moisture Content (%)	Plastic Limit (%)	Liquid Limit (%)	Plasticity Index (%)	Percentage passing 425µm sieve (%)	Volume Change Potential
BH101	5.00-5.45	28	29	70	41	100	High
BH101	9.50-9.95	24	30	73	43	100	High
BH101	25.50-25.95	24	27	63	36	100	Moderate
BH101	34.50-34.95	22	26	63	37	100	Moderate

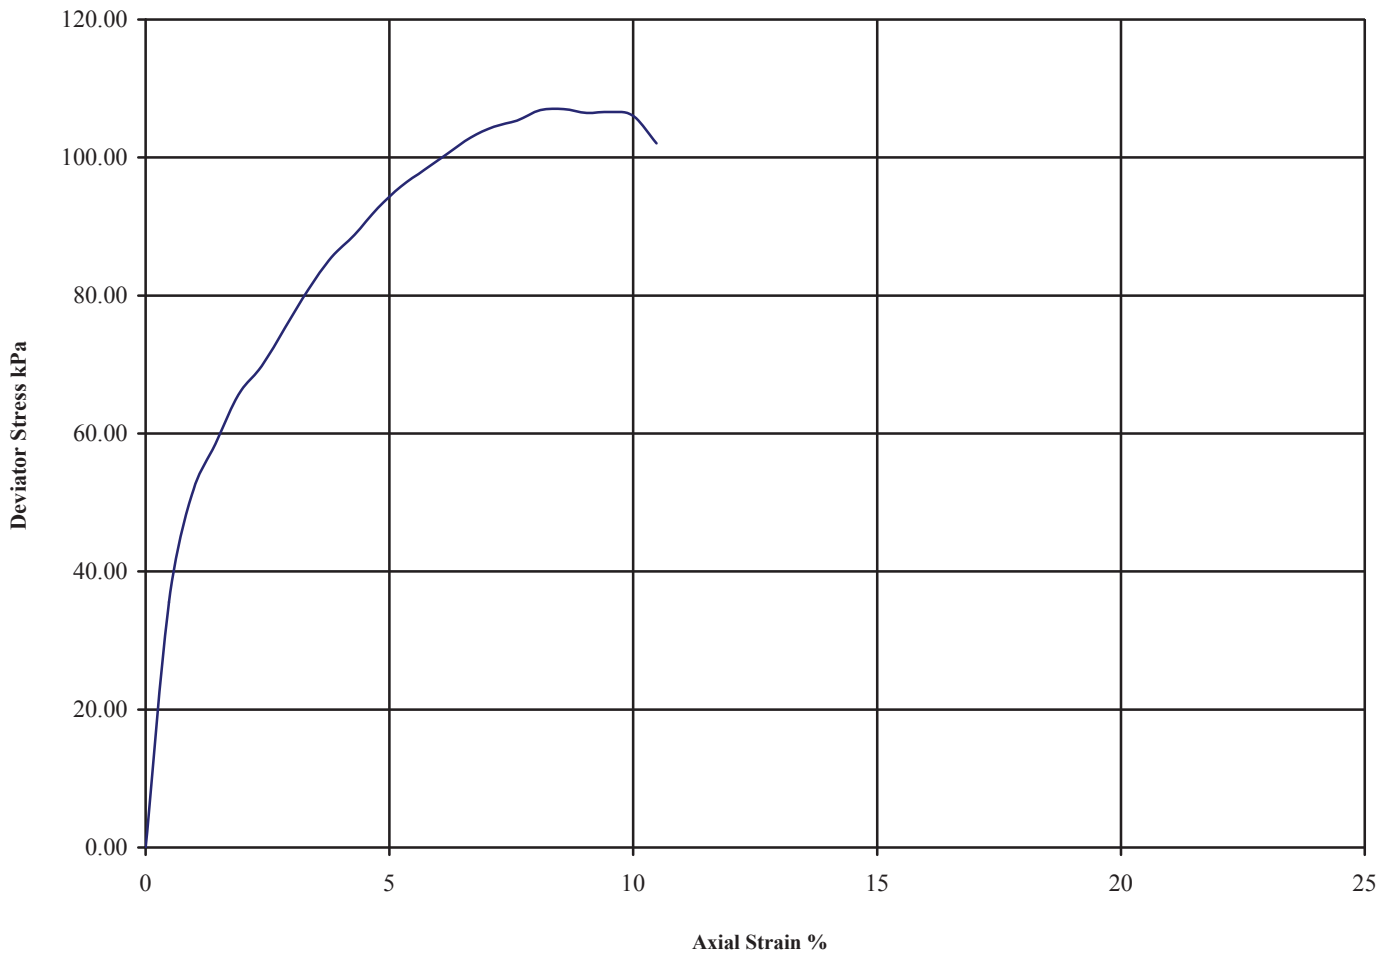
Undrained Shear Strength in Triaxial Compression

Diameter (mm):		102.0	Height (mm):		210.0	Test:		100 mm Single Stage. Undisturbed									
Specimen	Moisture Content (%)	Bulk Density (Mg/m ³)	Dry Density (Mg/m ³)	Cell Pressure (kPa)	Corr. Max. Deviator Stress (kPa)	Shear Strength Cu (kPa)	Failure Strain (%)	Mode of Failure	Remarks								
				θ_3	$(\theta_1 - \theta_3)_f$	$\frac{1}{2}(\theta_1 - \theta_3)_f$											
A	28	1.97	1.54	100	107	54	8.6	Brittle									
									Sample taken from top of tube Rate of strain = 1.9 %/min Latex Membrane used 0.2 mm thickness, Correction applied 0.36 kPa See summary of soil descriptions.								
									<table border="1"> <thead> <tr> <th>Checked</th> <th>Date</th> <th>Approved</th> <th>Date</th> </tr> </thead> <tbody> <tr> <td><i>Re</i></td> <td>15/05/14</td> <td><i>Re</i></td> <td>15/05/14</td> </tr> </tbody> </table>	Checked	Date	Approved	Date	<i>Re</i>	15/05/14	<i>Re</i>	15/05/14
Checked	Date	Approved	Date														
<i>Re</i>	15/05/14	<i>Re</i>	15/05/14														
			102 CAMLEY STREET, CAMDEN.				Contract No: PSL14/2054

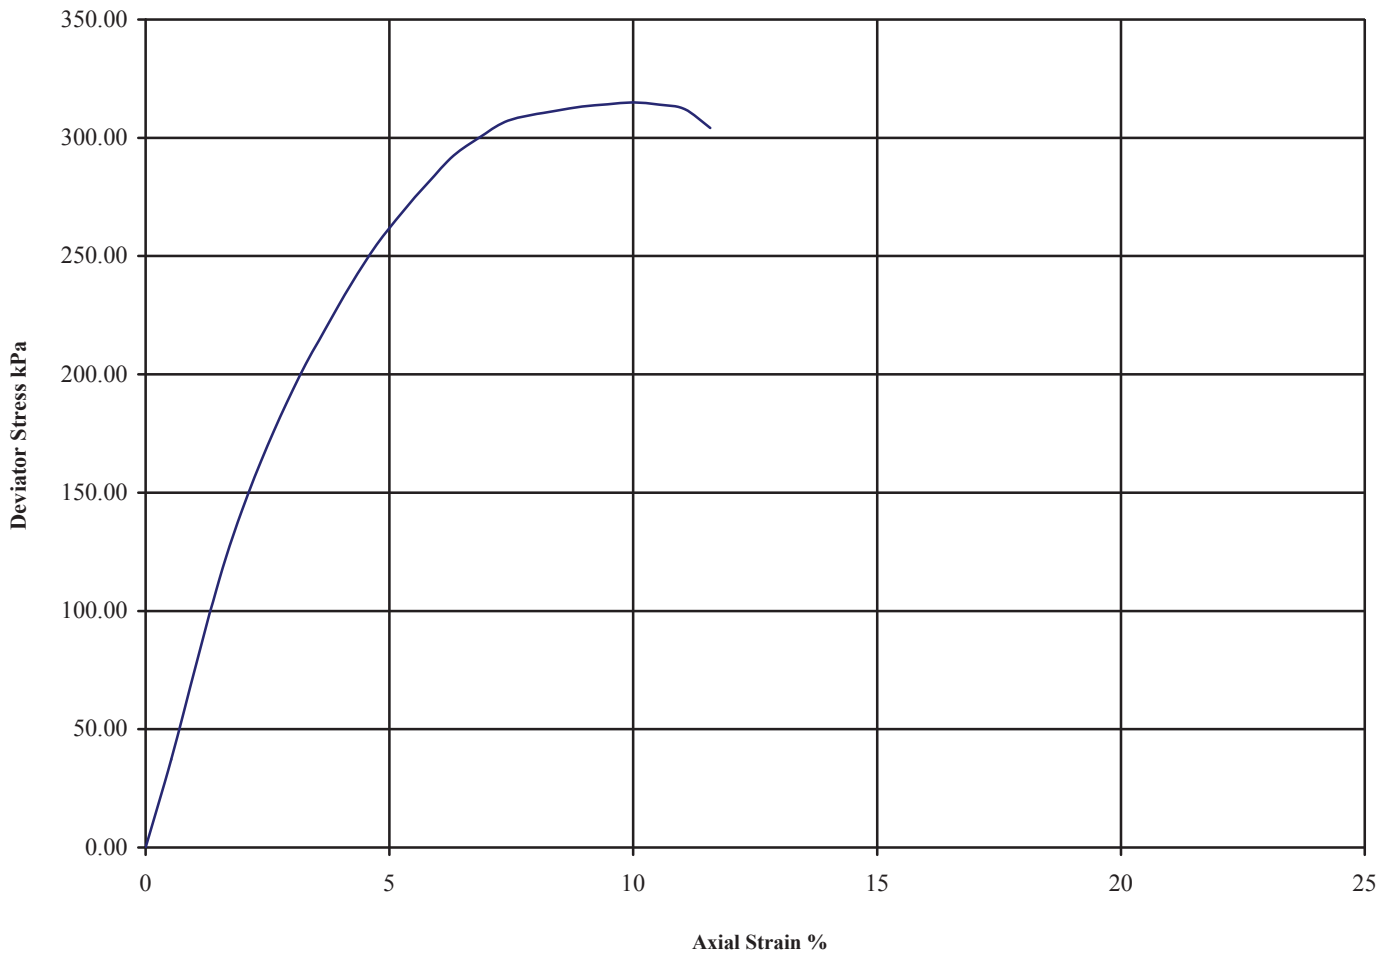
Undrained Shear Strength in Triaxial Compression

Diameter (mm):		102.0	Height (mm):		190.0	Test:		100 mm Single Stage. Undisturbed				
Specimen	Moisture Content (%)	Bulk Density (Mg/m3)	Dry Density (Mg/m3)	Cell Pressure (kPa)	Corr. Max. Deviator Stress (kPa)	Shear Strength Cu (kPa)	Failure Strain (%)	Mode of Failure	Remarks Sample taken from top of tube Rate of strain = 2.1 %/min Latex Membrane used 0.2 mm thickness, Correction applied 0.35 kPa See summary of soil descriptions.			
A	24	1.94	1.57	190	$(\theta_1 - \theta_3)_f$	$\frac{1}{2}(\theta_1 - \theta_3)_f$	10.0	Brittle				
									Checked	Date	Approved	Date
									<i>Re</i>	15/05/14	<i>Re</i>	15/05/14
				102 CAMLEY STREET, CAMDEN.				Contract No: PSL14/2054

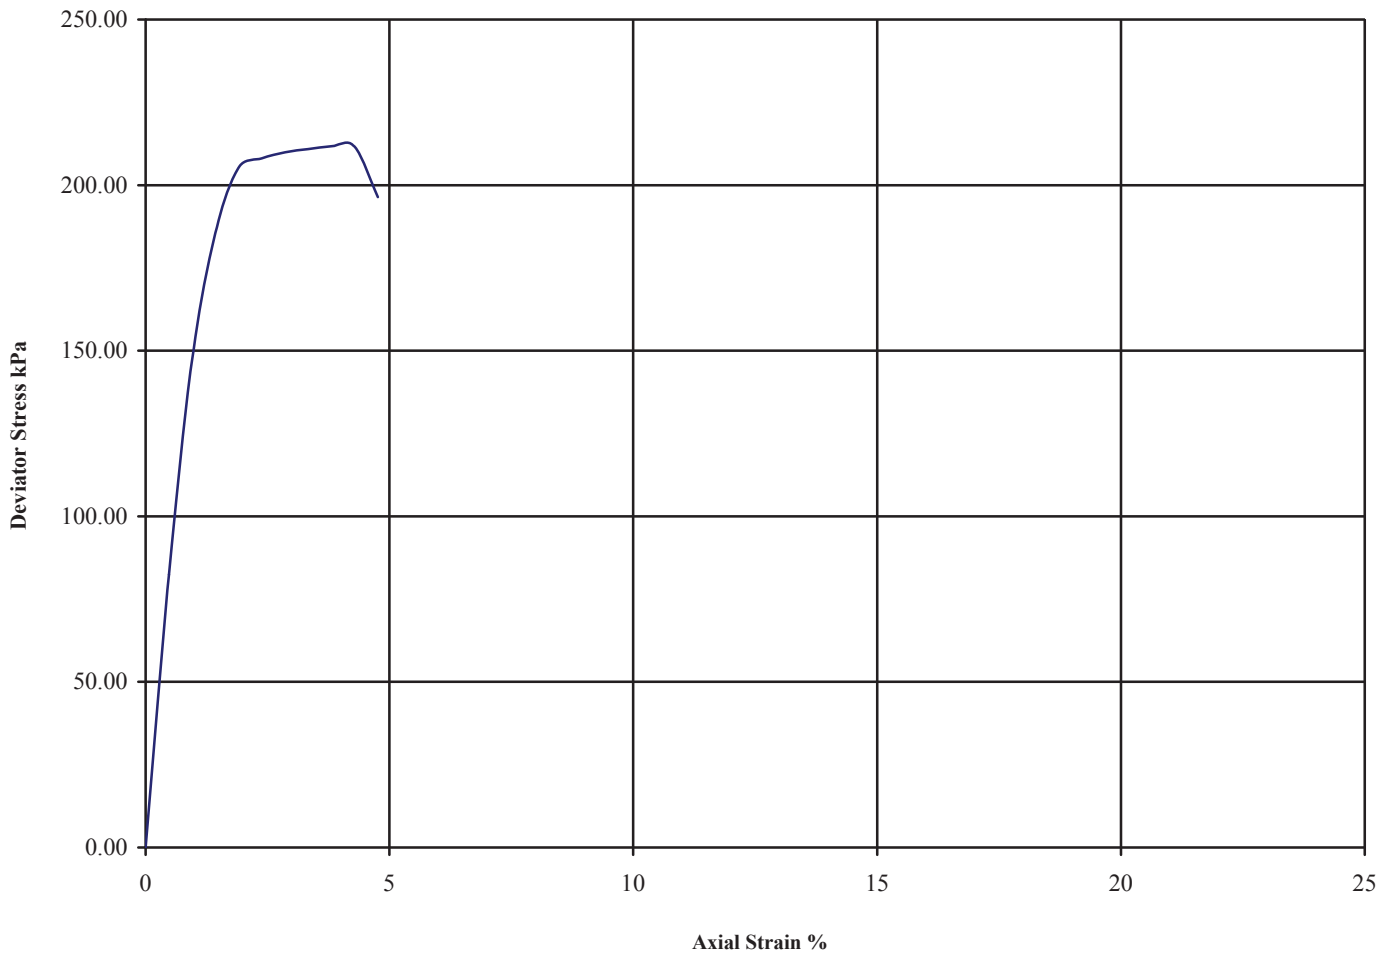
Undrained Shear Strength in Triaxial Compression

Diameter (mm):		102.0	Height (mm):		210.0	Test:		100 mm Single Stage. Undisturbed								
Specimen	Moisture Content (%)	Bulk Density (Mg/m3)	Dry Density (Mg/m3)	Cell Pressure (kPa)	Corr. Max. Deviator Stress (kPa)	Shear Strength Cu (kPa)	Failure Strain (%)	Mode of Failure	Remarks Sample taken from top of tube Rate of strain = 1.9 %/min Latex Membrane used 0.2 mm thickness, Correction applied 0.37 kPa See summary of soil descriptions.							
A	28	1.95	1.53	θ_3	$(\theta_1 - \theta_3)_f$	$\frac{1}{2}(\theta_1 - \theta_3)_f$	3.8	Brittle								
<table border="1"> <tr> <td>Checked</td> <td>Date</td> <td>Approved</td> <td>Date</td> </tr> <tr> <td><i>Re</i></td> <td>15/05/14</td> <td><i>Re</i></td> <td>15/05/14</td> </tr> </table>										Checked	Date	Approved	Date	<i>Re</i>	15/05/14	<i>Re</i>
Checked	Date	Approved	Date													
<i>Re</i>	15/05/14	<i>Re</i>	15/05/14													
				102 CAMLEY STREET, CAMDEN.				Contract No: PSL14/2054

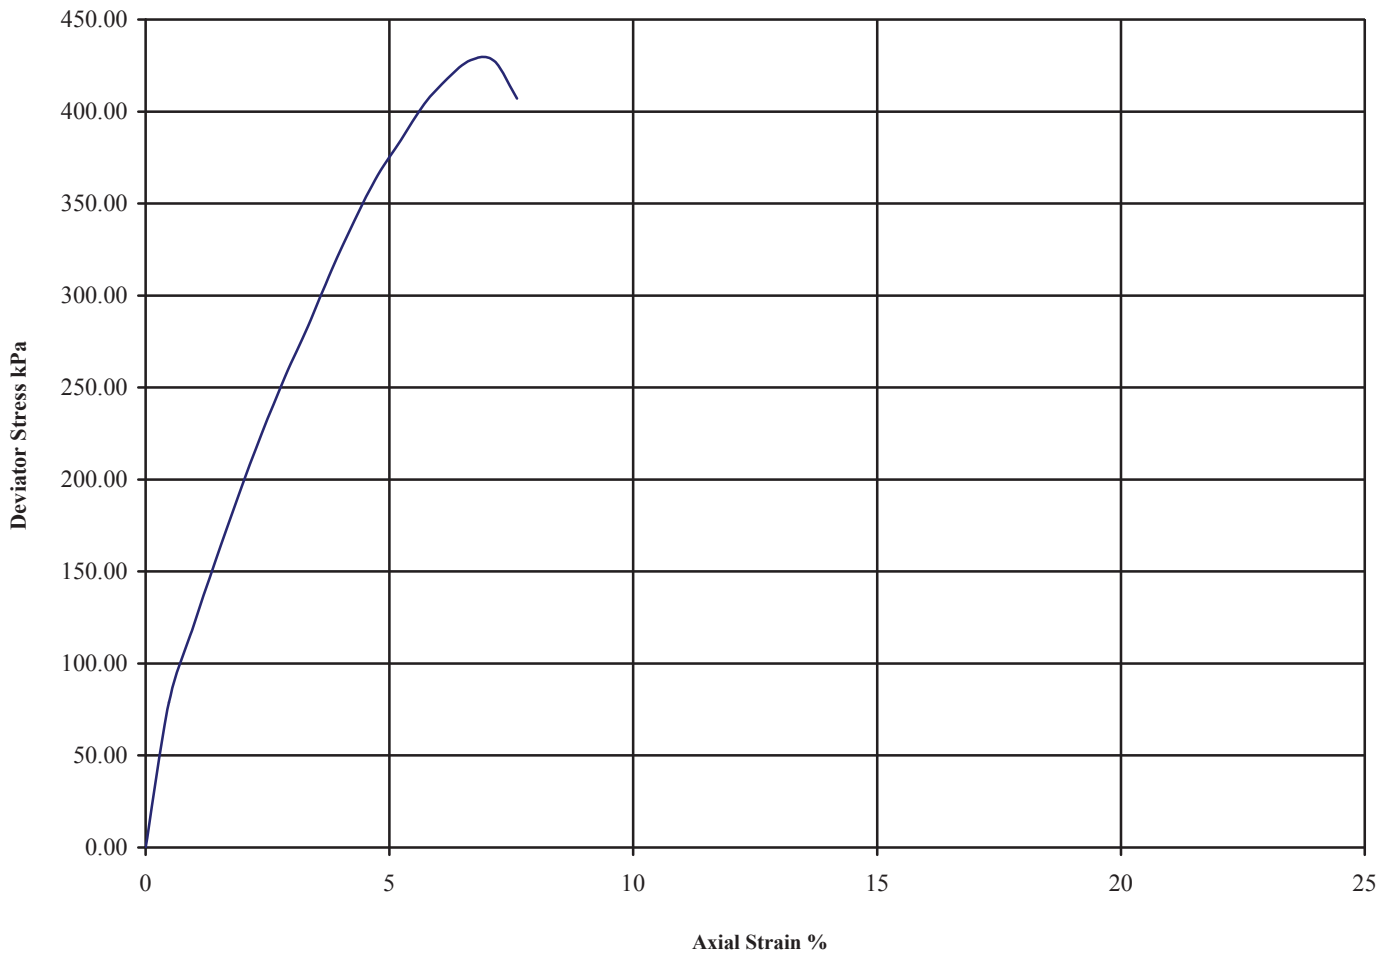
Undrained Shear Strength in Triaxial Compression

Diameter (mm):		102.0	Height (mm):		210.0	Test:		100 mm Single Stage. Undisturbed									
Specimen	Moisture Content (%)	Bulk Density (Mg/m3)	Dry Density (Mg/m3)	Cell Pressure (kPa)	Corr. Max. Deviator Stress (kPa)	Shear Strength Cu (kPa)	Failure Strain (%)	Mode of Failure	Remarks								
				θ_3	$(\theta_1 - \theta_3)_f$	$\frac{1}{2}(\theta_1 - \theta_3)_f$			Sample taken from top of tube Rate of strain = 1.9 %/min Latex Membrane used 0.2 mm thickness, Correction applied 0.36 kPa See summary of soil descriptions.								
A	24	1.94	1.57	510	428	214	6.7	Brittle									
									<table border="1"> <thead> <tr> <th>Checked</th> <th>Date</th> <th>Approved</th> <th>Date</th> </tr> </thead> <tbody> <tr> <td><i>Re</i></td> <td>15/05/14</td> <td><i>Re</i></td> <td>15/05/14</td> </tr> </tbody> </table>	Checked	Date	Approved	Date	<i>Re</i>	15/05/14	<i>Re</i>	15/05/14
Checked	Date	Approved	Date														
<i>Re</i>	15/05/14	<i>Re</i>	15/05/14														
				102 CAMLEY STREET, CAMDEN.				Contract No: PSL14/2054

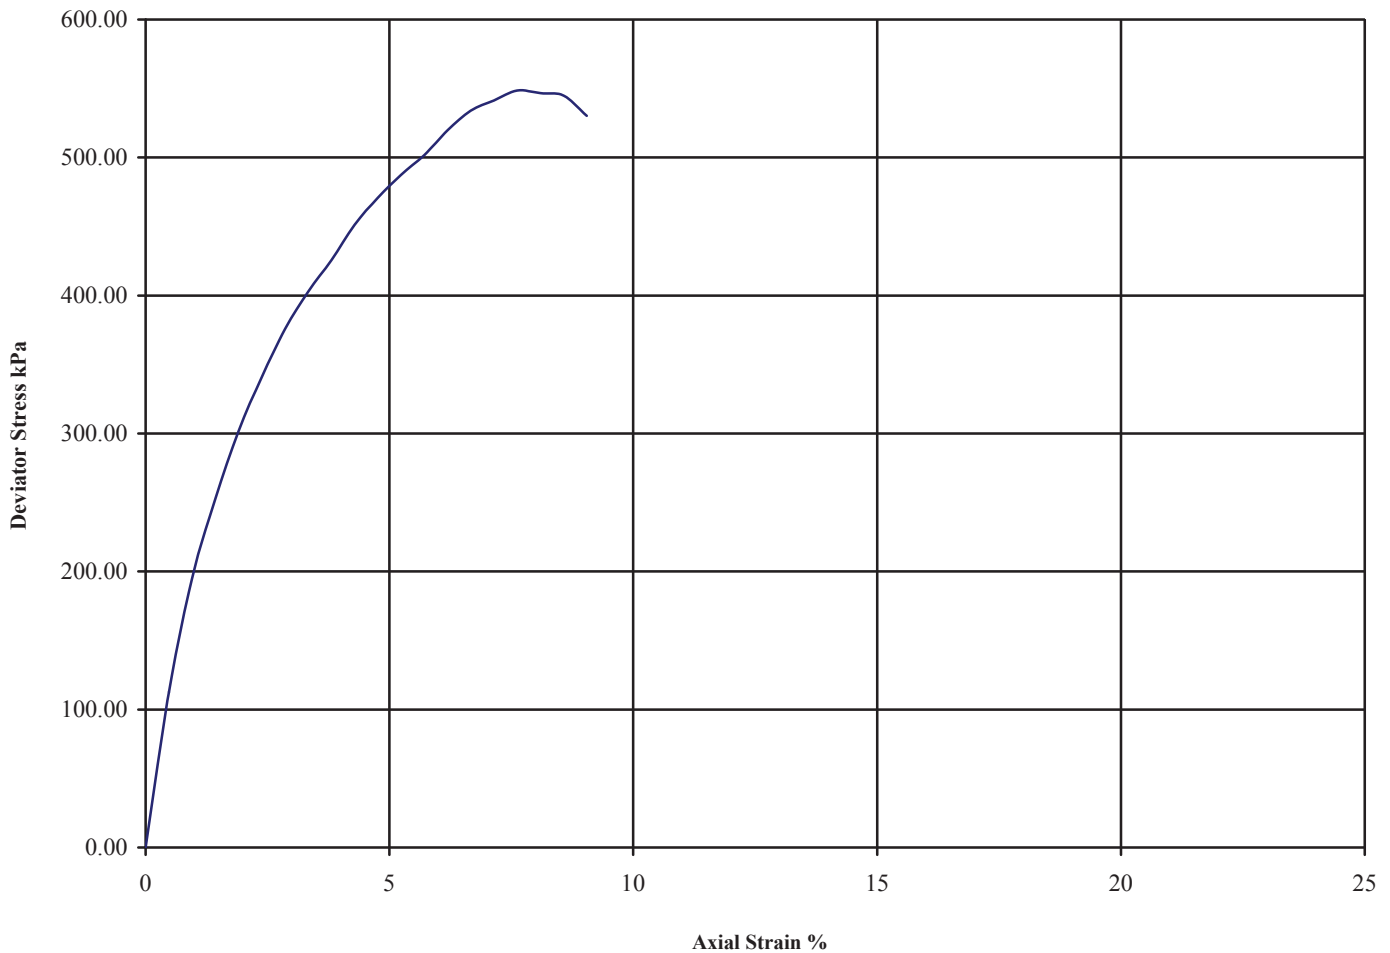
Undrained Shear Strength in Triaxial Compression

Diameter (mm):		102.0	Height (mm):		210.0	Test:		100 mm Single Stage. Undisturbed				
Specimen	Moisture Content (%)	Bulk Density (Mg/m3)	Dry Density (Mg/m3)	Cell Pressure (kPa)	Corr. Max. Deviator Stress (kPa)	Shear Strength Cu (kPa)	Failure Strain (%)	Mode of Failure	Remarks Sample taken from top of tube Rate of strain = 1.9 %/min Latex Membrane used 0.2 mm thickness, Correction applied 0.36 kPa See summary of soil descriptions.			
A	22	2.01	1.65	θ ₃	(θ ₁ -θ ₃) _f	1/2(θ ₁ -θ ₃) _f	7.6	Brittle				
									Checked	Date	Approved	Date
									<i>Re</i>	15/05/14	<i>Re</i>	15/05/14
				102 CAMLEY STREET, CAMDEN.				Contract No: PSL14/2054
