Job 14286 - Admiral Mann PH

Site Investigation Report

Site: Admiral Mann Public House, Hargrave Place, N7 0BP

Project Reference: J12113

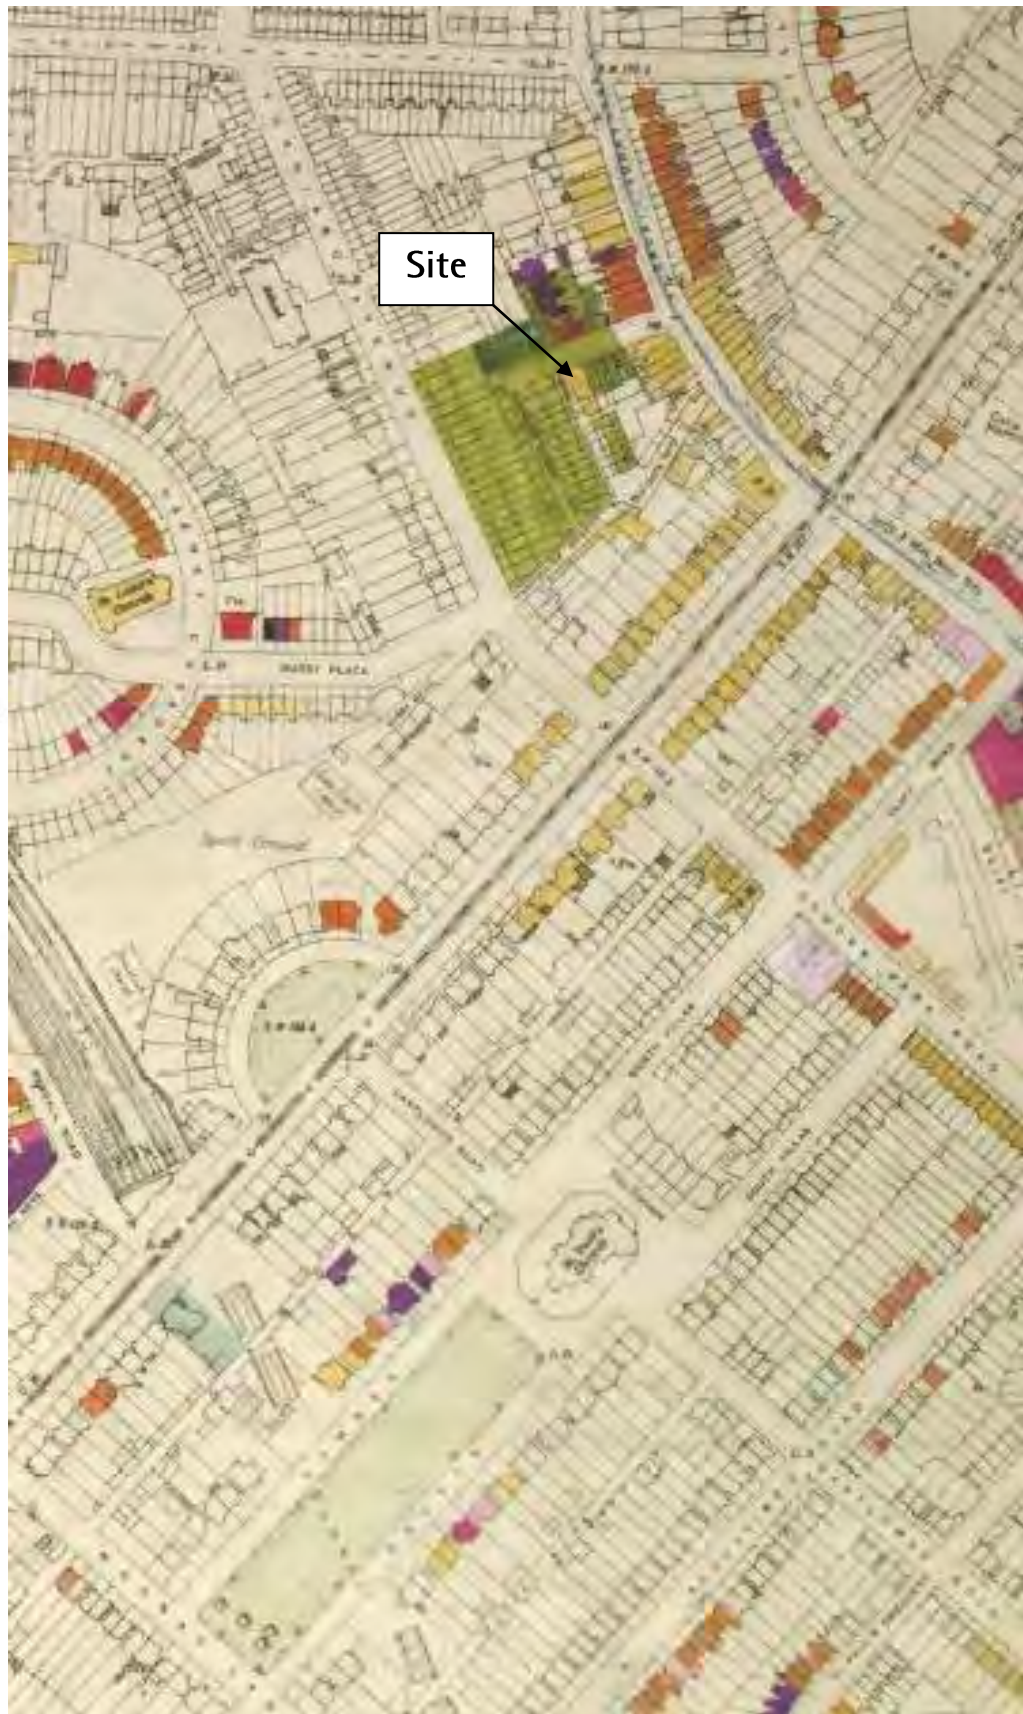
Bomb Map

- Black**
Total destruction
- Purple**
Damaged beyond repair
- Dark Red**
Seriously damaged; doubtful if repairable
- Light Red**
Seriously damaged, but repairable at cost
- Orange**
General blast damage – not structural
- Yellow**
Blast damage, minor in nature
- Light Blue**
Clearance areas
- Light Green**
Clearance areas

The published bomb map for the area, taken from the London County Council Bomb Damage Maps (1939-1945), shows that the site suffered blast damage, minor in nature (shown in yellow). The map also shows a number building to the north suffered damage beyond repair (shown in purple) with one building suffering total destruction (shown in black), a number of areas to the east and west of the site are shown as being clearance areas (shown in light green) please refer to Figure A presented within Appendix E.

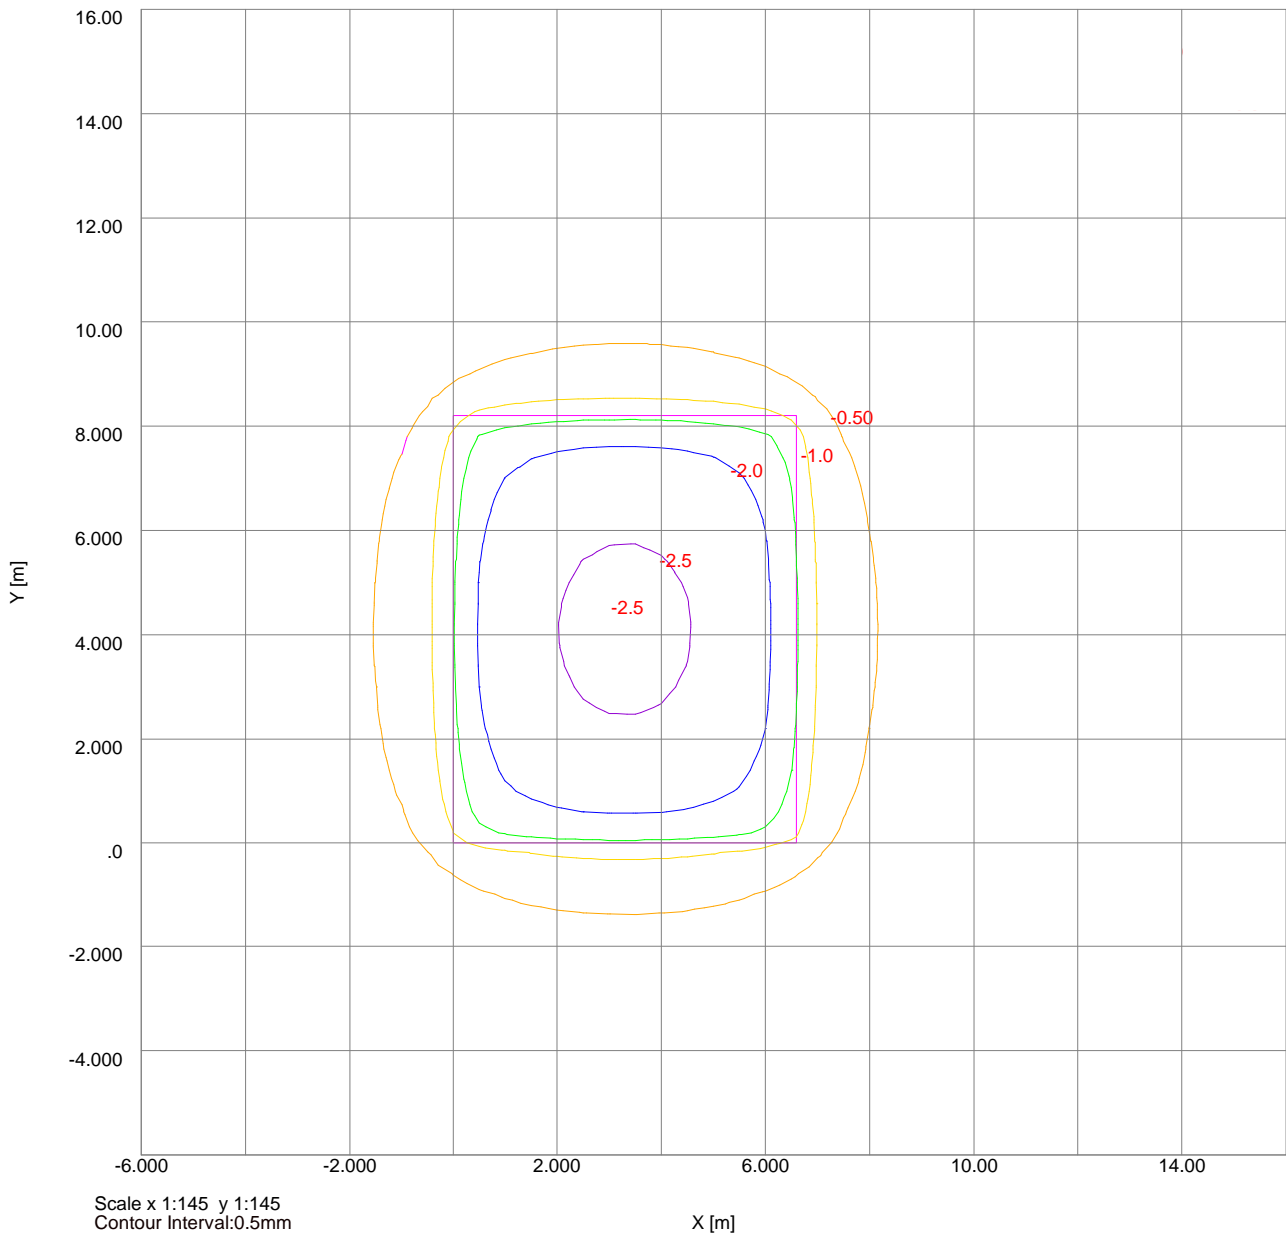
Settlement Contours : Grid 1 at -2.520m

Scale x 1:145 y 1:145
Contour Interval:0.5mm
