**Appendix C – Trial Pit Excavations from 19/5/15 – for information only**

Site Location:	<b>152 Royal College Street, London, NW1 0TA</b>	Ref:	<b>9819/KOG</b>
----------------	--	------	-----------------

### Results of Ground Gas/Groundwater Monitoring

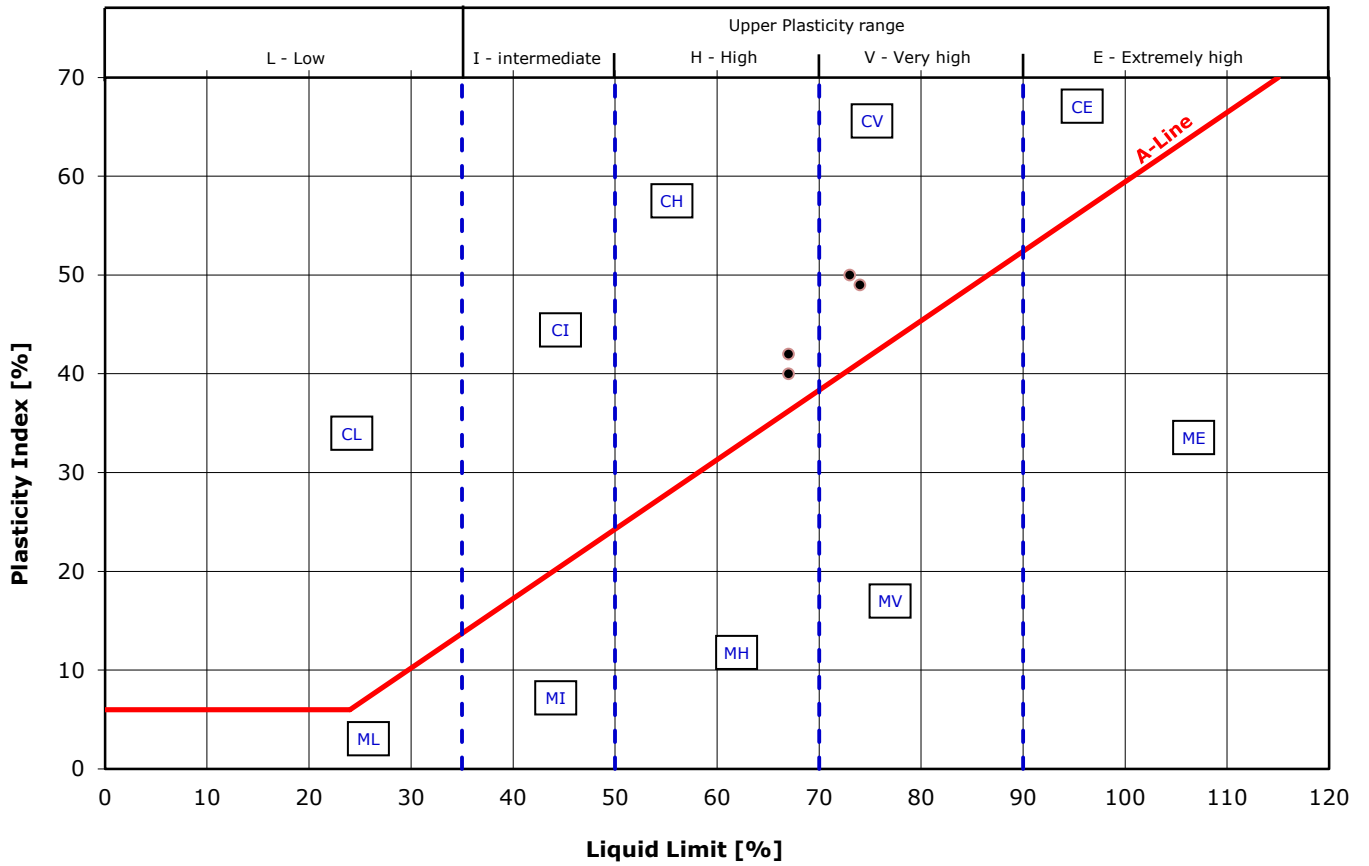
### Plasticity Chart

M - SILT [plots below the A-Line}  
C - CLAY [plots above the A-Line]

Classification in accordance with BS5930:1999+A2:2010 "Code of practice for site investigations"

BH ID	Depth (m)	Type	w (%)	wL (%)	wP (%)	Pass 425 (%)	IP (%)	Mod IP (%)	IL (%)	LOI (%)	Description
BH1	2.30	D	33	73	23	>95	50		0.20		Brown fissured CLAY
BH1	4.00	D	28	74	25	>95	49		0.07		Brown fissured CLAY
BH1	9.55	D	30	67	27	>95	40		0.08		Brown fissured CLAY
BH1	13.25	D	26	67	25	>95	42		0.03		Dark grey fissured CLAY with occasional silt/fine sand partings

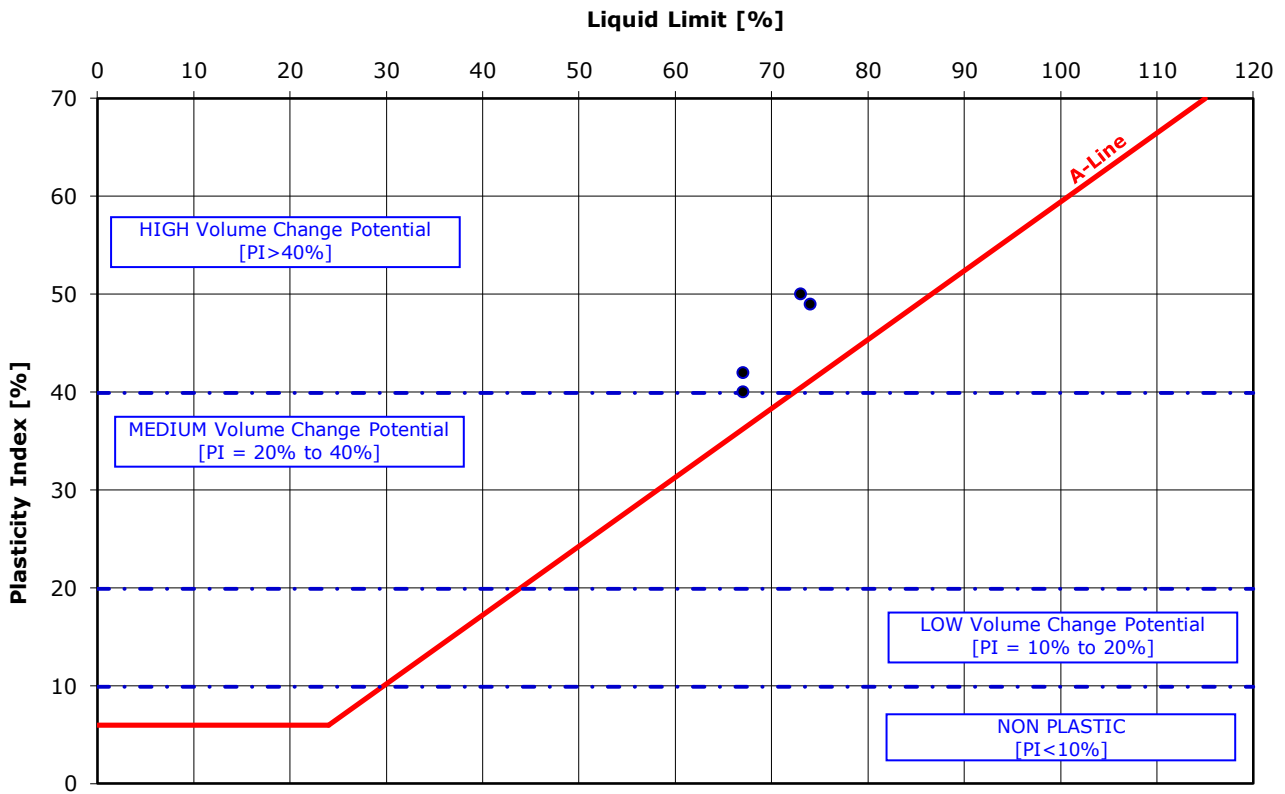
### Plasticity Chart

Modified Plasticity Index, I'p:

$$I'p = \frac{I_p \times (\% \text{ passing } 425\text{mm})}{100\%} \quad [\text{where } I_p = \text{Plasticity Index}]$$

Classification in accordance with NHBC Standards, Part 4 'Foundations', Chapter 4.2 'Building near trees'

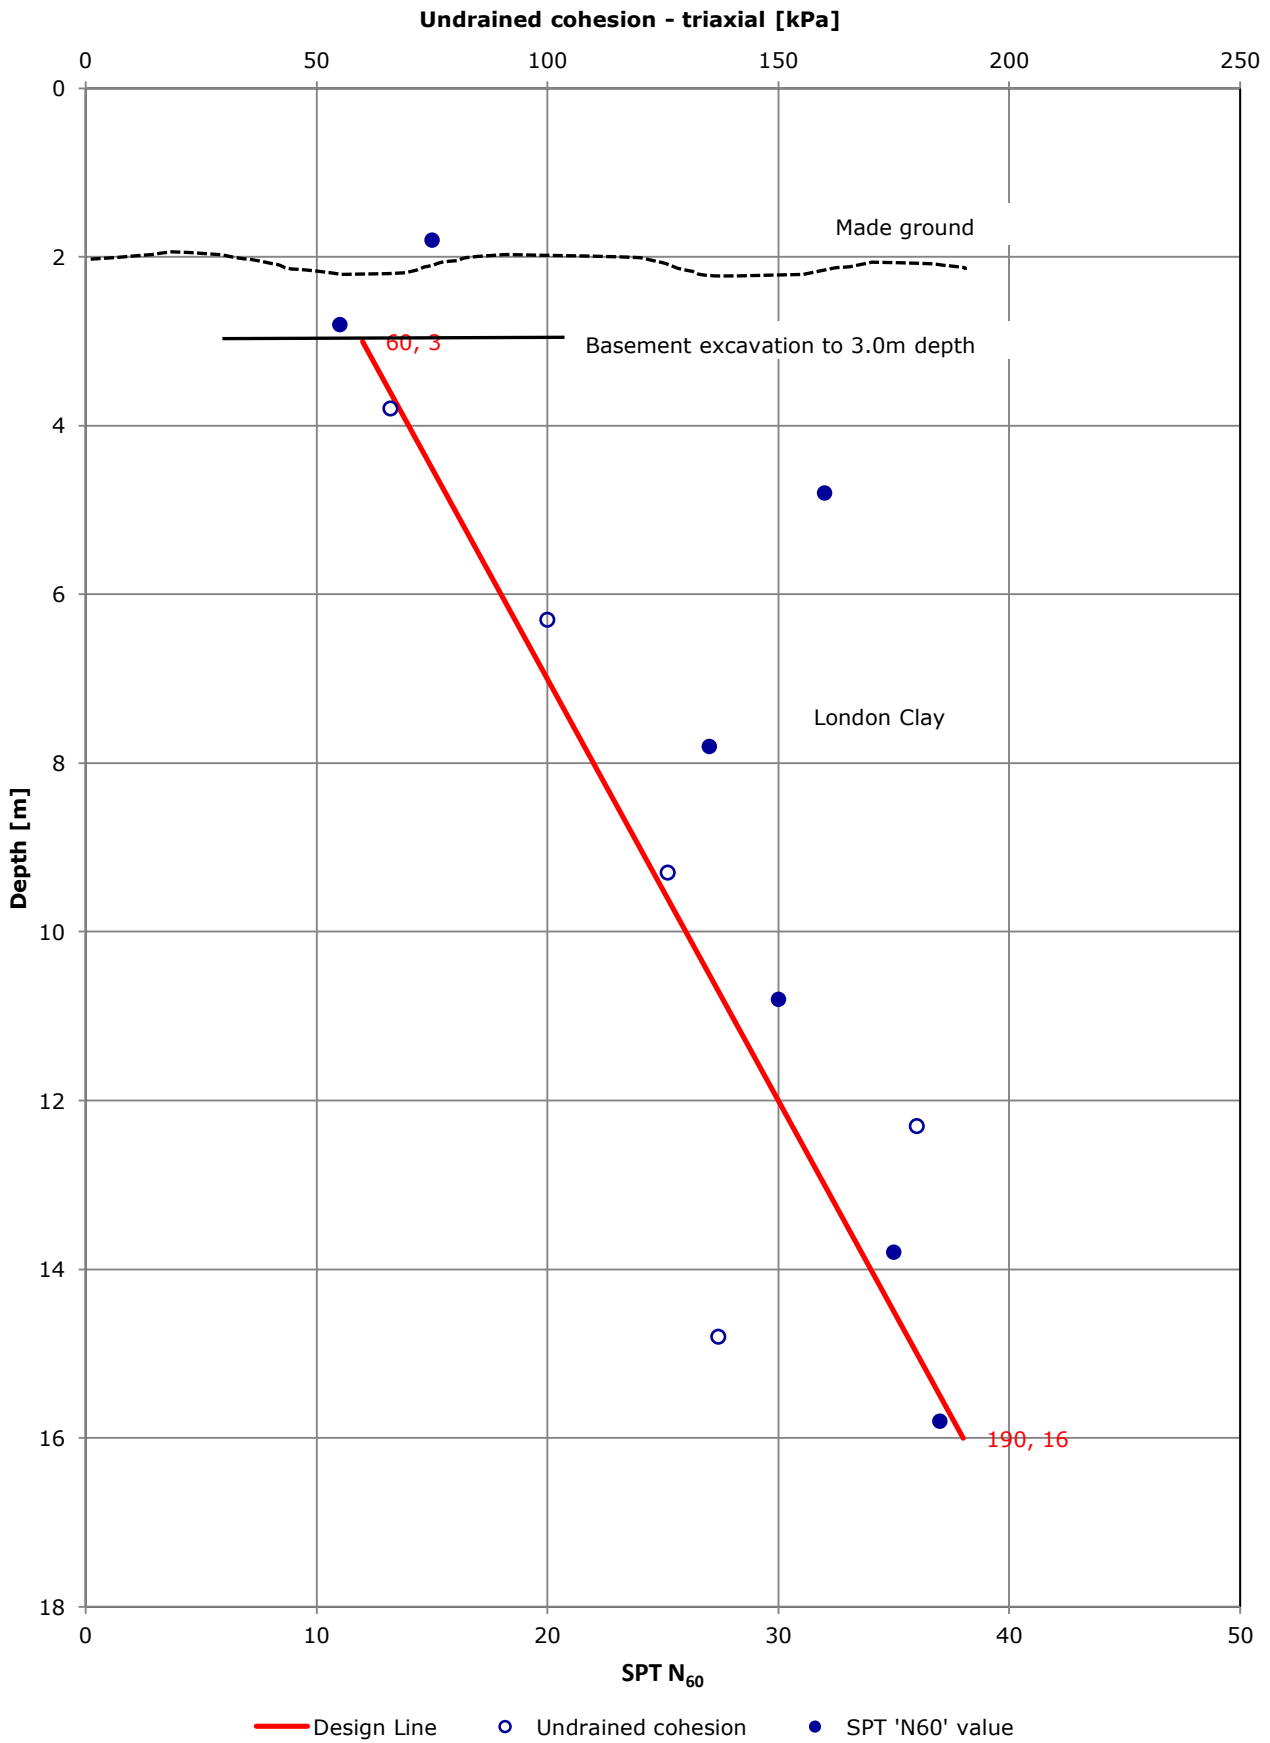
**Undrained cohesion and SPT [N60] vs depth**

**Design Line  $\Delta cu = 10kPa/m$**

Note: this plot may incorporate extrapolated results, generally where 'N' >50  
 - these are indicative only and should be used with caution

BH ID	Depth [m]	Moisture content [%]	Bulk density [Mg/m <sup>3</sup> ]	Dry density [Mg/m <sup>3</sup> ]	Cell pressure [kPa]	( $\sigma_1 - \sigma_3$ ) <sub>f</sub> [kPa]	Failure strain [%]	Failure mode	Undrained cohesion [kPa]	Remarks
BH1	3.50	29	1.94	1.50	100	132	7.00	I	66	
BH1	6.00	30	1.94	1.49	120	200	4.00	I	100	
BH1	9.00	30	1.94	1.49	180	252	4.50	I	126	
BH1	12.00	25	2.00	1.60	240	359	4.50	B	180	
BH1	14.50	27	1.98	1.56	290	274	4.50	B	137
