GROUND INVESTIGATION REPORT

35 GREVILLE ROAD, CAMDEN, LONDON NW6 5JB

| Report Reference: GWPR1303/GIR/August 2015 | | Status: FINAL |

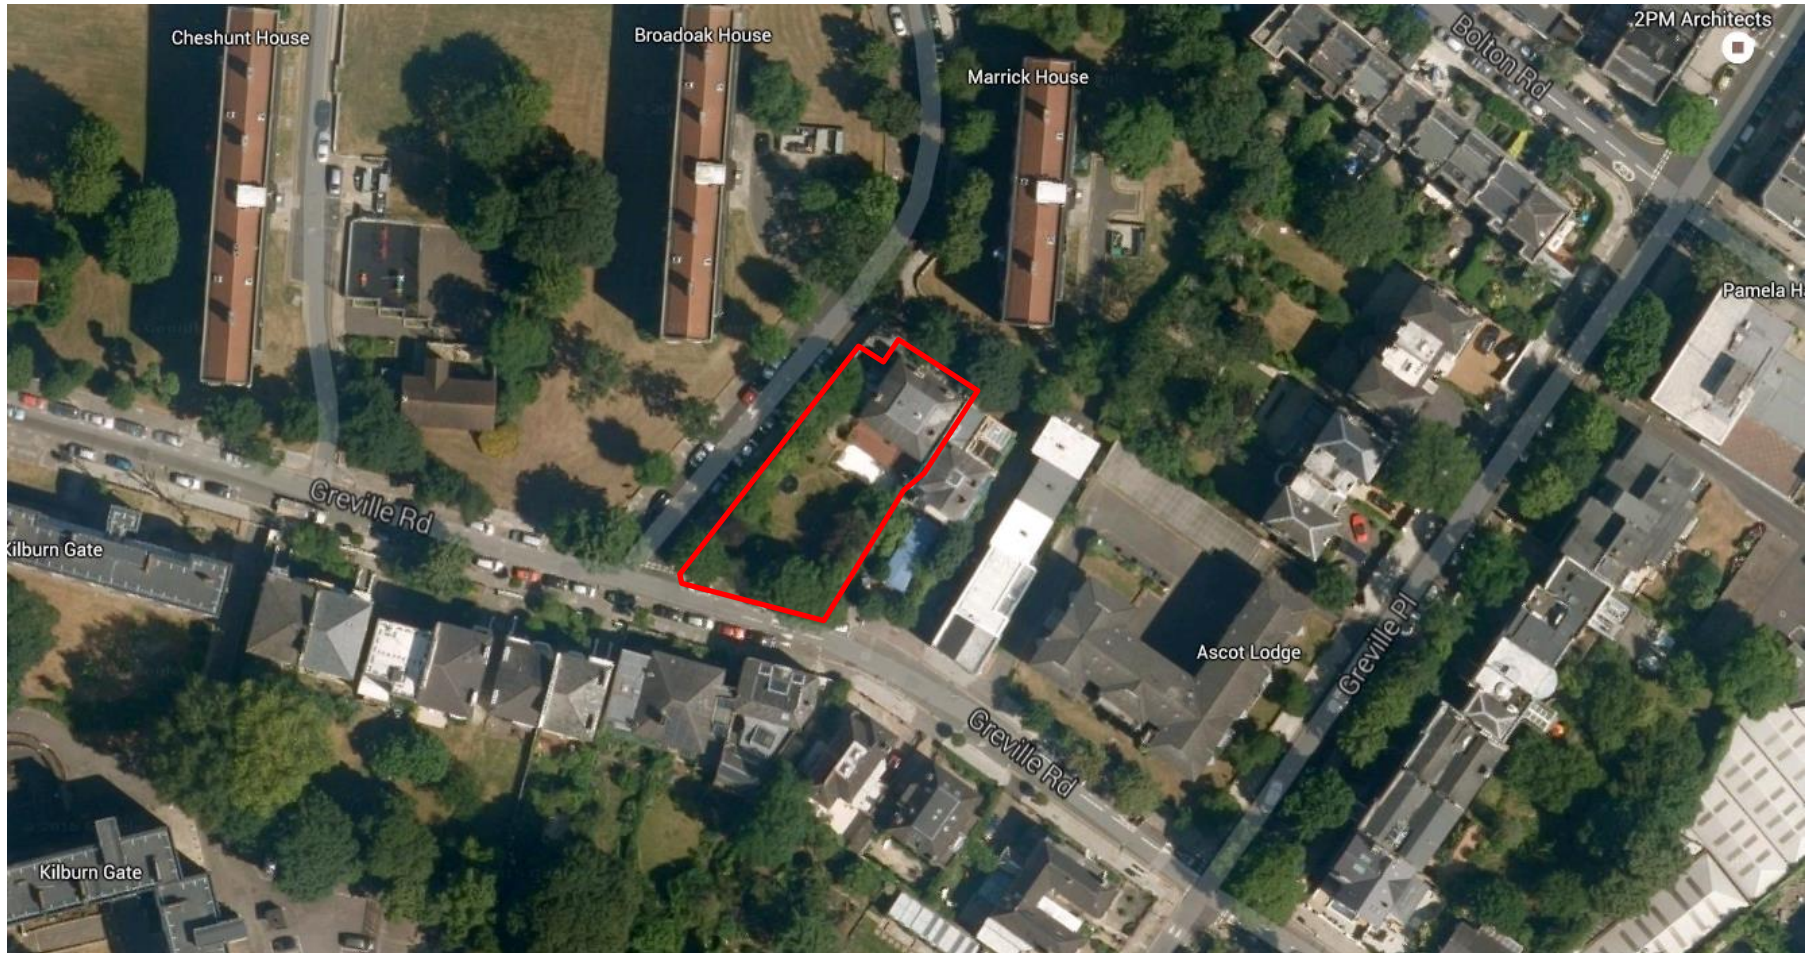
Figure 2

— APPROXIMATE SITE BOUNDARY

The national grid reference for the centre of the site was approximately TQ 25804 83516. A site location plan is given within Figure 1. A plan showing the boundary of the site is provided in Figure 2.

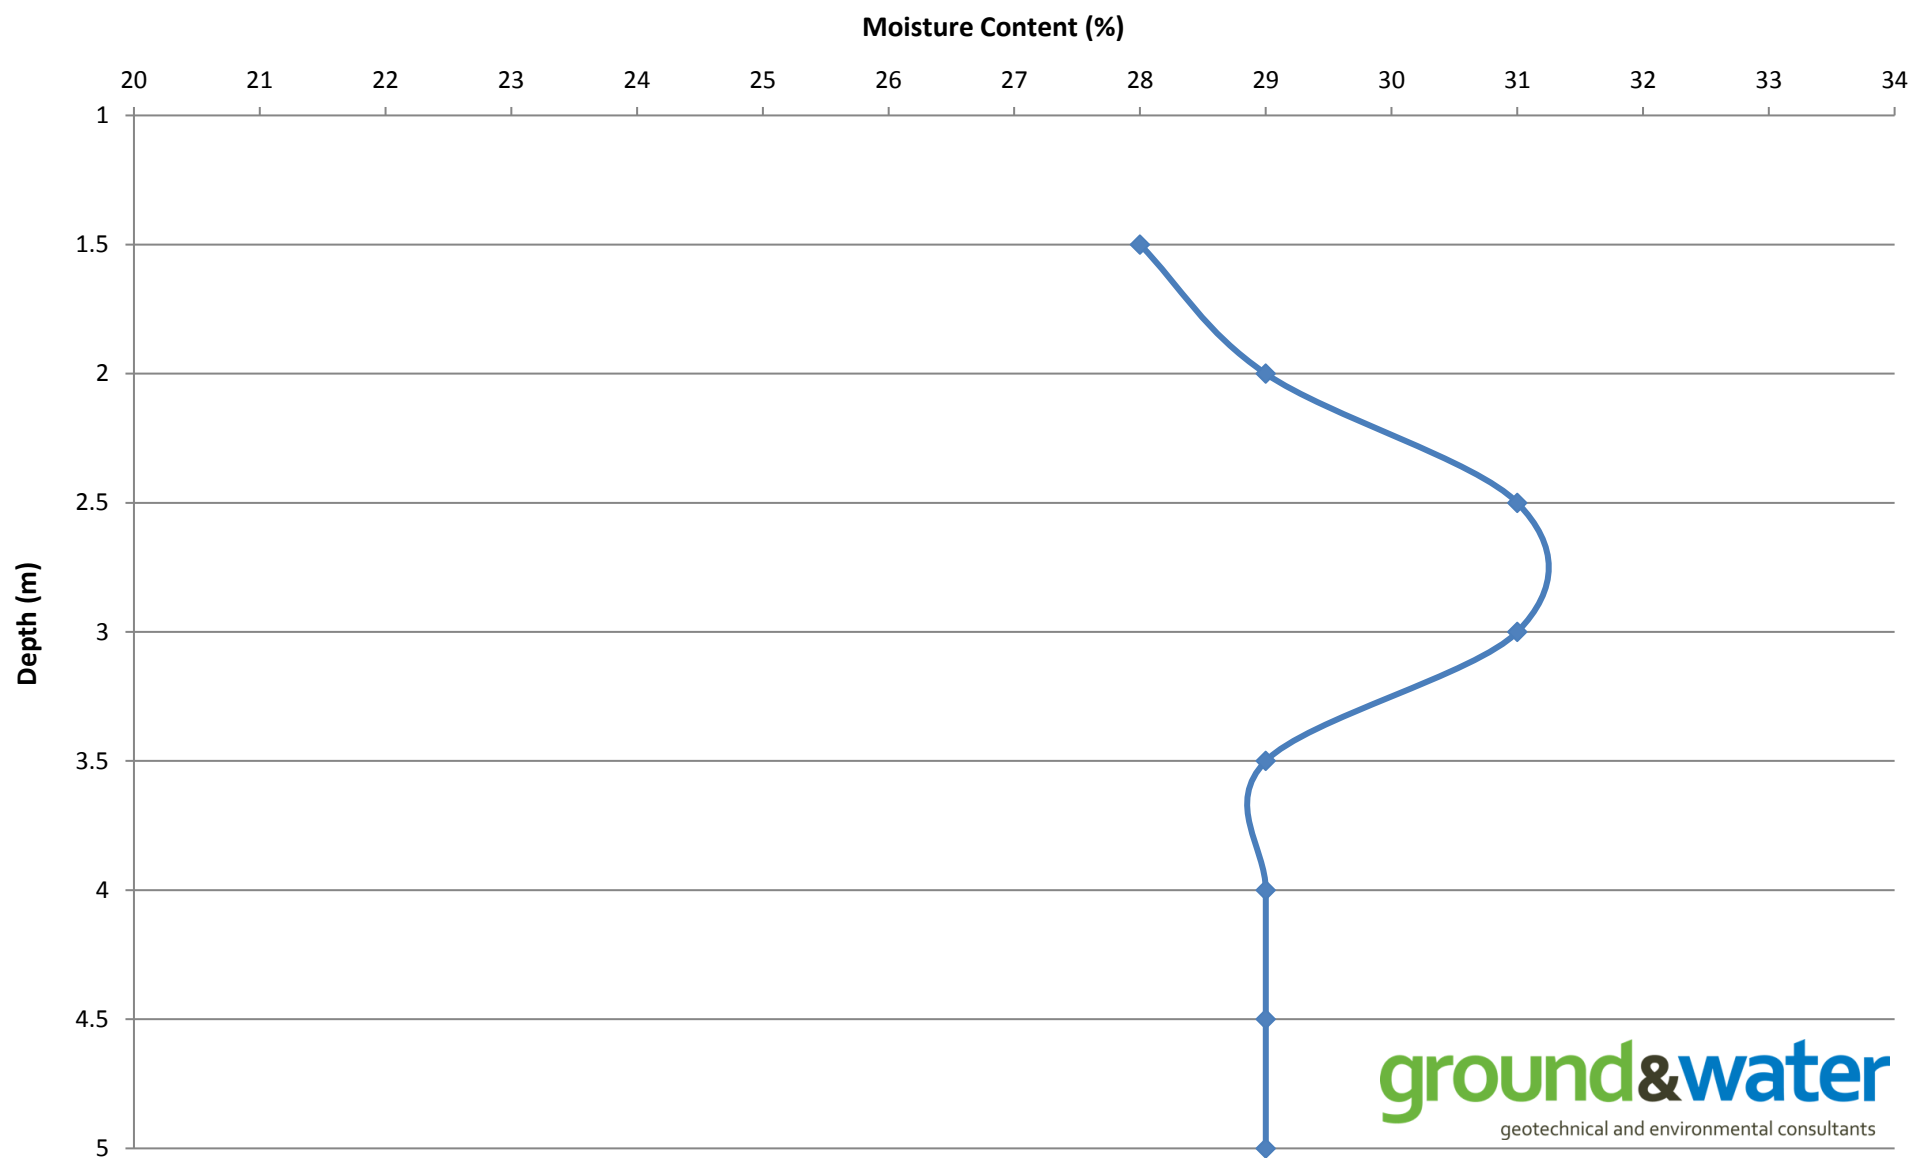
Figure 6: Change in Moisture Content With Depth Within BH1

Moisture content versus depth plots for BH1 can be seen within Figure 6. Within BH1 subtle variations in moisture content were noted with depth. The moisture content was noted to increase with depth to 2.50m bgl indicating a slight moisture deficit at the near surface. Roots were noted to 3.00m bgl and therefore the potential moisture deficit noted is likely to be associated with the moisture demand from roots/trees.

The results in the table above indicated that a potential significant moisture deficit was present within all four samples of the London Clay Formation tested within BH1 (1.50m, 2.50, 3.00m and 4.00m bgl). The moisture content values were below 40%

Potential significant moisture deficits were present within all four samples of the London Clay Formation tested (BH1/1.50m, BH1/2.50m, BH1/3.00m and BH1/4.00m bgl). The moisture content values were below 40% of the liquid limit. The samples were described as a brown and locally blue grey silty clay with traces of fine rootlets to 3.00m bgl. Traces of selenite crystals were noted within the samples at 1.50m and 4.00m bgl. The roots noted at 1.50m, 2.50m and 3.00m bgl could suggest that the moisture deficits within the samples were due to the moisture demand from surrounding roots/trees. The potential significant moisture deficit recorded within the sample at 4.00m is likely to be associated with the heavily overconsolidated nature of the soils rather than the moisture demand from roots/trees.
