# Bat/CfSH & BREEAM Report: Tybalds Estate, London Ref: LON-135-001 (REV03)

Report For: Durkan Ltd May 2015

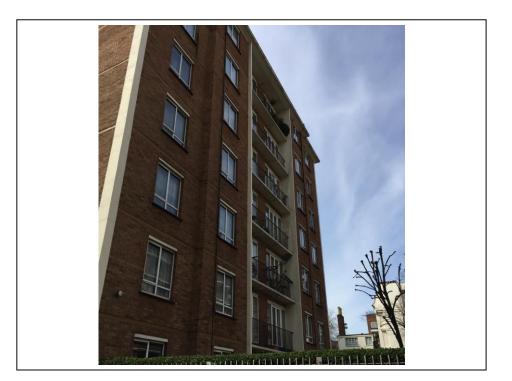
Photograph 1 – Falcon Residential Block

- Falcon Eight storey residential block (see photograph 1)
  - Richbell Eight storey residential block (see photograph 2)
  - **Springwater** Eight storey residential block (see photograph 3)

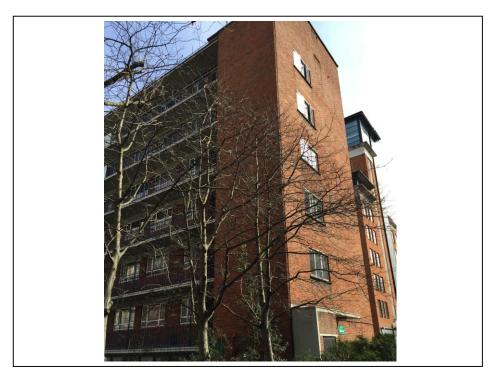
Photograph 4 – Windmill Residential Block

- Windmill Seven storey residential block (see photograph 4)
  - **Blemundsbury** Ten story residential block (see photograph 5)

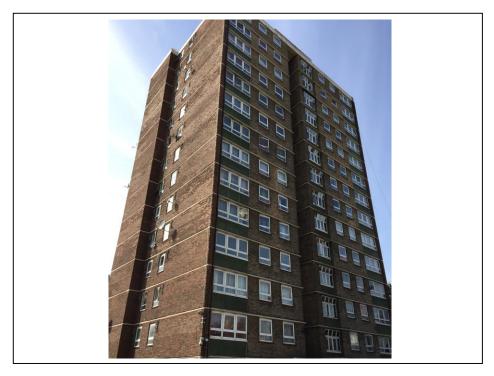
Photograph 6 – Babington Court

- **Babington Court** 14 storey residential block (see photograph 6)
- Chancellor's Court 14 storey residential block (see photograph 7)
- 6.6 **Devonshire Court** Devonshire court is a five storey residential block in the western section of the site. It is of a similar construction type to the other buildings present on-site. The brickwork appears to be in reasonable condition and there were no discernible cracks/crevices that would provide a suitable roosting location for bats. The eastern façade contains exterior walkways that provide access to the properties (see photograph 8). The windows and doors also appear to be in reasonable condition. The stairwell at the southern end of Devonshire Court has some lifted lead flashing (see photographs 9 & 10) where the facia board meets the roofing material (this feature was also identified in the previous ecological appraisal (Report Ref: RT-MME-111475-02 Rev1). This feature has some potential to support crevice dwelling bat species.

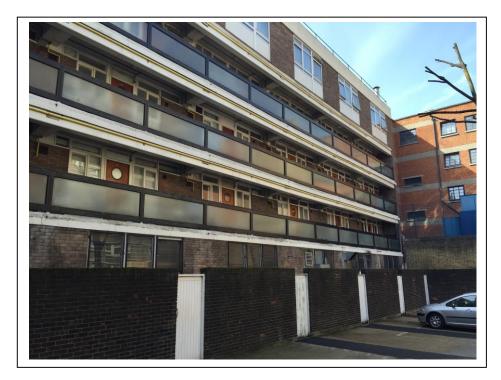
Photograph 8 – Devonshire Court

- 6.10 The features present on Devonshire Court are considered unlikely to support hibernation roosts for bats during the winter period (November to-March). It should be noted that the hibernation habits of some common species are poorly understood, therefore the presence of hibernating bats cannot be completely ruled out.

6.11 The redevelopment of Devonshire Court will require the demolition of the existing staircase and its replacement with a new shared stairwell. It is therefore recommended that all buildings are subject to further survey in advance of their removal in accordance with best practice guidelines.

- 6.14 It is recommended that the following surveys are undertaken:
  - **Devonshire Court (Existing Stairwell)** 1 x dusk emergence and 1 x dawn re-entry survey (2 x surveyors required)

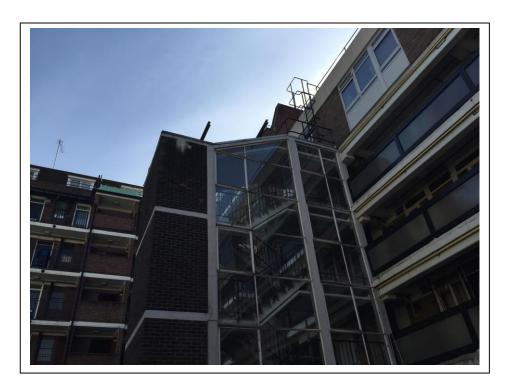
Photograph 9 – Covered Stairwell (Devonshire Court)

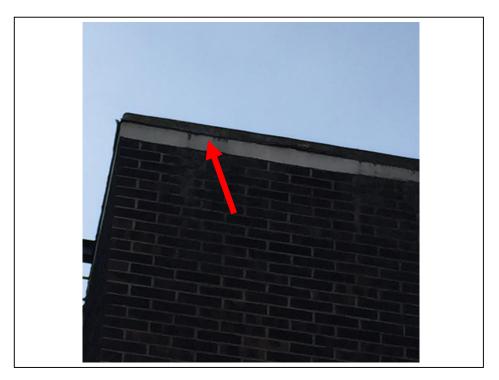
- 4.7 The results of an initial bat roost assessment undertaken on the 30<sup>th</sup> March 2015 are detailed in section 6 of this report. The existing stairwell of Devonshire Court contains lifted lead flashing that provides potential for crevice dwelling bat species. If the recommendations for further survey and mitigation with regards to the single building with potential to support roosting bats are followed, all UK and EU legislation should be adhered to. The remaining buildings and trees present on-site have negligible potential to support roosting bats

Photograph 10 – Lifted Lead Flashing: Covered Stairwell (Devonshire Court)

- 6.12 In accordance with the Bat Conservation Trust's Good Practice Survey Guidelines 2<sup>nd</sup> Edition (Hundt, 2012), buildings and trees assessed as having low to moderate potential are required to be subject to two further bat surveys (comprising a combined dusk emergence/dawn reentry visit) in order to determine the presence/likely absence of bats. All features identified as having potential to provide access/egress for bats would be observed by suitably experienced surveyors.

- 6.16 If a bat roost were to be identified in any of these surveys, its removal or disturbance would require a license from Natural England and an agreed mitigation scheme. In order to obtain an EPSM licence, Natural England must be presented with robust and conclusive survey data that provides a comprehensive description of how bats are using the site. In the event a bat roost is found on-site, further surveys may be required which comprise three dusk emergence/dawn re-entry surveys, carried out in accordance with good practice guidelines (Hundt, 2012).
