REPORT ON TREES AT

48 QUEENS GROVE
LONDON
NW8

Report on trees at 48 Queens Grove, NW8 for BB Partnership

Tree Projects Ltd, The Maisonette, 22 Old Park Avenue, London SW12 8RH Ref: TP/AAJ/Queens Grove Façade Retention Scheme ~ October 2011

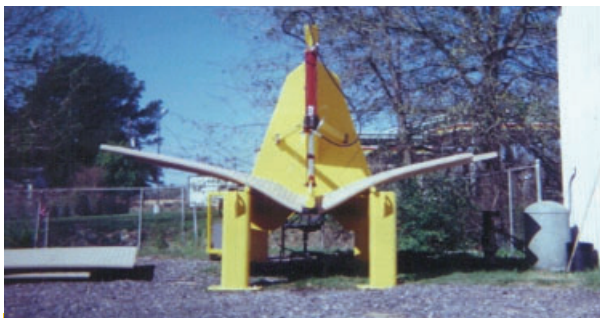
Strength

Test apparatus demonstrates mat tolerance to extreme deflection while maintaining high load bearing capacity in pure bending [span = 4 feet (1.2m)]. Pure compressive load capacity is approximately 600 psi (40 kg/cm²). Compressive loads in excess of 1000 psi (70 kg/cm²) have been observed in laboratory tests.

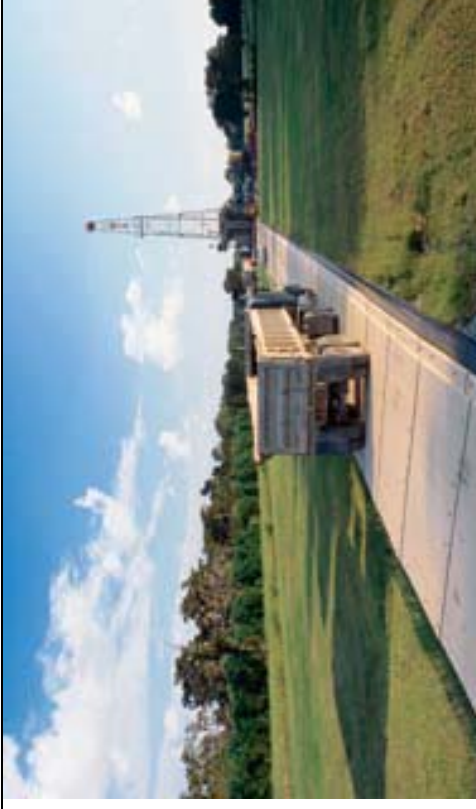
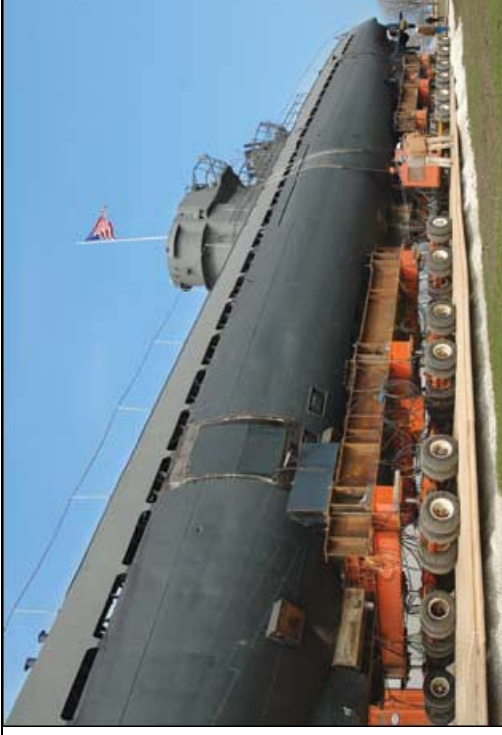
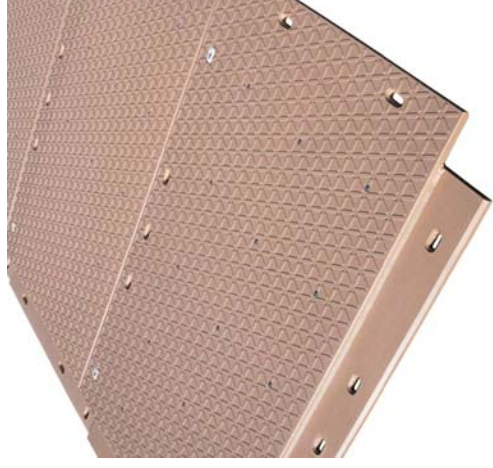
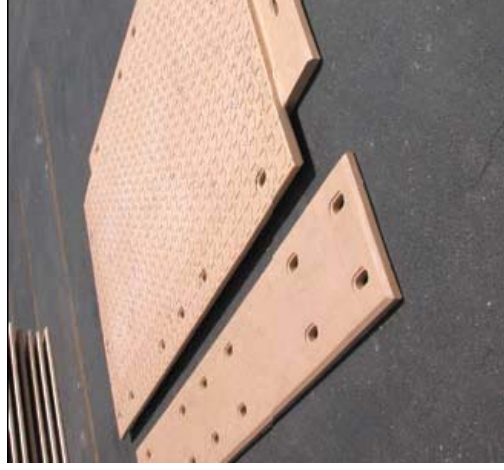
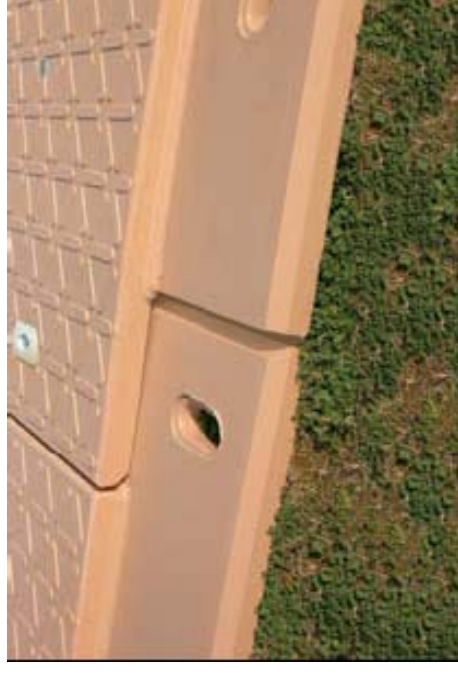
Image Samples of Durabase: as tree root protection area ground protection www.terrafirma.gb.com 01235 868 835

4.2 It is considered pragmatic to facilitate construction access and site circulation by use of interlocking Durabase panels. These panels are very heavy (aprox 500kg each) and interlock to provide a monolithic surface capable of protecting ground beneath, bridging level irregularities and can withstand very heavy loading. Full details at Appendix 3.

- Durabase ground protection is to be installed and locked into position. (panel arrangement has been prepared at scale in CAD) and levelled as necessary on baulk timbers.

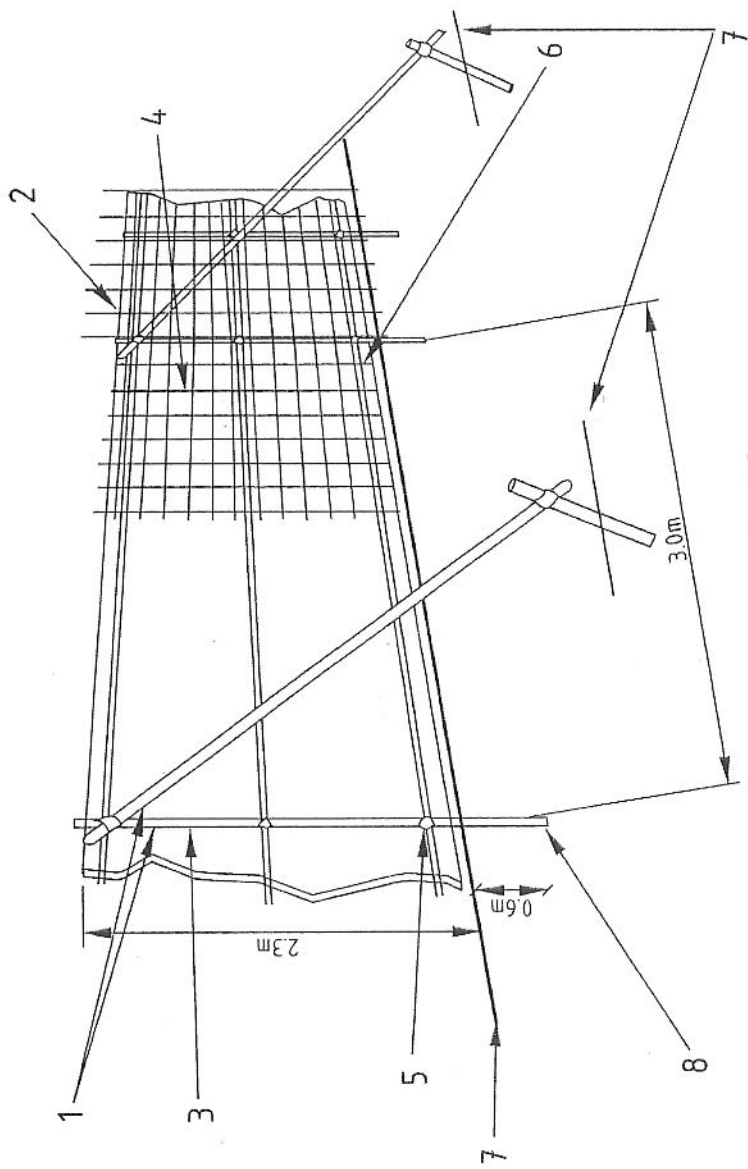
Figure 2 — Protective barrier

Tree Protective Barrier
To BS 5837 Fig 2

- 1 Standard scaffold poles
- 2 Uprights to be driven into the ground
- 3 Panels secured to uprights with wire ties and where necessary standard scaffold clamps
- 4 Weldmesh wired to the uprights and horizontals
- 5 Standard clamps
- 6 Wire twisted and secured on inside face of fencing to avoid easy dismantling
- 7 Ground level
- 8 Approx. 0.6 m driven into the ground

- Tree Protective Barrier: Comprising heras panels wire fixed to back braced scaffold framework in accordance with BS 5837 Fig 2. (Appendix 2)
- Ground protection by installation of interlocking Durabase panels. (Appendix 3)
