GROUND INVESTIGATION & BASEMENT IMPACT ASSESSMENT REPORT

39 Rosslyn Hill
London NW3 5UJ

J15236

November 2015

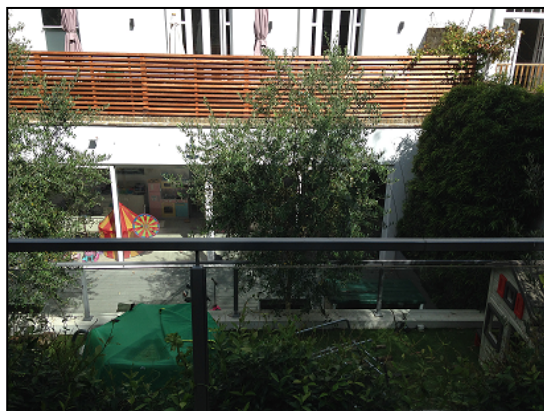
View down from top terrace.

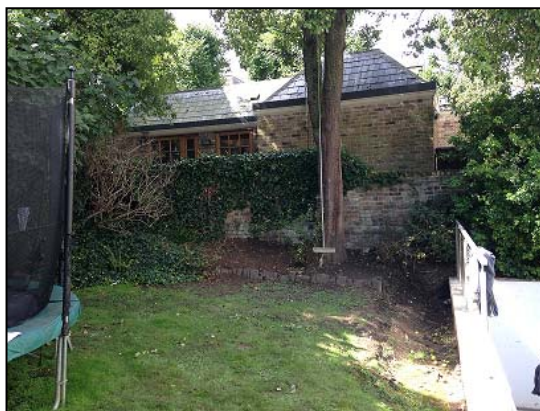
View of the area behind the top retaining wall.

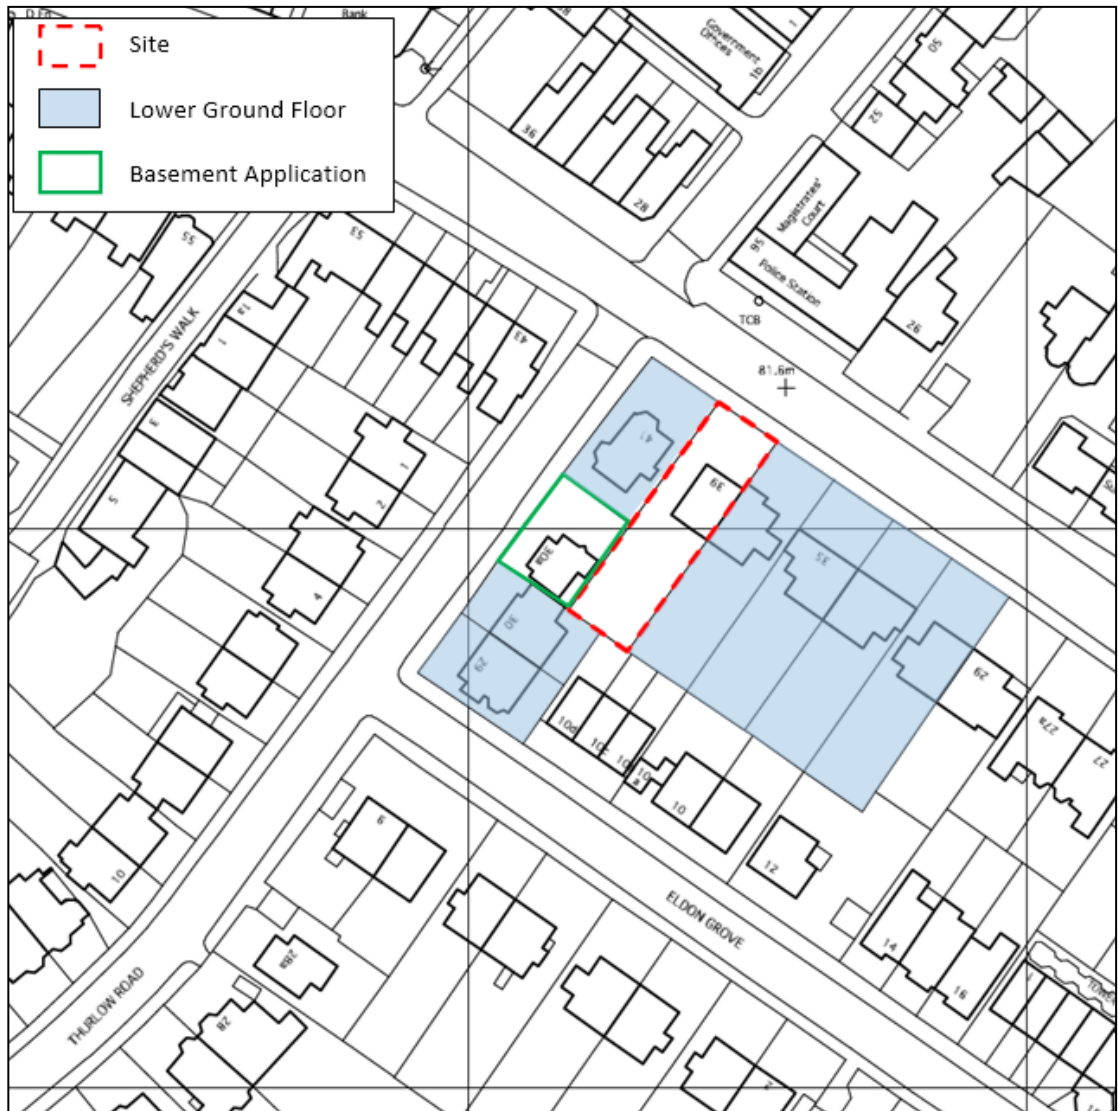
Information on the properties surrounding the site has been gathered by the project architects from the Local Authority planning portal and other sources, the results of which have been supplied to GEA by Conisbee. The results are summarised on the map below with the neighbouring properties along Rosslyn Hill including similar lower ground floor levels to the site, in addition to Nos 29 and 30 Thurlow Road, which also include a lower ground floor level. No 30a Thurlow Road currently has planning permission for a single level basement, although this work has not yet commenced. This property is understood to be currently supported on piled foundations.

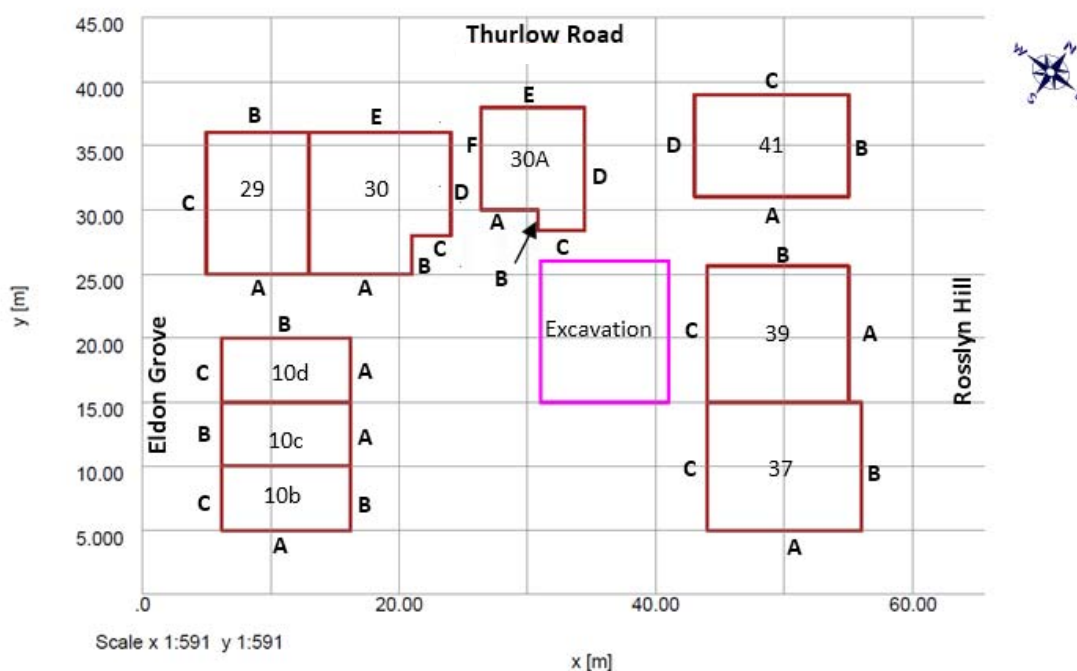
In addition to the above assessment of the likely movements that will result from the proposed development, some of the neighbouring structures have been considered as sensitive structures, requiring Building Damage Assessments, on the basis of the classification given in Table 2.5 of C580¹. The sensitive structures outlined above have been modelled as lines in the analysis and are the lines along which the damage assessment has been undertaken. A plan of the sensitive structures is provided below, and a key plan detailing the specific lines is included in the Appendix.

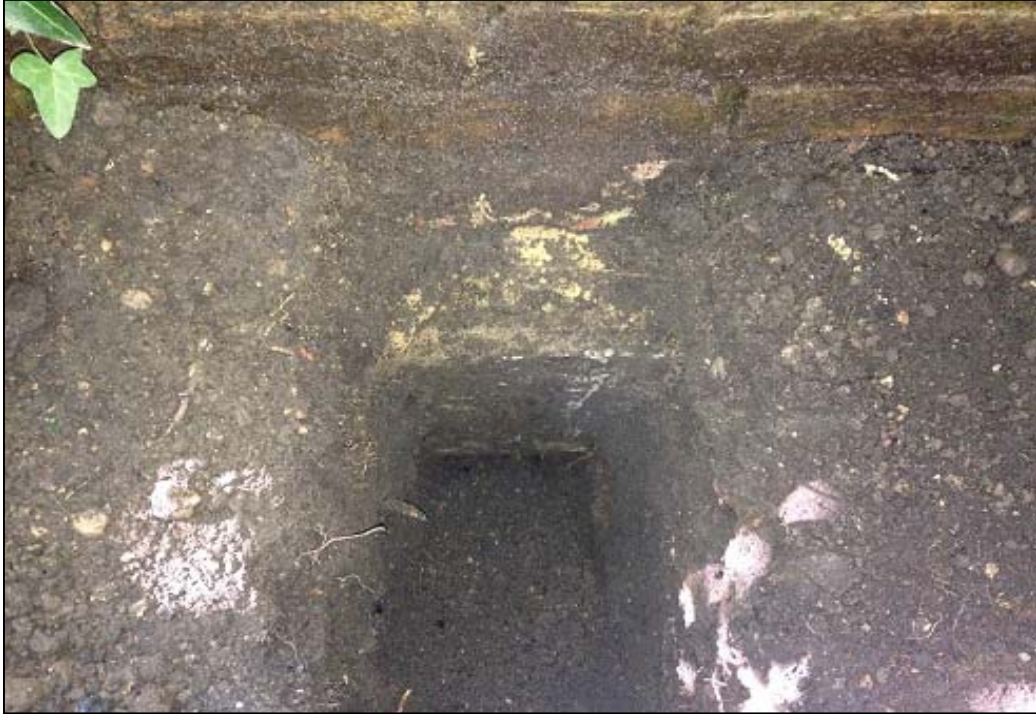
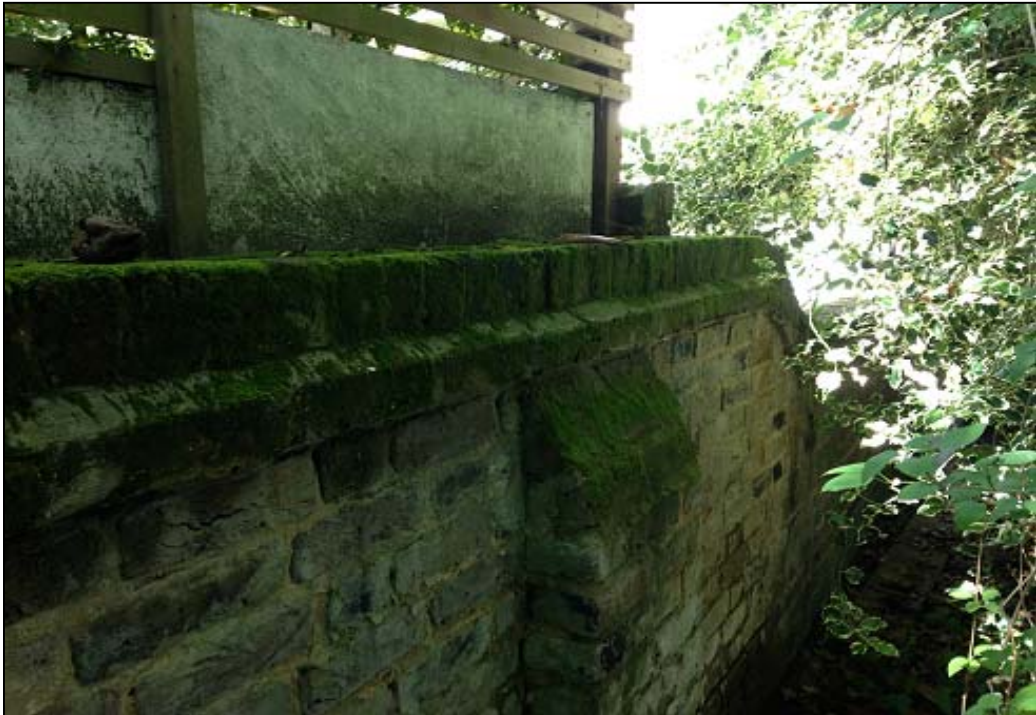
Excavation Method Manual	Dimensions 600 x 300 x 700	Ground Level (mOD) 86.02	Client Mr J Cohen and Ms A Lindsay	Job Number J15275
	Location	Dates 29/08/2015	Engineer Conisbee	Sheet 2 / 2

Remarks: All dimensions in millimetres Sides of trial pit remained stable during excavation Groundwater: not encountered	Scale: 1:20
	Logged by: ML

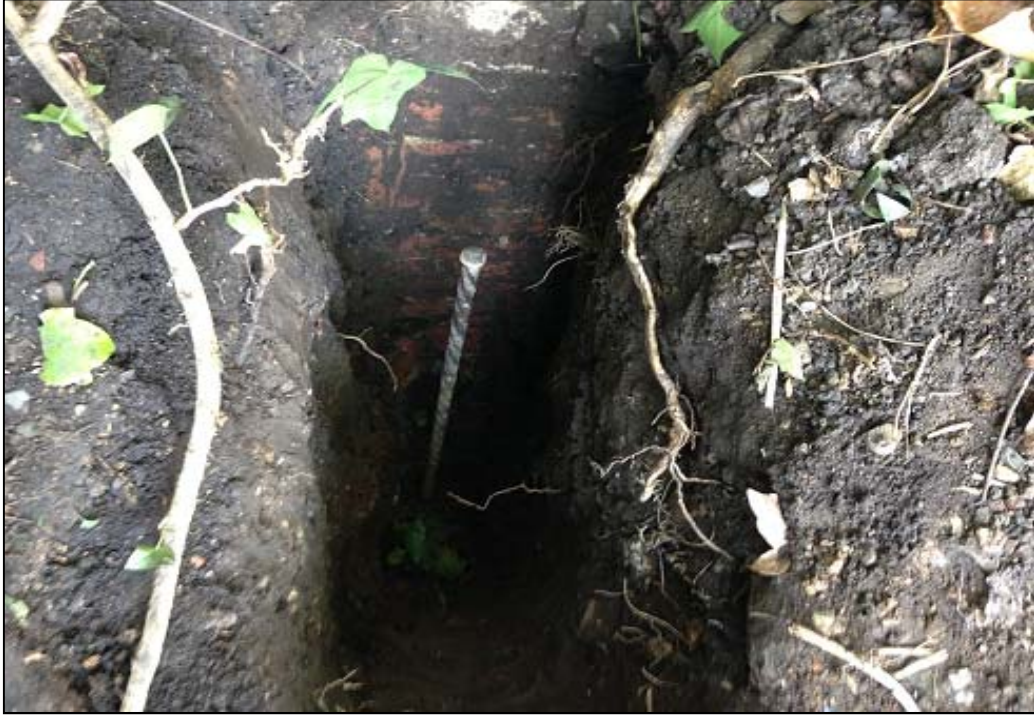
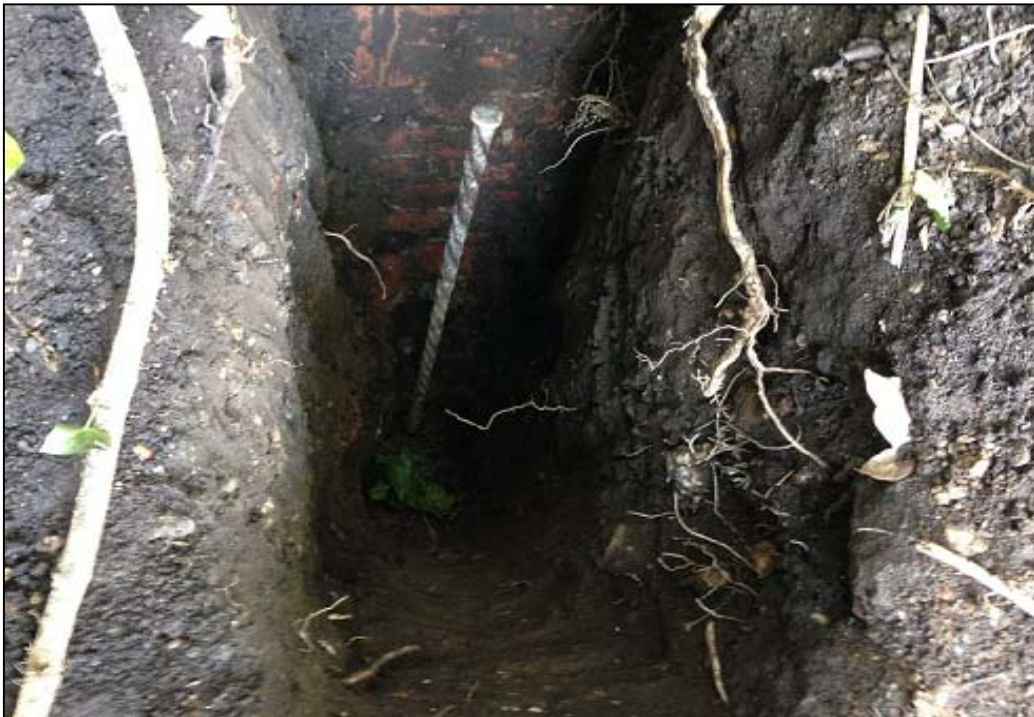
Excavation Method Manual	Dimensions 700 x 300 x 1300	Ground Level (mOD) 85.12	Client Mr J Cohen and Ms A Lindsay	Job Number J15236
	Location	Dates 29/08/2015	Engineer Conisbee	Sheet 2 / 2

Remarks:
All dimensions in millimetres
Sides of trial pit remained stable during excavation
Groundwater: not encountered

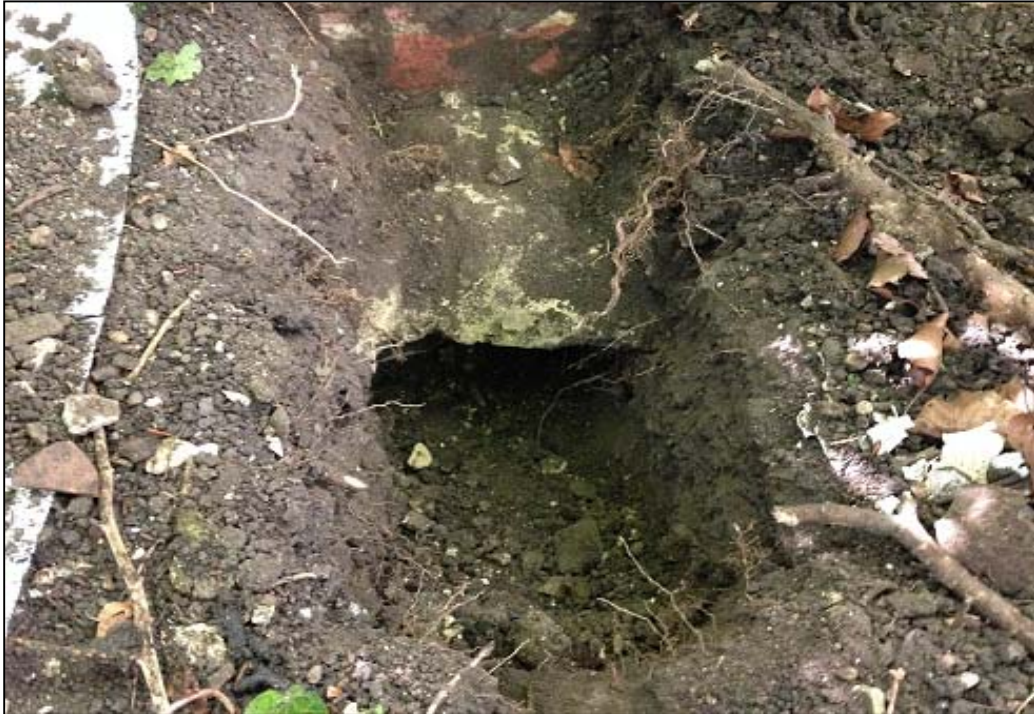
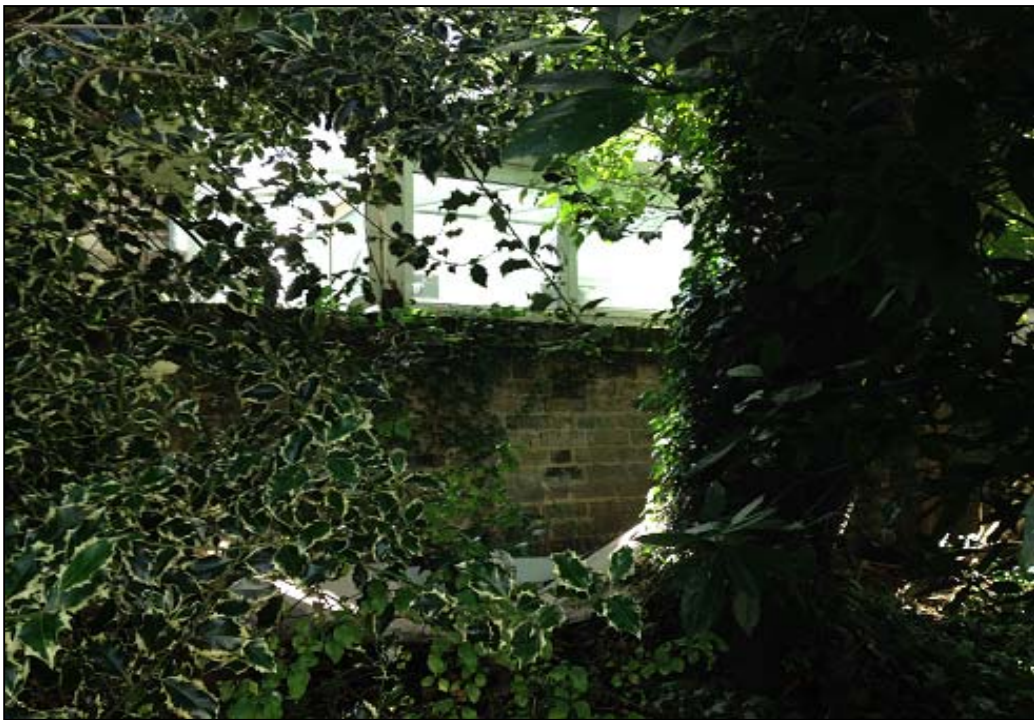
Excavation Method Manual	Dimensions 600 x 300 x 400	Ground Level (mOD) 85.99	Client Mr J Cohen and Ms A Lindsay	Job Number J15236
	Location	Dates 29/08/2015	Engineer Conisbee	Sheet 2 / 2

Remarks: All dimensions in millimetres Sides of trial pit remained stable during excavation Groundwater: not encountered	Scale: 1:20
	Logged by: ML
