GROUND APPRAISAL REPORT
for the site at
1 WADHAM GARDENS
LONDON
NW3 3DN
on behalf of
MARCUS COOPER GROUP

Report:	GROUND APPRAISAL REPORT
Site:	1 WADHAM GARDENS LONDON NW3 3DN
Client:	MARCUS COOPER GROUP
Date:	OCTOBER 2015
Reference:	GE10977 – GARv2JT151005
Version:	1.0
Prepared by:	 
	Luke Stock BSc (Hons)
	<u>Consultant Engineer</u>

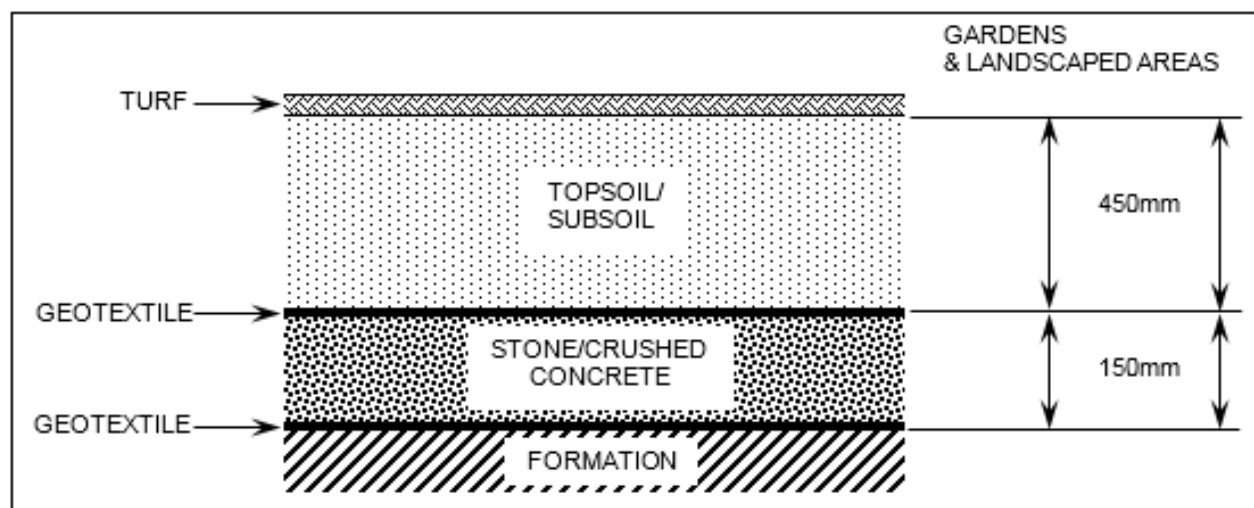
The results of the statistical analysis indicated that the null hypothesis could be rejected for all of the determinands with the exception lead. No outliers were detected for lead, though there were two results (761mg/kg and 2400mg/kg) which significantly exceeded the C4SL of 200mg/kg. The proposed landscaping plans indicate that much of the external garden areas are to be hard paved, which would effectively sever the pathway to the end users. However, within areas of proposed soft landscaping within the private gardens a cover system is recommended.

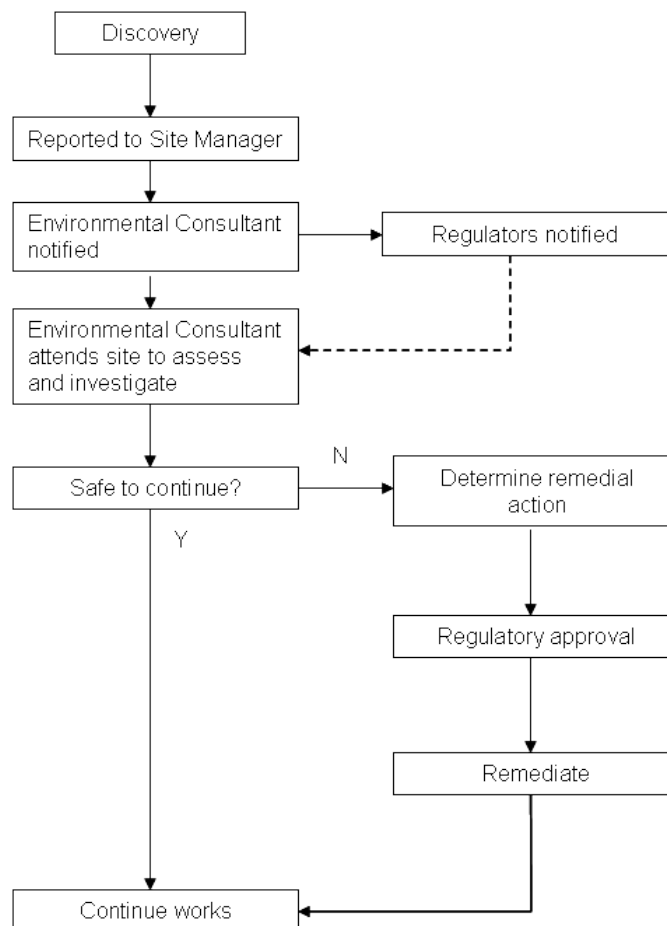
The process is summarised overleaf:

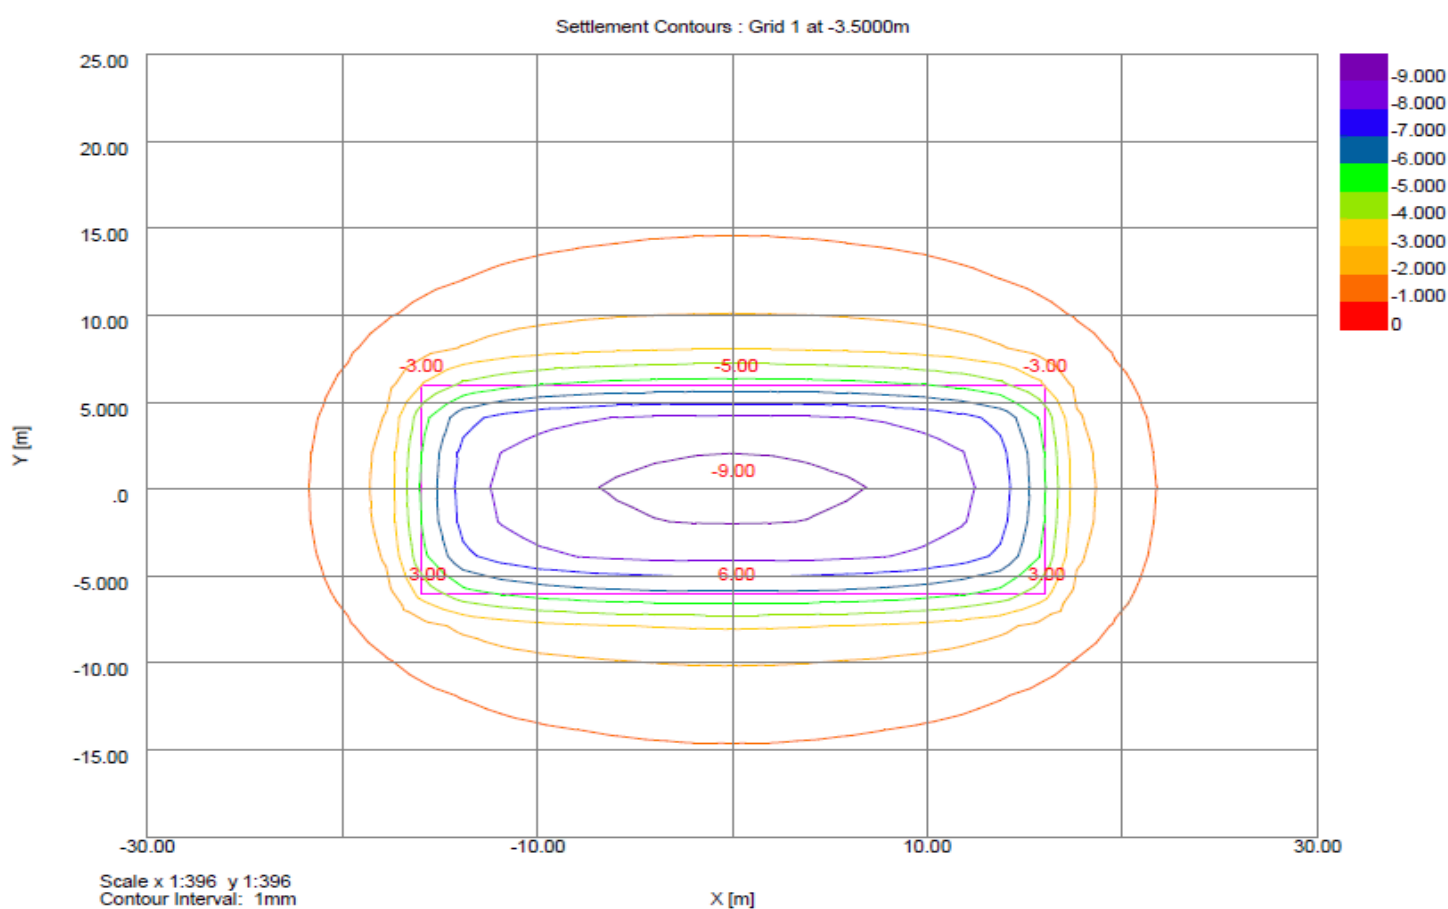
Settlement Contours : Grid 1 at -3.5000m

The ground response to stress changes have therefore been modelled in the short term for the unloading caused by excavation and removal of overburden pressure. The long term response has been modelled for the net stress change caused by the combination of demolition, the excavation and new loading.

It should be noted that the values of heave given at the party walls do not take into account any restraining effect the proposed underpins would have on vertical movements.

It should be noted that in practice, the heave movements that develop from unloading the soil do not occur in isolation from other ground movements (settlements) associated with basement construction so it is unlikely the magnitudes of movement calculated around the perimeter of the excavation would be realised.

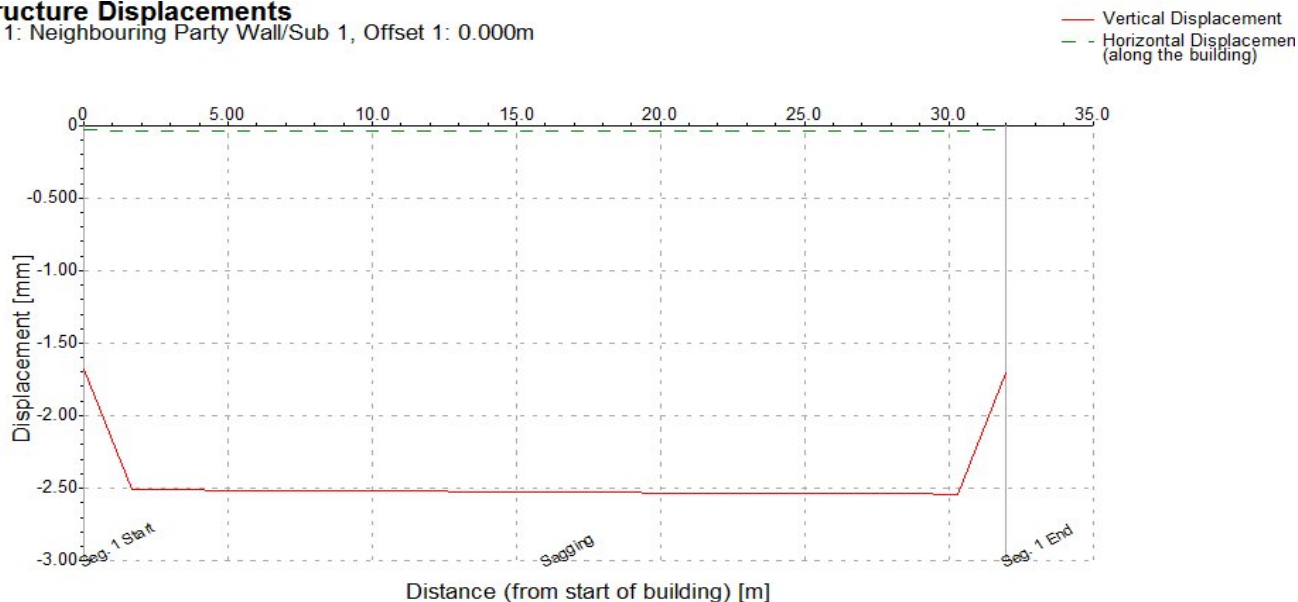
Building Damage Interaction Chart

Structure 1: Neighbouring Party Wall/Sub 1, Offset 1: 0.000m, Segment 1: length 32.000 m

Sub-Structure Displacements

Structure 1: Neighbouring Party Wall/Sub 1, Offset 1: 0.000m

The adjoining structures have been modelled in Xdisp in order to assess the potential category of damage in accordance with the criteria derived by Burland (1997) presented overleaf:

Table 9.1 summarises the walls assessed and the worst case category of damage calculated.

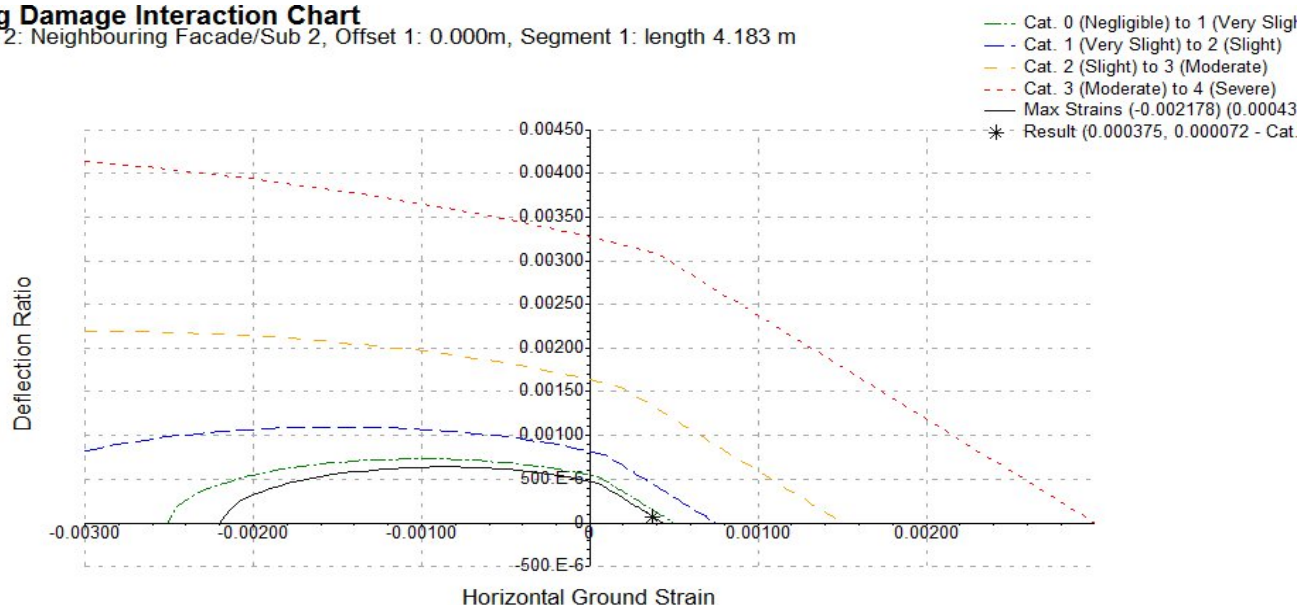
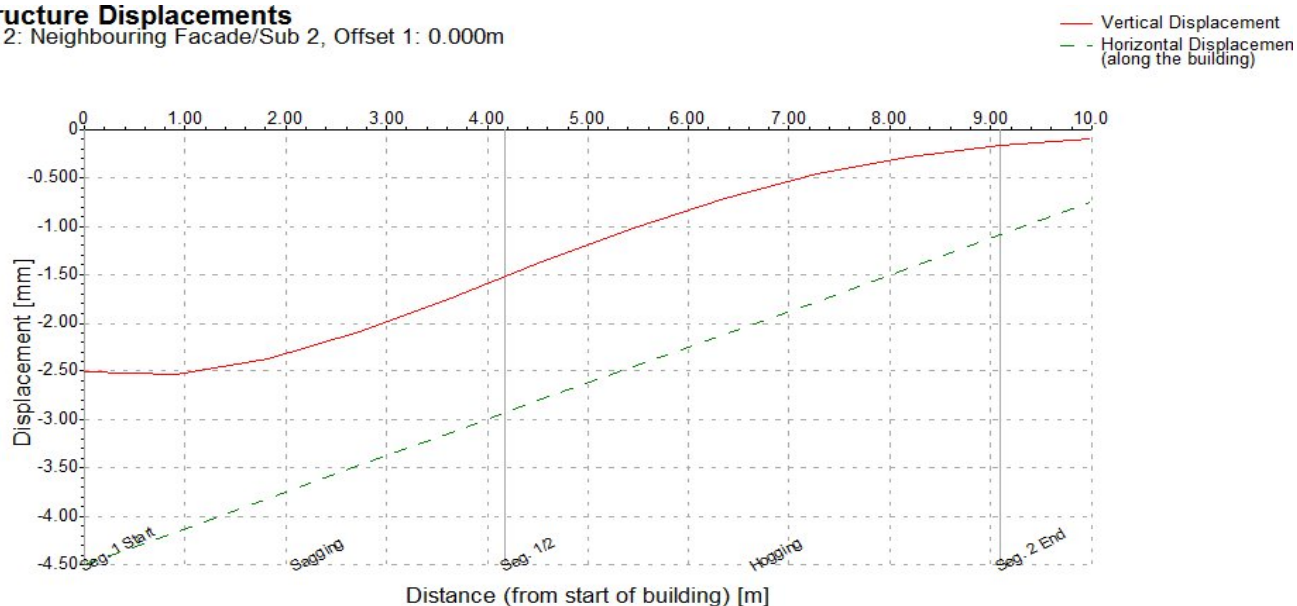
Building Damage Interaction Chart

Structure 2: Neighbouring Facade/Sub 2, Offset 1: 0.000m, Segment 1: length 4.183 m

Sub-Structure Displacements

Structure 2: Neighbouring Facade/Sub 2, Offset 1: 0.000m

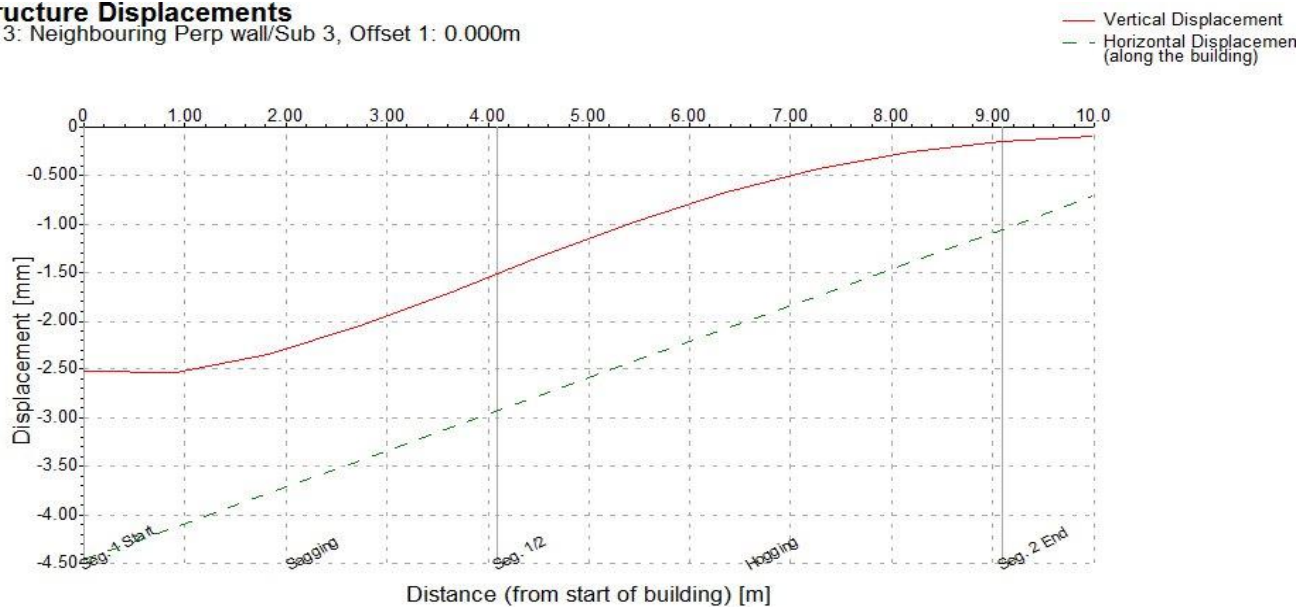
Building Damage Interaction Chart

Structure 3: Neighbouring Perp wall/Sub 3, Offset 1: 0.000m, Segment 1: length 4.084 m

Sub-Structure Displacements

Structure 3: Neighbouring Perp wall/Sub 3, Offset 1: 0.000m
