Heritage Statement for 11-15 Argyle Square
WC1H 8AS

Date: November 2015

The following report has been prepared for Planning application of new first floor rear extension at 11-15 Argyle Square. The purpose of the report is to set out the historic development and significance of the building and consider the current proposals.

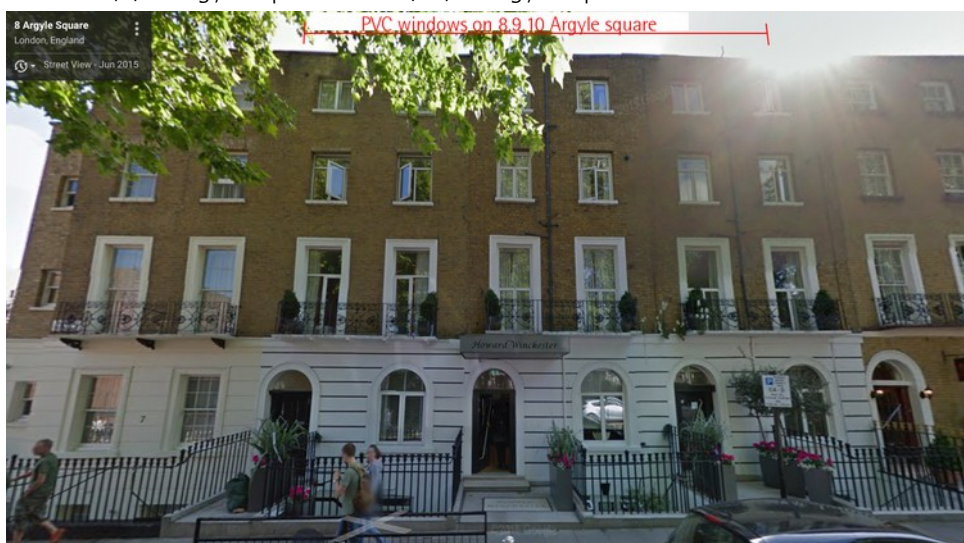
From our visual observations, there have been rebuilding from the original building fabric of the front elevation at the south side to the square where the proposed site situates. This can be seen from the existing bricks on the elevation also the windows replacement to the PVC windows installed on 8,9,10 Argyle Square and 16,17,18 Argyle Square for steel windows.

8,9,10 Argyle square with PVC windows

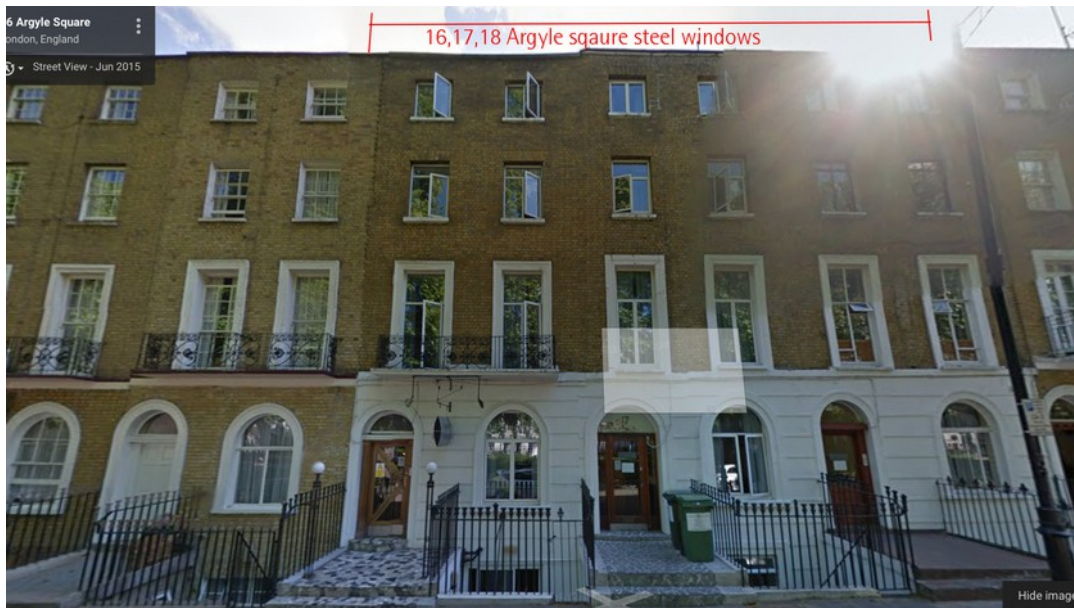
16,17,18 Argyle square with steel windows

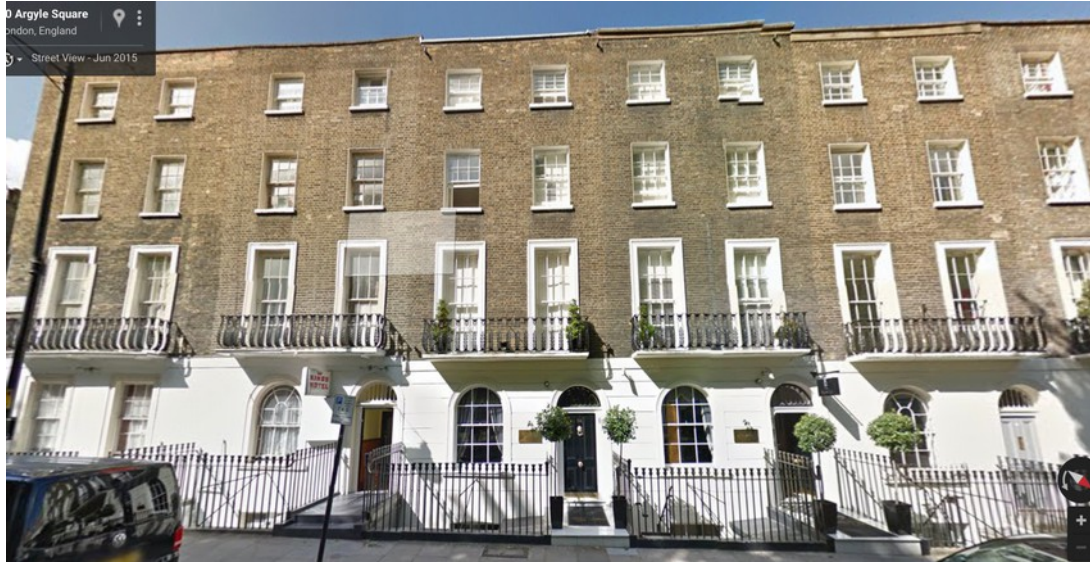
The west side of Argyle Square

The original building fabric appears to be more in tact on the west side and south side of Argyle Square.

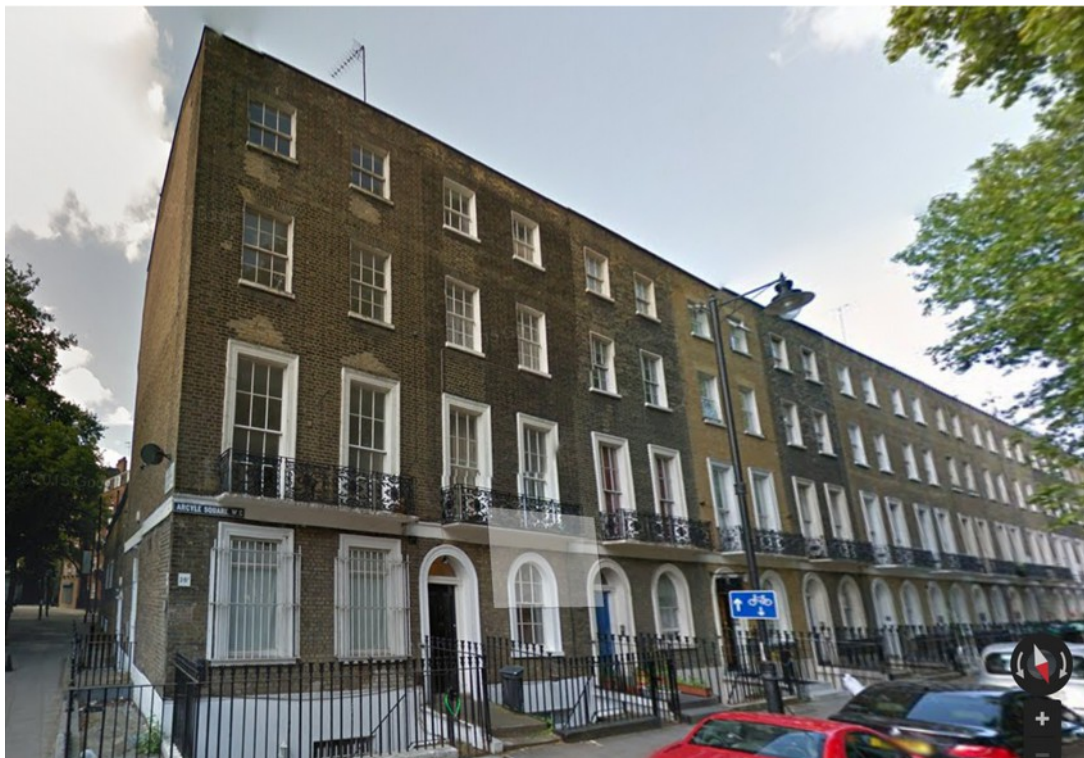
The south side of the square, the original fabric appears to be more intact than the east side as well

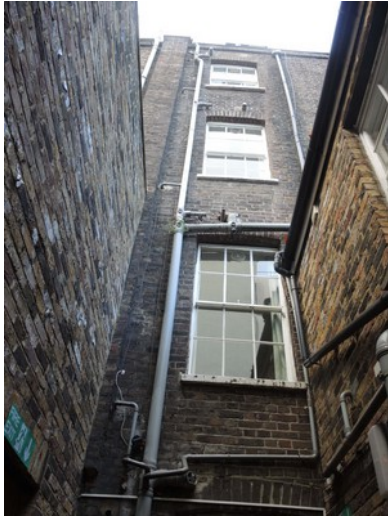
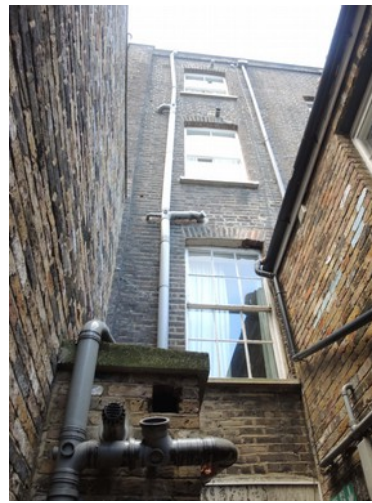
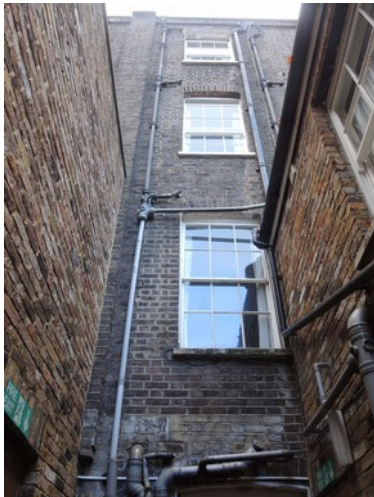
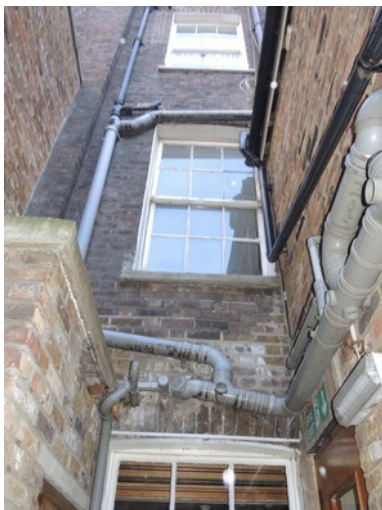
11 Argyle Square rear elevation

12 Argyle Square rear elevation

13 Argyle Square rear elevation

14 Argyle Square rear elevation

15 Argyle Square rear elevation

The existing rear windows are all traditional timber sash windows and all appear to have been replaced in last 25 years.

Looking at the age of the existing bricks the rear elevation appears to be the original walls although the basement and ground floor level the rear elevations were modified together in addition all rain water and soil pipes have been added and replaced.

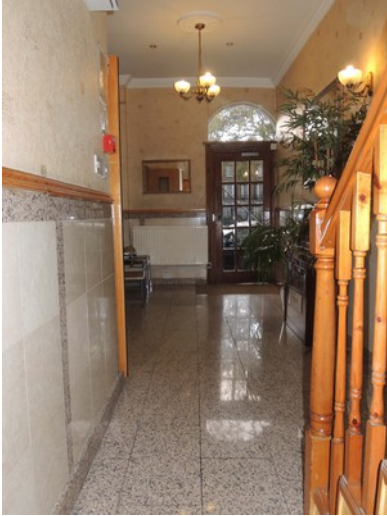
Main hotel entrance to
11-15 Argyle Square

From our observations it is evident that the original internal layout has been altered within all five properties in order to be adapted for the small hotel use. The existing retained entrances were no longer used except for the 11 Argyle Square where the hotel entrance has been allocated. There is no original feature has been found in the interior of the five buildings. All internal finishes have been covered with conventional wall papers and artificial stone tile materials.

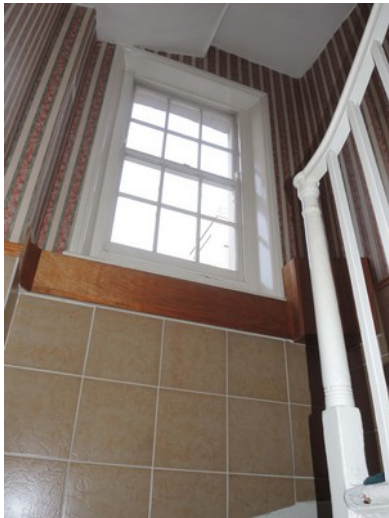
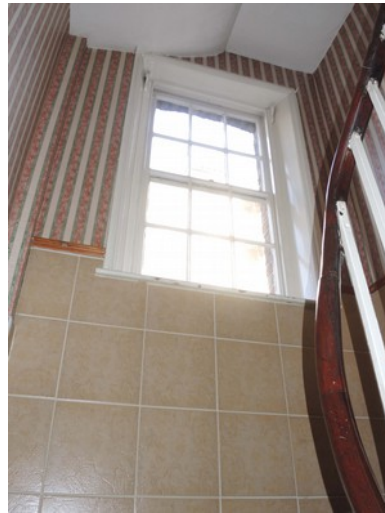
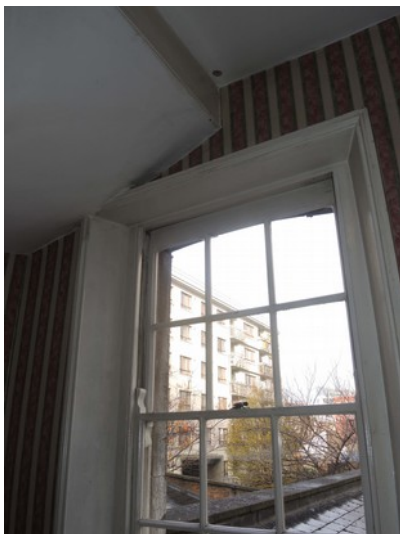
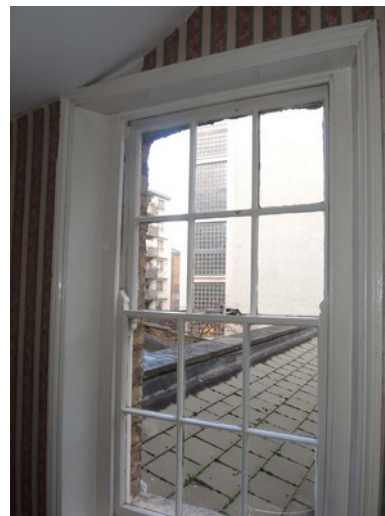
11 Argyle Square rear window internal
view at Stairwell

12 Argyle Square rear window internal
view at Stairwell

13 Argyle Square rear window internal
view at Stairwell

14 Argyle Square rear window internal
view at Stairwell

15 Argyle Square rear window internal
view at Stairwell

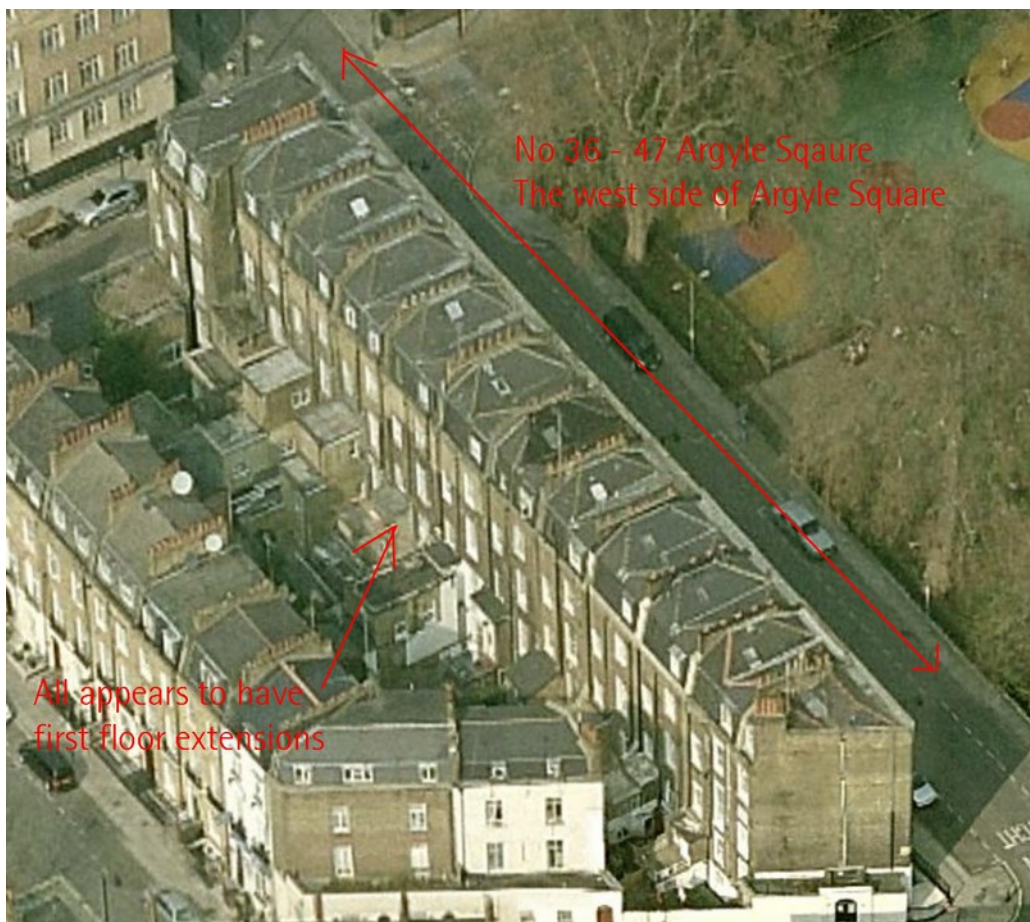
Rear of No 36-47 Argyle Square, all has first floor rear extension

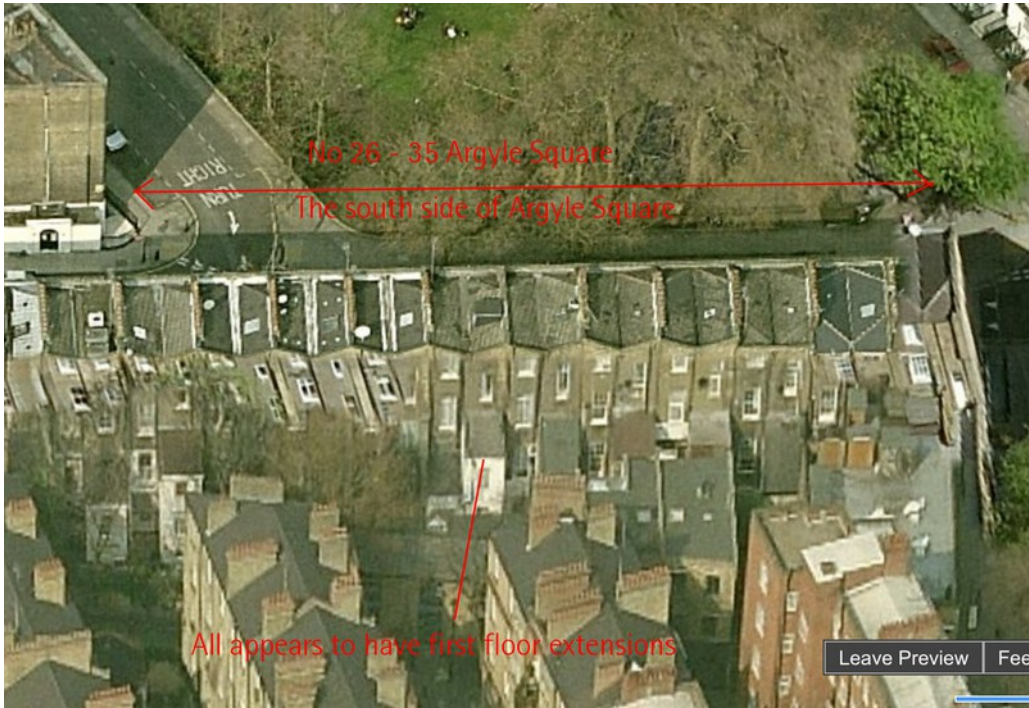
Rear of No 26-35 Argyle Square, all has first floor rear extension
