# **Heritage Statement**

**20 Perrin's Lane  
Hampstead  
NW3 1QY**

# **Alan Higgs Architects**

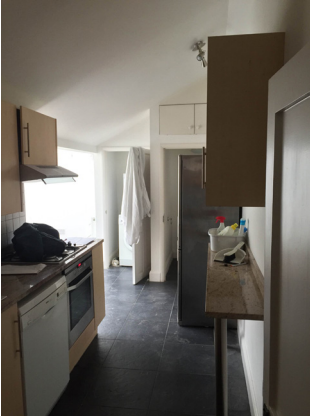
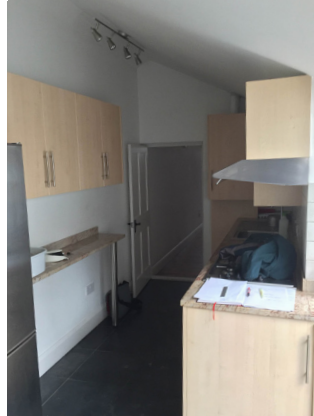
Fig.i and Fig.ii show the area of the kitchen within the original footprint of house.

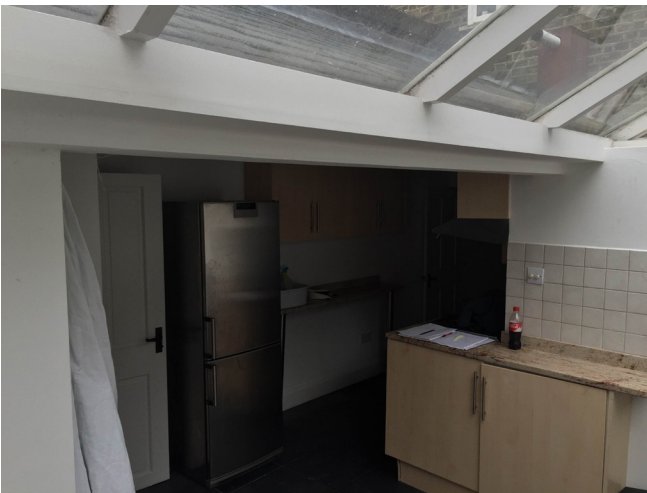
**Fig.iii**

Fig.iii looks back to the part of the kitchen within the original footprint of the house from the late 20th Century extension with glazed roof. The beam which creates head height issues can be seen here as well.

The floor level is proposed to be lowered by 180 mm in order to allow for a safe floor to ceiling height under an existing beam, between the kitchen from the original footprint of the house and the 20th Century extension. Trial holes have shown us that the current floor construction is a 20th Century Concrete floor.
