**PRECEDENT 1: THE CONNAUGHT HOTEL, MAYFAIR, LONDON**

PROJECT TITLE:		
<b>HOTEL RUSSELL</b>		
1 RUSSELL SQUARE, LONDON		
WC1B 5BE		
DRAWING TITLE:		
LISTED BUILDING PLANNING APP		
HOIST AND ASSOCIATED WORKS		
PRECEDENT 1 - CONNAUGHT HOTEL		
STATUS:		
N/A		
DATE:	DRAWN BY:	CHECKED BY:
04/12/2015		
SCALE:	PAPER SIZE:	JOB No:
N/A	A4	0143
DRAWING NUMBER:		REV:
0143-RUSS-SK10

PRECEDENT 2: THE SAVOY HOTEL, LONDON

PROJECT TITLE:			
<b>HOTEL RUSSELL</b>			
1 RUSSELL SQUARE, LONDON			
WC1B 5BE			
DRAWING TITLE:			
LISTED BUILDING PLANNING APP			
HOIST AND ASSOCIATED WORKS			
PRECEDENT 2 - SAVOY HOTEL			
STATUS:			
N/A			
DATE:	DRAWN BY:	CHECKED BY:	
04/12/2015			
SCALE:	PAPER SIZE:	JOB No:	
N/A	A4	0143	
DRAWING NUMBER:			REV:
0143-SK11

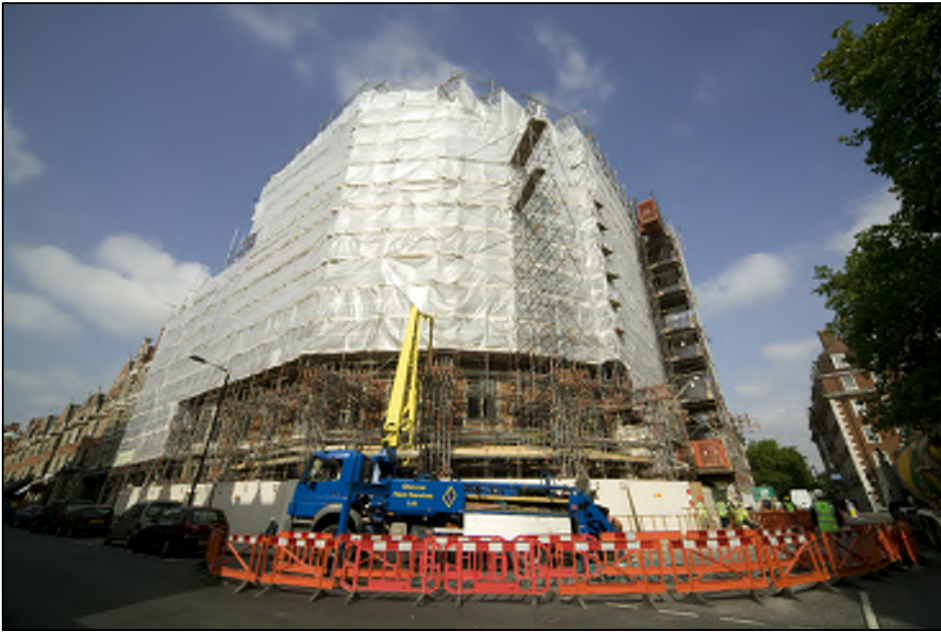
PHOTO 1: THE CONNAUGHT HOTEL DURING CONSTRUCTION

As can be seen from Photo 1 above, this scheme like the Russell Hotel necessitated an external hoist with access to the floors via existing windows. This required careful removal of the Portland Stone window mullions as well as terracotta and facing brickwork window reveals. These were reinstated towards the end of the constructions works to English Heritage Standards and approval.

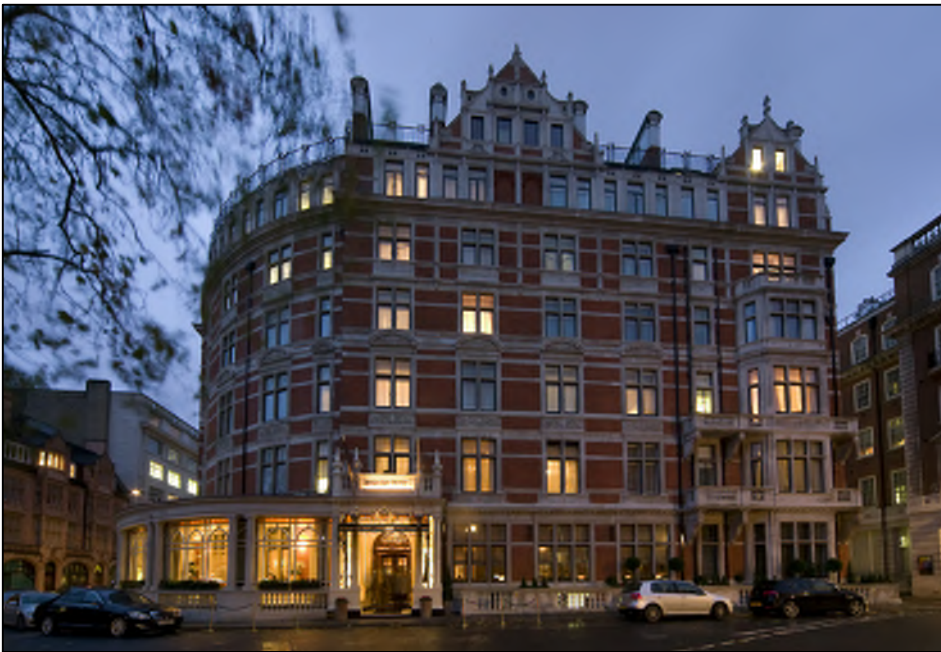
PHOTO 2: THE CONNAUGHT HOTEL POST COMPLETION

As can be seen from Photo 2, the reinstatement and re-building of the window mullions was done expertly and successfully and the overall facade uplifted to the highest standards

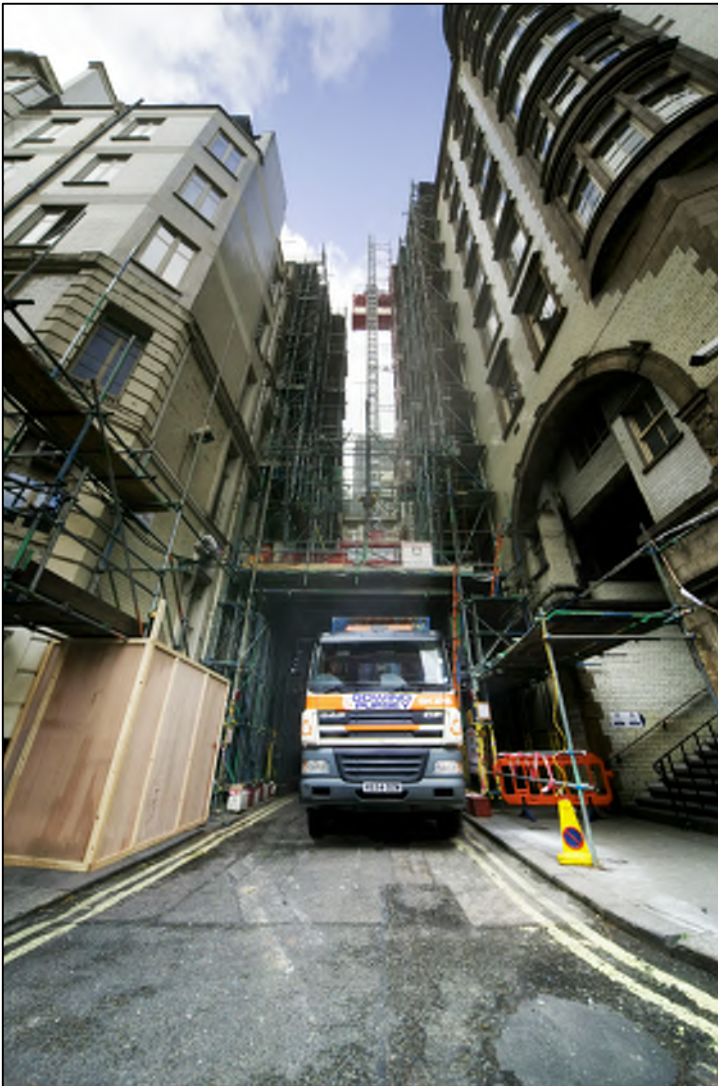
PHOTO 1: THE SAVOY HOTEL DURING CONSTRUCTION

As can be seen from Photo 1 above, this scheme like the Russell Hotel necessitated an external hoist with access to the floors via existing guestroom windows. This required careful removal of the timber and metal windows as well as portland stone and glazed brick reveals. These were reinstated towards the end of the constructions works to English Heritage and Westminster Council standards.

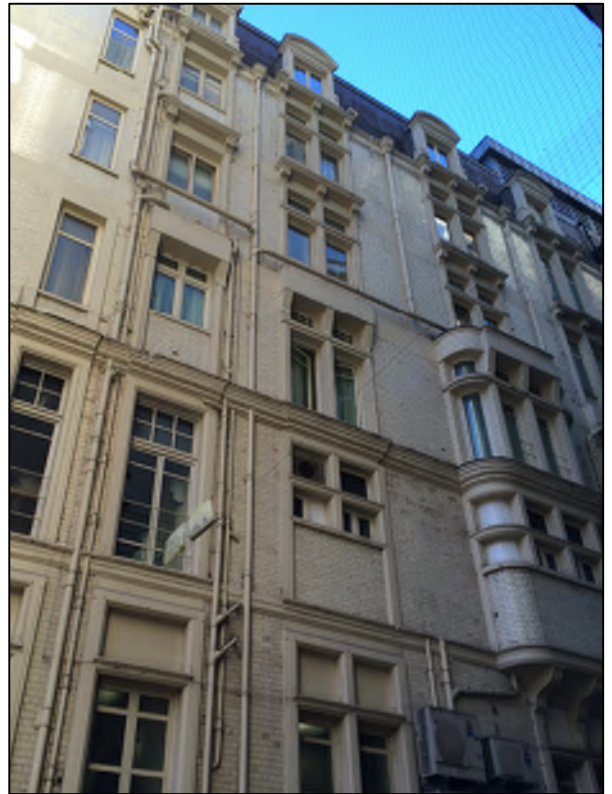
As can be seen from Photos 2 and 3, the reinstatement and re-building of all the window mullions was done expertly and to the highest quality.

PHOTO 2: THE SAVOY HOTEL POST CONSTRUCTION (AREA OF HOIST)

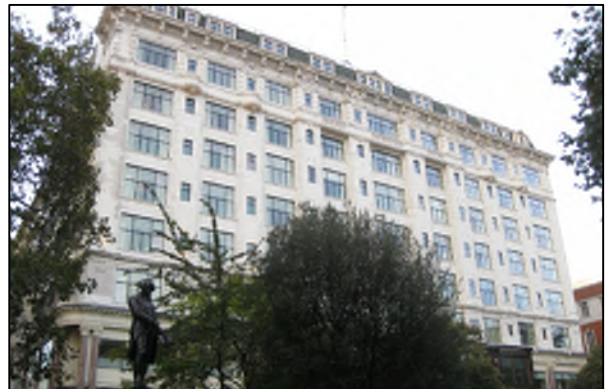
PHOTO 3: THE SAVOY HOTEL POST CONSTRUCTION
