**PLENDER STREET, CAMDEN, LONDON NW1 0LB
- SUPPLEMENTARY ASBESTOS INVESTIGATION**

This letter report (13804GI2) covers the further window sample boreholes to assess the risk posed by asbestos across the remainder of the site.

PROPOSED WINDOW SAMPLE HOLE LOCATION PLAN (Based upon drawing by others)	
Date 16 NOVEMBER 2015	Version A
Scale NOT TO SCALE	Drawing No 13804GI2/1
RSA GEOTECHNICS LIMITED

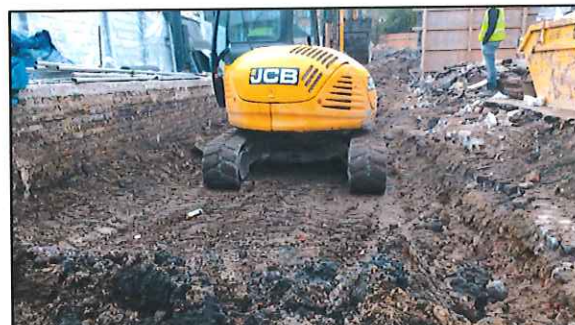
Figure 1

Since the previous fieldwork undertaken in 2014 the proposed development had been constructed across the north of the site. The southern portion of the 'T' was undergoing development and at the time of the site visit an excavator was removing soil in the southern area (Figure 1). A container was also located towards the southern boundary (Figure 2). Service drawings were provided by the Client on-site for the 'as-built'

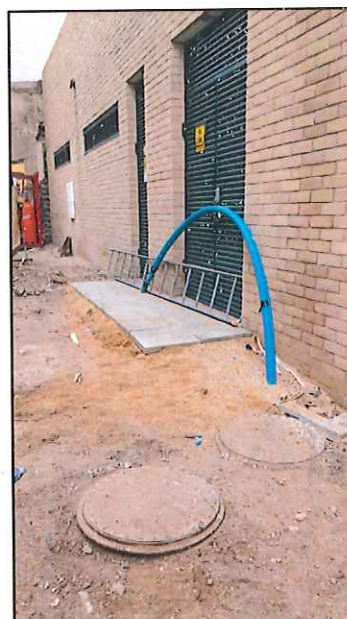
Figure 3

services. The main service runs were at the proposed locations of WS101 and WS102 with an electrical substation located adjacent to proposed WS101 (Figure 3).

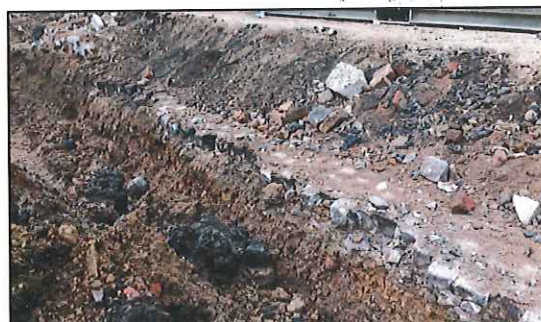
Figure 4

This was underlain in both window samples by a former cobble road 100 mm thick. The cobbles are shown in Figure 4. Underlying the cobbles in WS103 was medium to coarse brown sand with some subangular fine to coarse flint gravel and rare fine gravel size brick extending to 0.8 m probably representing the former road subbase.

The made ground in WS103 and WS104 was distinctively different from that encountered previously in the north eastern area of the site which comprised brick rubble. At a depth of 0.55 m an old cobble road was encountered in the southern area of the site and it is possible that material beneath this pre-dates bulk production and use of asbestos in the UK. The road was identified on historic maps dating back to 1851.

The presence of loose fibres prevents visual identification of ACM directly on site. It is therefore recommended that the remaining areas of groundwork are undertaken with the assumption that asbestos may be present above the cobblestone road construction. The proposed development includes limited soft landscaping approximately 5 m west of WS103 and WS104. In these locations a clean cover system should be installed to the top of the cobblestone road or an equivalent depth, approximately 0.55 m. A deter-to-dig membrane should be placed beneath the clean cover system to prevent further excavation into potentially contaminated soils.

former cobblestone road or equivalent depth (0.55 m) should be installed with a deter-to-dig membrane or 150 mm layer of clean crushed concrete at the base.
