GROUND INVESTIGATION & BASEMENT IMPACT ASSESSMENT REPORT

King's Cross Methodist Church
58 Birkenhead Street
London
WC1H 8WB

Client: West London Mission

November 2015

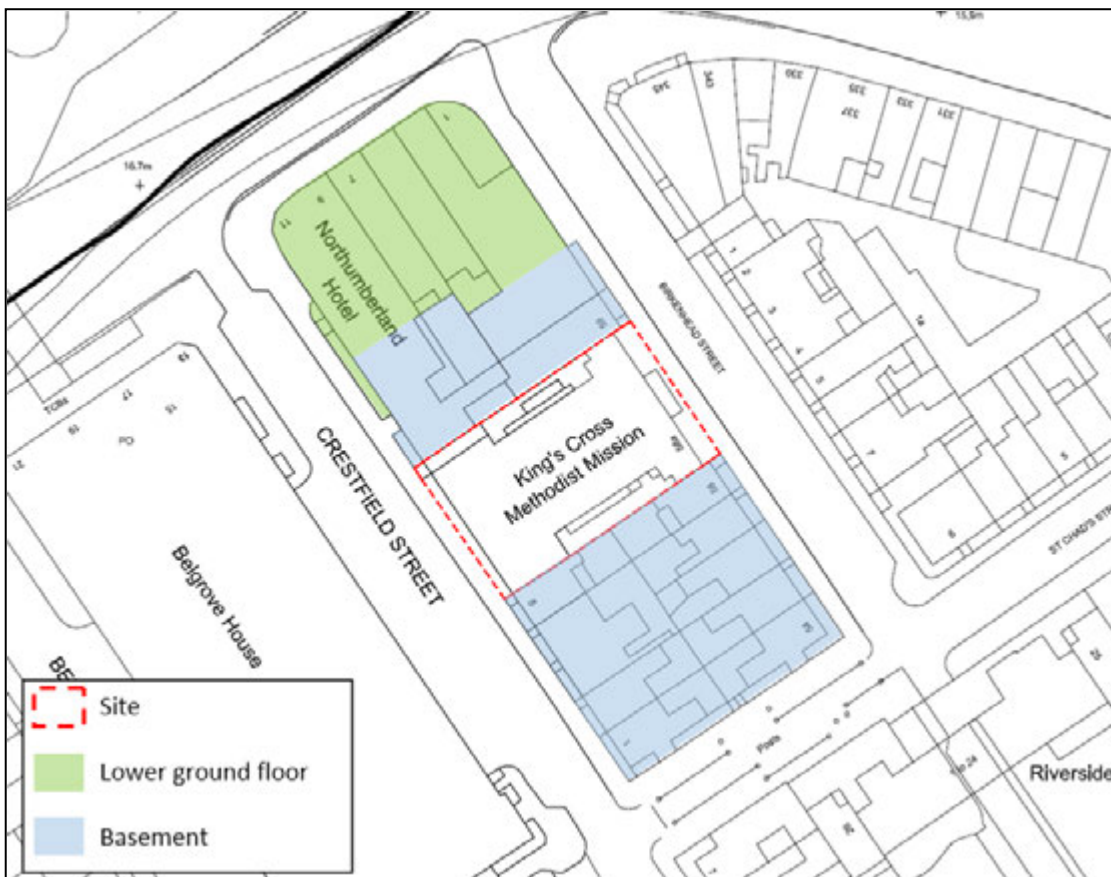
The plan below indicates lower ground floor and basement levels in the buildings neighbouring the site, which has been compiled using information from the site walkover and information available on the Local Authority planning portal.

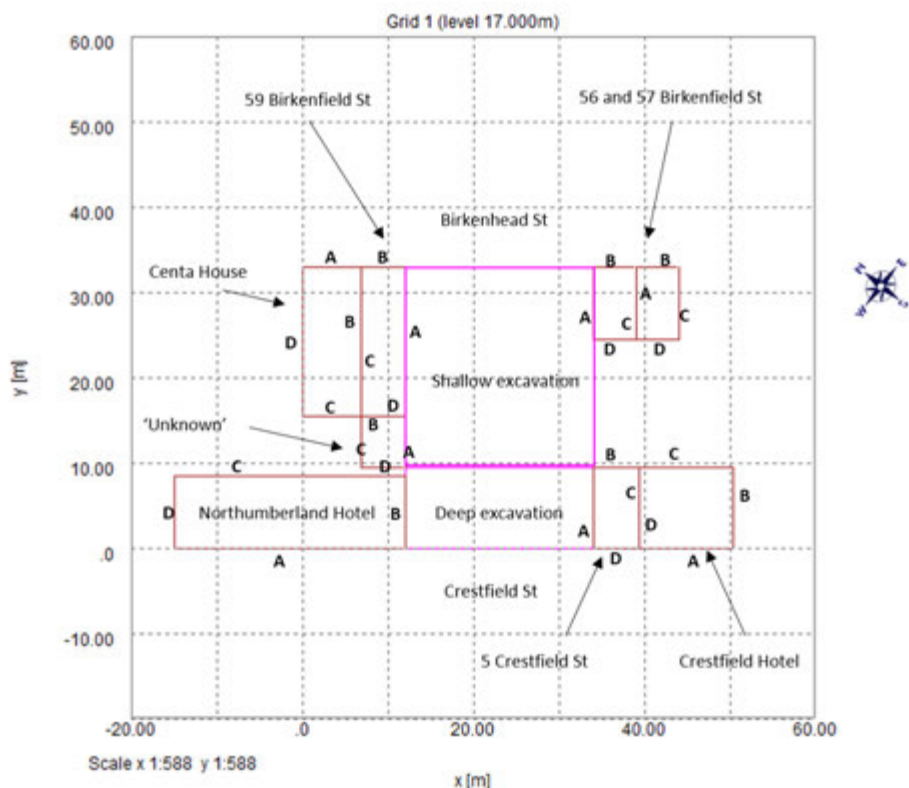
In addition to the above assessment of the likely movements that will result from the proposed development, some of the neighbouring structures have been considered as sensitive structures, requiring Building Damage Assessments, on the basis of the classification given in Table 2.5 of C580¹. These include the surrounding neighbouring properties which can be identified on the key plan in the appendix.

The sensitive structures outlined above have been modelled as lines in the analysis and are the lines along which the damage assessment has been undertaken. A plan of the sensitive structures is provided overleaf, and a key plan detailing the specific lines is included in the Appendix.

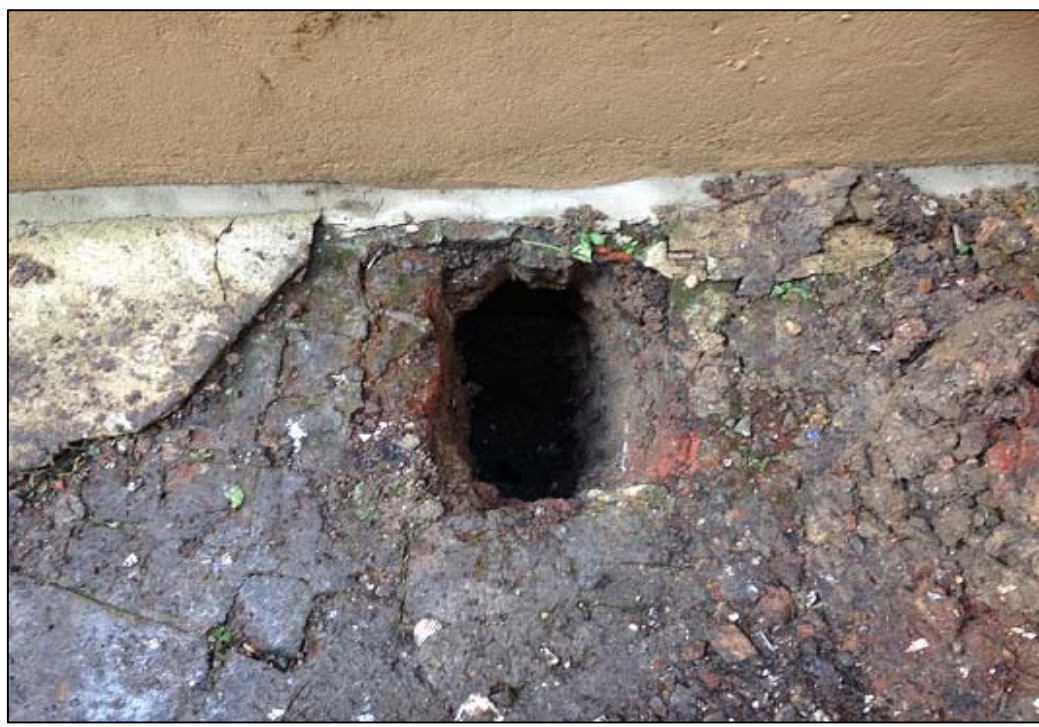
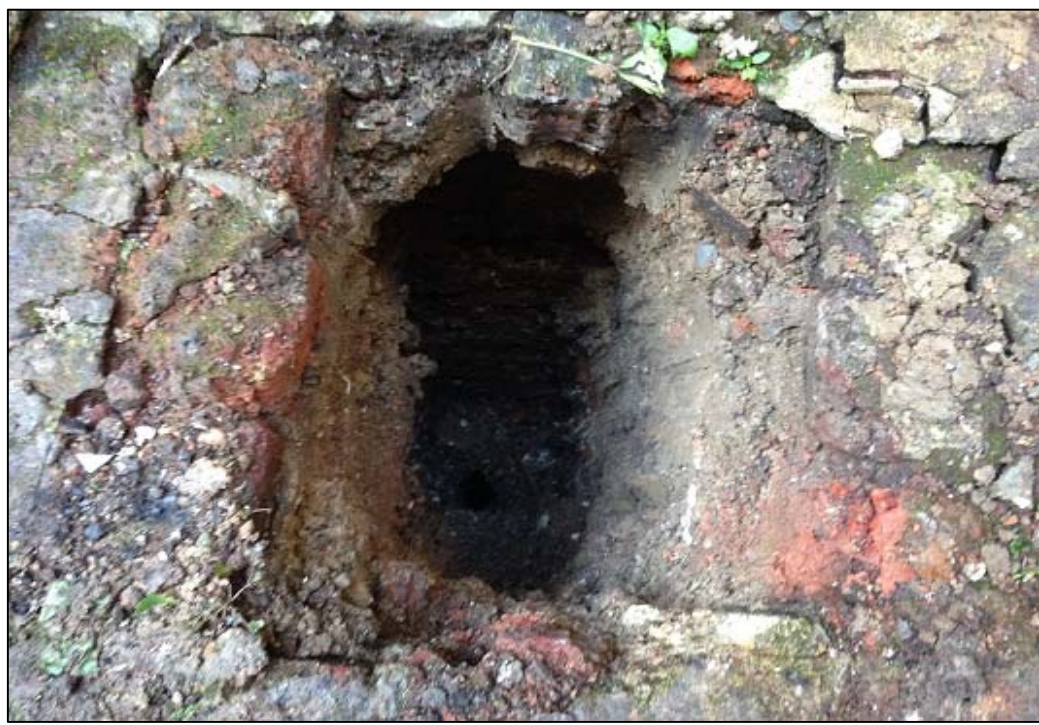
**Trial Pit
Number**
1

Excavation Method Manual	Dimensions 500 x 400 x 1300	Ground Level (mOD) 17.71	Client West London Mission	Job Number J14336
	Location	Dates 04/11/2014	Engineer Conisbee	Sheet 2 / 2

Remarks:
All dimensions in millimetres
Sides of trial pit remained stable during excavation
Groundwater: Not encountered

Base of footing not proved.
Borehole No 3 advanced through base of trial pit.

Trial Pit No 1 was excavated adjacent to the northwestern party wall, but the base of footing was not encountered at the maximum extent of the trial pit, at a depth of 1.30 m (16.41 m OD). Trial Pit Nos 2 and 6 were also excavated adjacent to this party wall, although from a lower level. The foundations were found to be bearing on London Clay at 0.30 m (14.58 m OD) and 0.60 m (14.51 m OD) respectively.

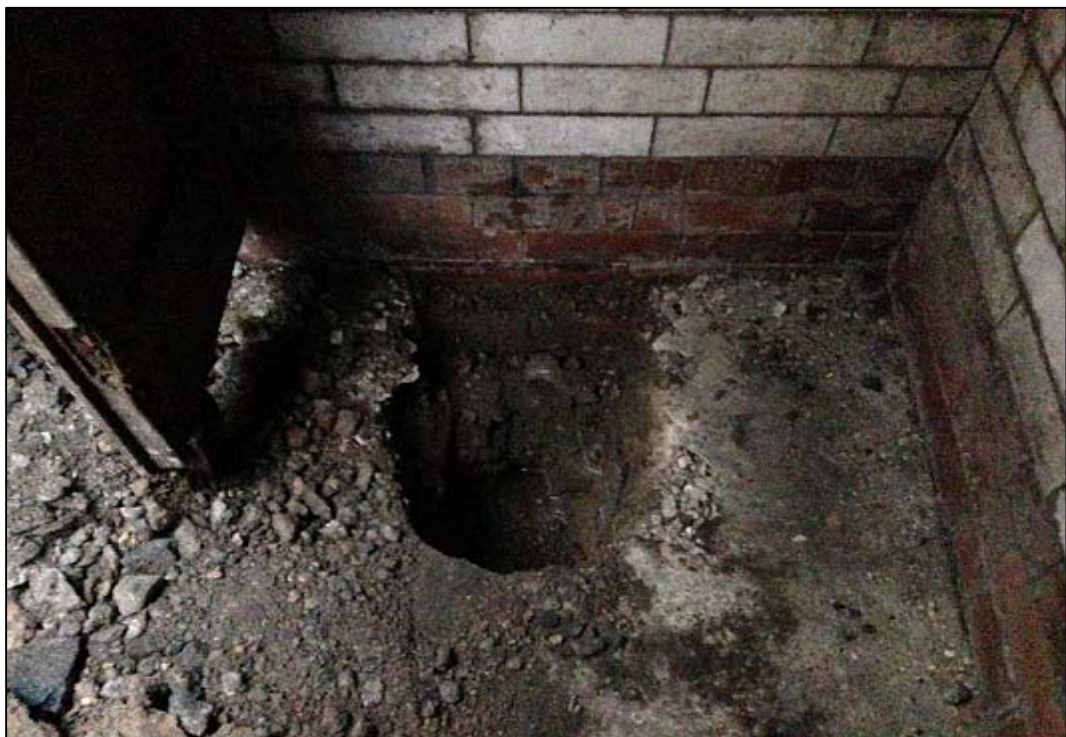
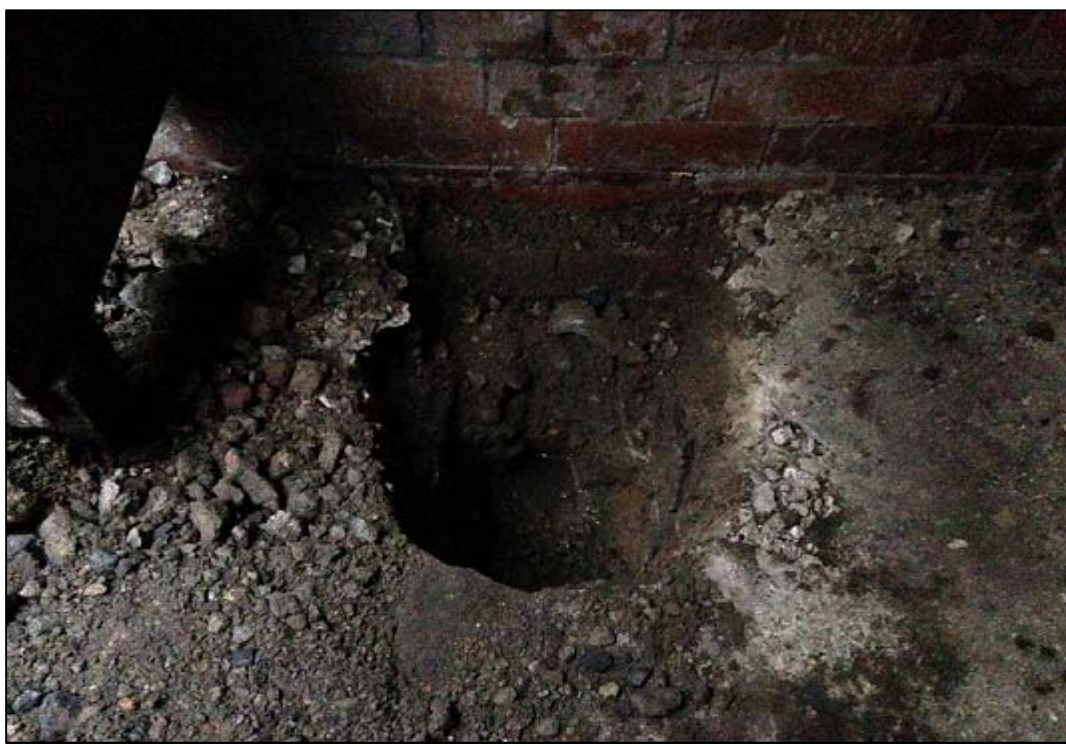
**Trial Pit
Number**
2

Excavation Method Manual	Dimensions 600 x 400 x 400	Ground Level (mOD) 14.88	Client West London Mission	Job Number J14336
	Location	Dates 05/11/2014	Engineer Conisbee	Sheet 1 / 2

Remarks:
All dimensions in millimetres
Sides of trial pit remained stable during excavation
Groundwater: Standing at 0.30 m

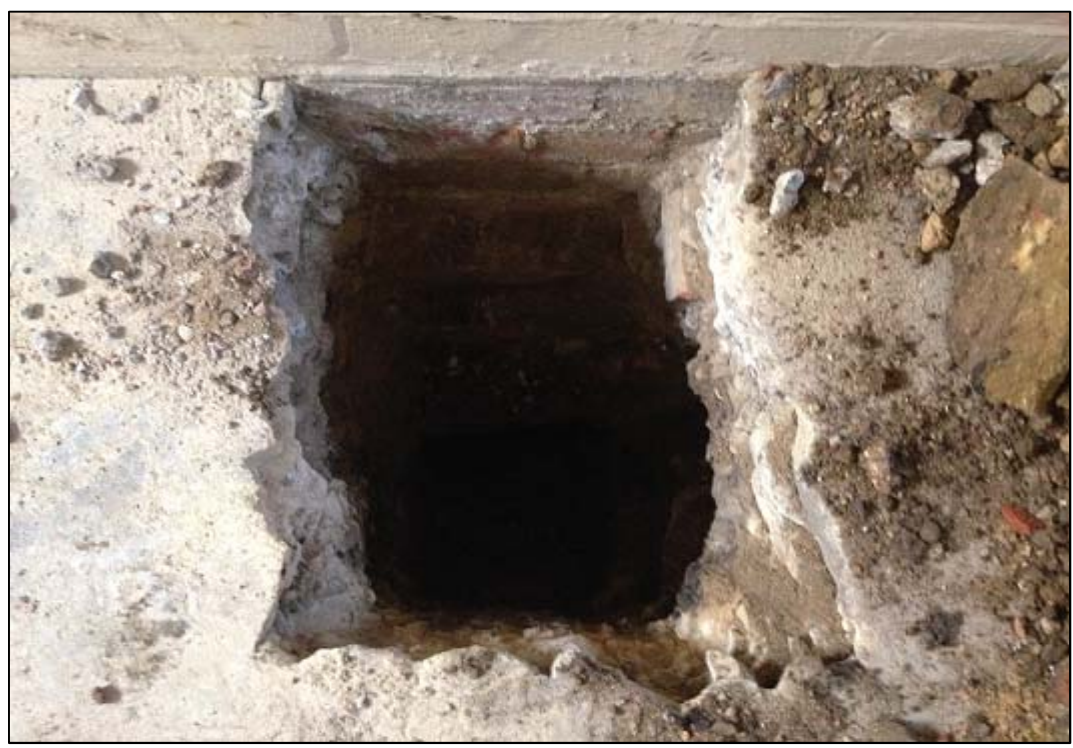
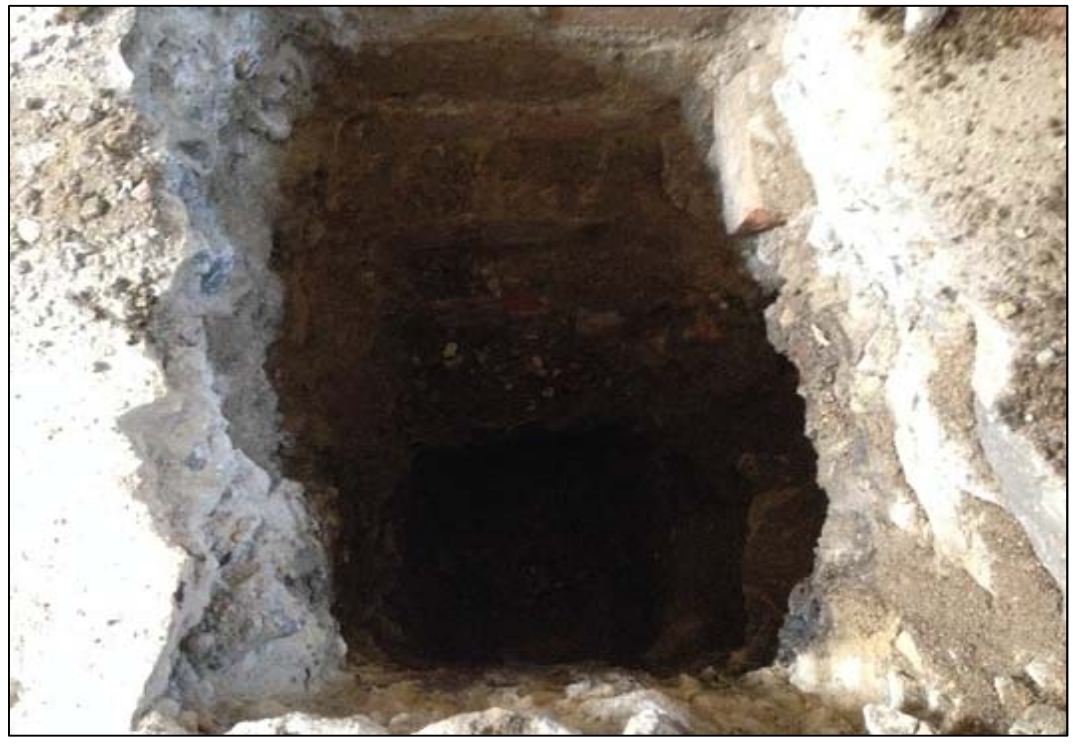
**Trial Pit
Number**
3

Excavation Method Manual	Dimensions 450 x 400 x 800	Ground Level (mOD) 17.03	Client West London Mission	Job Number J14336
	Location	Dates 05/11/2014	Engineer Conisbee	Sheet 1 / 2

Remarks:
All dimensions in millimetres
Sides of trial pit remained stable during excavation
Groundwater: Not encountered

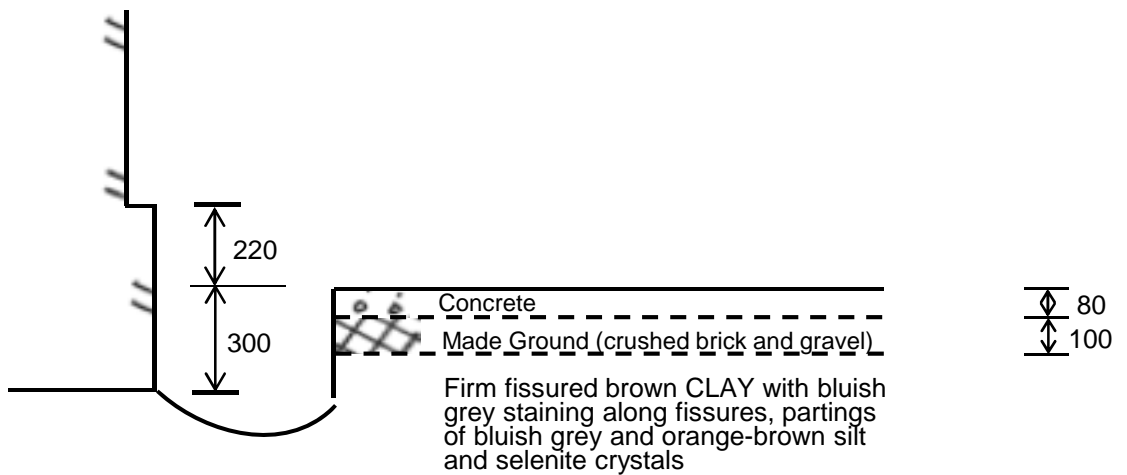
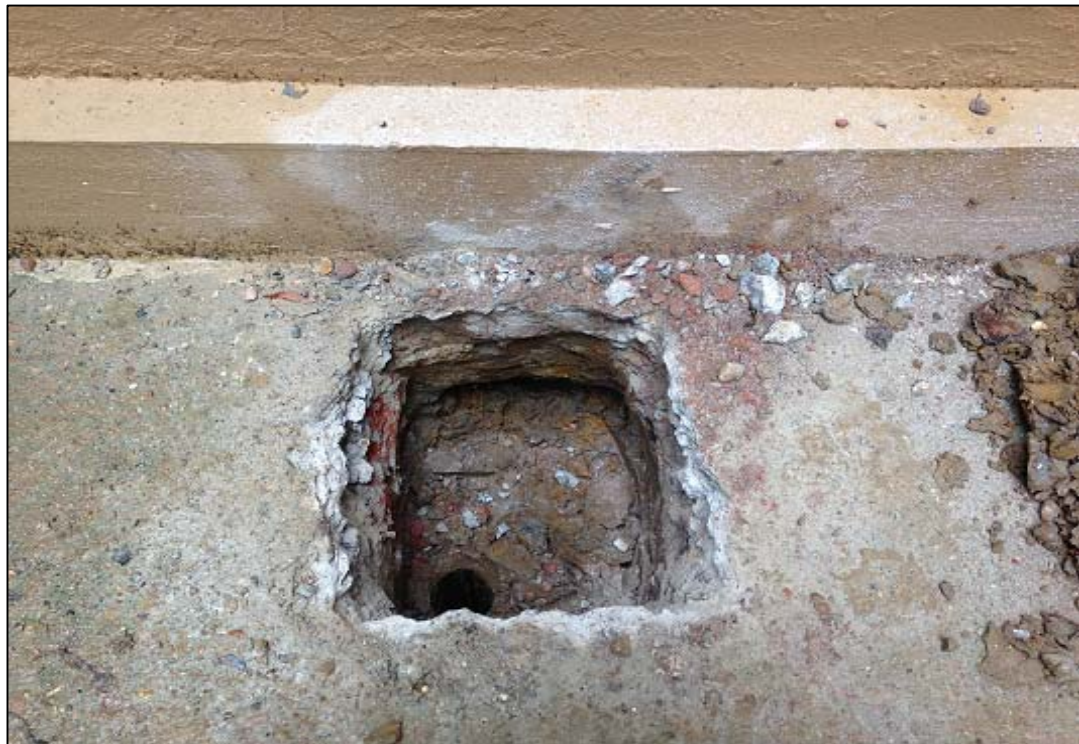
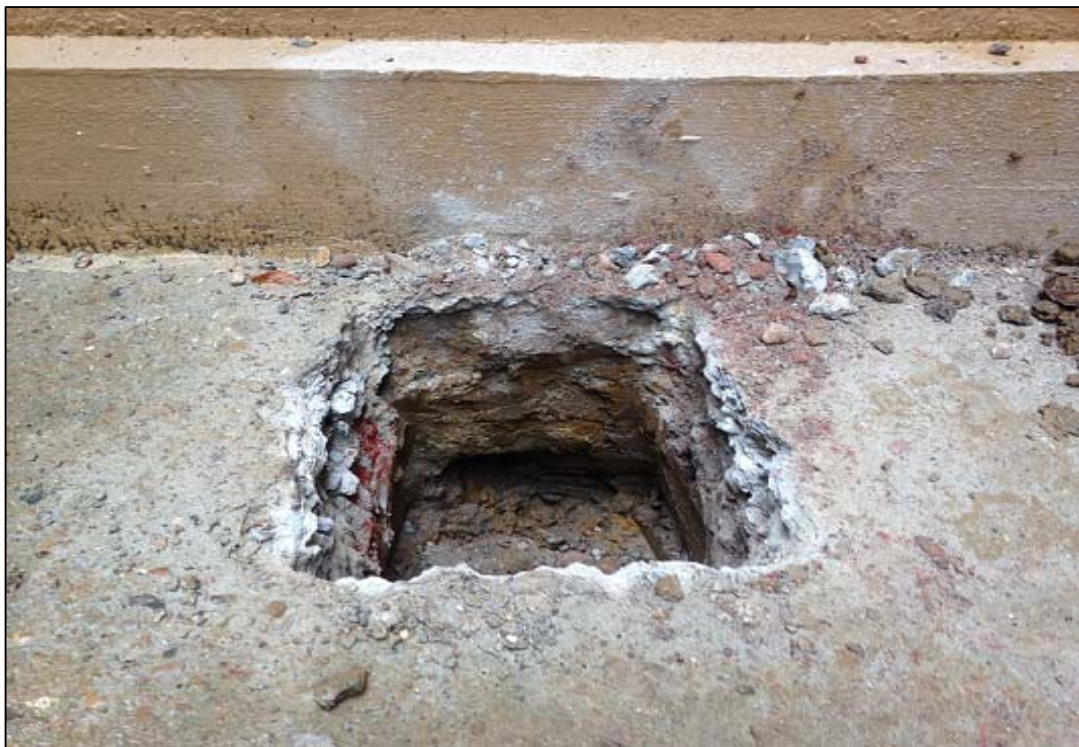
Trial Pit Number
4

Excavation Method Manual	Dimensions 450 x 400 x 450	Ground Level (mOD) 15.06	Client West London Mission	Job Number J14336
	Location	Dates 04/11/2014	Engineer Conisbee	Sheet 2 / 2

Remarks:
All dimensions in millimetres
Sides of trial pit remained stable during excavation
Groundwater: Not encountered

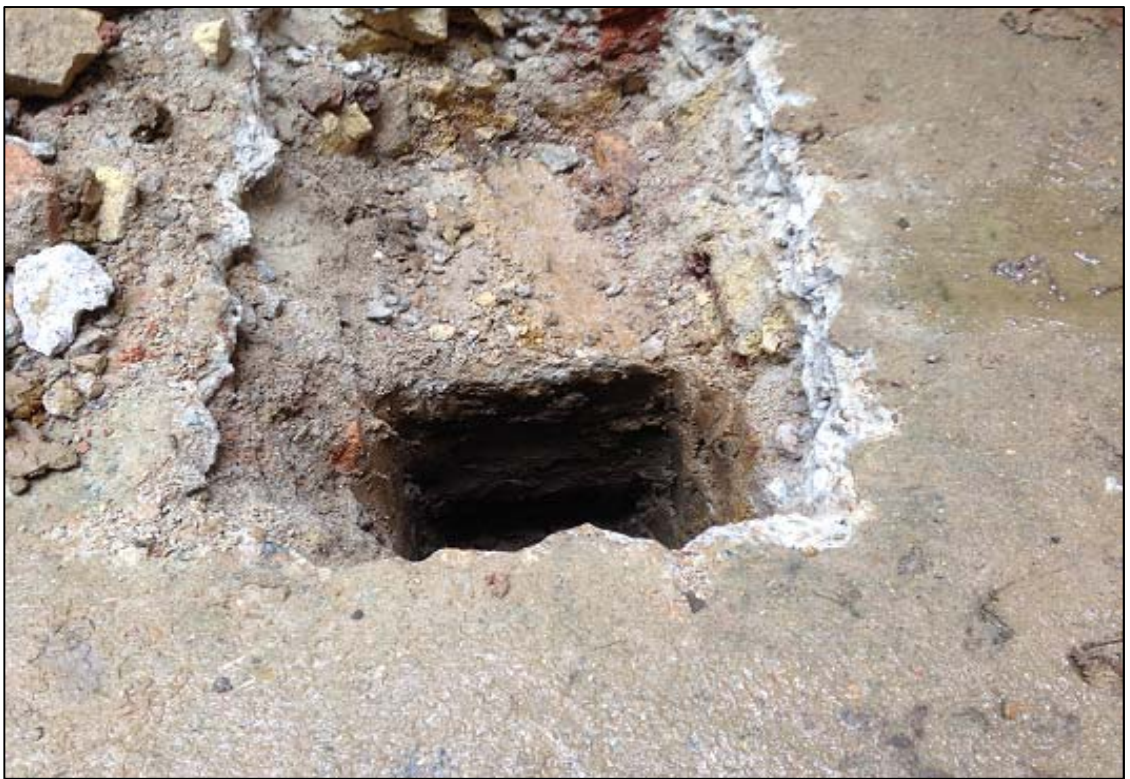
**Trial Pit
Number**
5

Excavation Method Manual	Dimensions 700 x 450 x 650	Ground Level (mOD) 15.05	Client West London Mission	Job Number J14336
	Location	Dates 05/11/2014	Engineer Conisbee	Sheet 2 / 2

Remarks:
All dimensions in millimetres
Sides of trial pit remained stable during excavation
Groundwater: Not encountered

The southeastern party wall was found to be supported by a concrete footing bearing within the London Clay at a depth of 0.60 m (14.45 m OD and 14.46 m OD), as indicated by Trial Pit Nos 5 and 7 respectively.

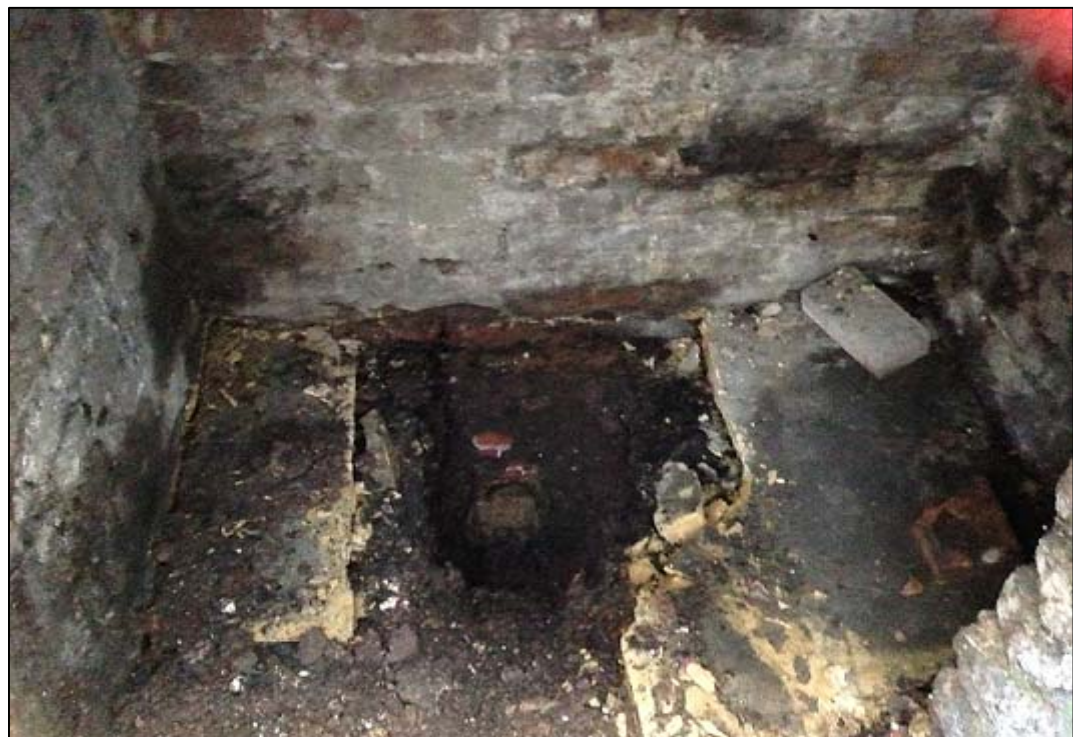
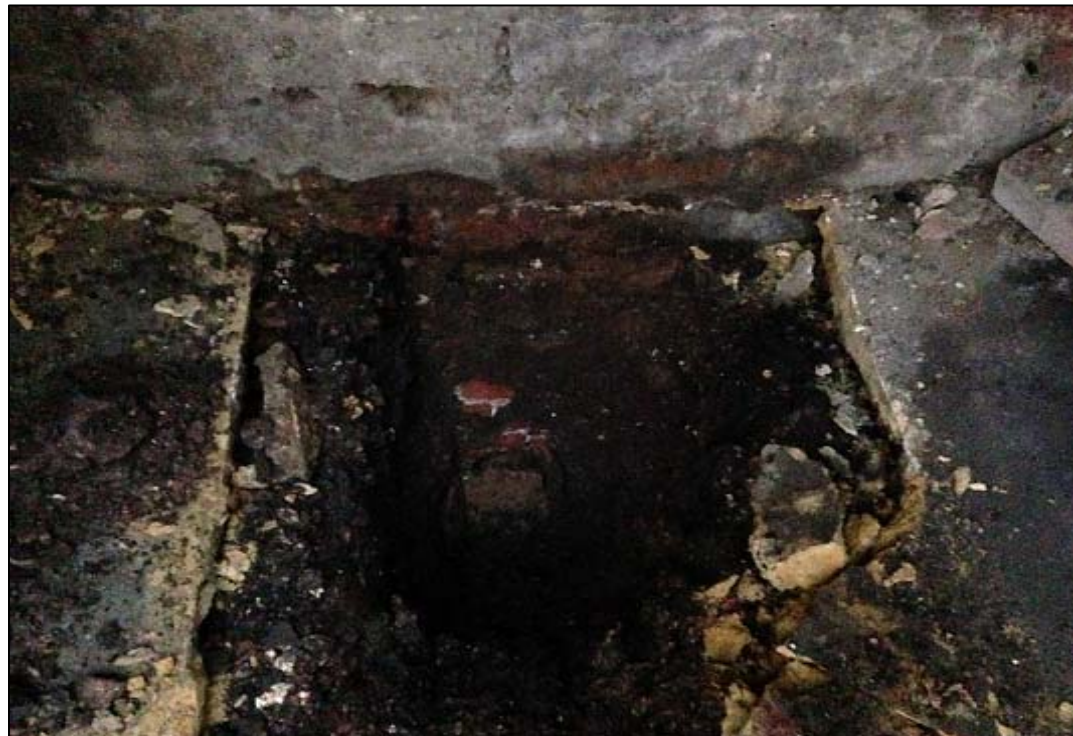
**Trial Pit
Number**
6

Excavation Method Manual	Dimensions 600 x 600 x 650	Ground Level (mOD) 15.11	Client West London Mission	Job Number J14336
	Location	Dates 05/11/2014	Engineer Conisbee	Sheet 2 / 2

Remarks:
All dimensions in millimetres
Sides of trial pit remained stable during excavation
Groundwater: Not encountered

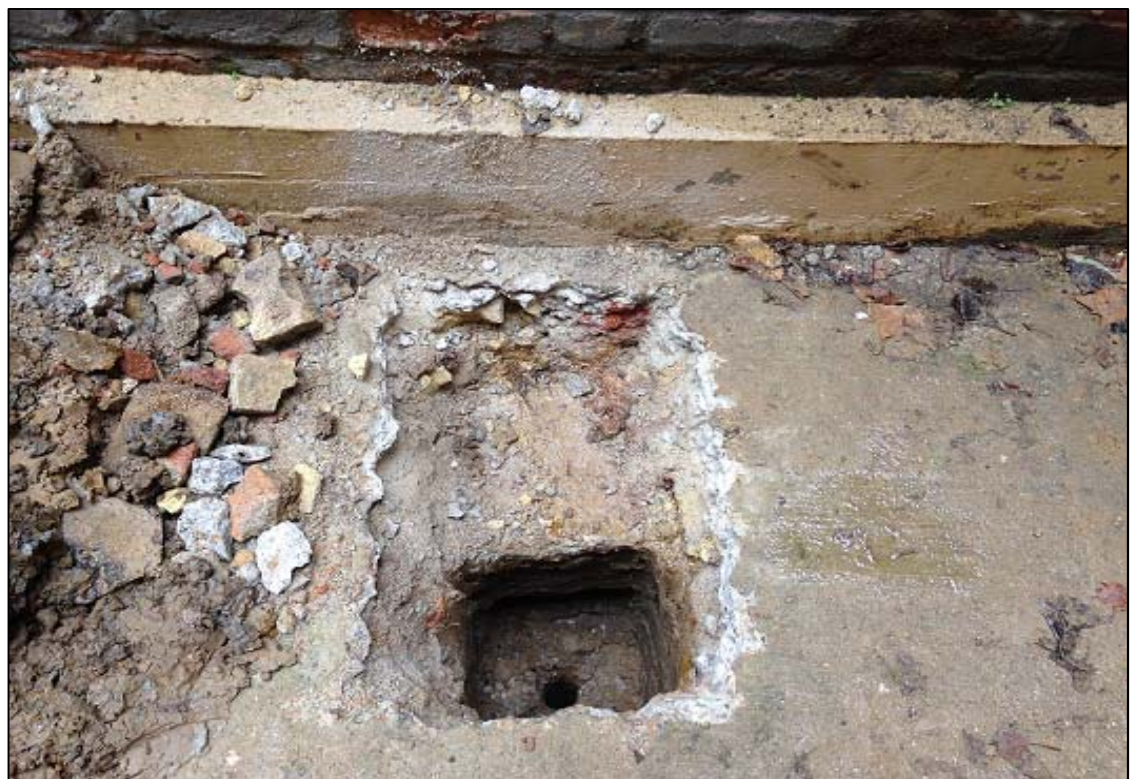
**Trial Pit
Number**
7

Excavation Method Manual	Dimensions 700 x 450 x 700	Ground Level (mOD) 15.06	Client West London Mission	Job Number J14336
	Location	Dates 04/11/2014	Engineer Conisbee	Sheet 2 / 2

Remarks:
All dimensions in millimetres
Sides of trial pit remained stable during excavation
Groundwater: not encountered

Sample: 0.3 m
Borehole No 2 advanced through base of trial pit.
