Heritage Statement

Kings Cross Methodist Church, London

Proposed demolition and redevelopment to provide replacement church facilities; community facilities; replacement on-site Manse and 11no. residential apartments including the installation of the necessary plant, ventilation and extraction, cycle storage and refuse and waste facilities.

November 2015

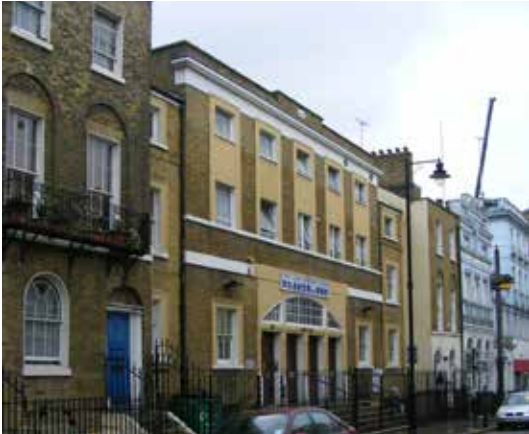
Birkenhead Street frontage, looking north. The frame of the original chapel is legible but the building is now almost residential in character.

Birkenhead Street is the historic 'front' of the Methodist Centre and at one time this was clearly the case in the architecture. The simplicity of the original design has been altered to provide a three storey frontage. In common with the adjacent townhouses, the ground floor is raised by half a storey, providing school rooms and ancillary space beneath. The ground floor is occupied by the chapel, with large foyer doors created in the original frontage. The former arched windows of the elevation have been adapted to provide windows to the two upper floors.

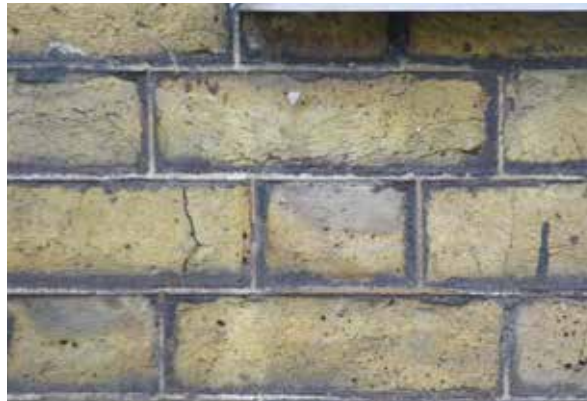
There are some sections of tuck pointing on the front elevation, where this has not been repointed or altered.

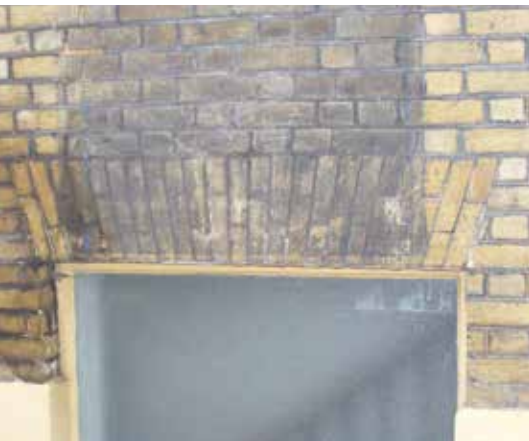
The gauged brick lintels on the remaining basement windows are indicative of the original build quality, although these remaining details are few.

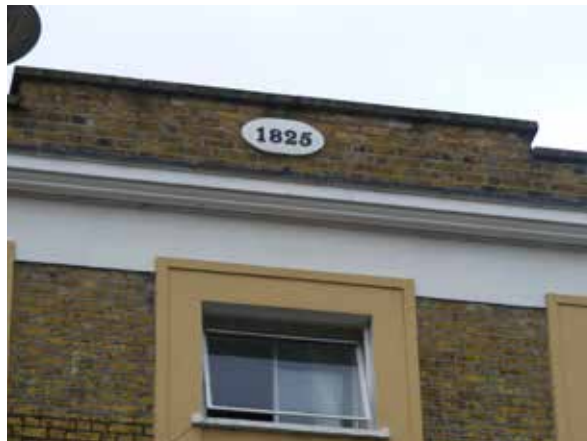
The 1825 datestone has been planted on an altered parapet which used to form part of the front pediment, removed when the roof was taken down to create the top floor flats.

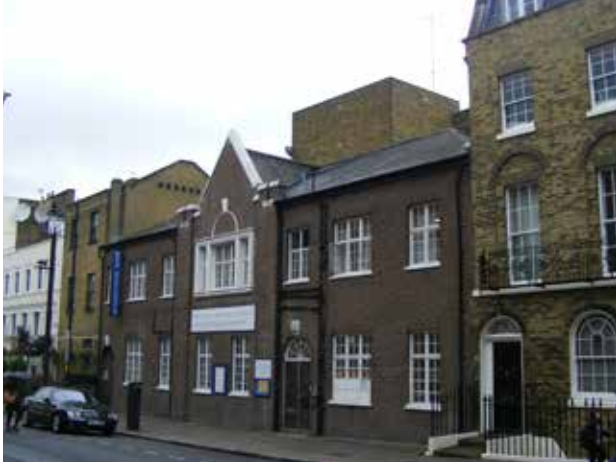
The Crestfield Street frontage used to be occupied by the rear of the chapel and the burial ground prior to the erection of the present Mission House in c1951. The existing building is two storeys in height with a frontage which is much wider than the narrow townhouses alongside. The brick access shaft to the top floor flats, added in the 1970s, is visible behind the ridgeline.

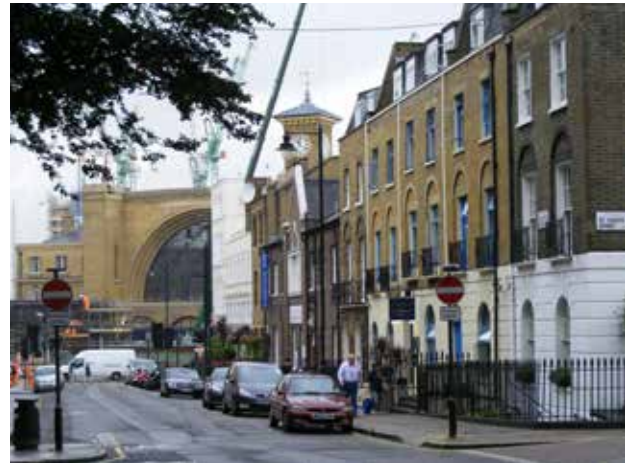
The brown brick, two storey height and wide plot is uncommon in an area dominated by narrow speculative housing plots of the 1840s. The existing building reads as something of an 'infill' amongst buildings of a superior quality and detail.

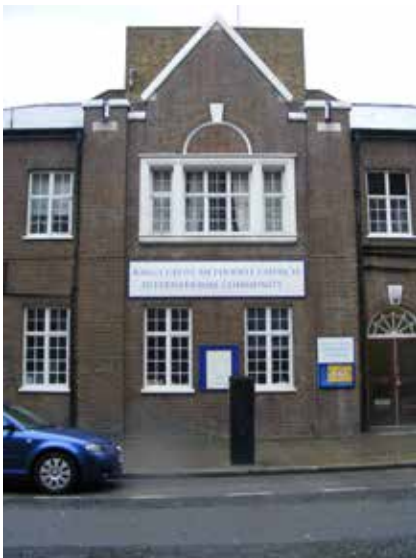
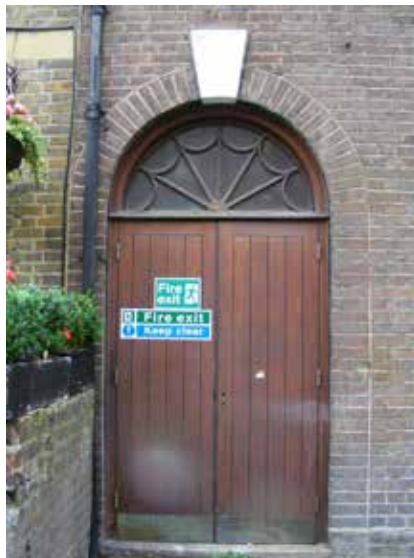
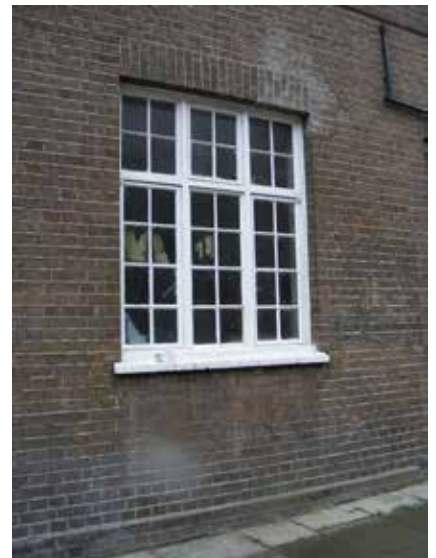
The formality of the terraces which run along Argyle Square and into Crestfield Street is broken by the Mission House. Its gable is not a strong presence but it does bring variety as Kings Cross is approached.

The design of the Mission House, dating between 1951, is a restrained and rather old-fashioned Gothic. The detailing is robust but the overall impression is rather dull in visual terms.

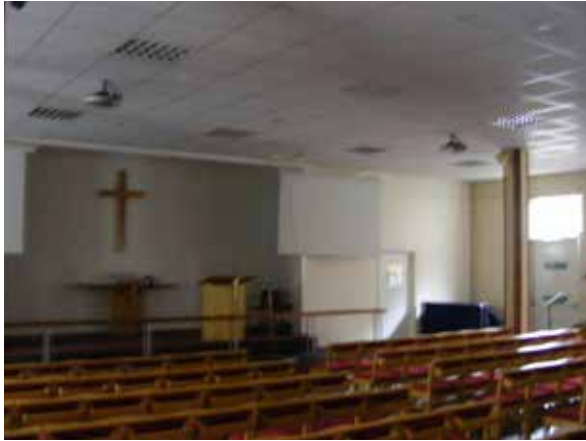
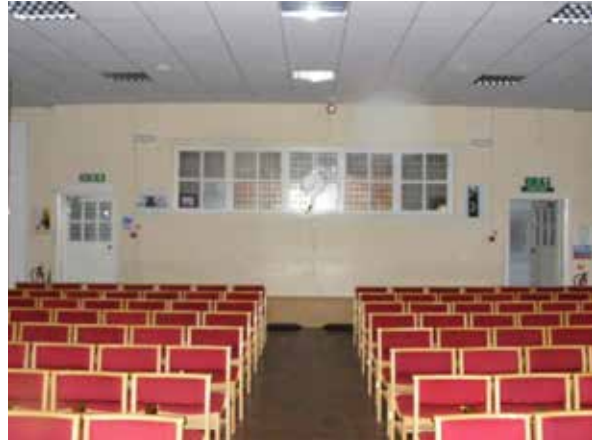
The interior of the Methodist Centre is, as a result of the adaptation and conversion, a series of utilitarian spaces which are not remarkable architecturally and do not possess any of the original chapel's features of note. The original chapel space is not recognisable, but it continues to provide a large area for worship. The floors above are tightly converted to form apartments.

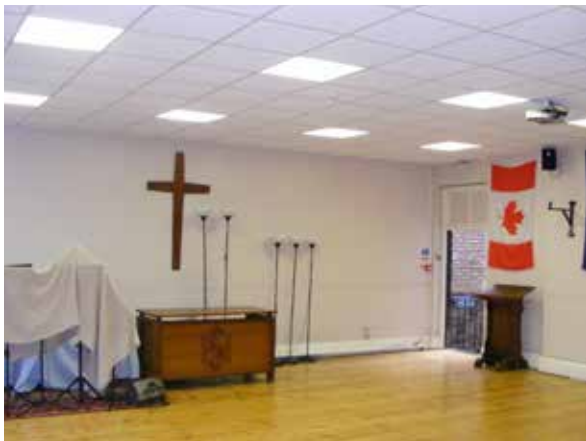
The main chapel space provides evidence of the gallery columns, although it is thought that these have been strengthened to provide the floors above. The recess on the far wall would have provided the location of the pulpit and organ above.

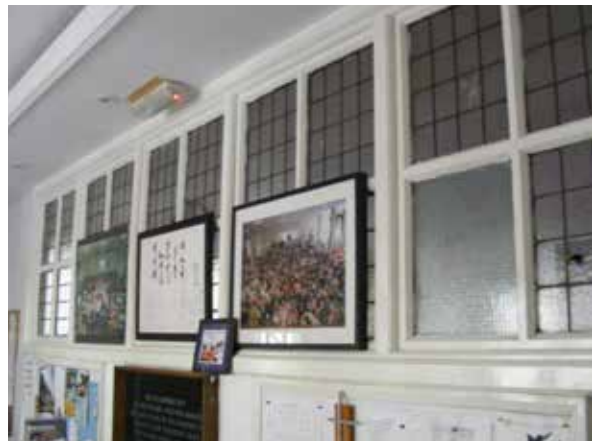
The mission hall provides further worship and meeting space

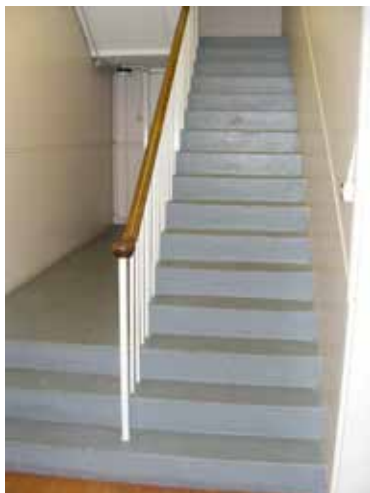
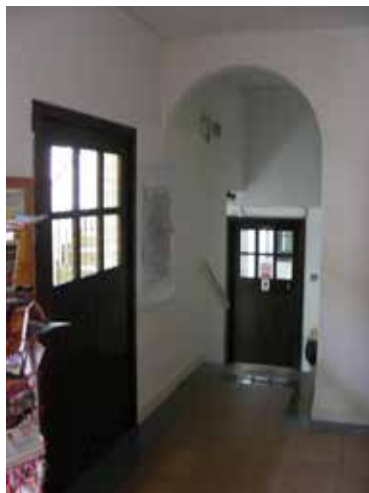
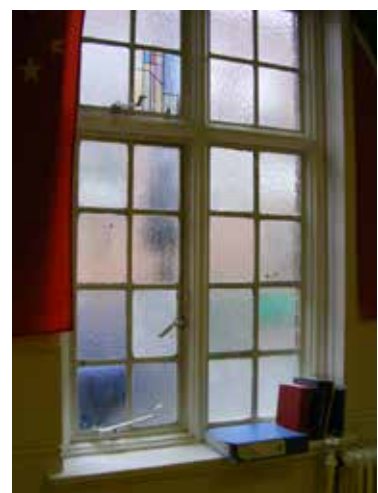
The mission hall contains the most intact features, including the staircase, doors and windows - all of early 1950s date.

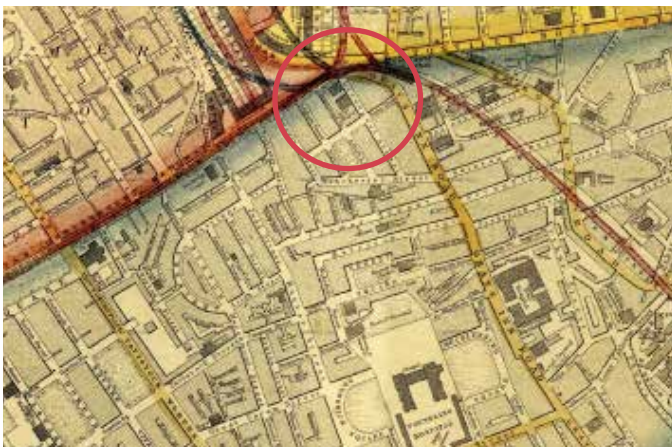
1837 The 1837 map shows a similar arrangement to 1827, with the Battle Bridge area still not developed fully. The chapel is clearly noted again, this time with the heavier black footprint alongside which was the Royal Clarence Theatre which was re-opened in 1832 to replace the failed Panarmion Theatre.

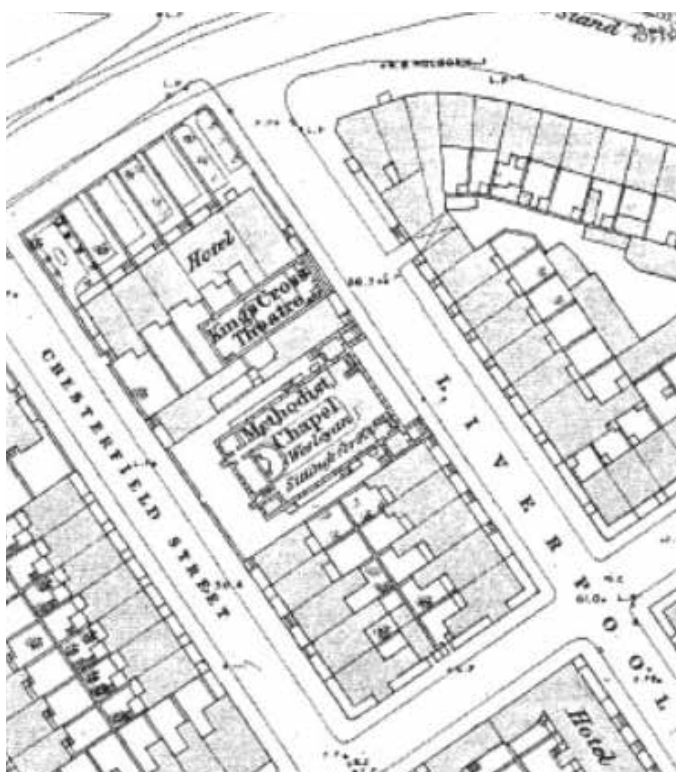
1874 The map of 1874 is of considerable interest as it not only shows the street layout but also an indication of the internal arrangement of the chapel itself. There are a number of important elements to note:

- the separate access points from Liverpool Street leading to side access into the chapel.
- two internal staircases lead to the gallery above. The extent of the gallery is noted in the plan as being of considerable size.
- the organ and pulpit are marked as being at the west end of the building, with two accesses leading through to vestry and other ancillary spaces behind including a church parlour and deaconess's room.
- external steps are shown on both sides leading down to the basement school-rooms, which are also accessed via the side porches.
- a wall appears to run along the Chesterfield Street frontage, with a central pedestrian gate.

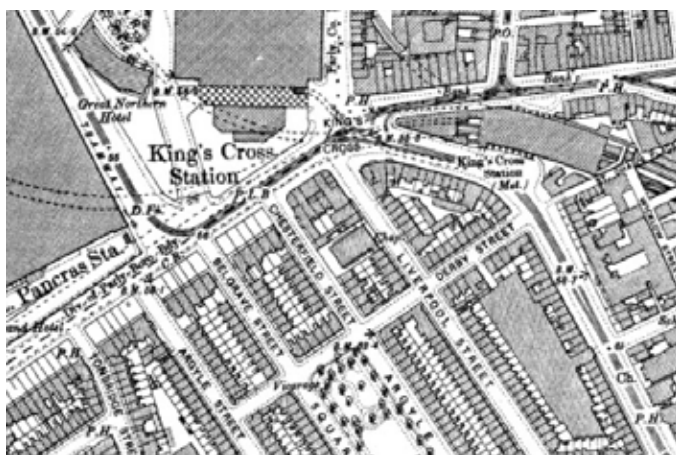
1896 This plan shows little variation in terms of the chapel and its immediate surroundings, however it is notable how the former front gardens at the north end of the block have now been built on, reflecting the levels of activity surrounding Kings Cross.

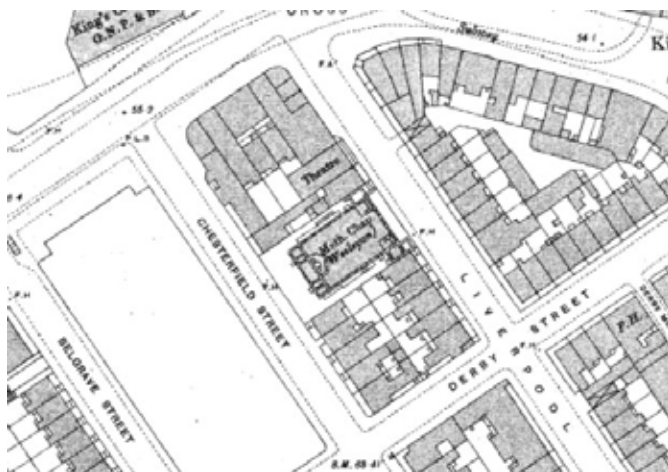
1922 The 1922 plan provides an interesting level of detail in relation to the chapel, clearly indicating the side porches and accesses to basement level. Also shown are the gallery stairs and pulpit.

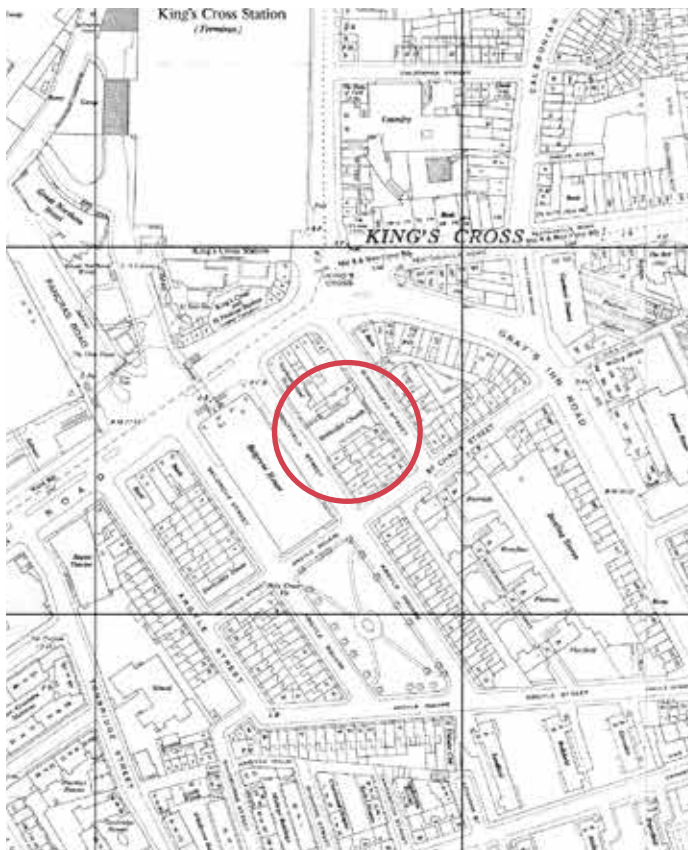
1953 The 1953 map clearly indicates the further extension of the chapel onto Crestfield Street in the form of the Mission House, constructed over the rear churchyard area since the 1951 plan.

The bomb damage to the east of Argyle Square has now been cleared and the four large high-rise blocks bridging over the previous route of Birkenhead Street, and clearly named as Riverside, Riverfleet, Fleetway and Fleetfield.

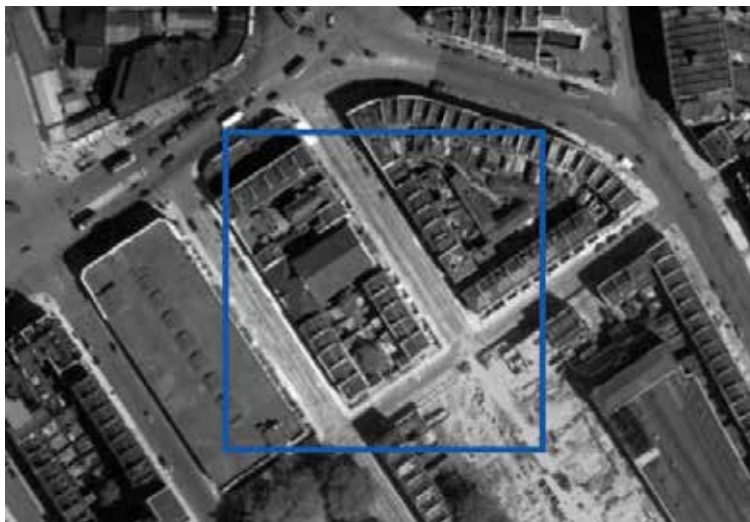
The adjoining aerial photograph evidently dates from the post WWII period as the large site to the south of St Chad's Street has been cleared and is ready for re-development following bomb damage. The new flats were on place in this site by 1953 and the aerial photographs over London were generally taken between 1947 and 1953. The date of this image is likely to be c 1950/1.

Of particular note is the presence of the original pitched roof over the chapel, clearly spanning the large internal space. The original parapet fronting Birkenhead Street is clearly visible, and partially so onto Crestfield Street.

It is also evident that the Mission House fronting Crestfield Street was in place at this date, but probably only just completed in c 1950. Also noticeable are the re-positioned steps leading to a central door on the Birkenhead Street frontage.

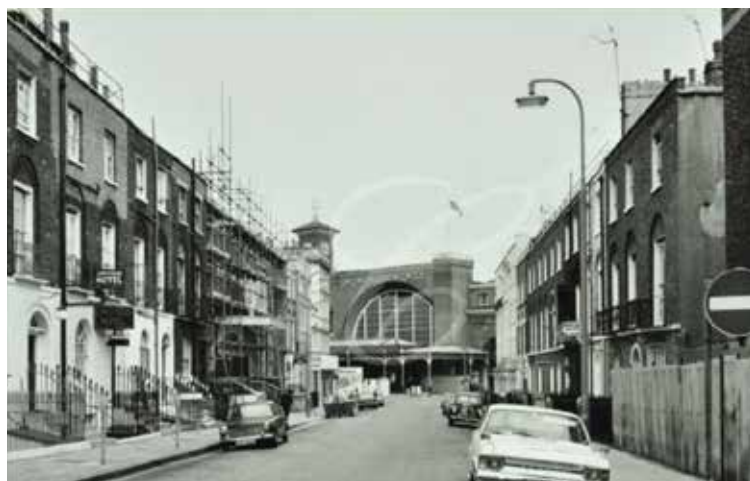
The adjoining image illustrates Birkenhead Street in c1970. The Methodist Chapel is behind the scaffolding on the left-hand side of the street and it is not possible to determine any detail beyond this. The presence of the scaffolding, in conjunction with the evidence of the picture below, suggests that this work may have been related to the implementation of the application of 1967 for the addition of the top storey to provide residential accommodation for German Methodist Students.

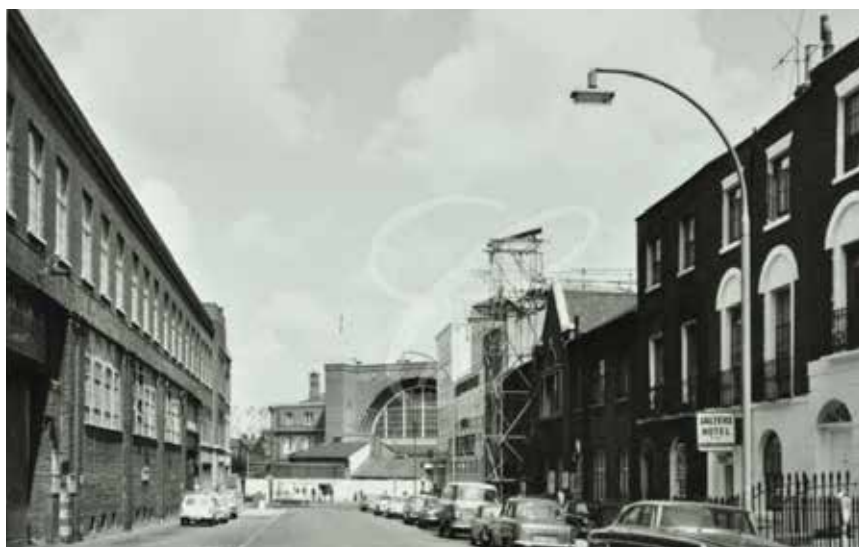
The Crestfield Street photograph, also of c1970, indicates the presence of scaffold across part of the elevation and an access level across the roof of the frontage building indicating work being undertaken to the rear. This would also seem to indicate the works associated with the conversion of the chapel and the addition of the top floor.

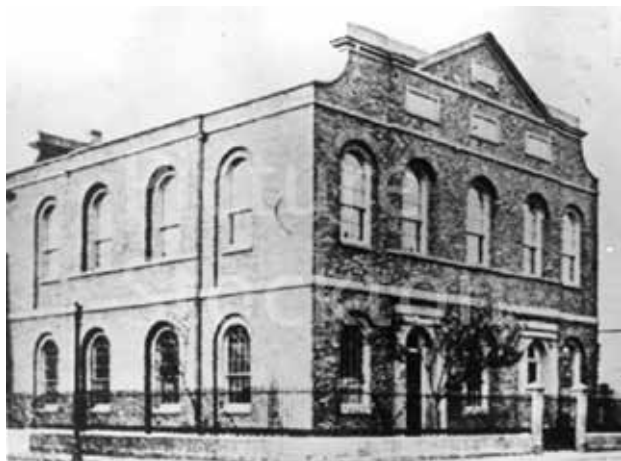
Brunswick Methodist Chapel, Stockton-on-Tees

The chapel at Stockton -on-Tees bears significant similarities with the original Kings Cross chapel, not only in the date of its construction, 1823, but also in the design. Like Kings Cross, it is based on a plan-form of 5 bays across the frontage and 4 bays to the side, creating an almost square footprint. Adornment is limited to the pediments, arched windows and string courses, bringing a simple elegance to the building. Two doorways originally led to each side of the chapel, matched it is assumed by two gallery stairs. The label moulded datestone is identical to Kings Cross.

Internally, it is almost certain that the detailing is similar to that which would have existed at Kings Cross prior to the alterations. The layout of the gallery is similar to the evidence we have from the 1874 map.

Although in a deteriorating condition, this chapel is a very good, intact example of the type of Chapels being constructed around the country at this date and warrants its statutory listing in Grade II*.

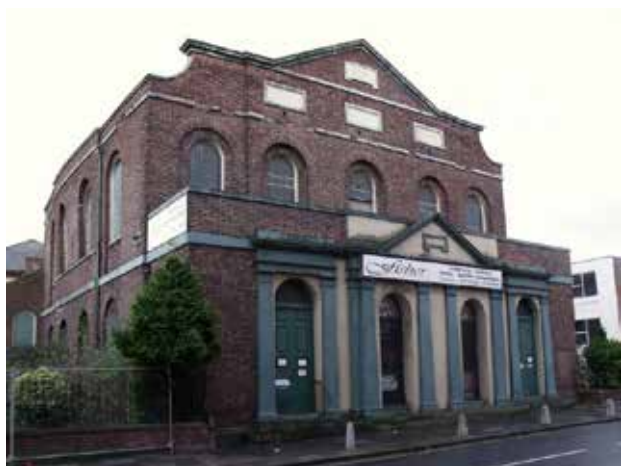
19.1.51 Brunswick Methodist Chapel, Stockton on tees

1823 by the Hull architect W Sherwood who designed the Brunswick Chapel, Newcastle to which it bears marked resemblance. Built of brick. 2 storeys. 5 windows to Dovecot Street, 4 windows to side. Single storey, slightly later narthex with portico. Band over ground floor continues across portico and is returned at sides. Stone parapet bands and cope, also returned. The front is ramped up to cornice and parapet, central 3 bays break forward slightly and are crowned by a pediment containing a panel inscribed "Methodist Chapel 1823"; 3 panels below. Square leads in windows which are round headed and recessed in a brick surround. The narthex projects, 4 round headed openings of a pilastered portico and a pediment over central 2 openings; panelled floor; side doors have cornice and blocking course. The side elevations, to Brunswick and William Street, break forward slightly over 2 central bays. The rear gable end is also ramped up to crowning cornice, parapet and pediment. Railings to side elevations. 2 storey 1 window annex to William Street - glazing bar sash window 1st floor with cambered head and cill band. Round headed doorway with panelled doors. Listing NGR: NZ4434018970

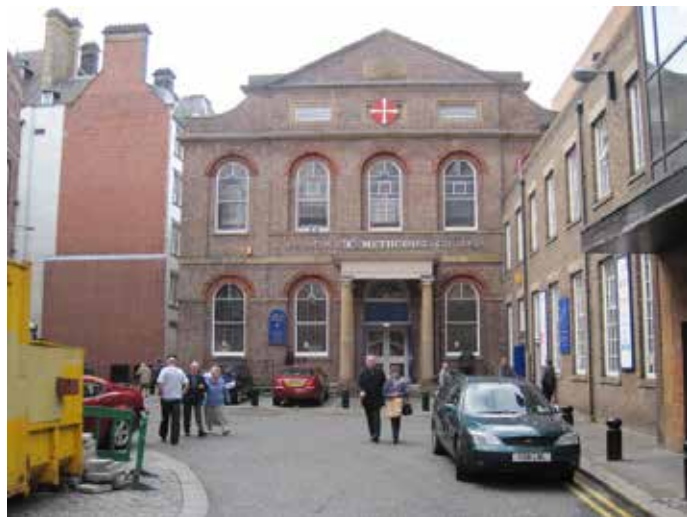
16/135 and 20/135 Brunswick Methodist Chapel, Newcastle

Methodist chapel. Dated 1820 in pediment. Brick with ashlar dressings; Welsh slate roof with stone gable copings. 2-storey, 5-bay pedimented east front, the right bay obscured by buildings. Steps up to Tuscan porch with prominent cornice which contains steps up to central 6-panelled double door, with radiating glazing bars to fanlight. Round-headed windows, most with stone sills, in arched recesses have sill band to upper windows. Eaves level band; 3 rectangular stone surrounds to ventilators, the central blind, in projecting bays under pediment; pediment continuous with cornice partly over side bays with ramped coping to meet it. Plainer door and windows in 6-bay left return to Northumberland Court, the last 3 bays pedimented. Interior: ground floor extensively altered c.1983 and first floor inserted; upper part; now chapel, has panelled gallery and pews; plaster walls and delicate stucco ceiling decoration; Corinthian pilasters frame west apse containing wide panelled pulpit. Listing NGR: NZ2482764497

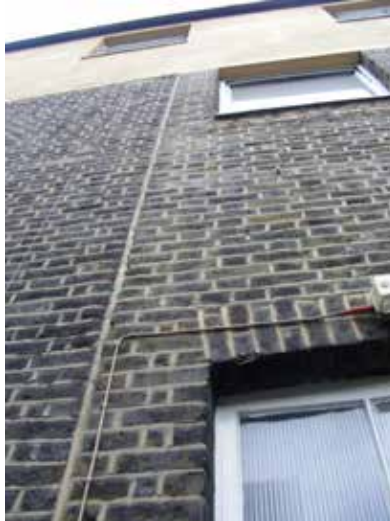
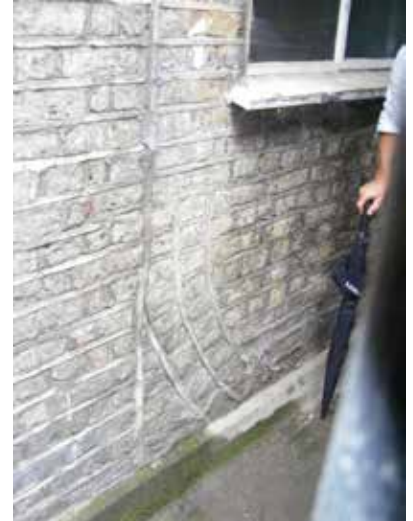
These two images show the straight joint at which the original 1825 chapel was extended by 2 bays in 1865-66 to increase capacity and provide a location for the organ. This was clearly an extensive alteration to the original building, although the dealing carries through into the new work very well and was presumably overseen by Robert Eckett, the minister and owner of the building company who more than likely carried out the extension work.

The extension provided an additional 2 bays, but also resulted in the loss of the original vestry at the rear of the original building.

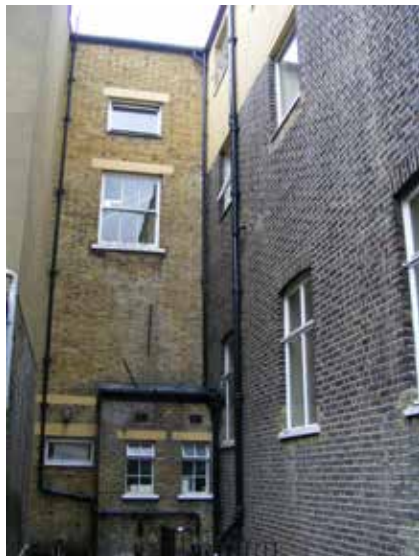
The image below illustrates the rear of the northern link and the northern flank wall of the original chapel. The difference between the brickwork colour is stark, although this is not so evident on the front elevation where the older brickwork has been cleaned, presumably during the 1970s alterations, when the top floors of the two links were also added.

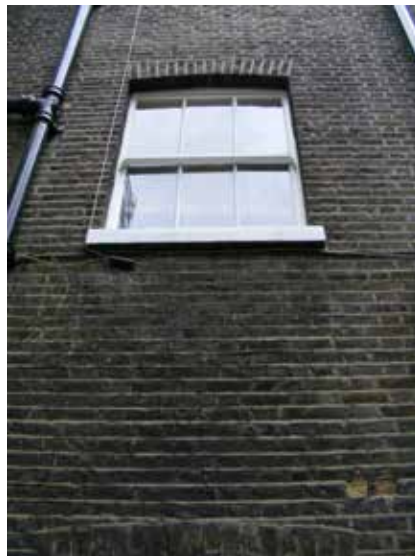
Below is one of the very few remaining historic windows in the chapel - the remainder have been altered to modern pivot types. The window is a 6 pane design with horns, and forms part of the 1865 extension.

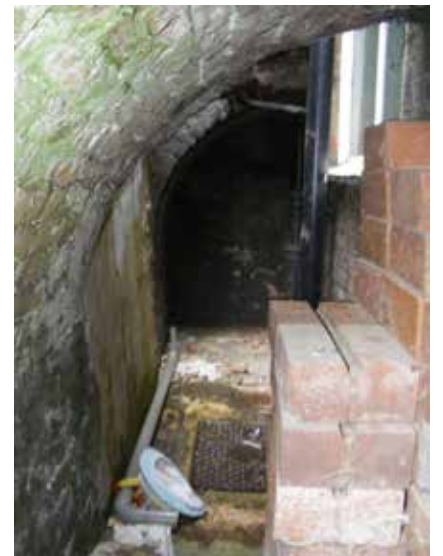
A series of brick retaining arches run along the north elevation, supporting the lightwells. Ground level on the south side is lower and this arrangement was not required.

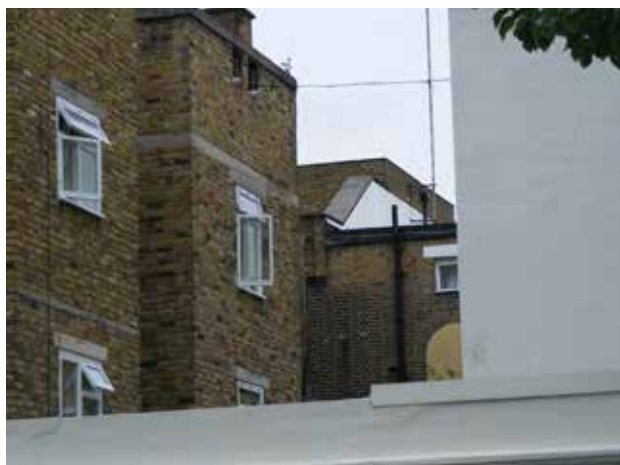
This view looks northwards from St Chad's Street towards the south flank of the chapel but also shows what remains of the pediment on the western face of the extended chapel towards Crestfield Street. This has been truncated as part of the 1970s alterations. The section of pediment, on both sides of the access tower, dates from the 1865-6 extension.

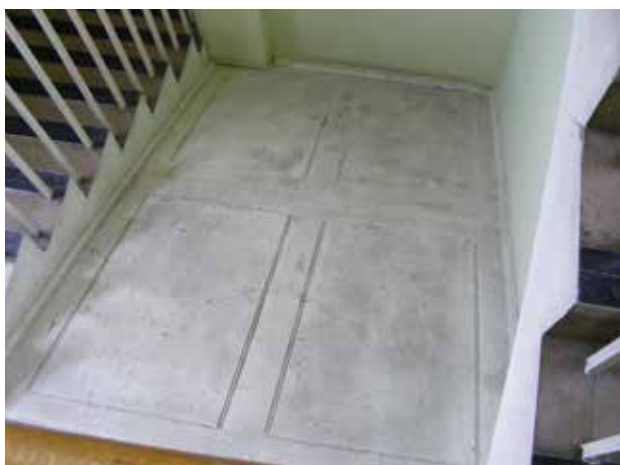
This timber infill panel appears to be re-used in this location but is of a simple detailing which is likely to date from the 19th century and may have been used in a similar fashion on the original gallery stairs.

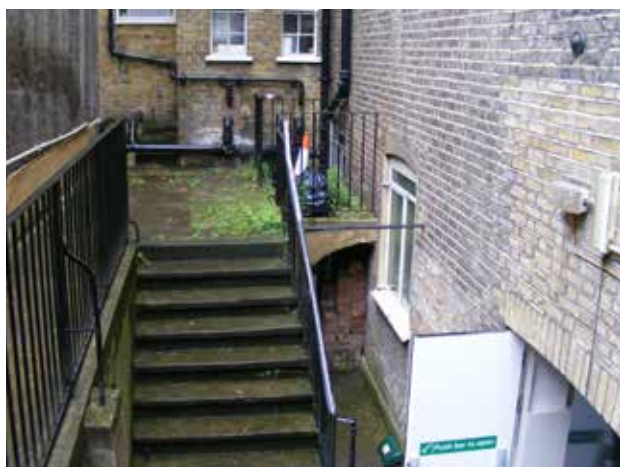
The steps from ground floor to basement level provided access to the school rooms and date from the original build period, 1823-5.

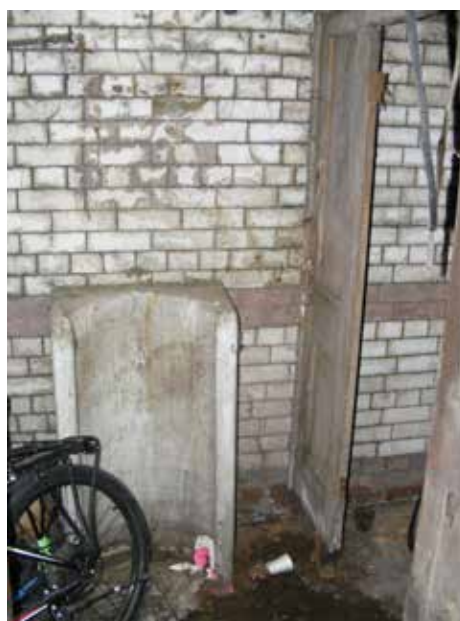
The toilets for the school rooms are located at basement level. The urinal is an early 20th century addition to the earlier cubicle arrangement.

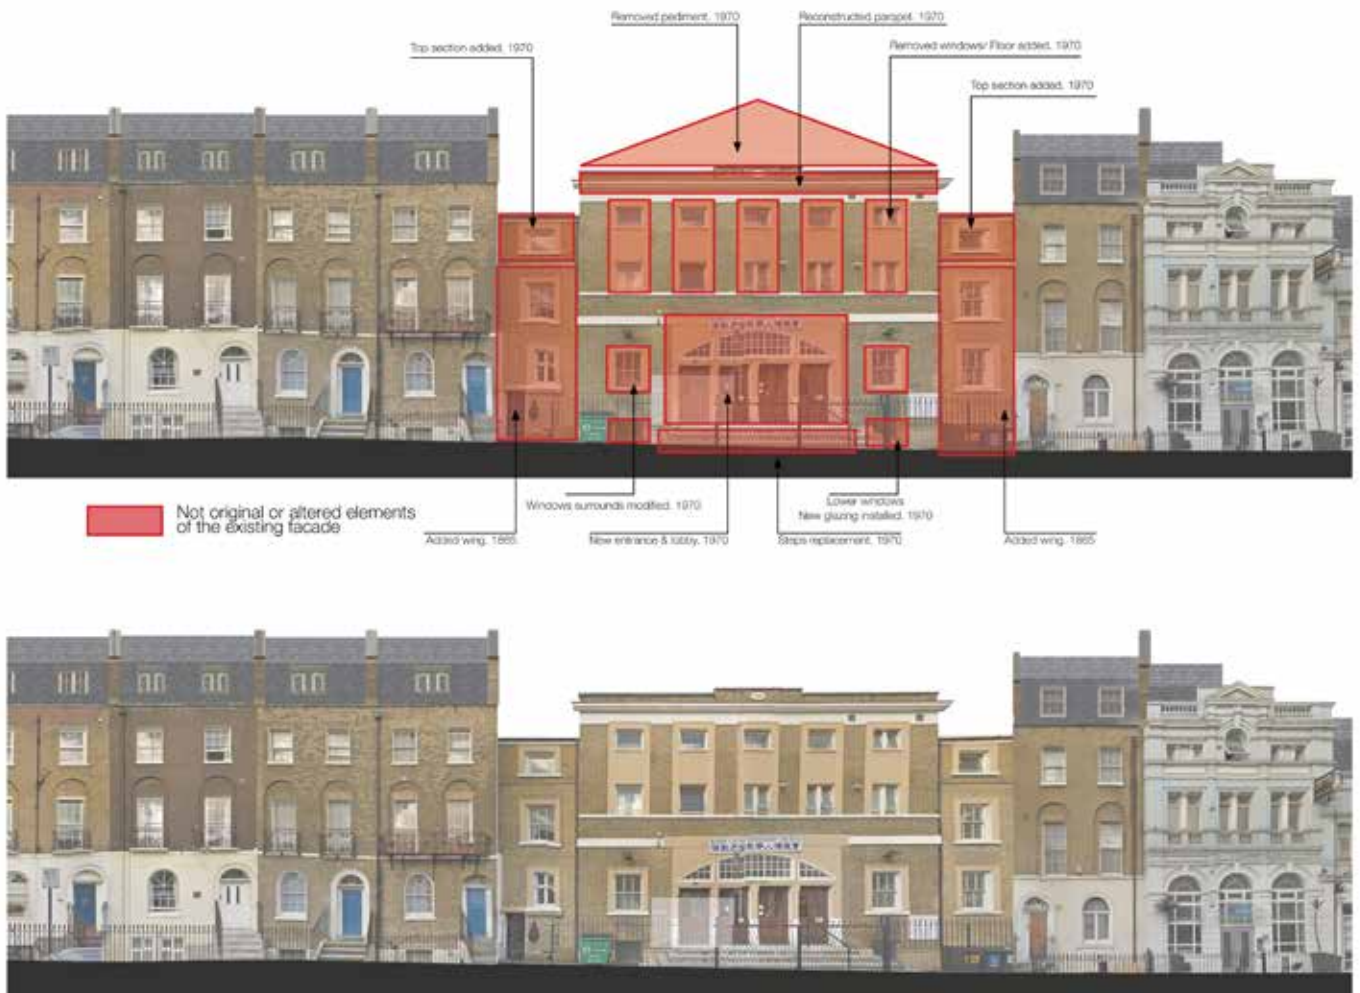
Birkenhead Street existing elevation. Altered, lost or additional areas to original shown in red (Dexter Moren Associates)

The link elements on the Birkenhead Street frontage were added some time after 1865, and most likely in the 1870s to provide improved access to the first floor gallery. These replaced the attractive porte cochere of the 1865 works and they have been altered with a flat-roofed top floor to provide access to the second floor flats.

The whole top floor of the chapel is now formed by flat-roofed apartments, rising above the original eaves level and entirely replacing the original pitched roof over both the 1820s and 1860 chapel. In addition, these works which were carried out in the 1970s resulted in the removal of the top section of the pediment onto Birkenhead Street and its replacement with a flat parapet, below which a datestone of 1825 is rather meanly set.

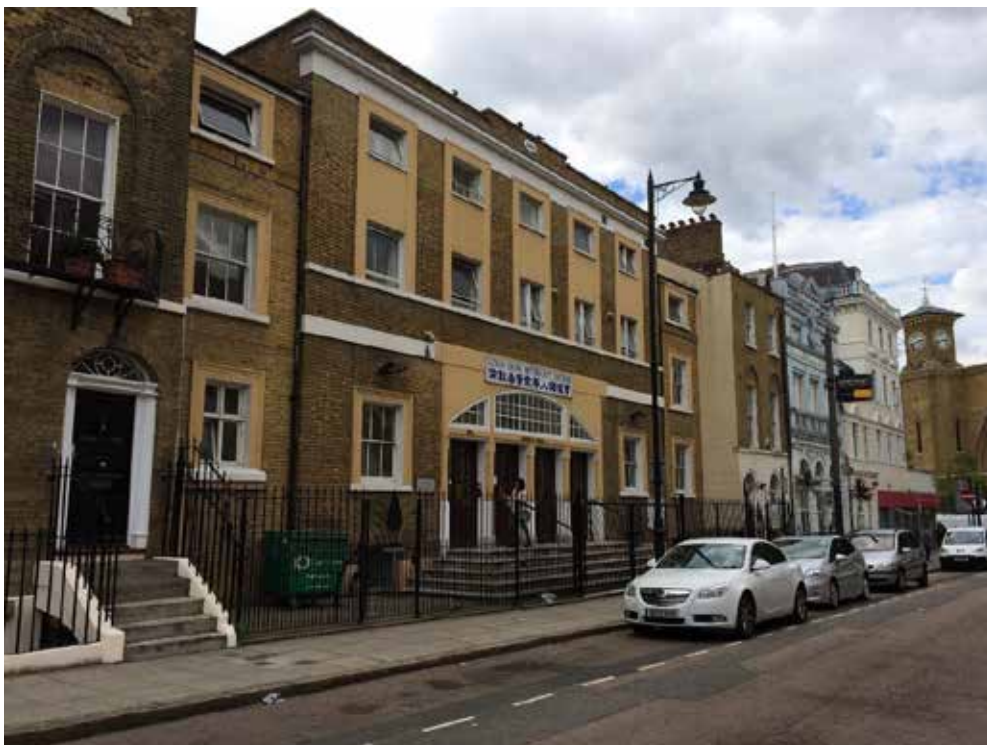
The Birkenhead Street frontage is a poor residential conversion of the former chapel

In terms of architectural detailing, there has been a deterioration in the quality of the detailing both of the remaining original elements and of the newer work. Of the remaining brickwork from early 19th century date, there is some evidence of the fine tuck-pointing remaining but much of this has been re-pointed. The result has been to depress the appearance of the brickwork by widening the joints, concealing the brick arises and, where cement-based mortar has been used, introducing a dominant grey coloration to the joints which reduces the prominence of the yellow brick.

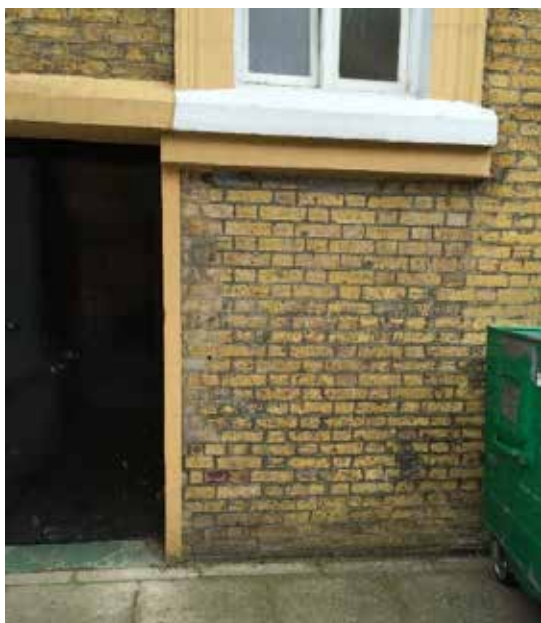
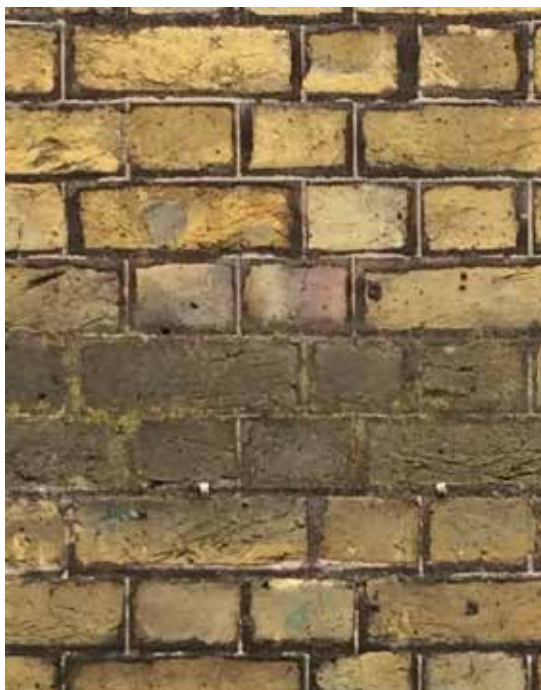
Original lime tuck-pointing has been replaced by large areas of cement-based repointing. The quality and consistency of the pointing overall is poor.

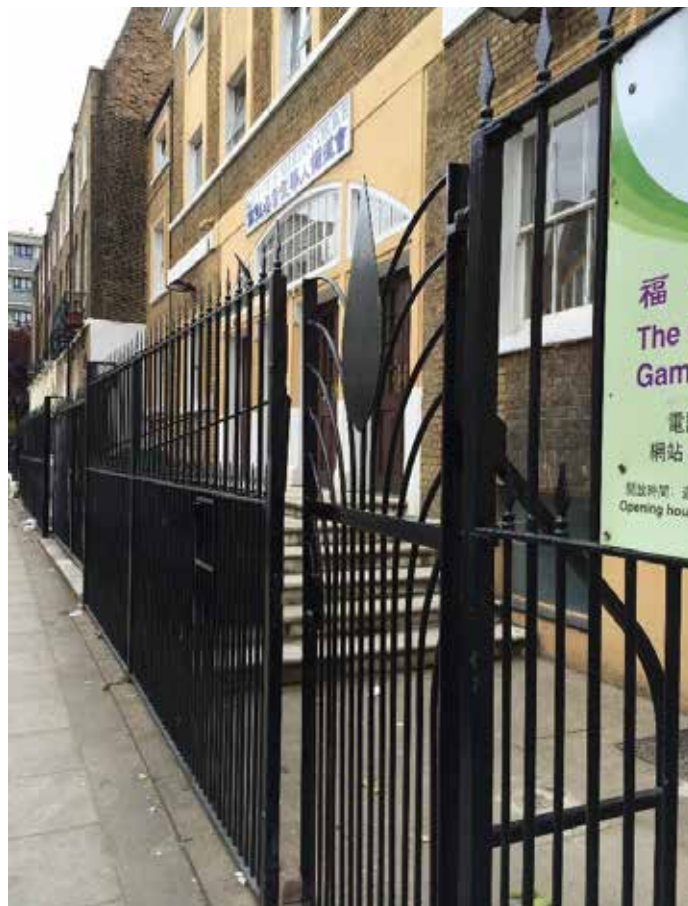
Consideration also needs to be given to the townscape value at pedestrian level. Whilst in original form, the building's landscaped forecourt was accessible and approachable, set behind low level railings which did not conceal the building behind, the current situation is harmful to the pedestrian experience of the street. The high and continuous railings create quite a hostile edge to the pavement and also restrict the ability to appreciate the building – particularly in oblique views.

Oblique views across frontage are limited by tall security fencing

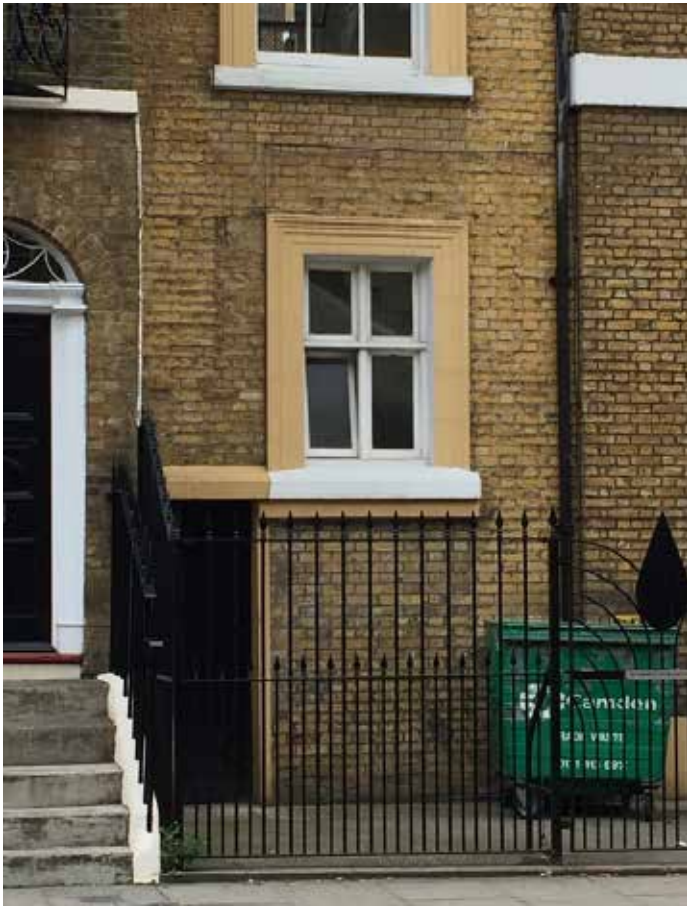
The boundary fencing is too tall to be railings, and the area behind is hard-surfaced and used, in part, for bin storage.

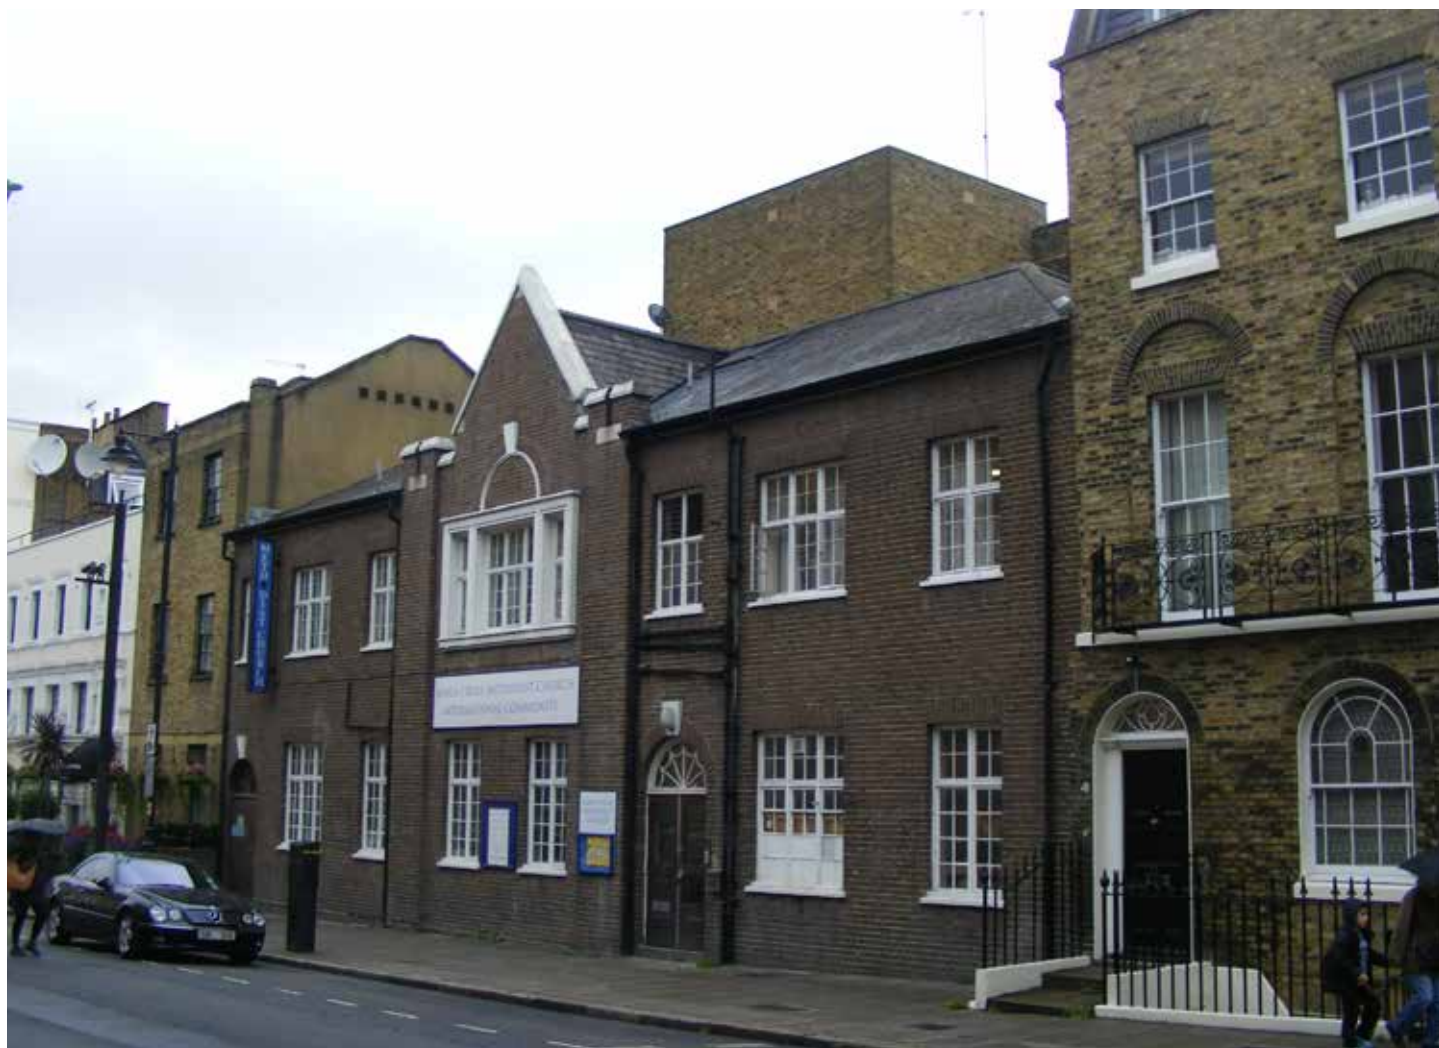
Existing frontage to Crestfield Street

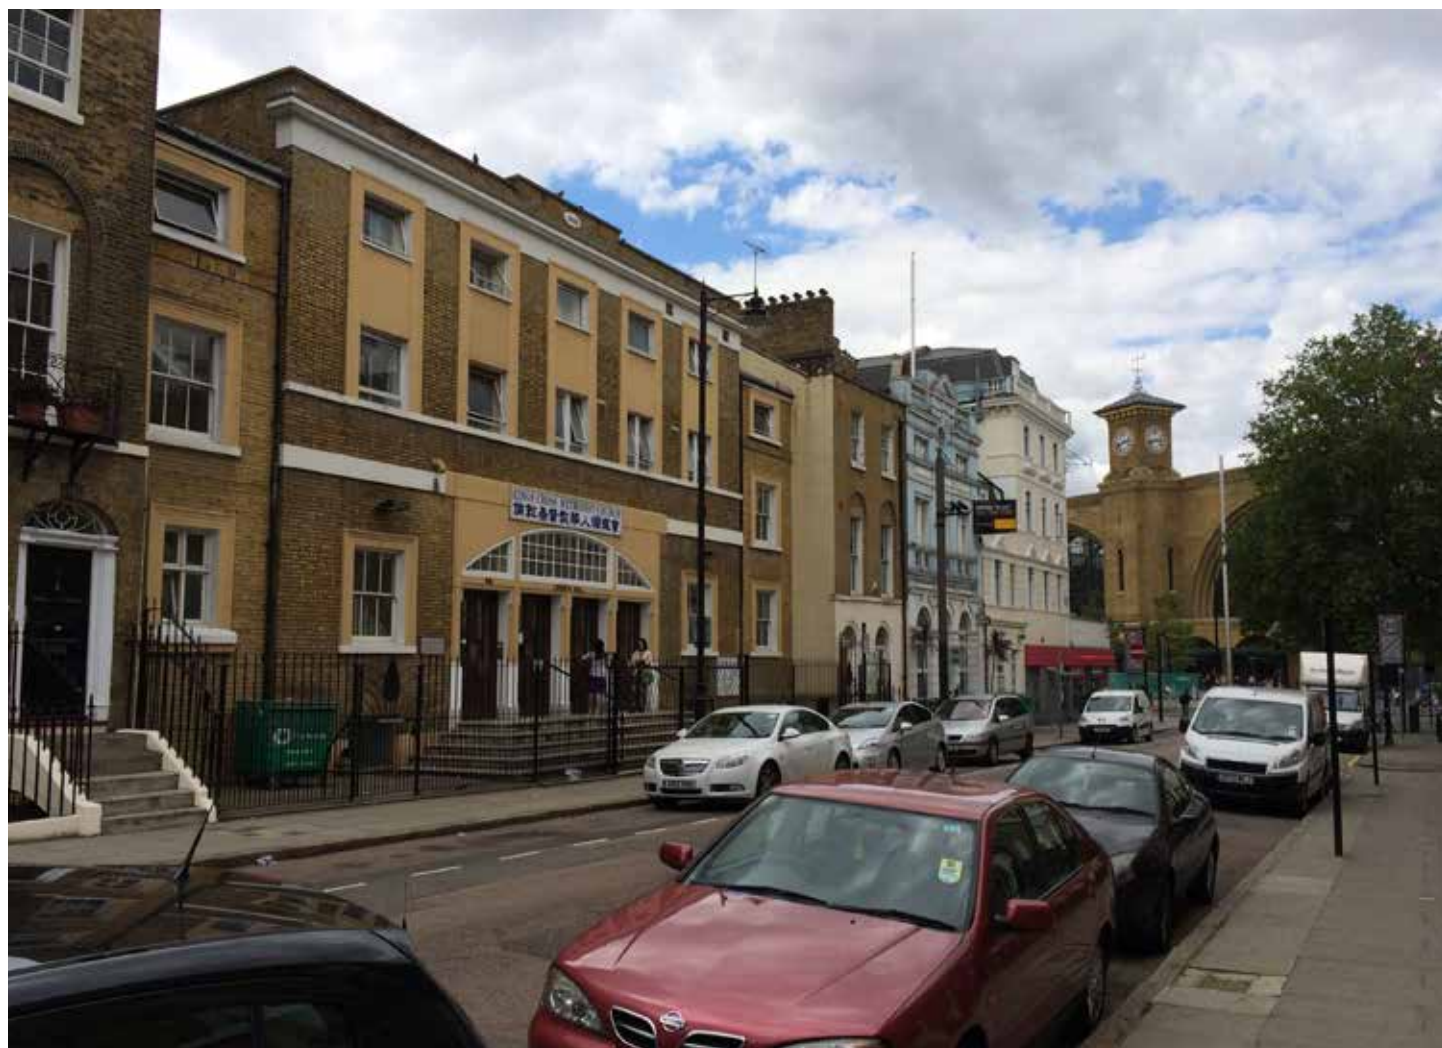
Existing frontage to Birkenhead Street

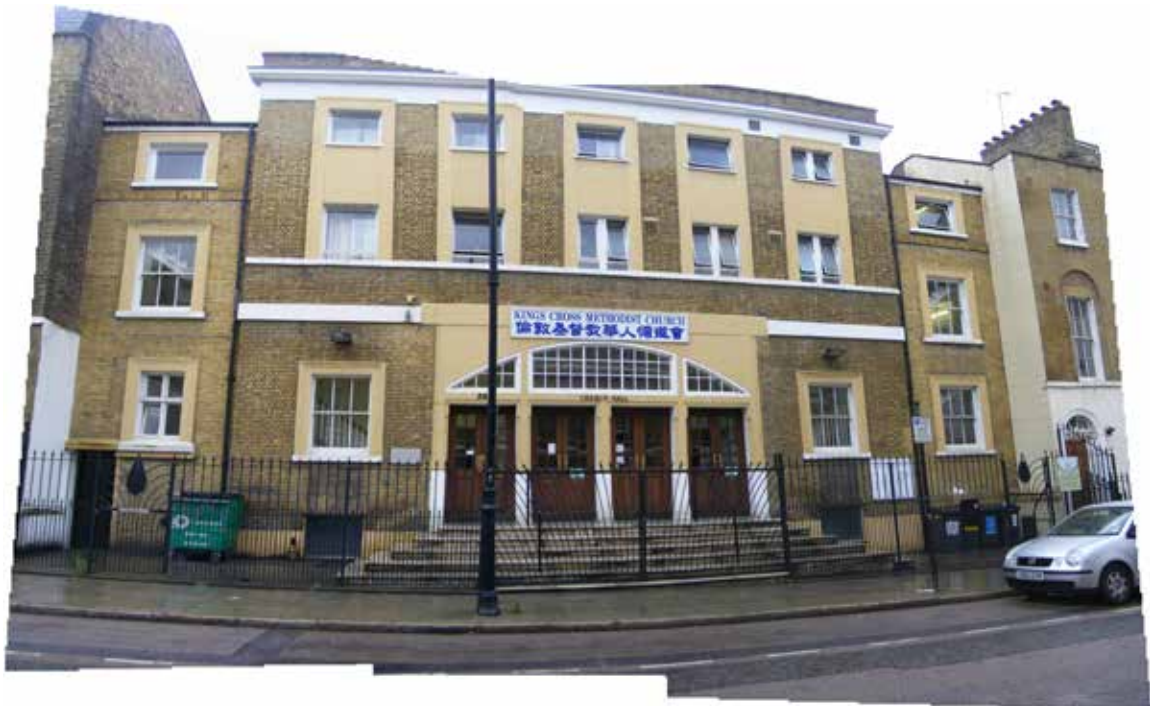
Existing, adapted frontage to Birkenhead Street

The principal elevation, formerly the well-proportioned 5-bay design, has been disfigured by the formation of the upper storey into two, with a consequential repositioning of floor levels and creation of new fenestration serving both. In itself, this alteration has entirely altered the character of the original building. However, in addition, the detailing of the work carried out has further reduced the architectural quality of the building. The squat windows sit within render panels which confuse the composition, and the detailing of the centre-pivot, large pane windows is both poor and inconsistent with the quality of the surrounding built form. The cubic, rectilinear character of the original building is further confused by the widening of the entrance doors at ground floor level and the insertion of the curved glazing above them.
