80 Charlotte Street & 65 Whitfield Street:

Ground Contamination Risk Assessment
and Remediation Strategy

Ground contamination risk
assessment and remediation strategy

Issue 2 | 8 December 2015

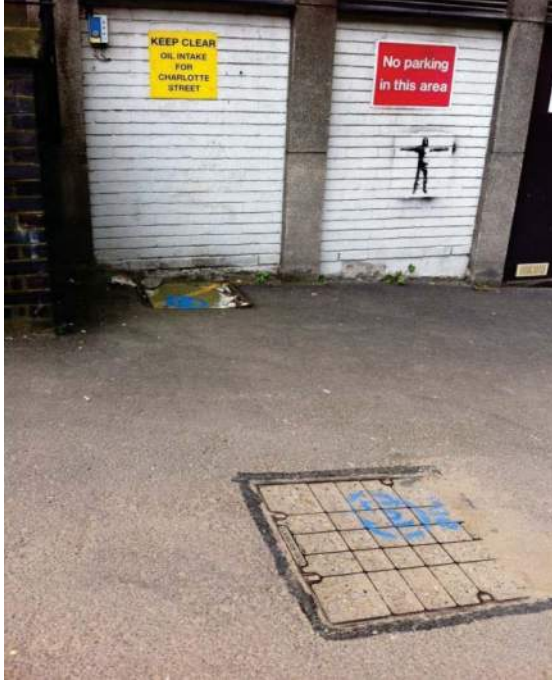
<p>Photograph 1: Chitty Street tank</p>

Notes	Action by
<p>~14:00 – 14:30</p> <p>Met with Richard Cage, Saatchi maintenance supervisor, on site to discuss tank status and conditions.</p> <p>Chitty Street tank (Southern corner of courtyard) (Photograph 1):</p> <ul style="list-style-type: none"> • Tanks is still in use, it stores 6000 litres of oil. • The oil used is called 35 Seconds Gas Oil. • The oil in this tank is used for heating the Chitty Street portion of the building (Block K) • The tank is filled at a separate filling point (Error! Reference source not found.). • The tank would have been installed when the building was constructed in the late 1950s. • About 12 years ago the tank was emptied for inspection as it was thought water was infiltrating into the tank. • BH122 is located 3.9m south-west of the tank (Photograph 3).

Hydrocarbon dating analysis indicates that the hydrocarbon contamination found in the area of the Chitty Street tank is a weathered diesel, dating between 18 years old in BH204 at 4.10mbgl, 16 years old in BH203A at 3.6mbgl and 9 years old in BH203A at 3.4mbgl. This type of hydrocarbon dating is not exact and subject to various caveats. Whilst the laboratory suggests the resolution is ± 2 years, it may be wider than that. It is known that the type of fuel used in the Chitty Street tank is 35 Second oil gas, otherwise known as red diesel. This description therefore confirms that the tank is the likely source of hydrocarbon contamination in that area.

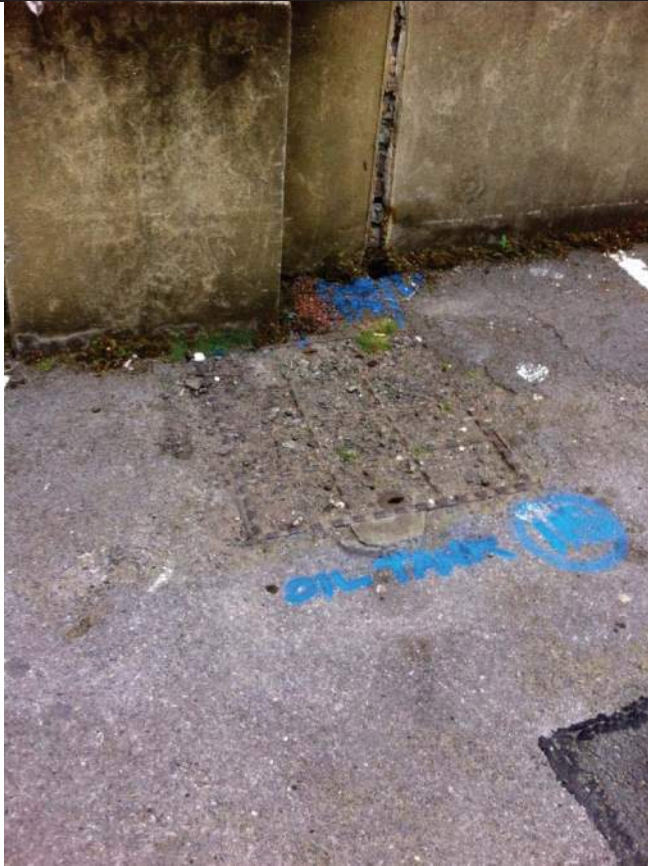
<p>Photograph 4: Charlotte Street Tank</p>

Notes	Action by
<p>Charlotte Street Tank (North-west in court yard) Photograph 4</p> <ul style="list-style-type: none"> • This tank stores 35,000 litres of 35 second gas oil. It is still in use. • The oil of this tank generates heating for the largest proportion of the Saatchi building (Block H). • The boiler room generated by this tank is located on the Howland Road side of the building. • There will be extensive pipe work connecting this tank to the boiler room. • It was emptied 12 years ago as it was thought the tank was losing oil. • The filling point is separate and is located behind a car park separator wall Photograph 5.

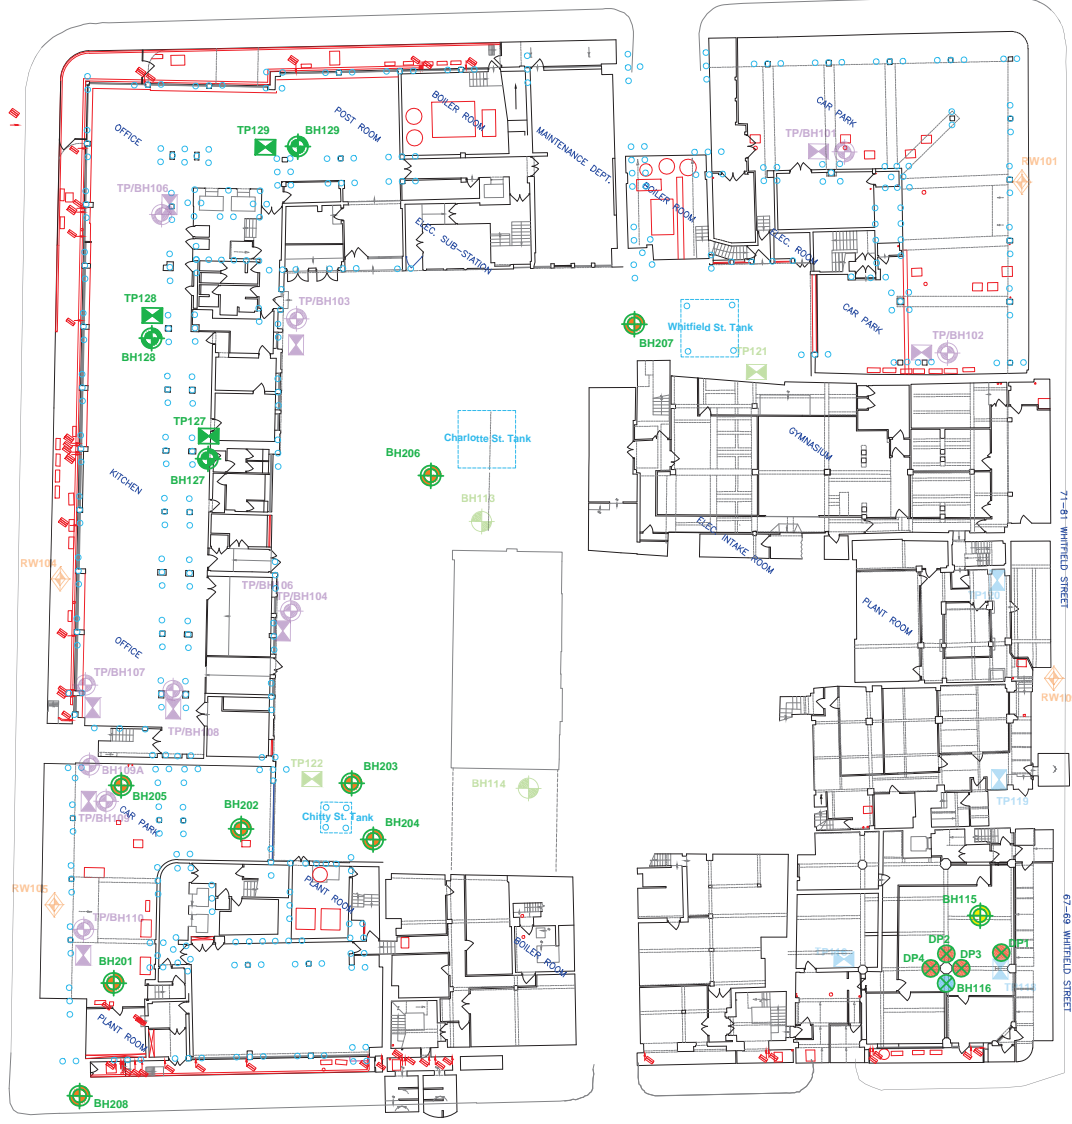
**FITZROVIA REDEVELOPMENT
 SITE INVESTIGATION: PHASE 2
 EXPLORATORY HOLE LOCATIONS
 01/10/2012
 SCALE 1:400 @A3**

- PHASE 1: BOREHOLE FOR PARALLEL SEISMIC TESTING
- PHASE 1: OBSERVATION PIT TO EXPOSE PILE / PILE CAP
- PHASE 1: HORIZONTAL & VERTICAL CORES THROUGH RETAINING WALL
- PHASE 1: TRIAL PIT TO EXPOSE SHALLOW FOUNDATIONS
- PHASE 1: BOREHOLE FOR GEOTECHNICAL CHARACTERISATION
- PHASE 1: TRIAL PIT FOR CHEMICAL SAMPLING
- PHASE 2: EXTENT OF GROUND PENETRATING RADAR SURVEY OF EXISTING PILE CAPS & SHALLOW FOUNDATIONS
- PHASE 2: BOREHOLE FOR GEOTECHNICAL CHARACTERISATION
- PHASE 2: BOREHOLE FOR PARALLEL SEISMIC TESTING
- PHASE 2: TRIAL PIT
- PHASE 2: PROBE HOLE TO ESTABLISH FOUNDATION EXTENT
- PHASE 2: PROBE HOLE WITH CORE THROUGH FOUNDATION
- SERVICES (INDICATIVE ONLY, SEE OTHER PLANS FOR FULL SERVICES)
- ASSUMED PILE LOCATIONS (INDICATIVE ONLY)
