LNW137638
9 Harley Road, London

BUILDING DAMAGE ASSESSMENT
for the site at
9 HARLEY ROAD
LONDON
NW3 3BX
on behalf of
SITE ANALYTICAL SERVICES LTD

Report:	BUILDING DAMAGE ASSESSMENT
Site:	9 HARLEY ROAD LONDON NW3 3BX
Client:	SITE ANALYTICAL SERVICES LTD
Date:	DECEMBER 2015
Reference:	GE15167 – BDAv1JT151202
Version:	1.0
Prepared by:	 
	Jonathan Tingley CEnv, BEng (Hons), MSc, FGS, MEnvSc Technical Director
Reviewed by:	 
	Laura Legate CGeol, CSci, BSc (Hons), MSc, FGS Senior Consulting Engineer

Geo-Environmental Services Limited (Geo-Environmental) was instructed by Site Analytical Services Limited to prepare a building damage assessment for a proposed new basement at 9 Harley Road, London NW3 3BX.

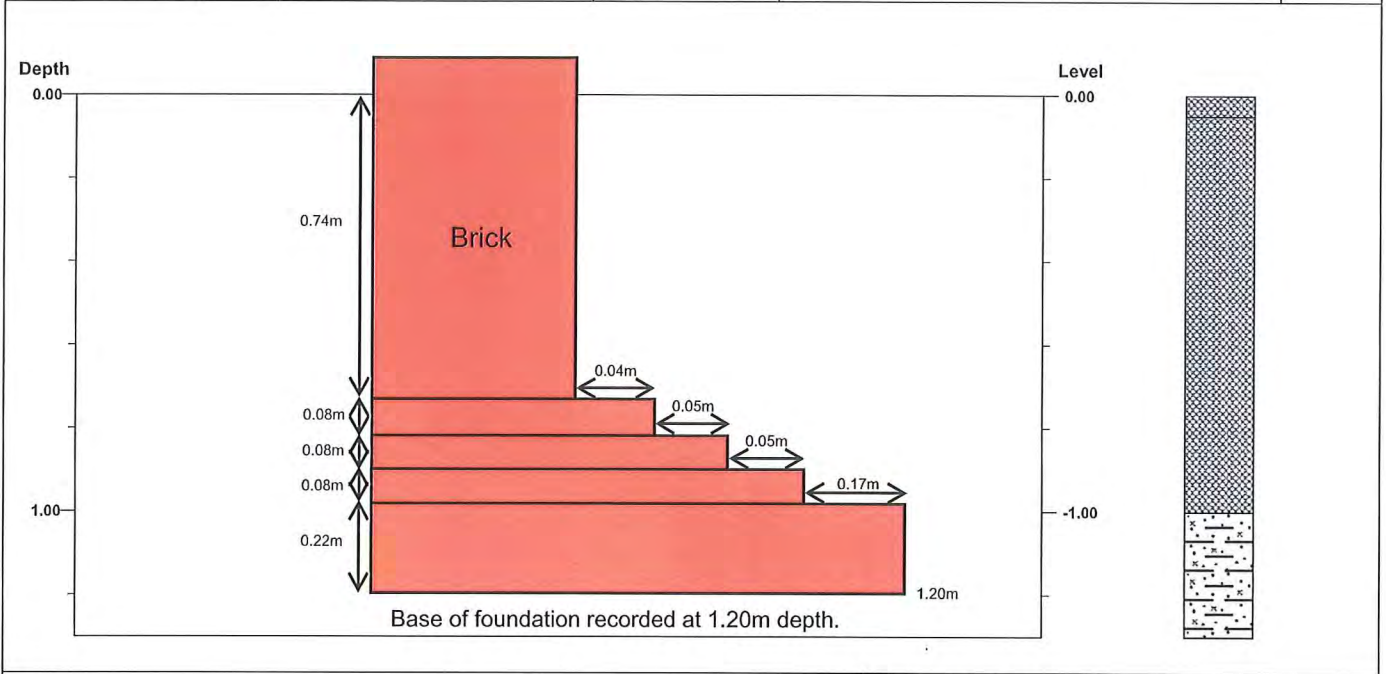
Scale (approx) 1:50	Logged By TM	Figure No. 1523973.TP1
-------------------------------	------------------------	----------------------------------

Strata			Samples and Tests		
Depth (m)	No.	Description	Depth (m)	Type	Field Records
0.00-0.05	1	MADE GROUND: Brick paving.			
0.05-1.00	2	MADE GROUND: Silty sandy slightly gravelly clay containing brick fragments and concrete cobbles.	0.25 0.50 0.75 1.00 1.20	D1 D2 D3 D4 D5	
1.00-1.30	3	Mottled brown silty sandy CLAY containing partings of silty fine sand.

Excavation Method:
HAND EXCAVATION

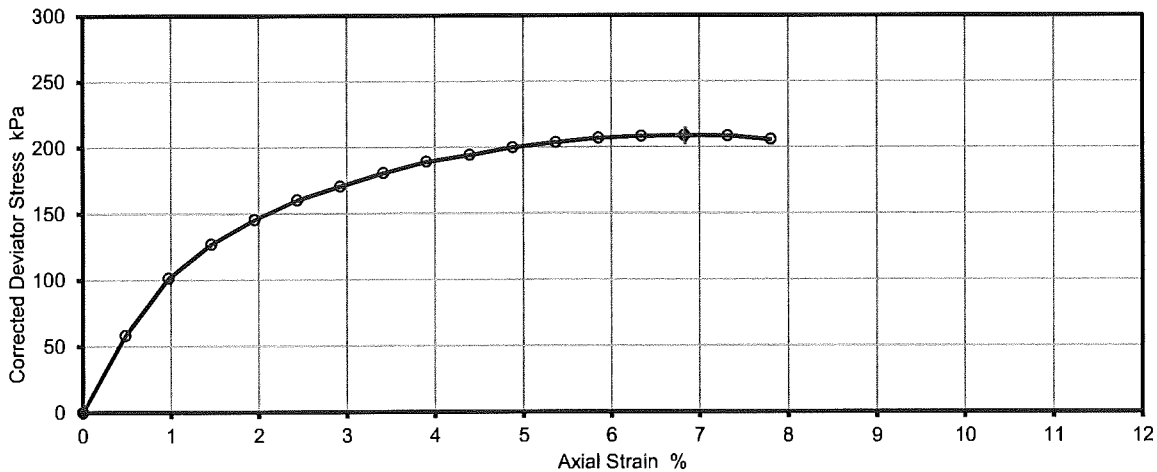
Test Number	1	
Length	205.0	mm
Diameter	105.0	mm
Bulk Density	1.89	Mg/m ³
Moisture Content	29	%
Dry Density	1.47	Mg/m ³
Rate of Strain	2.0	%/min
Cell Pressure	80	kPa
Axial Strain	6.8	%
Deviator Stress, (σ ₁ - σ ₃) _f	209	kPa
Undrained Shear Strength, c _u	104	kPa ½(σ ₁ - σ ₃) _f
Mode of Failure	Brittle

Deviator Stress v Axial Strain

Mohr Circles

Deviator stress corrected for area change and membrane effects

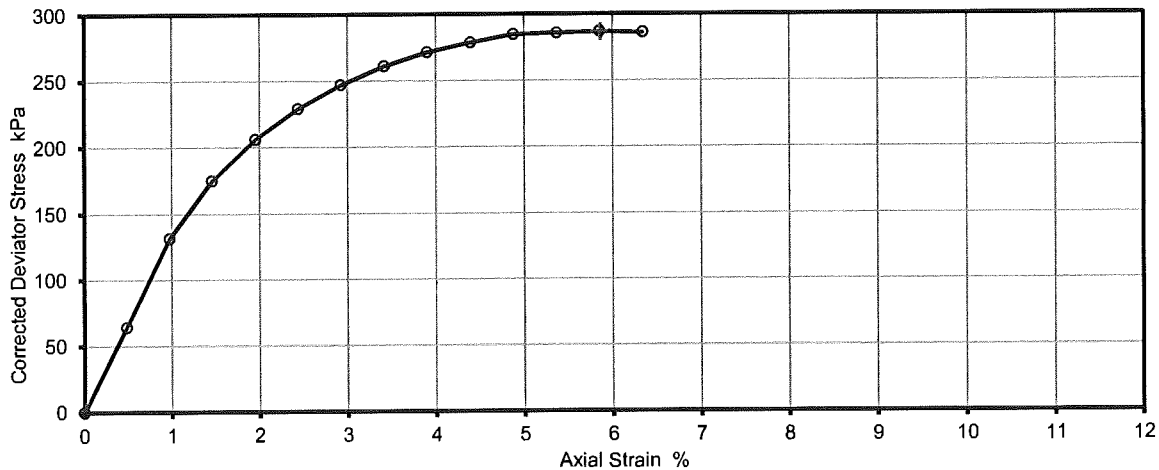
Test Number	1	
Length	205.0	mm
Diameter	105.0	mm
Bulk Density	1.91	Mg/m ³
Moisture Content	29	%
Dry Density	1.48	Mg/m ³
Rate of Strain	2.0	%/min
Cell Pressure	190	kPa
Axial Strain	5.9	%
Deviator Stress, ($\sigma_1 - \sigma_3$) f	287	kPa
Undrained Shear Strength, cu	143	kPa $\frac{1}{2}(\sigma_1 - \sigma_3)$
Mode of Failure	Brittle

Deviator Stress v Axial Strain

Mohr Circles

Deviator stress corrected for area change and membrane effects

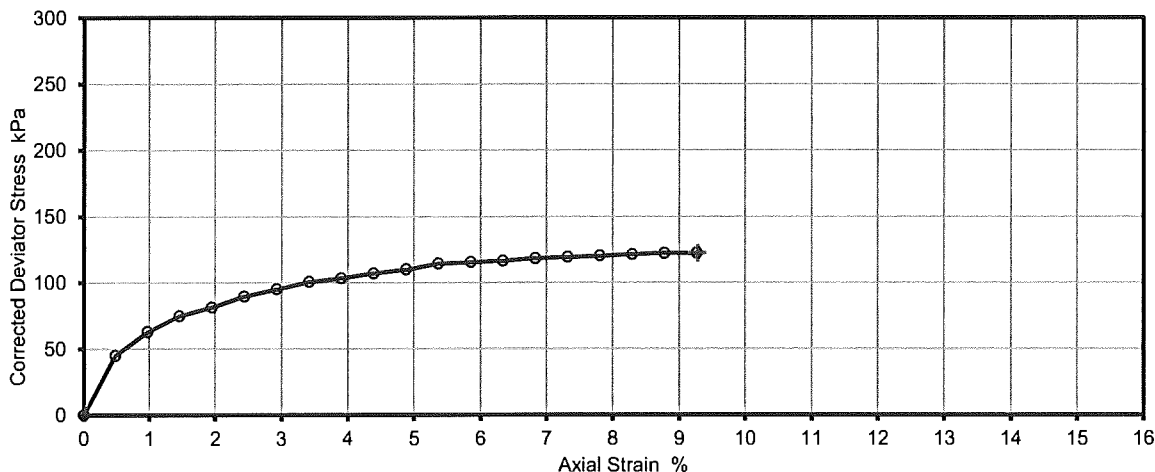
Test Number	1	
Length	205.0	mm
Diameter	105.0	mm
Bulk Density	1.89	Mg/m ³
Moisture Content	31	%
Dry Density	1.44	Mg/m ³
Rate of Strain	2.0	%/min
Cell Pressure	80	kPa
Axial Strain	9.3	%
Deviator Stress, (σ ₁ - σ ₃) _f	122	kPa
Undrained Shear Strength, cu	61	kPa ½(σ ₁ - σ ₃) _f
Mode of Failure	Brittle

Deviator Stress v Axial Strain

Mohr Circles

Deviator stress corrected for area change and membrane effects

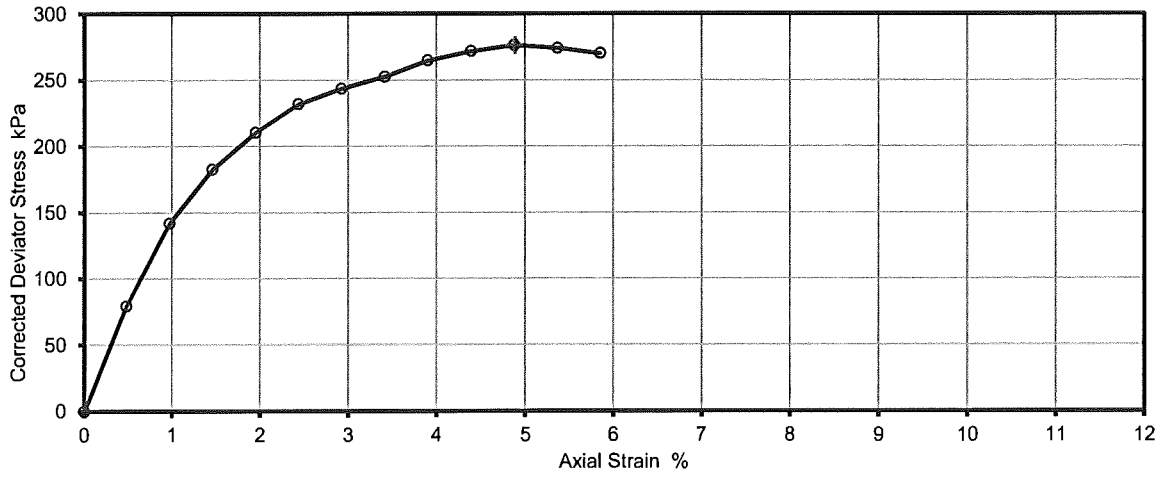
Test Number	1	
Length	205.0	mm
Diameter	105.0	mm
Bulk Density	1.93	Mg/m ³
Moisture Content	28	%
Dry Density	1.51	Mg/m ³
Rate of Strain	2.0	%/min
Cell Pressure	190	kPa
Axial Strain	4.9	%
Deviator Stress, (σ ₁ - σ ₃) _f	276	kPa
Undrained Shear Strength, c _u	138	kPa ½(σ ₁ - σ ₃) _f
Mode of Failure	Brittle

Deviator Stress v Axial Strain

Mohr Circles

Deviator stress corrected for area change and membrane effects

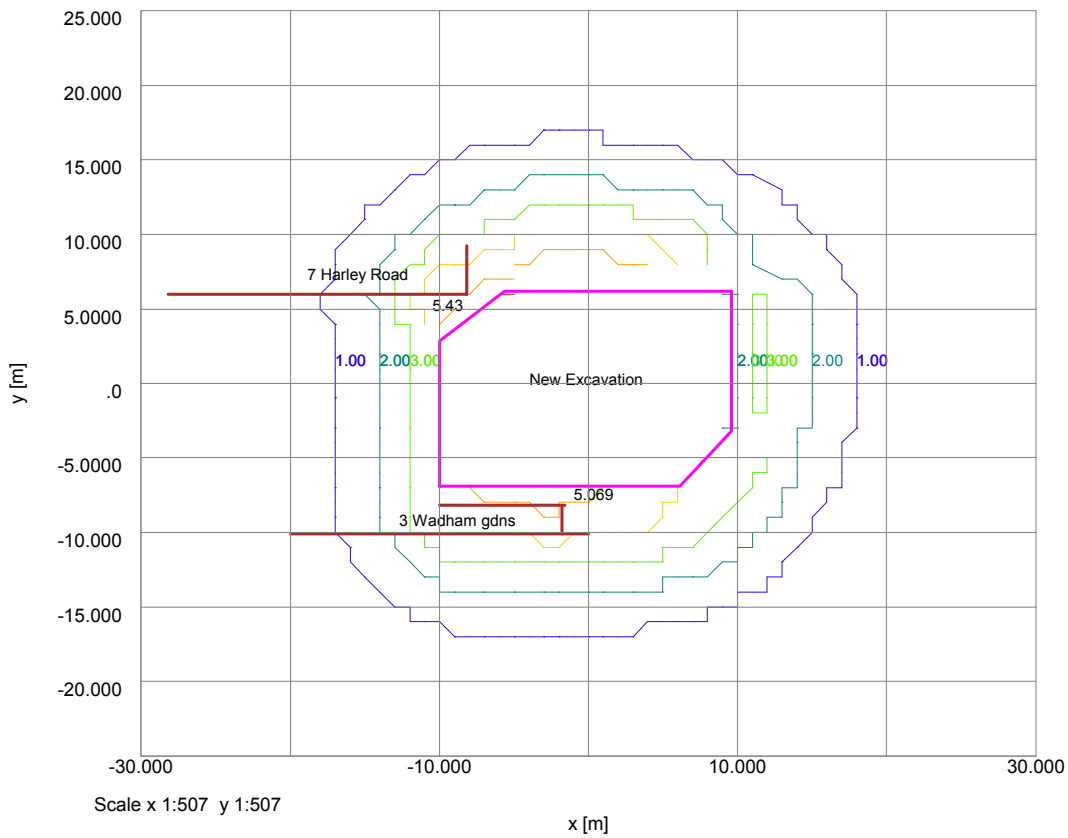
Job No.	Sheet No.	Rev.
GE15167		
Drg. Ref. Figure 7		
Made by JT	Date 30-Nov-2015	Checked

Vertical Settlement Contours: Grid 1 (level 0.000m) (Interval 1mm)

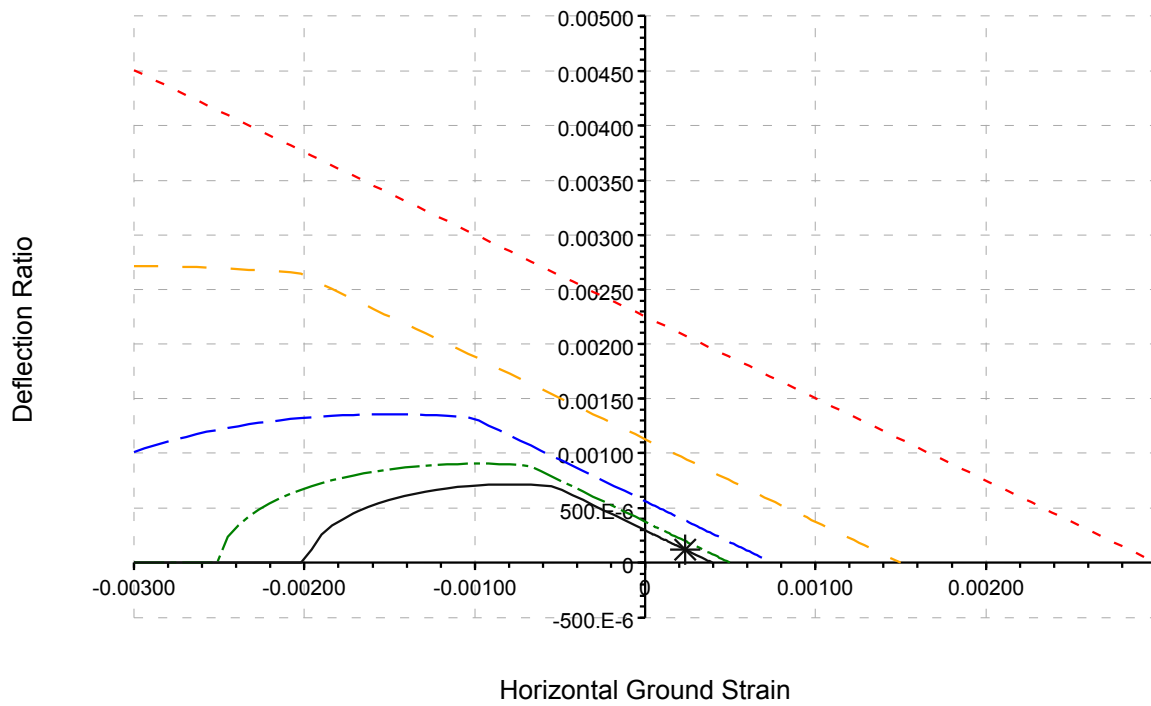
Structure 5: 7 Harley Road/Main Party Wall, Offset 1: 0.000m, Segment 1: length 7.003 m

- Cat. 0 (Negligible) to 1 (Very Slight)
- Cat. 1 (Very Slight) to 2 (Slight)
- Cat. 2 (Slight) to 3 (Moderate)
- Cat. 3 (Moderate) to 4 (Severe)
- Max Strains (-0.001976) (0.000395)
- * Result (0.000236, 0.000119 - Cat. 0)

FIGURE 13 Damage Classification Chart for 7 Harley Road Main Party Wall
