**6 NUTLEY TERRACE, GREATER LONDON**

**DAYTIME BAT SURVEY**

Report No: RT-MME-118690-02

Date: January 2015

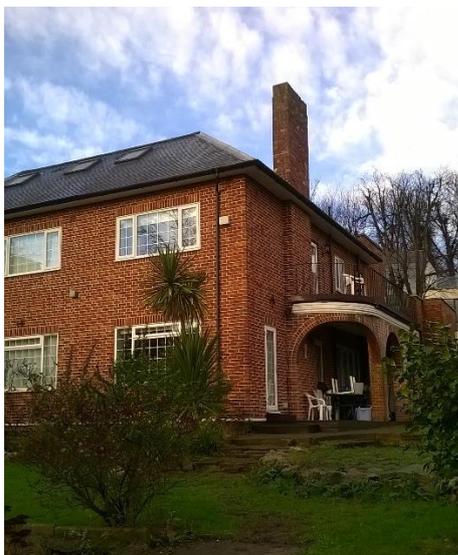
The main house on site was a modern two-storey brick structure with a concrete tiled flat-topped pyramid roof (Plates 4.1 and 4.2). A small pitched section with a hipped end extended north from the north eastern corner of the main roof.

**Plate 4.1: 6 Nutley Terrace viewed from the South.**

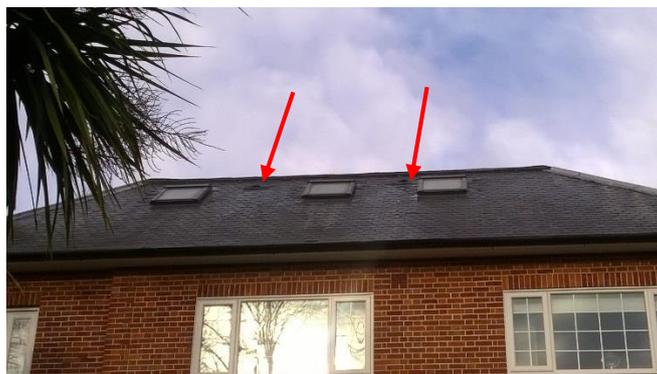
A number of skylights were installed into the pitched elevations of the roof. A number of roof tiles were slipped and broken on the northern and southern elevations, in particular around the skylights on these elevations (Plate 4.3). Areas of the southern elevation appeared to have been patched with roofing felt

where tiles had been removed. The lifted and missing tiles provide potential ingress points for roosting bats but due to their height these features could not be fully inspected at the time of the survey.

**Plate 4.3: Missing and slipped tiles of southern elevation.**

The main house had a number of features suitable for roosting bats. These included slipped and missing roof tiles on the north and south elevations. Due to the height of the building it was not possible to assess the flat roof; and the presence of a parapet wall meant it was not possible to fully assess the northern pitch.

Due to the features of the building identified as suitable for roosting bats but which could not be fully inspected, the building is concluded to have a high potential for use by roosting bats. As such, recommendations are made in Section 6.

It is recommended that an endoscope survey of the missing and lifted tiles noted on the southern elevation is carried out (from an extendable moving platform or scaffolding). This will also allow an assessment of the flat roofed section. If all these features are fully accessed and surveyed, and no bats or evidence of bat activity (in the form of scratch marks, feeding remains, grease marks, urine staining or droppings) are found, then works can commence as planned as no bat roost is present. However, if any areas are inaccessible, evidence of bat activity is identified, or it is not possible to conclusively state that bats are not present then it will be necessary to undertake the bat activity surveys outlined in Option 2.

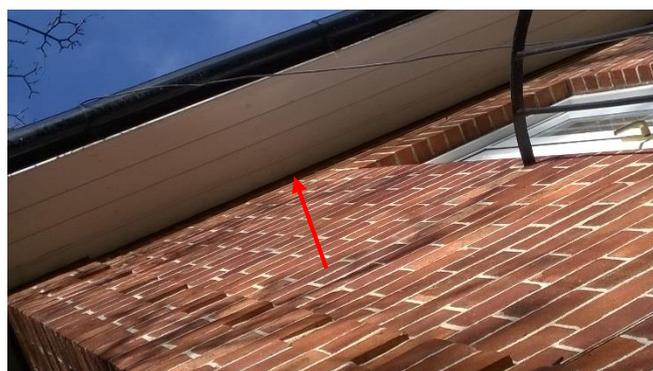
uPVC soffits and plastic guttering were present on the east, south and western elevations of the building. The soffit was in good condition, but occasional gaps were present between the soffit and brickwork of the walls (Plate 4.4). When inspected with a high powered torch and binoculars these were found to be heavily cobwebbed, indicating no recent faunal use.

**Plate 4.3: Gap between soffit and brickwork.**
