APPENDIX 2

ENVIRONMENTAL SEARCHES

Address: LAND BY 1,ELLERDALE ROAD,LONDON, NW3 6BA

It is understood that it is proposed to construct a new garden house within the rear garden of the existing property at 1 Ellerdale Road, Hampstead. Consequently, a site investigation has been undertaken in order to ascertain the nature and engineering properties of the soils underlying this site, and to obtain data which will assist in the formulation of a safe and economical foundation solution.

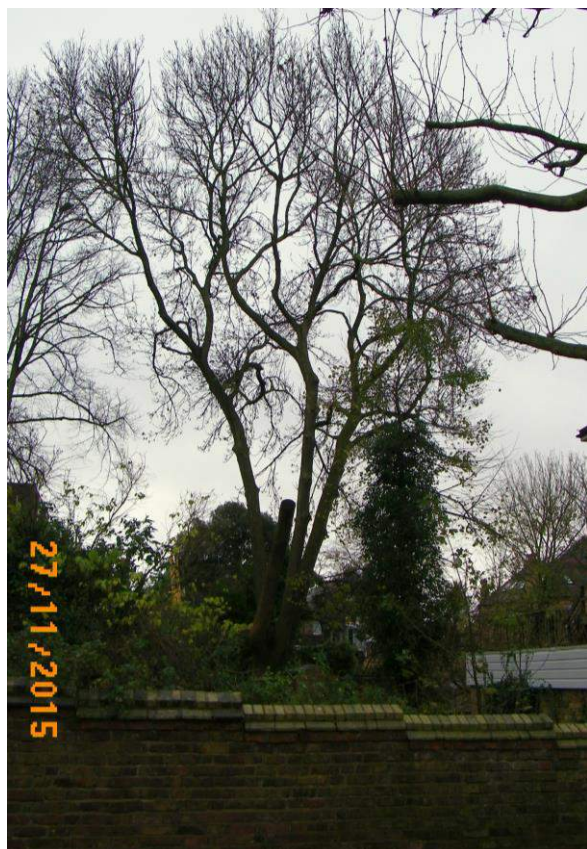
Fig.1 Subject tree T1 as seen from Ellerdale Road, looking east

- 4.1 The subject tree T1 is a mature common ash (*Fraxinus excelsior*) which is the subject of a tree preservation order – See Fig.1. It is approximately 22 metres in height, has a broadly symmetrical crown extending approximately 7 metres from the stem in all directions and a stem diameter of 700mm (estimated) – See Fig.2. It has good vitality and no obvious structural defects. We consider this tree of moderate quality with a life expectancy of up to 40 years in its current urban setting, hence a ‘B’ category.

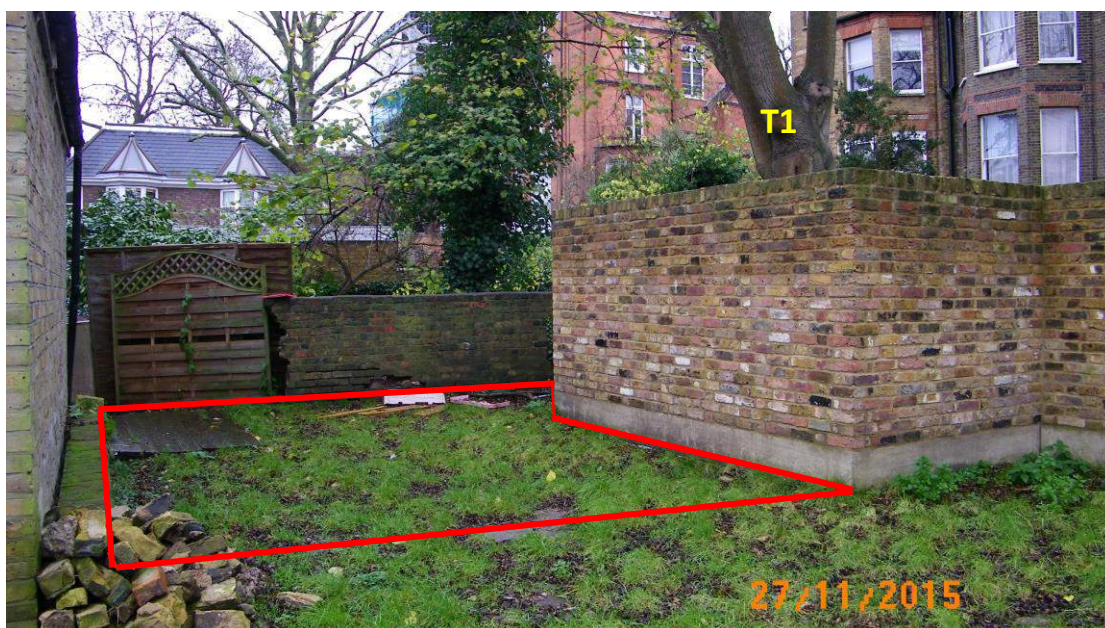
Fig.3 View of site, showing area in which arboricultural supervision will be required during any excavation or ground works i.e. within red line

- 6.1 Although the type of foundation design that is proposed for the main structure would not facilitate a watching brief in respect of root treatment, any excavation works that take place at the west end of the site (see appendix 1 & Fig.3) should be undertaken under the direct supervision of the appointed arboriculturist, who can advise on the most appropriate methods of severing and/or protecting tree roots that may be encountered. Such advice cannot be given pre-emptively, but should be scheduled to coincide with commencement of the relevant ground works.
