Factual Report on Ground Investigation

Denmark Place, London

Report No. 36237-001
June 2008

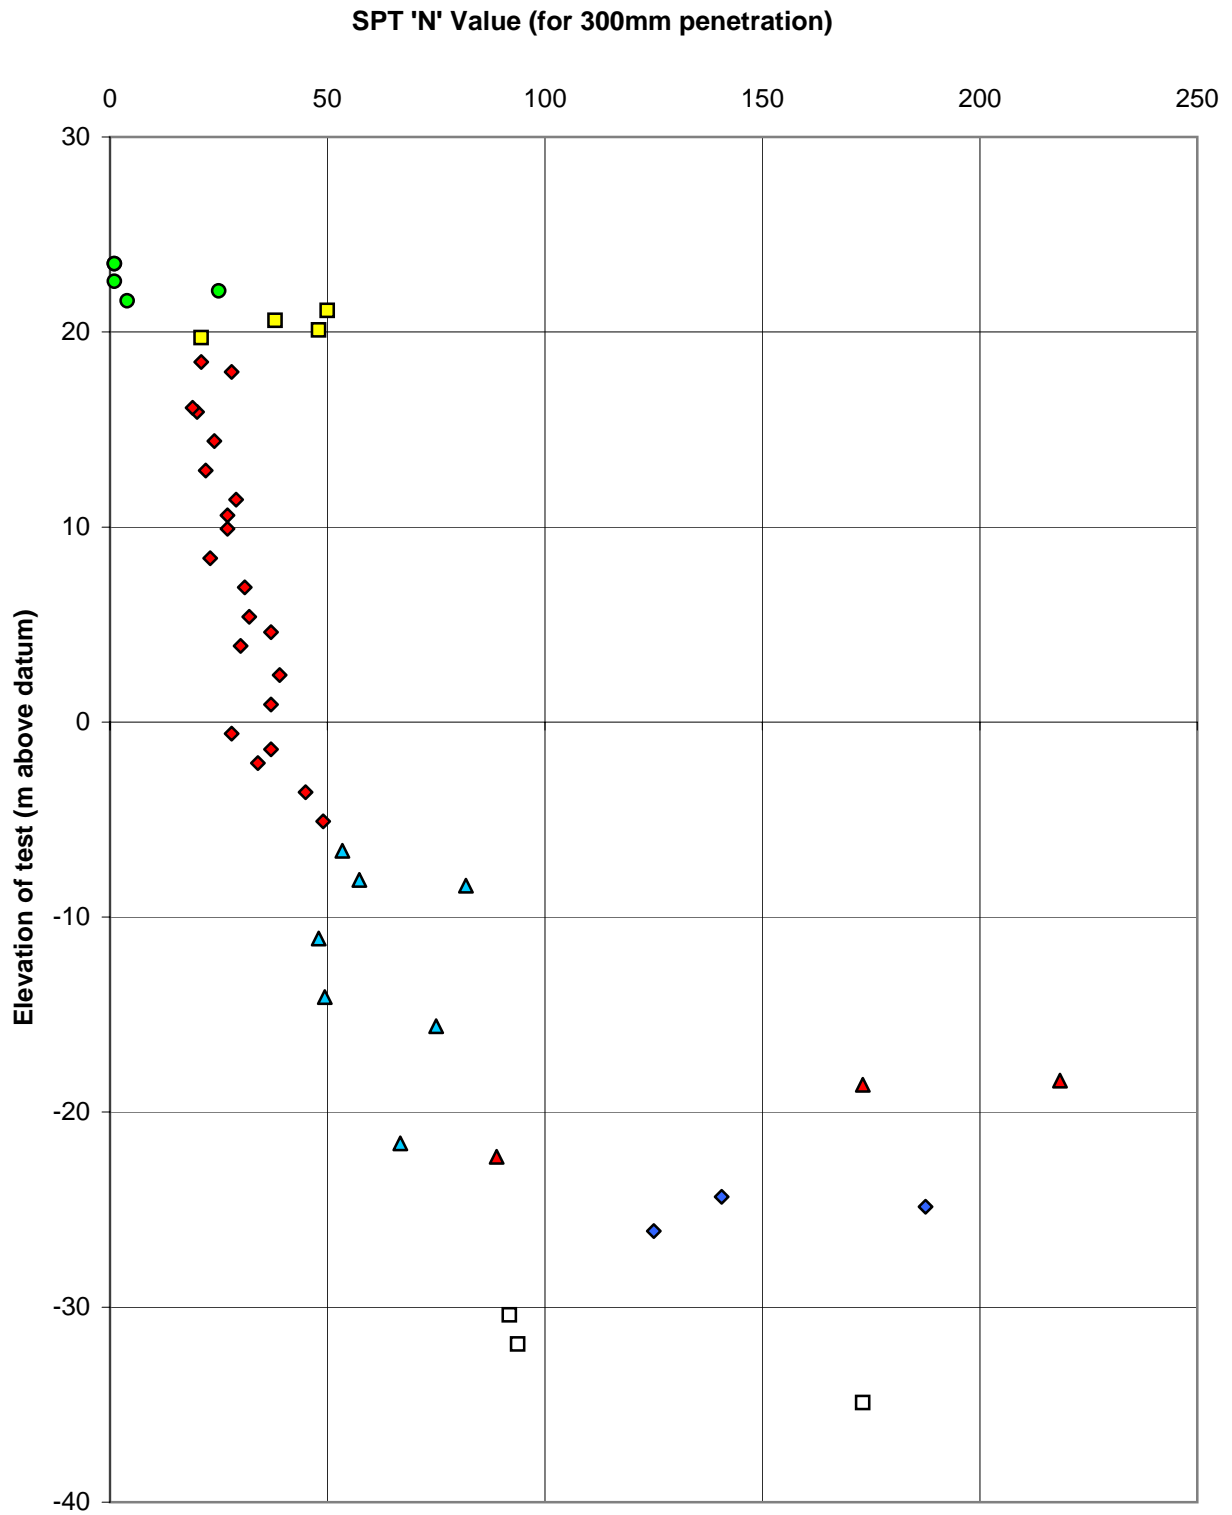
SPT 'N' VALUES vs Elevation

- ▲ Lambeth Group (Cohesive) ▲ Lambeth Group (Granular) ◆ London Clay
- Made Ground ■ River Terrace Deposits ◆ Thanet Sand Formation
- White Chalk

Soil Parameters	Range	Results
Liquid Limit (%)	32	Appendix B; Figure 6
Plastic Limit (%)	17	Appendix B
Plastic Index (%)	15	Appendix B; Figure 6
Modified Plasticity Index (%)	7.5 to 15	
Volume Change Potential (NHBC)	Low	
Moisture Content (%)	16 to 28	Appendix B; Figure 5
SPT 'N' Values	1 to 25	Appendix A; Figure 3

Soil Parameters	Range	Results
SPT 'N' Values	21 to 50	Appendix A; Figure 3
Density Term	Medium Dense to Very Dense

Soil Parameters	Range	Results
Moisture Content (%)	13	Appendix B; Figure 5
SPT 'N' Values	89 to 218	Appendix A; Figure 3
Density Term	Very dense

Soil Parameters	Range	Results
SPT 'N' Values	125 to 188	Appendix A; Figure 3
Density Term	Very dense

Soil Parameters	Range	Results
SPT 'N' Values	92 to 173	Appendix A; Figure 3
Moisture Content (%)	21.1 to 26.2	Appendix B
Saturation Moisture Content (%)	22.3 to 26	Appendix B
Dry Density (Mg/m ³)	1.55 to 1.69	Appendix B
Uniaxial Compressive Strength (MPa)	3.7 to 5.2	Appendix B
Young' Modulus (GPa)	0.08 to 0.17	Appendix B
Density Scale	Medium Density

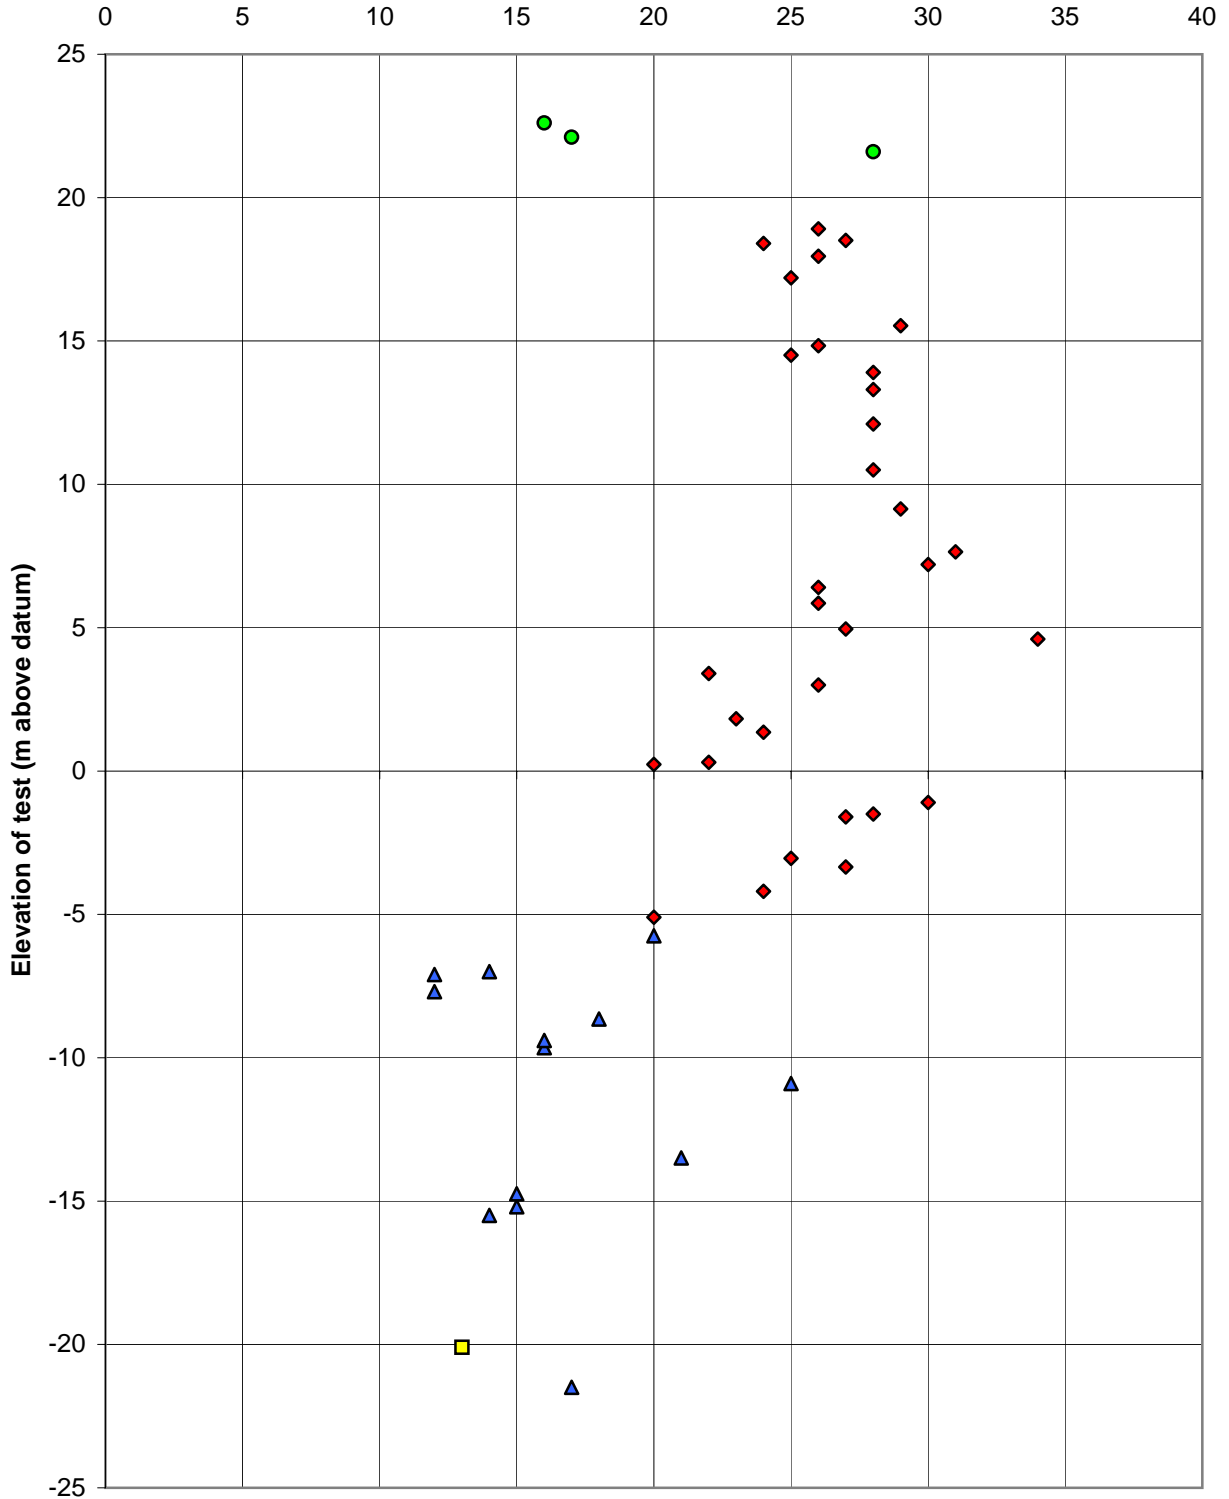
MOISTURE CONTENT vs ELEVATION

Natural Moisture Content (%)

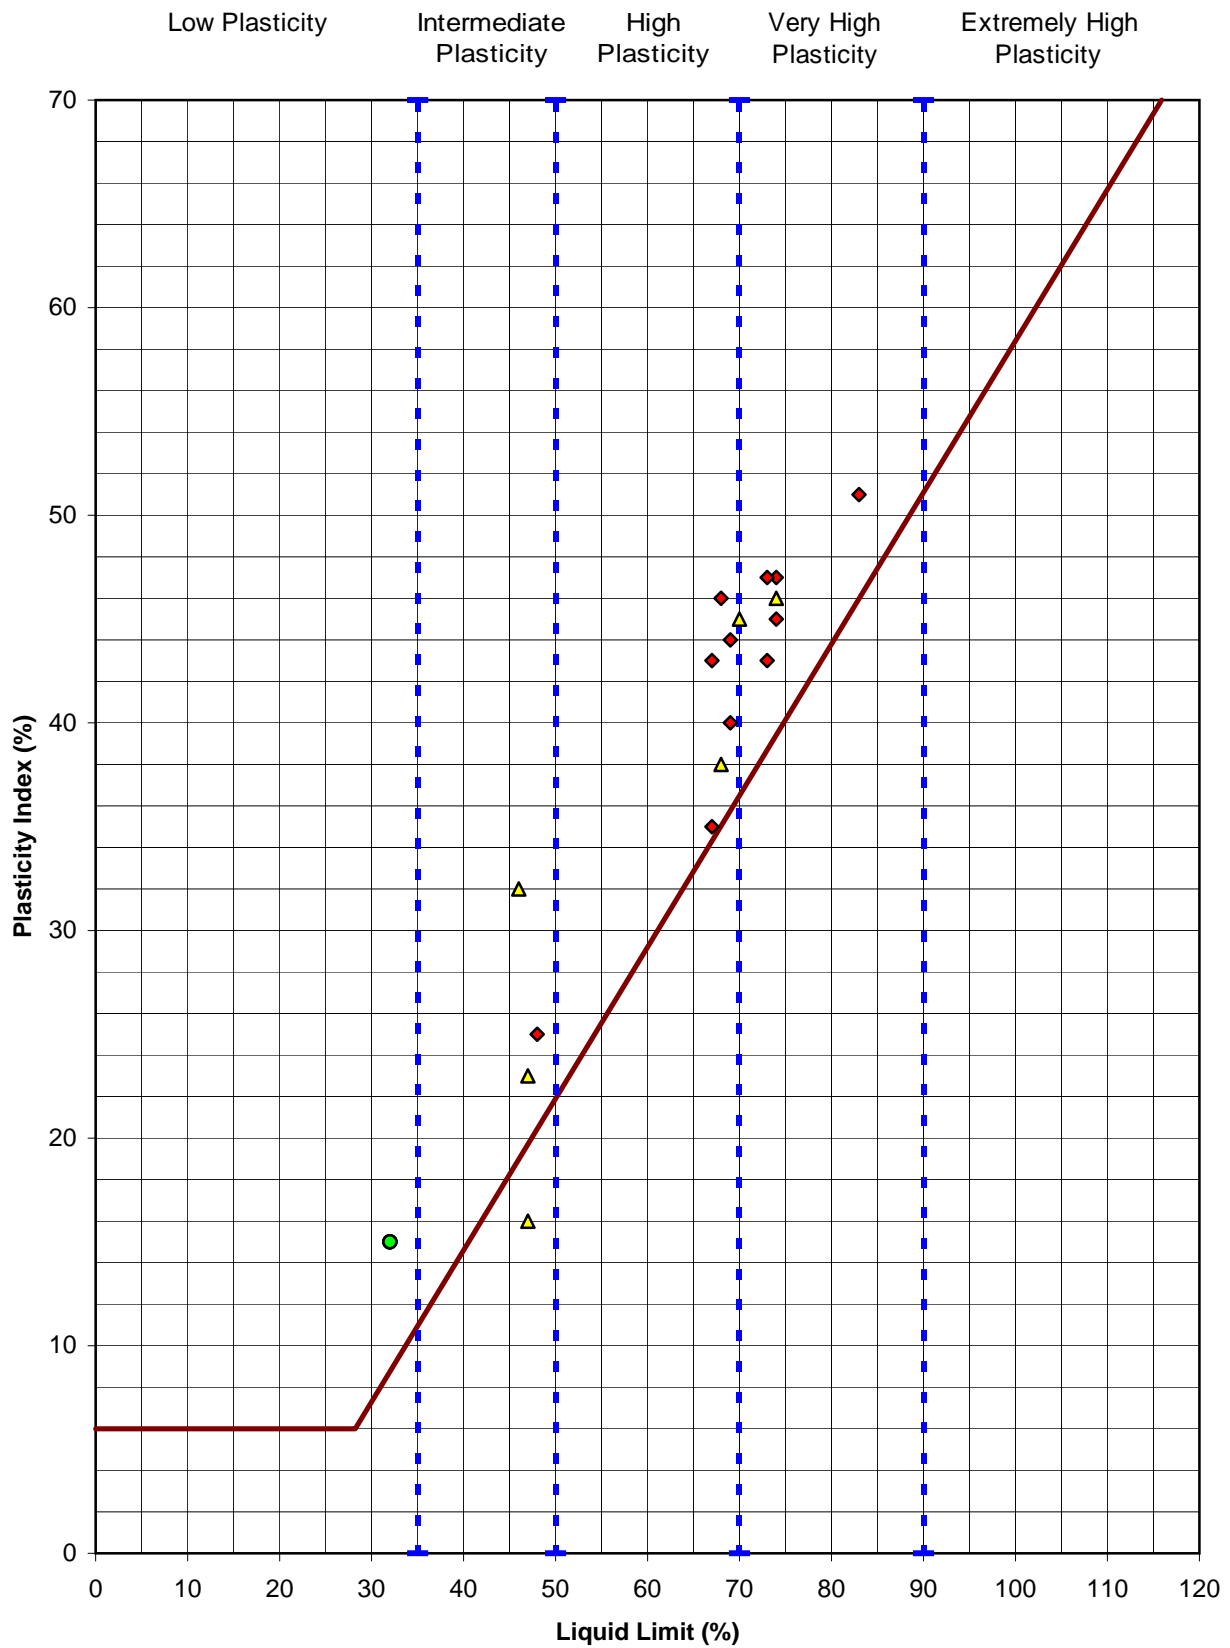
PLASTICITY CLASSIFICATION CHART

▲ Lambeth Group (Cohesive) ■ Lambeth Group (Granular) ◆ London Clay ● Made Ground

Soil Parameters	Range	Results
Liquid Limit (%)	48 to 83	Appendix B; Figure 6
Plastic Limit (%)	22 to 32	Appendix B
Plastic Index (%)	25 to 51	Appendix B; Figure 6
Modified Plasticity Index (%)	22.25 to 51	
Plasticity Term	Intermediate to Very High	Figure 6
Volume Change Potential (NHBC)	Medium to High	
Moisture Content (%)	20 to 34	Appendix B; Figure 5
SPT 'N' Values	19 to 49	Appendix A; Figure 3
Undrained Shear Strength (kN/m ²) measured by Triaxial Testing	64 to 360	Appendix B; Figure 4
Strength Term	Firm to Very Stiff

Soil Parameters	Range	Results
Liquid Limit (%)	46 to 74	Appendix B; Figure 6
Plastic Limit (%)	14 to 31	Appendix B
Plastic Index (%)	16 to 46	Appendix B; Figure 6
Modified Plasticity Index (%)	16 to 46	
Plasticity Term	Intermediate to Very High	Figure 6
Volume Change Potential (NHBC)	Low to High	
Moisture Content (%)	12 to 25	Appendix B; Figure 5
SPT 'N' Values	48 to 82	Appendix A; Figure 3
Undrained Shear Strength (kN/m ²) measured by Triaxial Testing	193 to 955	Appendix B; Figure 4
Strength Term	Very Stiff to Hard
